# Operation UPSHOT-KNOTHOLE

EFFECTS OF AN ATOMIC EXPLOSION ON TWO TYPICAL  
TWO-STORY-AND-BASEMENT WOOD-FRAME HOUSES

FEDERAL CIVIL DEFENSE ADMINISTRATION  
WASHINGTON D.C.

Federal Civil Defense Administration  
Washington, D. C.  
September 1953

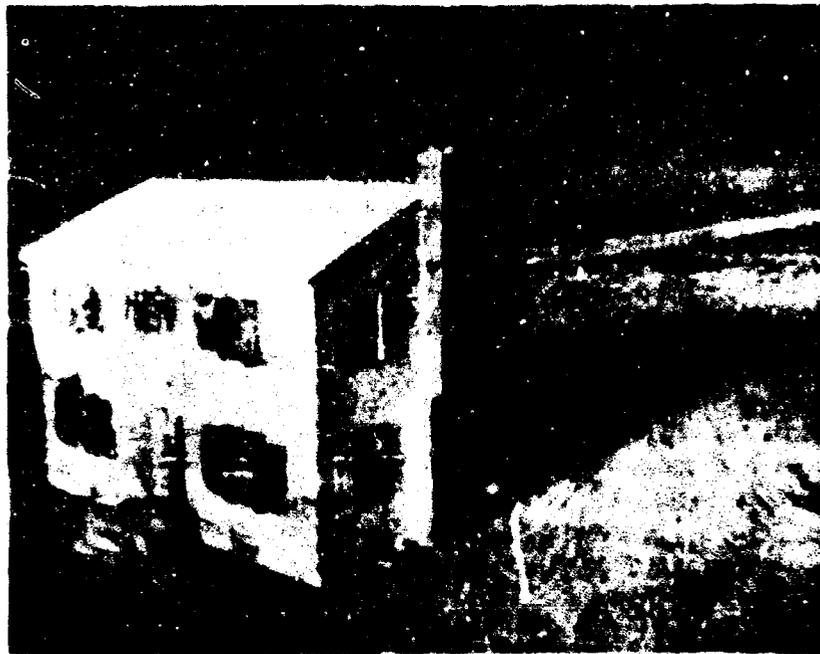
**Fig. 1.2**—House at 3500 ft,  $\frac{1}{100}$  sec after detonation. The charring deepens around the windows and doors; the wood base of the floodlight pole (lower right) is smoking.

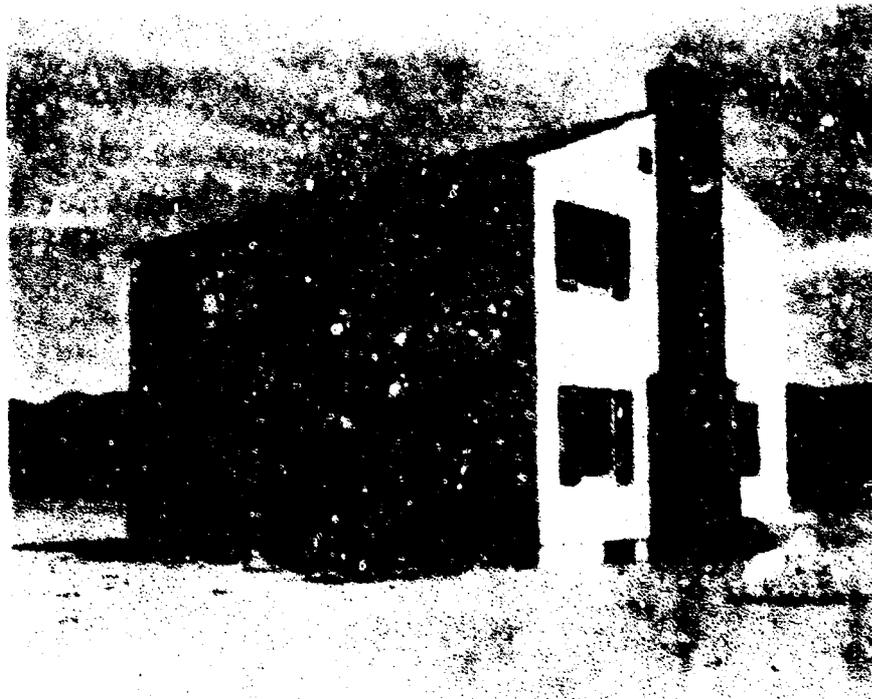
Fig. 2.2—House at 7500 ft after the blast.

Figures 2.1 and 2.2 show the far-range house before and after the blast. Figures 2.3 to 2.6 show blast damage from the outside on sides and rear of the house. Doors, windows, and window frames in general either were blasted out of the walls or remained in place in badly damaged condition. The glass in the windows was shattered into small particles and scattered uniformly about the interior of the house. The exceptions to the general rule were four windows in the rear of the house, which had been sheltered by partitions from the blast that entered through the front and side openings, and the basement windows in the rear of the house, which were blown open inward.

Considerably less damage to the sash would have occurred if, instead of the commercial type of sash with its comparatively weak muntins, a stronger improved design had been specified. The window frames would probably have remained in place in the walls if they had been nailed through blocks into the studs of the jambs.

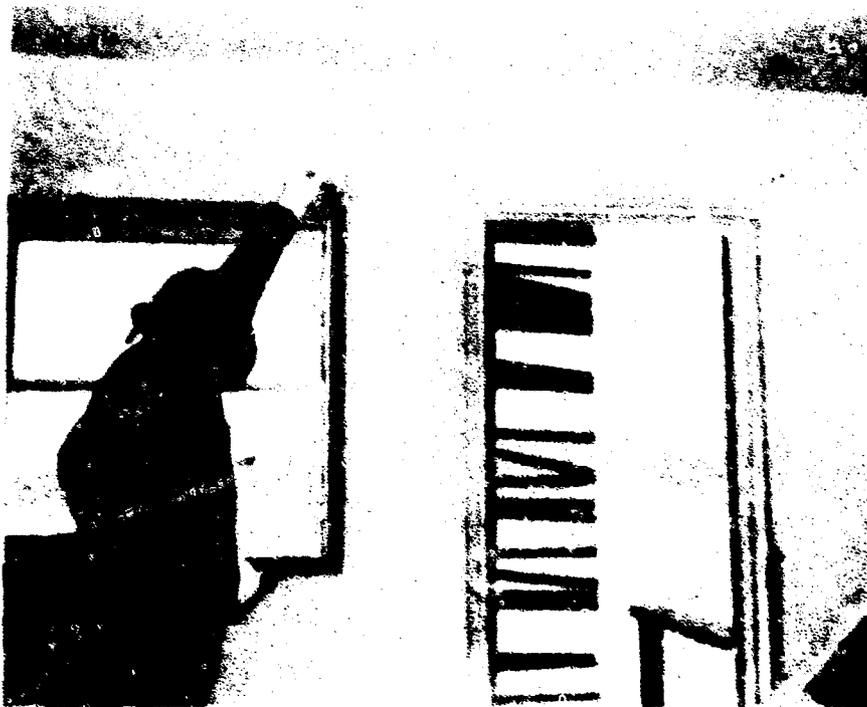
The kitchen in the rear of the house was protected somewhat by the partition wall between it and the dining room, yet furniture was thrown about, and the door to the dining room was broken and portions embedded in the plaster of the rear wall, as shown in Fig. 2.24. Figure 2.25 shows part of the kitchen-celling damage. The kitchen wall on the side of the house, between the door and window, bulged inward slightly, causing plaster cracks, as indicated in Fig. 2.26. The studs in this part of the wall may have been broken.

Fig. 2.26—Kitchen entrance after the blast showing plaster cracks.

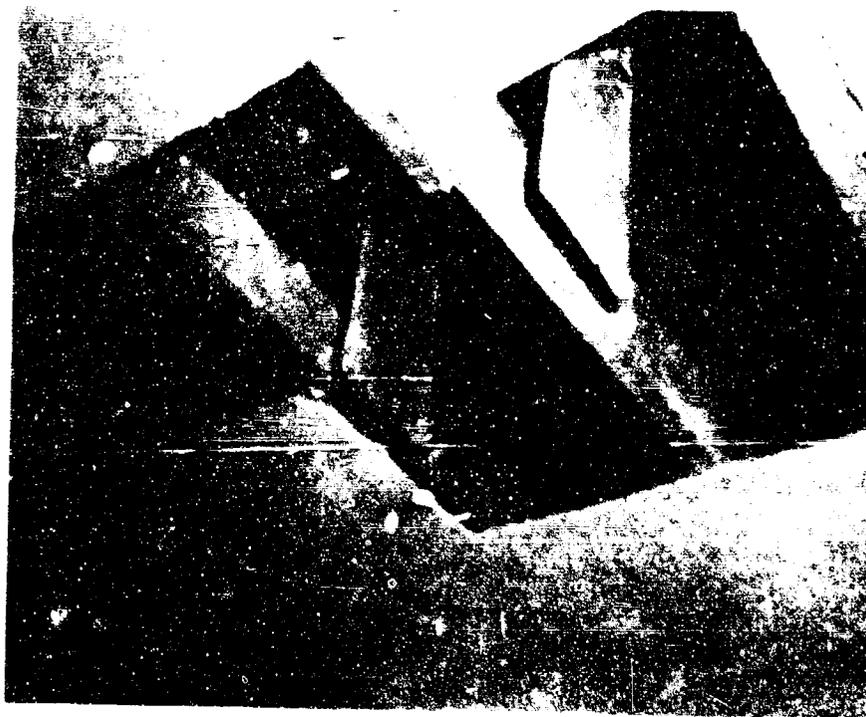
Figure 2.33 is a view of the front roof rafters taken through the hole in the master-bedroom ceiling. Only one broken roof rafter is visible. However, all roof rafters on the front of the house with the exception of one near the gable end were broken at approximately midspan (see Fig. 2.34). A photograph (Fig. 2.35) taken through a hole in the rear-bedroom ceiling shows the ridge board, which was carried down by the broken rafters in the front of the house, and the rear roof rafters that suffered no damage. Figure 2.36 shows damage to the south closet in the master bedroom and the Venetian blind from the front window of this room.

**Fig. 2.33—Master-bedroom ceiling damage.**

In the front of the house the 2- by 6-in. roof rafters, which were spaced 16 in. on centers, failed in bending at the middle of the span. While the size of these rafters is satisfactory for the usual static load, this test proved that, under blast loading, the roof construction was the weakest structural part of this house. No other structural portions failed so completely.

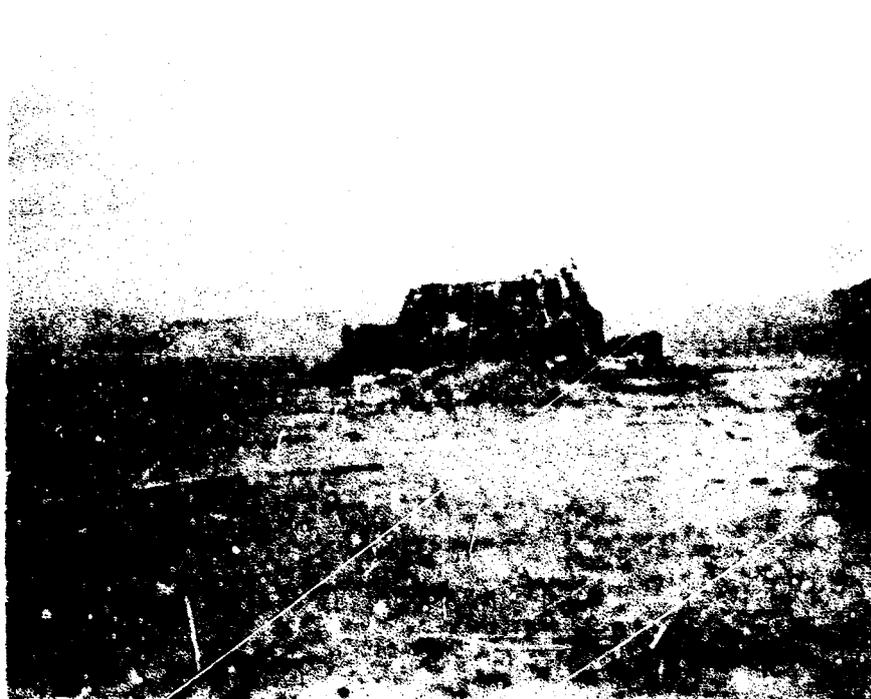
Figure 2.42 shows the large area over which debris was scattered. The front half of the roof broke in the middle at approximately the midspan of the rafters, the lower part lifting at the eaves, as shown by motion pictures, pivoting about the break, and sailing through the air to land on the ground in the rear of the house (see Fig. 2.43). The upper part of this broken roof was found upside down on the ground in front of the house, as shown in Fig. 2.44. The rear half of the roof slid off the house to the rear over a test automobile shown in Fig. 2.45. This section was later laid on the ground at the back of the house and can be seen in Fig. 2.43.

**Fig. 2.42—Debris from the house at 3500 ft.**

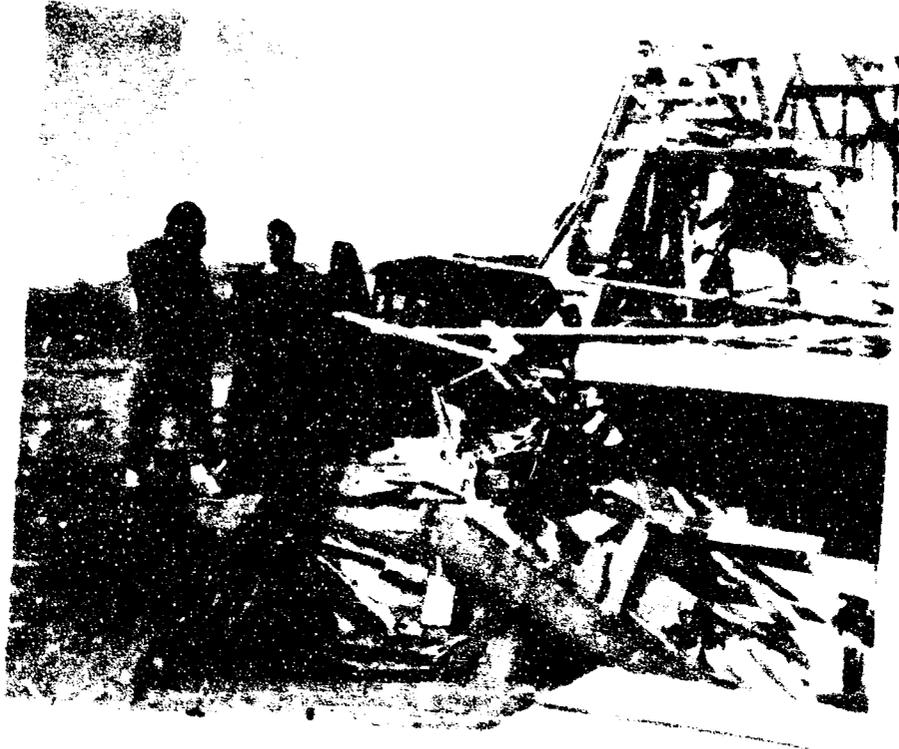
Fig. 2.55—Rotation and movement of the second story at front.

The second story did not drop vertically on the first floor but moved with a clockwise rotation in relation to the front basement wall of the house. The right front corner of the second floor settled 5 ft 8 in. from the front and 8 ft 3 in. from the right-side basement wall, while the left front corner of the second floor was 12 ft from the front basement wall and overhung the left-side basement wall by 10 ft 2 in. The motion appeared to be a rotation and a movement toward the left rear corner of the foundation wall. This is shown in Fig. 2.55.

The box-sill construction used at the top of the block foundation wall failed. Generally, the 2- by 8-in. plate, which was bolted to the block wall, remained in place. In the front of the house, the 2- by 8-in. closure or header split at the top horizontally, with the top portion moving with the first floor and the lower portion remaining with the plate, as shown in Fig. 2.55. At the sides of the house, where the closure was nailed into the ends of the floor joists, the nails bent, allowing the joists to slide to the rear of the house with the floor and separating the closure from the plate. This is also illustrated in Fig. 2.55.

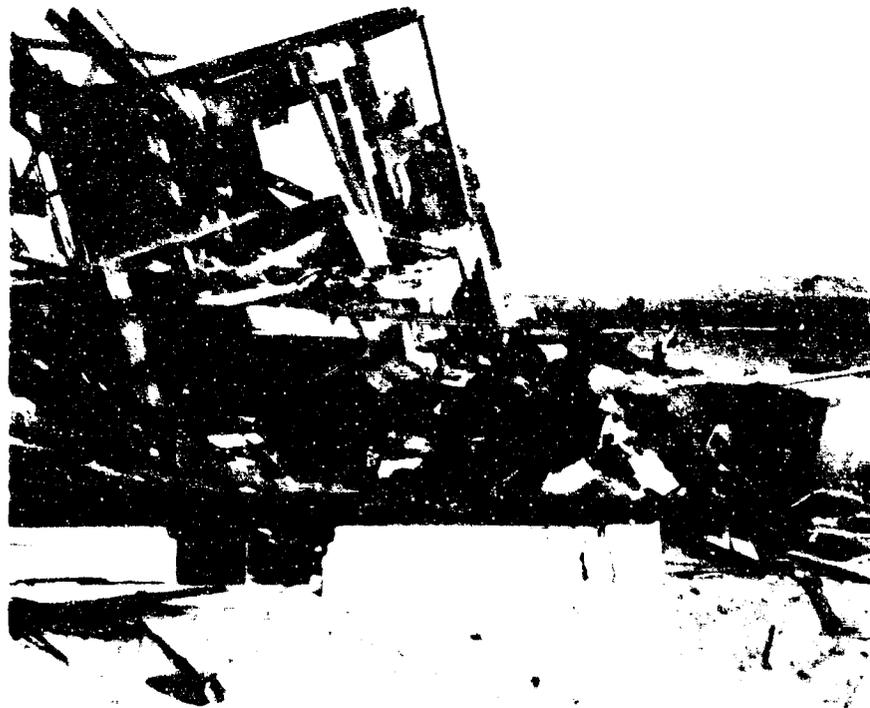
**Fig. 2.57—Front foundation wall above grade after the blast.**

The foundation wall above grade suffered little damage on the front and sides but was damaged at the rear by the movement of the first-floor system. However, the front foundation wall (Fig. 2.57) was cracked through vertically from sill to basement floor at each end, about 1 ft from the corner, and was moved in at the top about 1 in., hinging at the basement floor level. The hinged wall showed no bowing or cracking, however. Lateral earth pressure due to the pressure on the ground in front of the house was the most probable cause of this effect.
