**Loss of Pitch Control on Takeoff
Emery Worldwide Airlines, Flight 17
McDonnell Douglas DC-8-71F, N8079U
Rancho Cordova, California
February 16, 2000**

Aircraft Accident Report
NTSB/AAR-03/02

**NTSB/AAR-03/02
PB2003-910402
Notation 7299A
Adopted August 5, 2003**

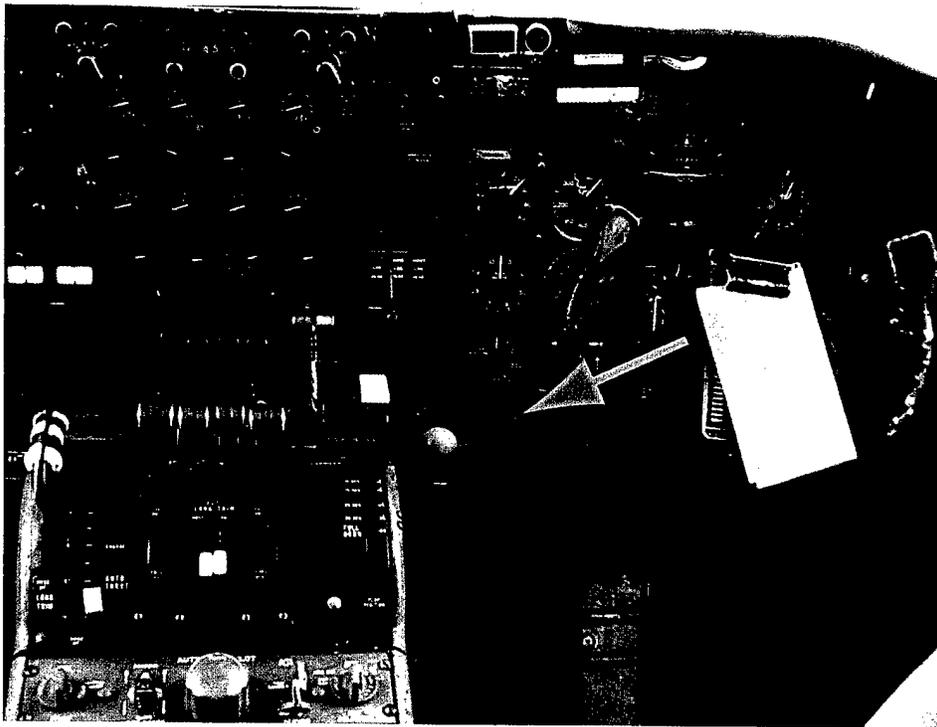
AD 78-01-15 specified that operators install the EPI gauge on the first officer's instrument panel such that full forward movement of the control column and wheel would not obstruct the first officer's view of the gauge. The AD did not comment regarding visibility of the gauge from the captain's seat. As a result, DC-8 operators installed the EPI where they found room for it and where the first officer could see it on an airplane's existing instrument panel. Because Emery purchased its DC-8s from several other operators and EPI placement was not standardized, EPI gauges in Emery's fleet were installed in several different locations; according to Emery personnel, however, they were generally installed on the lower portion of the first officer's instrument panel.

Figure 4. EPI installation on the lower left side of the first officer's instrument panel (shown by the yellow arrow), similar to that on the accident airplane.

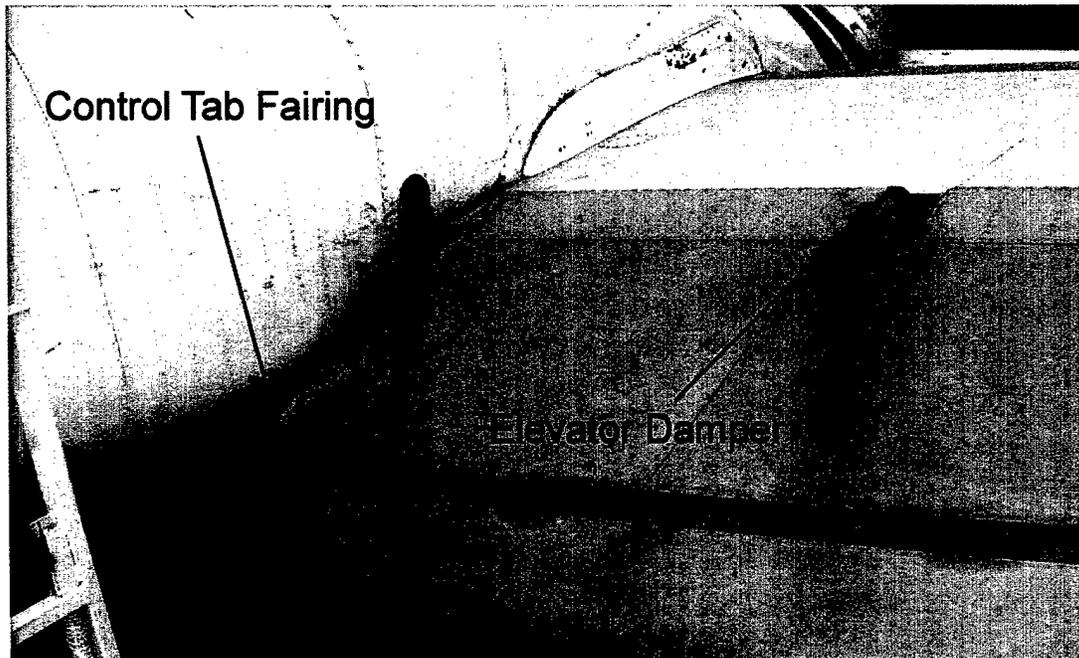
The accident airplane's maintenance records revealed that on November 25, 1999, eight days after the D inspection was completed (which included the installation of the elevator assemblies), a pilot reported that he had to apply "more back pressure than normal" on the control column to flare during the preceding landing and during the elevator check before the previous takeoff. The corrective action for this pilot report (performed by Emery maintenance personnel) was described in the accident airplane's maintenance logbook as follows: "Found [left/right] elevator dampers reversed, moved [left to right] side, [right to left] side, ops ck'd good, no defects noted." Figure 5 shows the elevator damper's location on the right elevator of a DC-8.

Figure 5. Photograph showing the elevator damper's location on the right elevator of a DC-8.

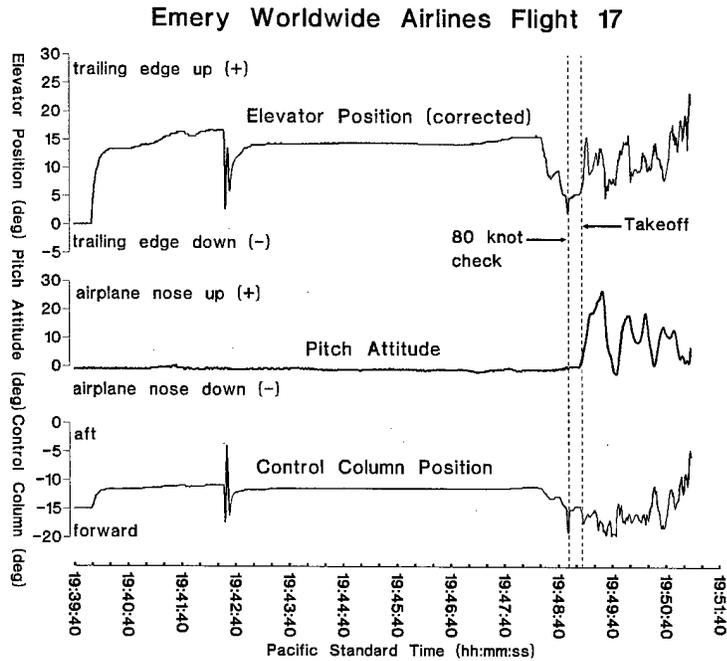
The Safety Board's examination of the corrected elevator position data revealed that the airplane's elevator never traveled below its neutral position to a TED deflection during the accident flight, although recorded forward control column inputs should have resulted in a TED elevator deflection. For example, although the FDR data indicated that, during the 80-knot elevator check at MHR, the control columns were moved to about 6° forward of their rigged neutral position, the elevators did not deflect below 2.2° TEU. In contrast, during the 80-knot elevator check on the previous takeoff (at RNO) the FDR recorded elevator movement to 8° TED, with less forward control column movement. Figure 7 shows plots of the pitch attitude, control column position, and elevator position FDR data for the accident flight. Elevator position is shown using the conversion that corrected for the 11° offset. Figure 7 also shows when the 80-knot elevator check and takeoff occurred. Figure 8 shows the same information for the takeoff from RNO.

Figure 7. Pitch attitude, control column position, and (corrected) elevator position FDR data from the accident flight. About the first 20 seconds of data were recorded while the gust lock was engaged.

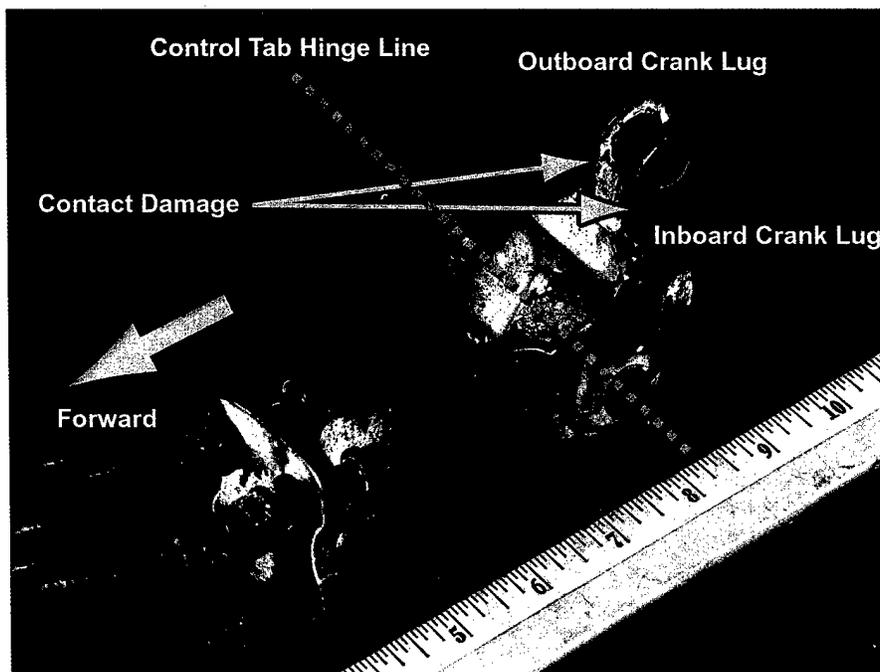
(See figure 2, in section 1.6.2, for a diagram of the elevator control tab installation.) The right control tab pushrod was recovered separately, with its aft rod end (which would normally have been bolted to the tab crank fitting) intact. Examination of the forward edges of the elevator control tab crank fitting lugs revealed evidence of repeated contact damage (including gouge marks and indentations). (Figure 9 is a photograph of damage to this area.) The internal surfaces of the pushrod aft rod end bearing and the bushings in the crank fitting lugs showed no visible signs of damage or deformation. The bolt and associated hardware that normally secures the right elevator control tab pushrod to the tab crank fitting⁶¹ was missing and not recovered.

Although the inboard portions of the left elevator, control tab, crank fitting, and attachment hardware were not recovered and were presumed consumed by postcrash fire, the left elevator control tab pushrod was recovered. Unlike the right control tab pushrod, the left control tab pushrod's aft rod end (normally attached to the tab crank fitting) was fractured and about 75 percent of it and its associated bearing were missing. The forward end of this pushrod was fractured at its rod end attachment holes, and the pushrod had about an approximately 90° bend at its midpoint. No fire damage was observed on the left control tab pushrod assembly.

Figure 9. A photograph of the accident airplane's right elevator control tab crank fitting. Note damage on forward face of control tab crank fitting lugs.

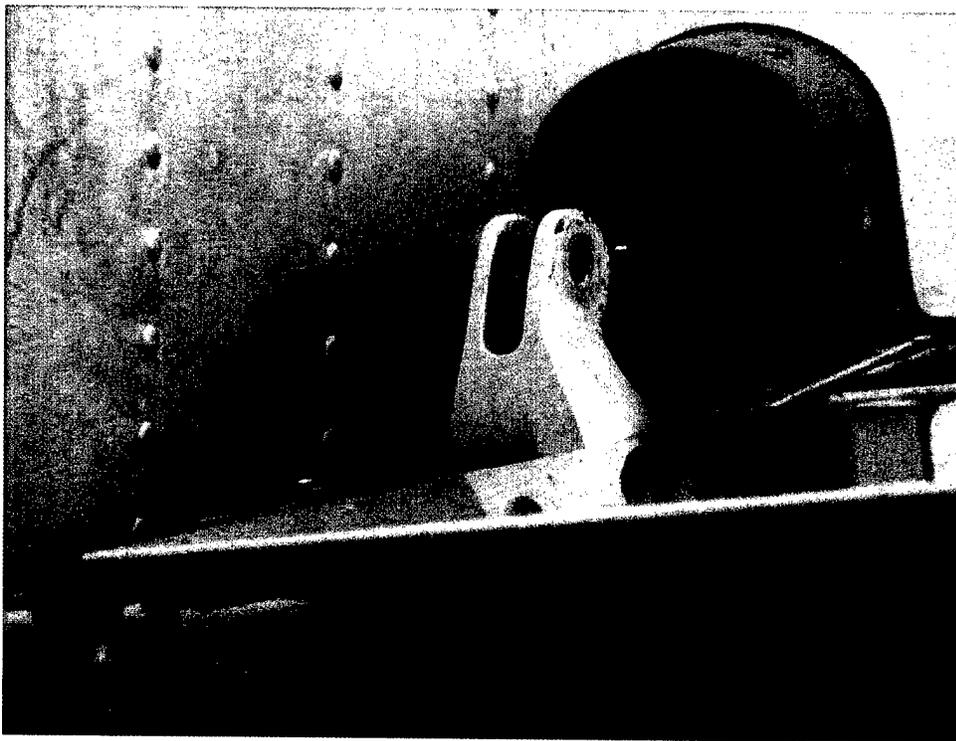
Because a free elevator control tab pushrod might not necessarily always displace itself inboard into alignment with the crank fitting as it did on the test airplane (especially if the pushrod is disconnected while the airplane is in flight and aerodynamic forces are acting on the flight control surfaces), the Safety Board examined other potential interference modes between a free elevator control tab pushrod and crank fitting. These tests revealed that in general, contact between a free pushrod and the forward face of either crank fitting lug (accounting for rod end misalignment, etc.) resulted in a mismatch of approximately 25° between the left and right control tabs. These tests also revealed that a disconnected control tab could be rotated about 3° to 4° in the TEU direction if the crank fitting remained centered about the pushrod; however, further movement was restricted by contact between the crank fitting and shoulders of the aft end of the pushrod. Figure 11 is a photograph of the test airplane's control tab in this position.

Figure 11. Photograph of the test airplane's disconnected right elevator control tab pushrod centered between the lugs of the crank fitting with the control tab rotated 3° to 4° in the TEU direction after the attachment bolt was removed.

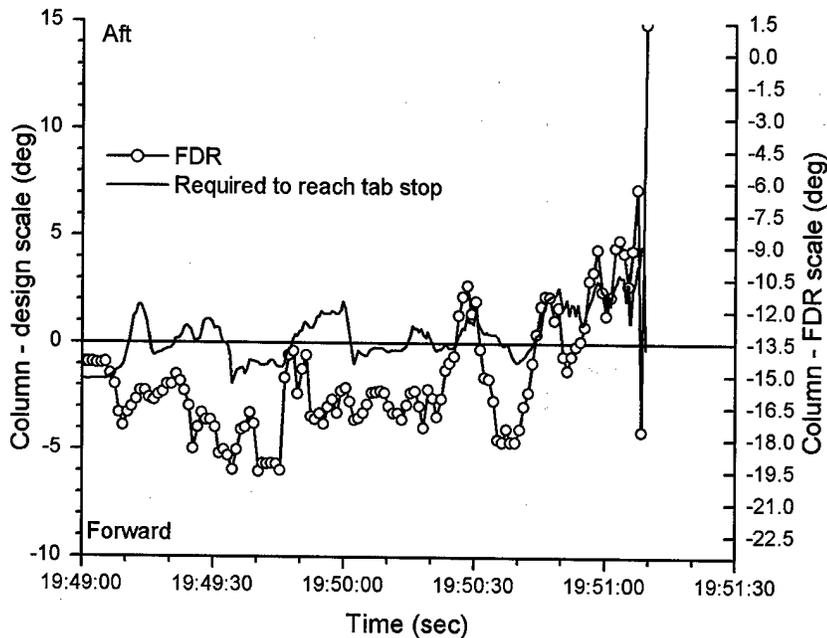
The Safety Board's examination of the FDR data for the flights preceding the accident flight revealed that a change in the relationship of control column movement to elevator response occurred about 8 minutes and 20 seconds before the accident airplane landed at MHR. The Board's performance study derived the control tab positions at the time of this change. The study showed that the change in FDR data could be explained by a shift of about 3° to 4° in the TEU direction of the right control tab, assuming that the right control tab's pushrod to crank fitting attachment bolt separated at this time. This change in the FDR data was evident until the airplane landed at MHR. As previously discussed, a scenario in which a disconnected pushrod remained between the lugs of the aft crank fitting (shown in figure 11) resulted in a 3° to 4° control tab shift in the TEU direction.

Figure 12. The control column position required for the left elevator control tab to reach its TEU physical stop (for the recorded elevator position) and the actual recorded control column position for the accident flight.

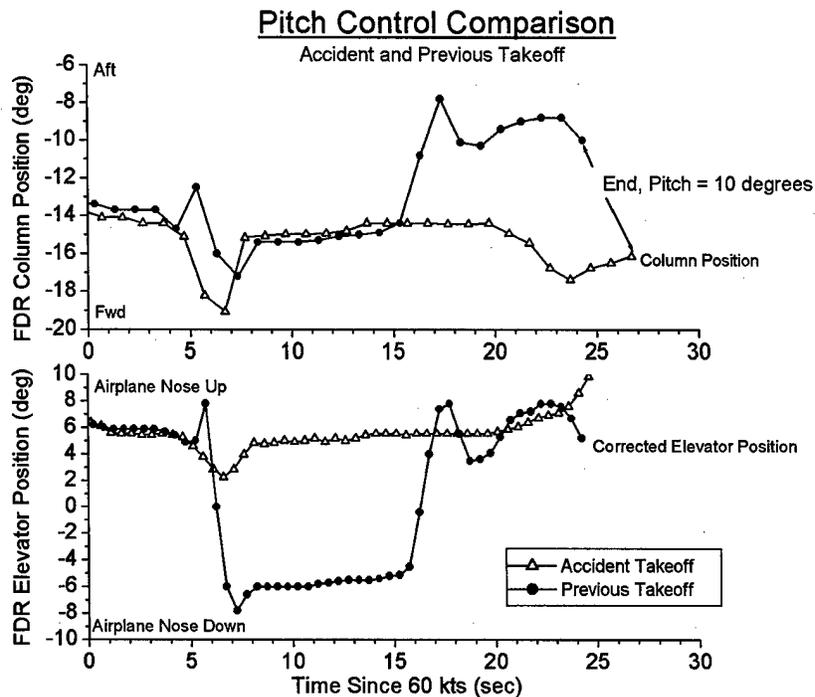
The study also showed that the stabilizer moved in an ANU direction at the same time that the pilot pushed the control column forward to resume the descent after a brief period of level flight at 10,000 feet. The direction of this stabilizer movement was opposite that which would be expected when the pilot provided a forward control column input. The study showed that the slight ANU stabilizer shift balanced the effect of the change in the relationship between the recorded elevator and control column movements and that the elevator remained responsive to pilot input. Figure 13 shows plots of the control column and elevator for the accident takeoff roll and the previous takeoff roll (from RNO).

Figure 13. Plots of the control column and corrected elevator position recorded by the accident FDR during the accident takeoff roll and the previous takeoff roll (from RNO).
