**TWENTY-FIRST**

**PROGRESS REPORT**

**THE FIRESTONE TIRE & RUBBER CO.**

**105 MM BATTALION ANTI-TANK PROJECT**

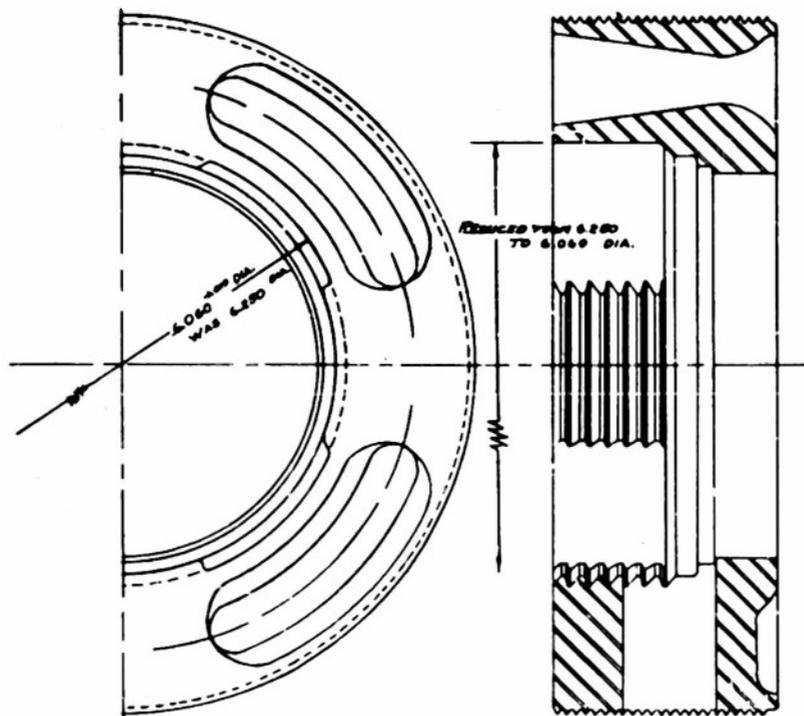
Fig. 1. Revision of Breech Ring.  
Firestone Drawing No. DRD-206-19.

During the course of firing 300 rounds from the T-137 E1 rifle at Aberdeen Proving Ground, evidence appeared that there was excessive stress in the thin web section of the vent ring. Steps have been taken to correct this condition by increasing the thickness of this web. The I.D. of the thin section has been decreased from 6.250 to 6.060 (Figure 1).

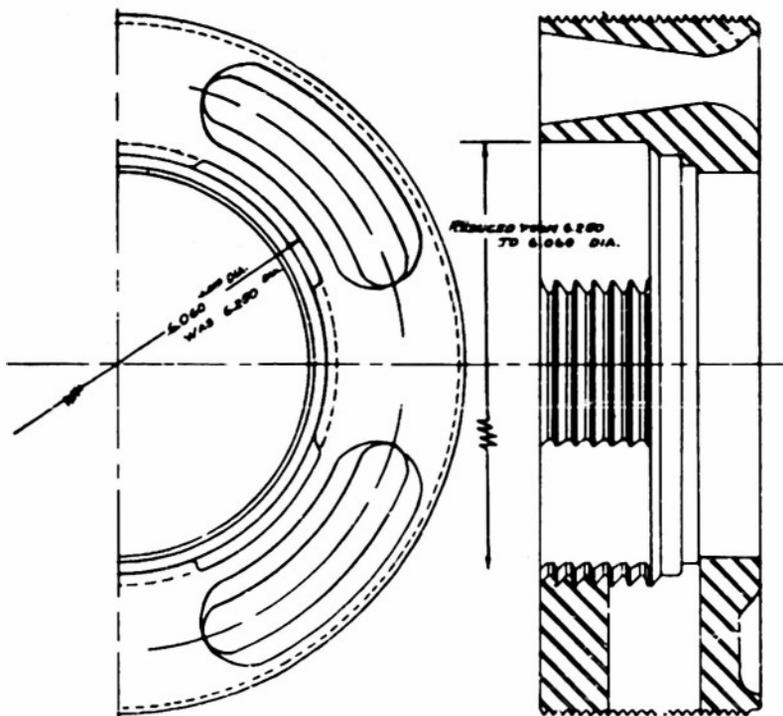
Fig. 1. Revision of Breech Ring.  
Firestone Drawing No. DRD-206-19.

During the course of firing 300 rounds from the T-137 E1 rifle at Aberdeen Proving Ground, evidence appeared that there was excessive stress in the thin web section of the vent ring. Steps have been taken to correct this condition by increasing the thickness of this web. The I.D. of the thin section has been decreased from 6.250 to 6.006 (Figure 1).

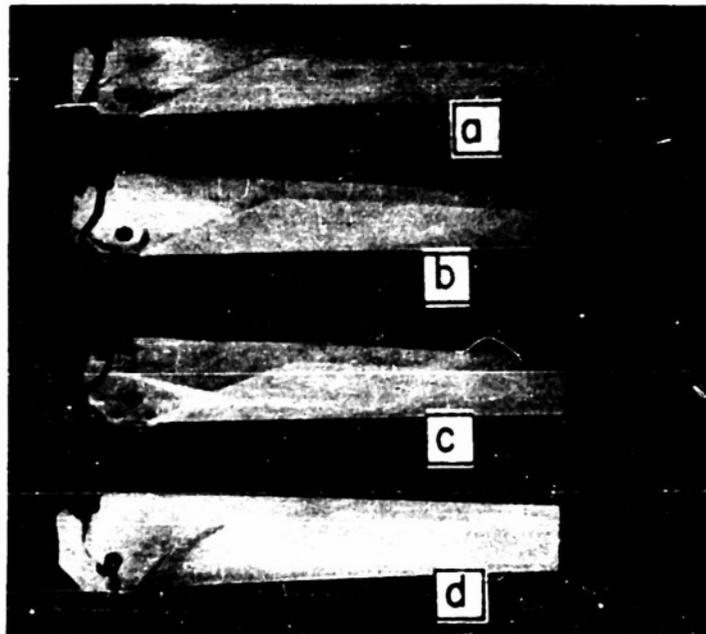
Projectile number 45 was assembled with die cast fins. This projectile was fired through three yaw cards into the recovery box. Recovery of the projectile revealed that each of the fins had broken in a very similar way, at the gear form. One recovered fin is shown as "a" in Figure 3. Inspection of the yaw cards indicated that the fins had broken under the rapid deceleration of the opening action, had over-traveled, and then had returned to their correct positions before entering the recovery box. Since the failure seemed to be caused by impact deceleration, a Riehle pendulum impact tester was modified to accommodate the fin. The complete tester, with pendulum in the raised position, is shown in Figure 4. Figure 5 shows the fin in the test fixture about to be struck by the pendulum. Several fin designs were tested in this machine for impact strength. The data are shown in Table I.

The first group of fins (see fin "b" of Figure 3) were die cast and differed from

While modifications resulted in a minor improvement over the original casting, the impact strength was still considerably below that of fins milled from 24ST-4 aluminum plate. Consideration is being given to the use of a steel insert in the region of the failure.

Fig. 3. T-119 Projectile Fins.  
 Test samples showing typical impact failure. Fins "a," "b," and "c" are A360 aluminum die castings and "d" is a fin milled from 24 ST4 aluminum plate.

1. A larger radius was added at the root of the gear form to reduce stress concentrations.
2. The gear form was die cast and broached to the final tolerance to avoid sharp tool marks.
3. The flat portion of the fin was milled over the region of the hinge pin hole only to preserve as much of the high strength skin as possible.

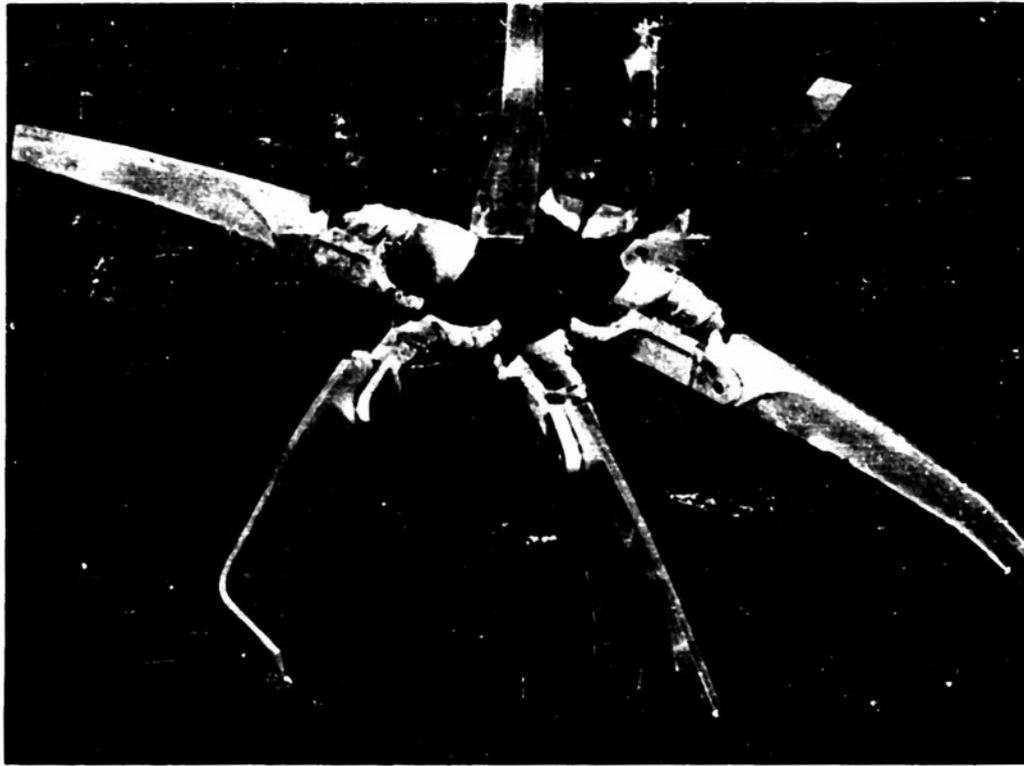
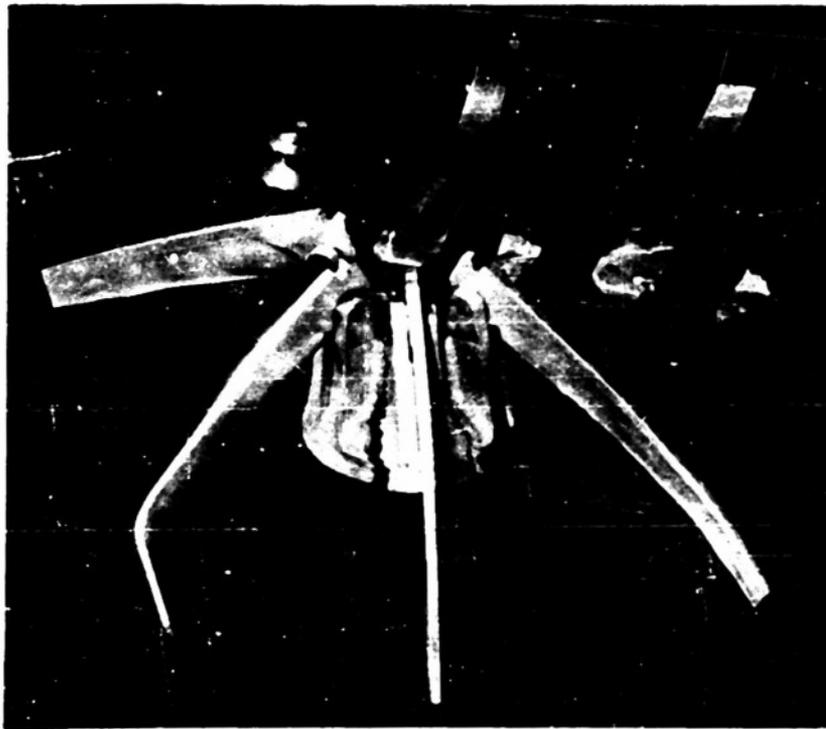
gress Report, Table XIII. The housing failed when the projectile was fired and the recovered fragments are shown in Figures 6 and 7.

The evidence seems to indicate that the failure occurred soon after the projectile left the muzzle and that the failure was caused by the sudden reversal of the pressure differential at the projectile chamber at muzzle exit. This conclusion is supported by the lack of projectile

Fig. 6. Sand-Cast Housing From T-119 Projectile.

Fig. 7. Sand-Cast Housing From T-119 Projectile.

planned but it does not appear probable that a satisfactory housing can be made by die casting.

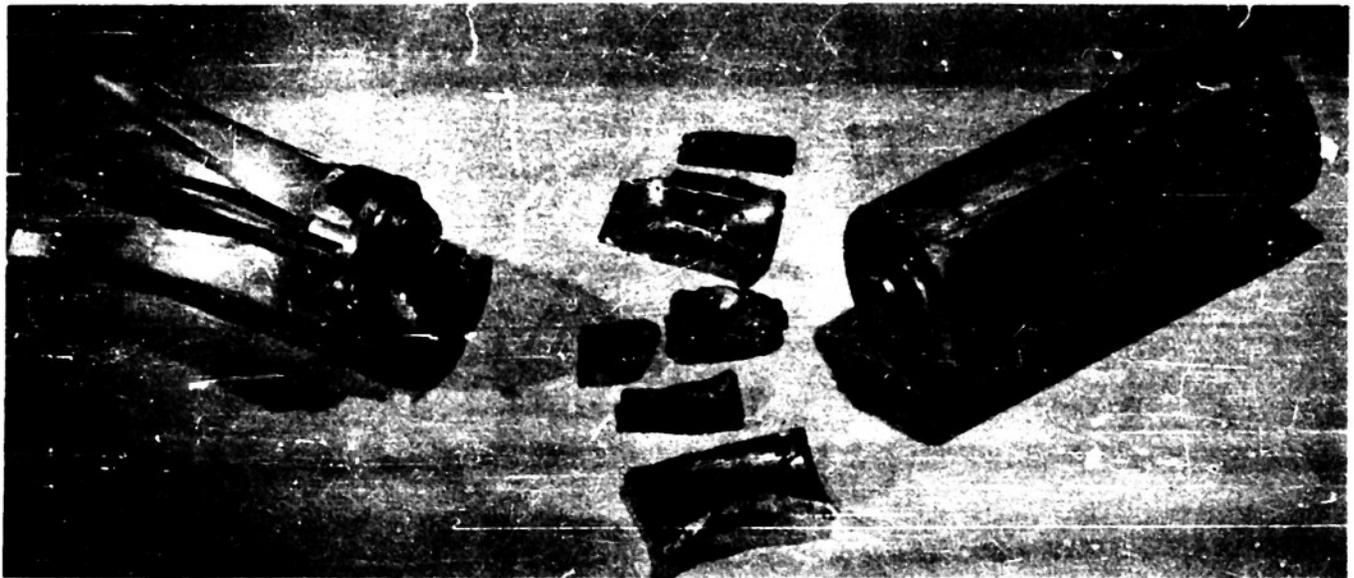
When projectile number 64 was fired from the howitzer it broke apart but the

pieces were recovered. An examination of the recovered fragments and of the yaw cards indicated that the projectile gas chamber collapsed in the gun from the pressure of the propellant gases. The recovered fragments are shown in Figure 10 and the first yaw card is shown in Figure 11.

Fig. 10. Recovered Fragments of T-119 Projectile.  
Fired from 105mm. howitzer, M2A1.

Since all components, with the exception of the chamber, appeared to survive the launching in good condition, it is felt that a 105mm T-119 projectile can be made to successfully withstand the higher pressures of a howitzer by simply strengthening the projectile gas chamber.

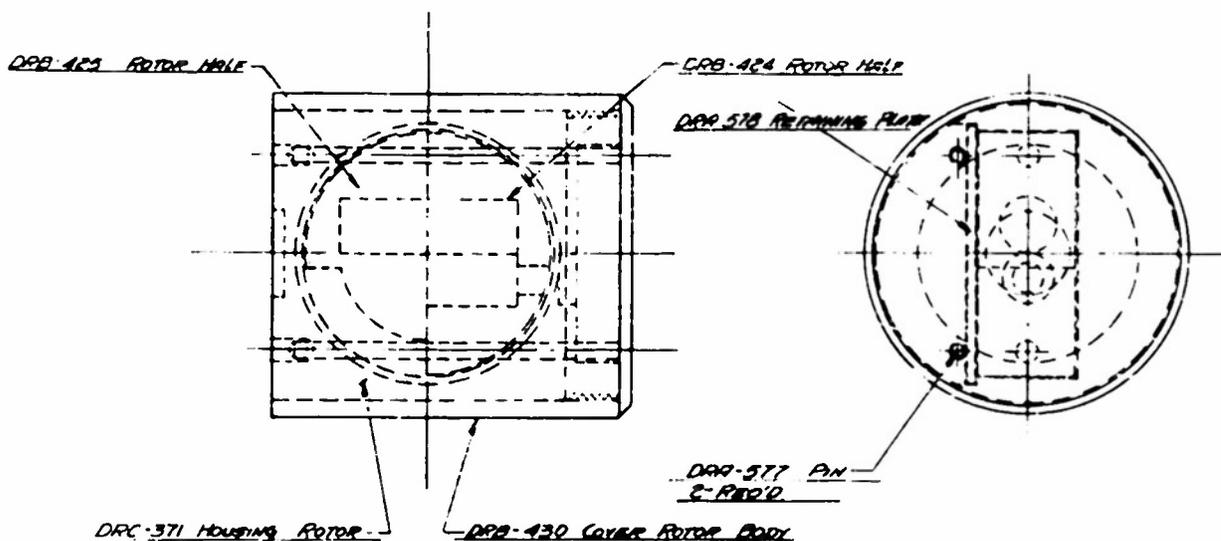
Six of the assemblies had the T-18 detonator and the EX-9 primer-delay arranged with the explosive ends flush (See Figure 16). These six assemblies failed to fire the T-18 detonator when the EX-9 primer-delay was functioned.

Fig. 16. First Arrangement.  
Explosive ends of detonator and primer-delay flush.

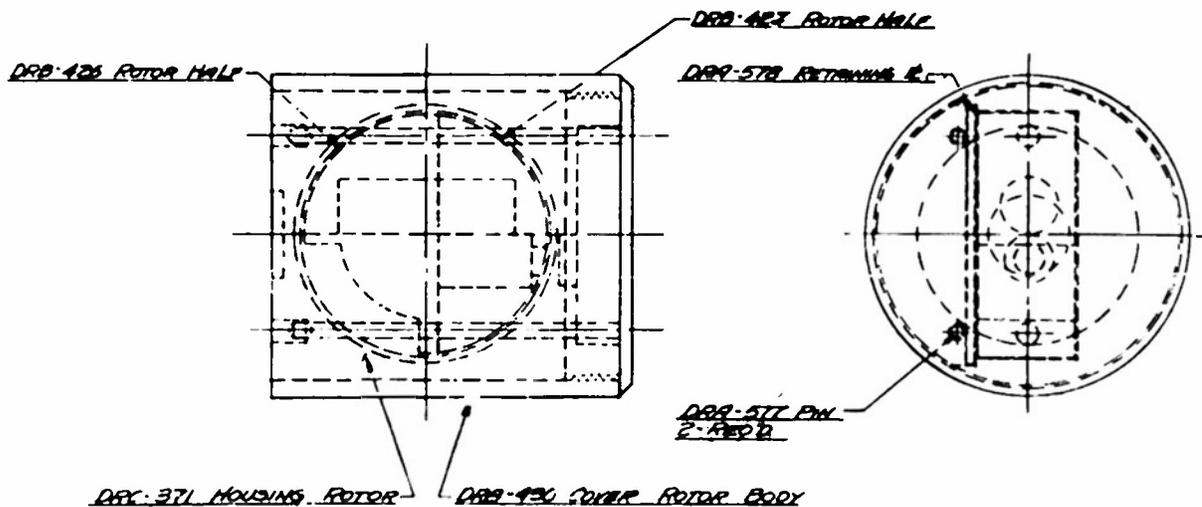
Six assemblies had the T-18 detonator staggered in the rotor with respect to the EX-9 primer delay (See Figure 17). Five of these pyrotechnic trains functioned while one failed to function.

Fig. 17. Second Arrangement.  
Detonator staggered in rotor with respect to primer-delay.
