**AEROPLANE AND ARMAMENT
EXPERIMENTAL ESTABLISHMENT**

SEA VENOM MK. 20 WK. 379
(GHOST 3)

RADIO ACCEPTANCE TRIALS

10th Part of Report No. AAEE/868/1.

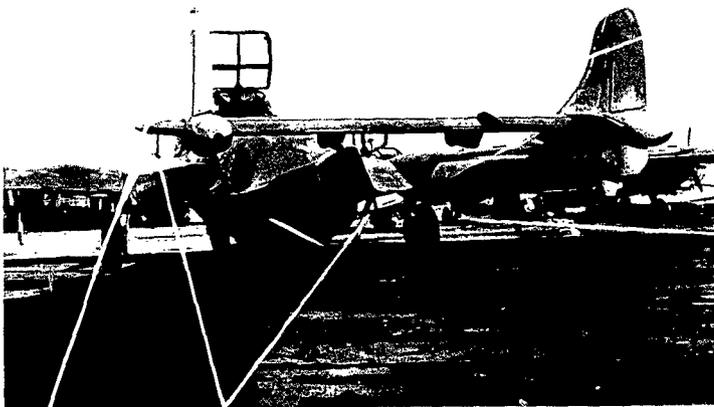
FIG. 2.

4.1.5. The I.F.F. Aerial type 90 was mounted centrally on top of the port boom (Fig. 2) and was satisfactory for operational requirements.

5.1.3. The aerials were positioned, one on the port tail plane extension, and the other on the underside of the starboard flap shroud near the fuselage (Fig. 2).

The aerials had been repositioned in accordance with para. 84 Form 555 of the Final Conference. The total length of the feeder is now 61 feet, making it very difficult to adjust some receivers to the necessary Residual Altitude of 48.75 feet. This is also very near the limit of the range of delays available from Test Set Type 16. (i.e. 51 feet absolute maximum).

The position of the aerials was satisfactory from the performance point of view.

11.2. A.Y.F. The performance of this installation is satisfactory. It is recommended that the aerial feeders be shortened by 5 feet if possible, so that any receiver can be easily set up to the required residual delay (see para. 5.1.3.)

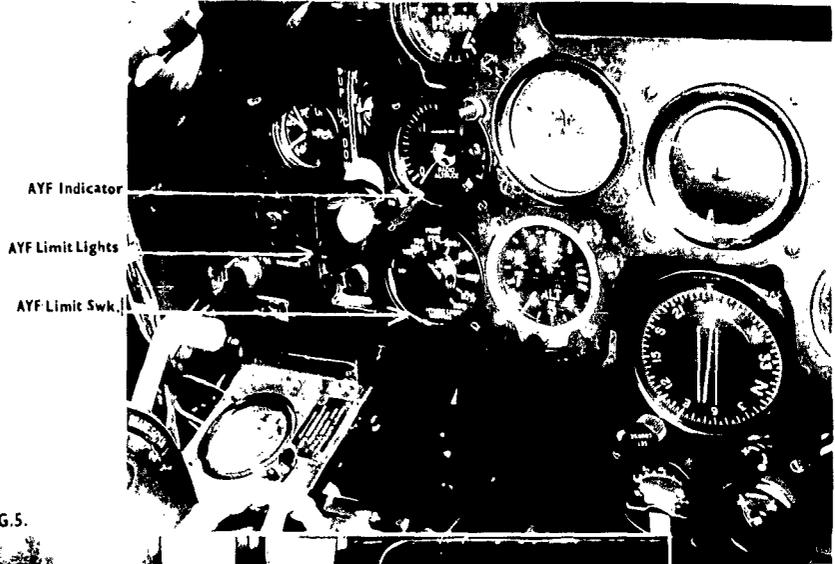
FIG.4.

5.1.2. The Indicator, Limit Switch and Limit Lights were all positioned on the port side of the pilot's instrument panel (Fig. 4) and were satisfactory for operation and viewing.

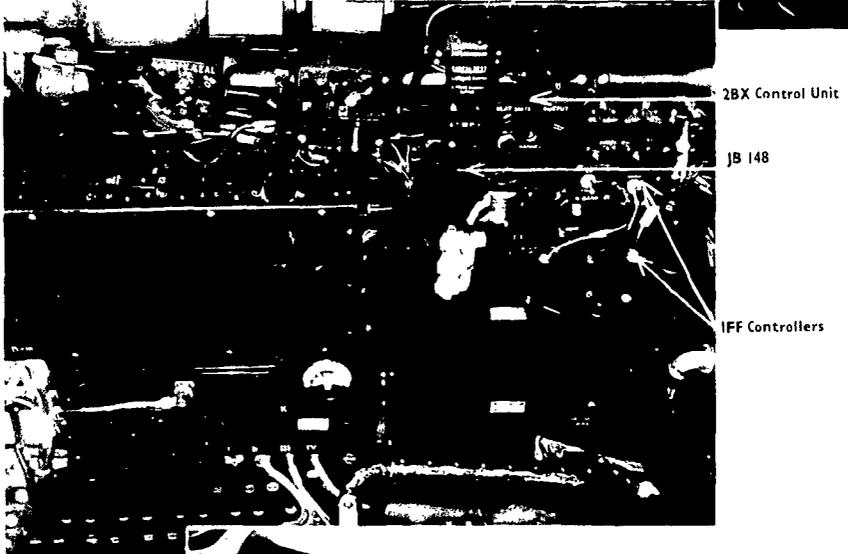
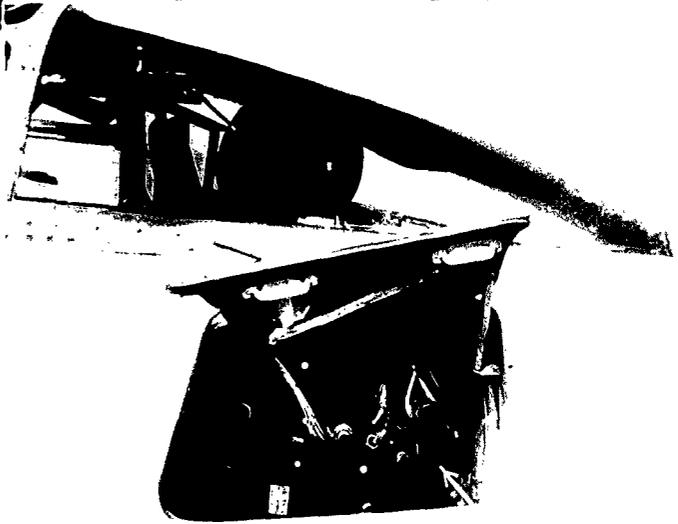
FIG.5.

4.1.3. Controller type C54/APX-1 was mounted on the starboard side of the cockpit (Fig. 5) in a satisfactory position for operation.

4.1.4. Controller type C.53/APX-1 was also mounted on the starboard side of the cockpit (Fig. 5) and was satisfactory for operation.

7.1.3. The J.B. 148 was positioned on the starboard side of the cockpit (Fig. 5) and was satisfactory for operation and maintenance.

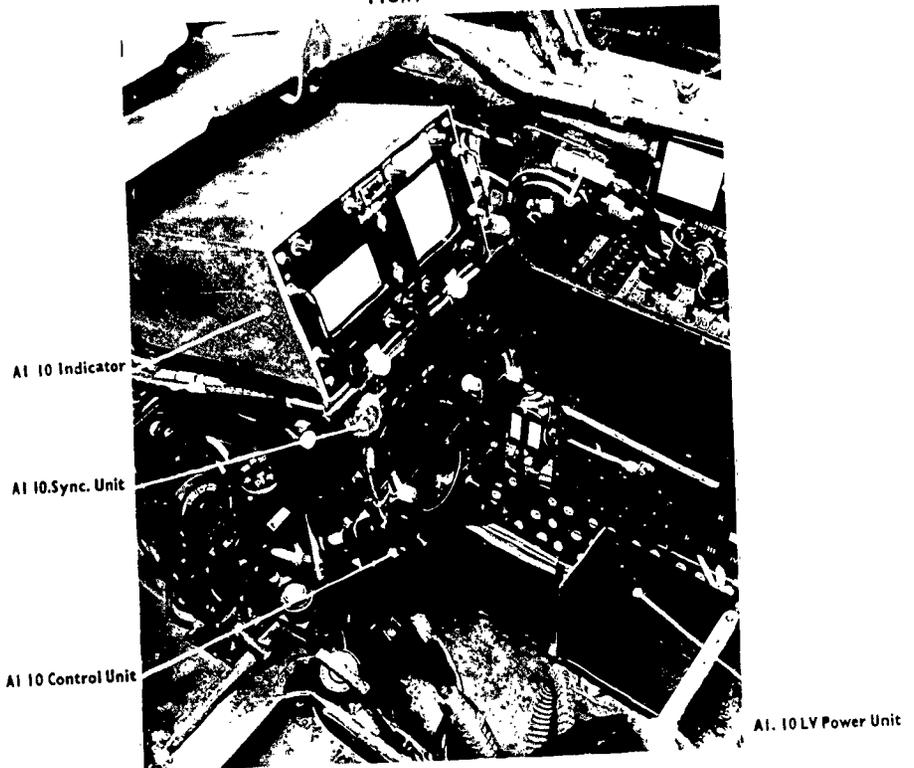
FIG. 7.

6.1.1. The Indicator was mounted in the radio cradle in front of the observer's seat (Fig. 7), and was satisfactory for operation and maintenance. When the cradle adjustment control was operated, the hand fouled the pilot's altimeter.

6.1.2. The Synchroniser Unit was also in the radio cradle immediately under the Indicator (Fig. 7), in a satisfactory position for operation and servicing.

6.1.3. The Control Unit type BC.1150C was fitted in the cradle under the Synchroniser Unit (Fig. 7), in a satisfactory position for operation and maintenance.

6.1.9. The Low Voltage Power Unit was positioned under the observer's seat (Fig. 7), and cannot be removed for servicing without first removing the observer's seat.

6.3.12. Accessibility of controls. The position of the Units was satisfactory and the controls could be easily operated. When operating the control to raise or lower the radar set the observer's hand, when wearing gloves, fouled the cockpit altimeter.

- (iv) The G.4B master indicator should be fitted either above or below the A.P.I. (para. 6.3.13(a) refers).
 - (v) It is recommended that an observer's altimeter be fitted, or the existing pilots one re-positioned, so that the observer can easily see it. (para. 6.3.13(b) refers).

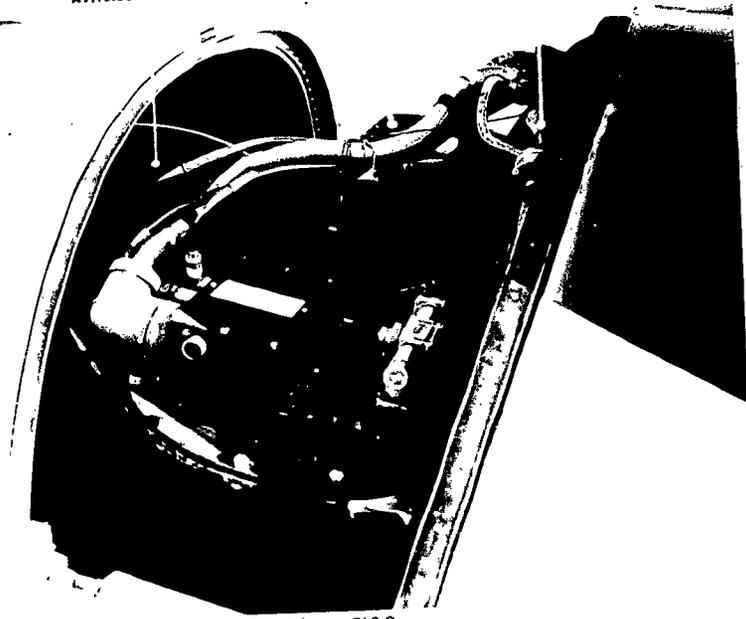
AI.10. R.F. Unit FIG. 8.

6.1.4. Junction Box type 253 was fitted on the Bulkhead at the rear of the nose compartment (Fig. 8) in a satisfactory position for maintenance.

6.1.5. The Scanner type RC.94A-A was mounted in the nose of the aircraft (Fig. 8) and was enclosed in a fibre glass radome, neoprene covered. This radome was also fitted with a zinc spray screen to reduce the altitude curtain, and as detailed under para. 6.3.5, prevents the full use of the -20° tilt facility.

6.1.7. The Modulator Unit B.C.1142A and R.F. Unit type B.C.1091A were mounted on runners attached to the bulkhead wall in the nose compartment (Fig. 8), both being satisfactory for servicing. When the modulator is being removed from its mount all connectors should be removed first.

6.1.12. It was found after the trials that a number of connectors were damaged. This was done when removing the scanner or modulator units for servicing, the main area of damage being on the forward face at the base of the bulkhead, starboard side, and it is suggested that a hinged guard be fitted for protection. A guard should also be fitted over cables on the cockpit floor, which were severely damaged by servicing personnel unwittingly standing on them.

- (viii) The zinc spray pattern should be altered to enable the full use of the -20° tilt position of the scanner.
 - (ix) It is recommended that a small notice should be provided adjacent to the connectors which are mounted on the bulkhead above the modulator, to read as follows:- "Disconnect cables from bulkhead before removing modulator".

- (x) A protective guard should be fitted over the cables on the cockpit floor and also over connectors at the base of the forward bulkhead wall on the starboard side to prevent damage when removing units, etc.

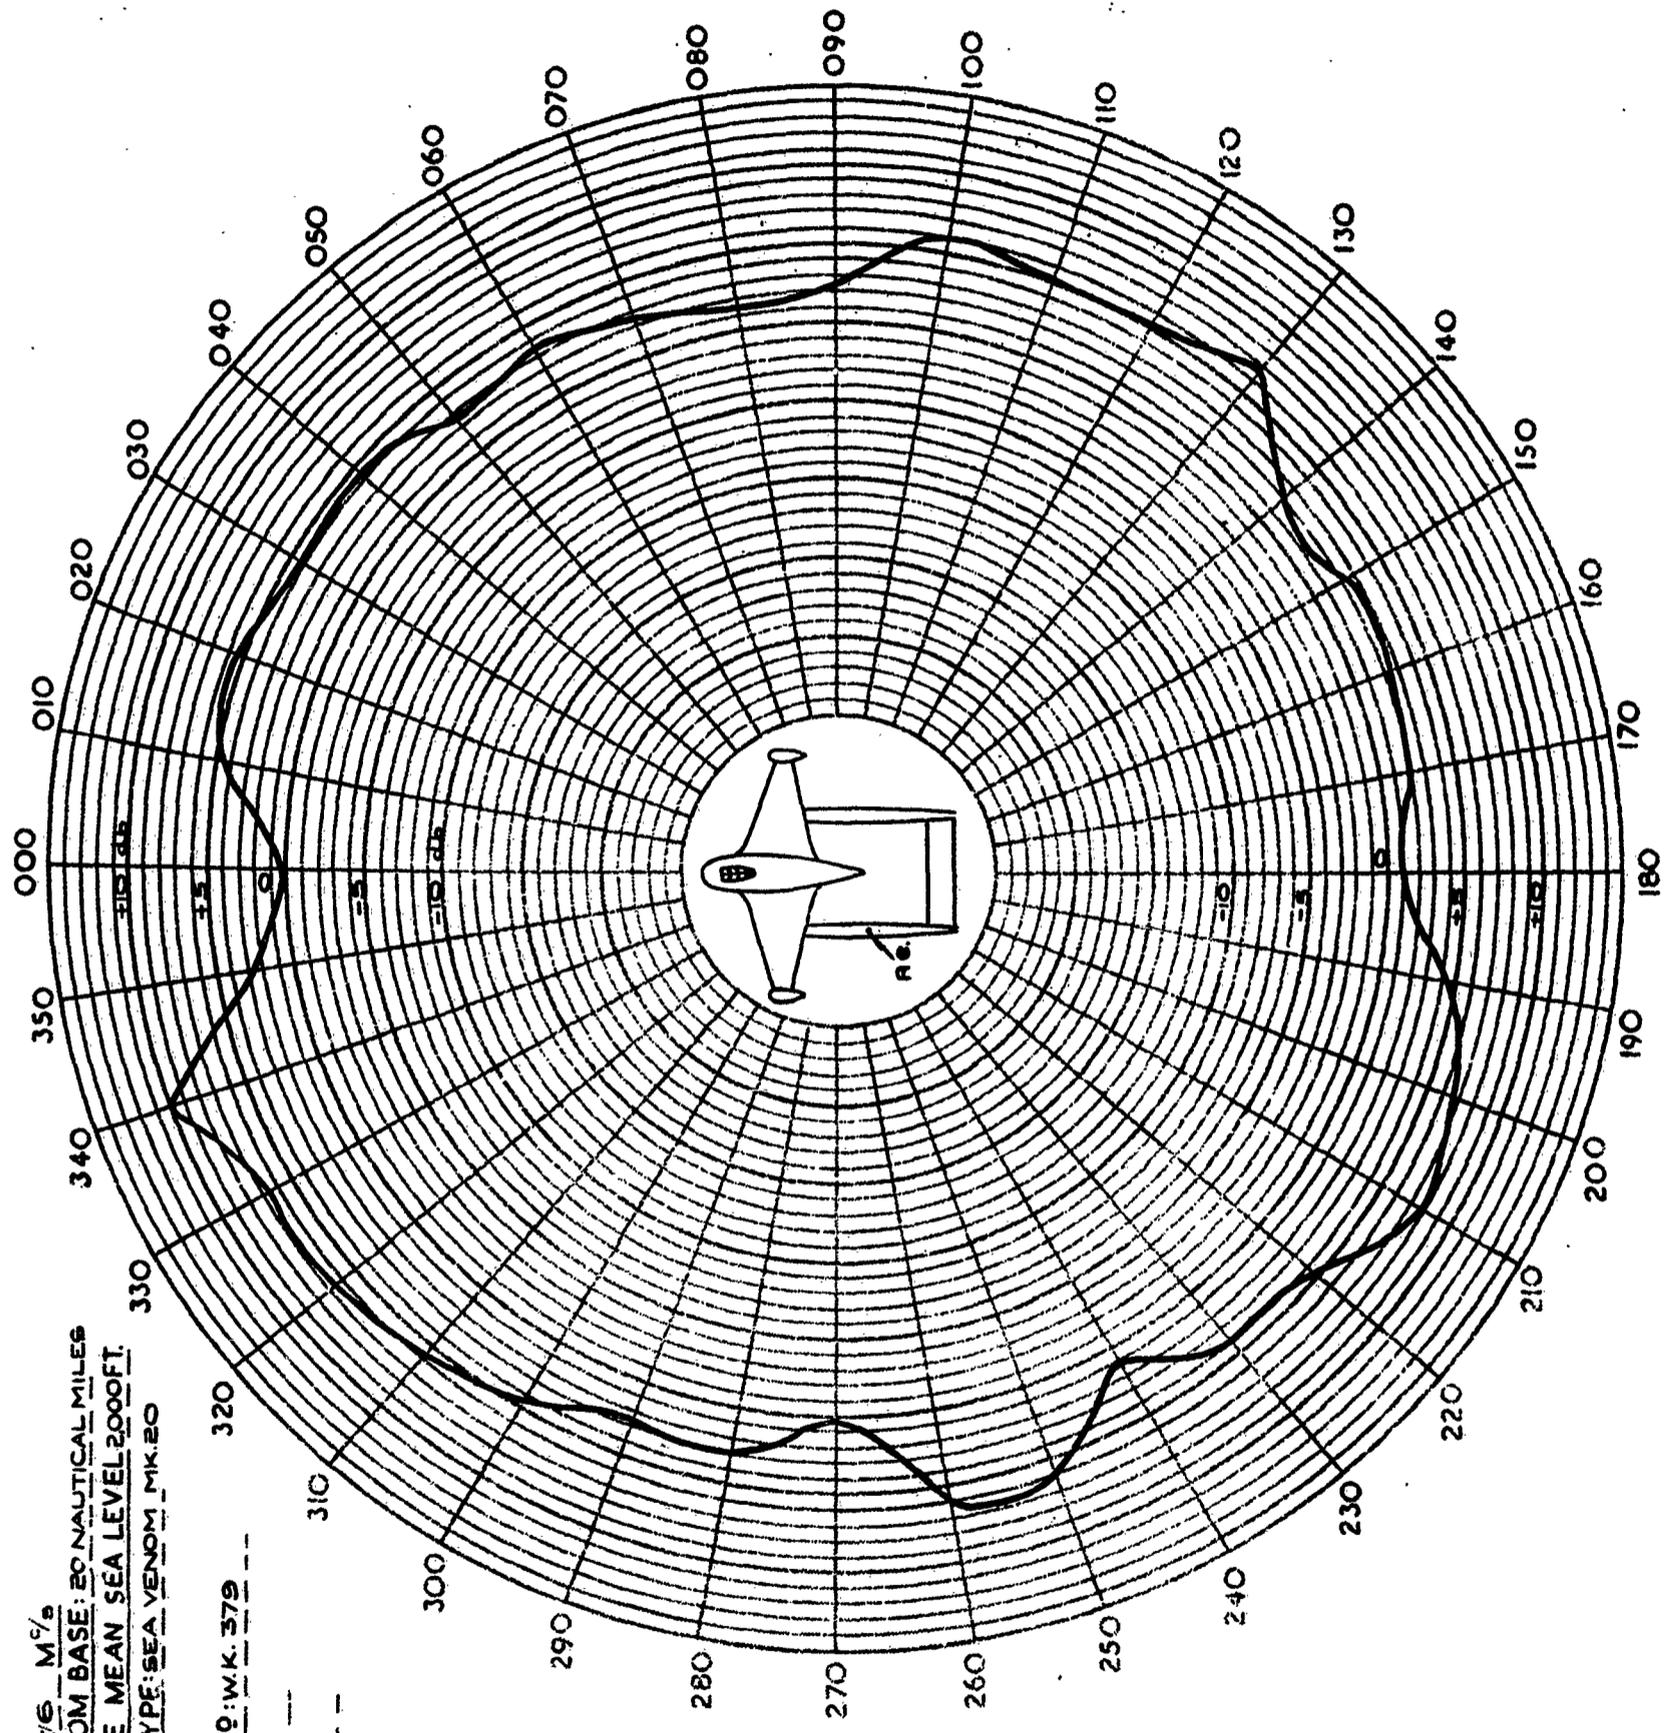
FIG. II

4.3.3. Polar Diagram. The results are shown in Fig. 11 and were considered satisfactory.

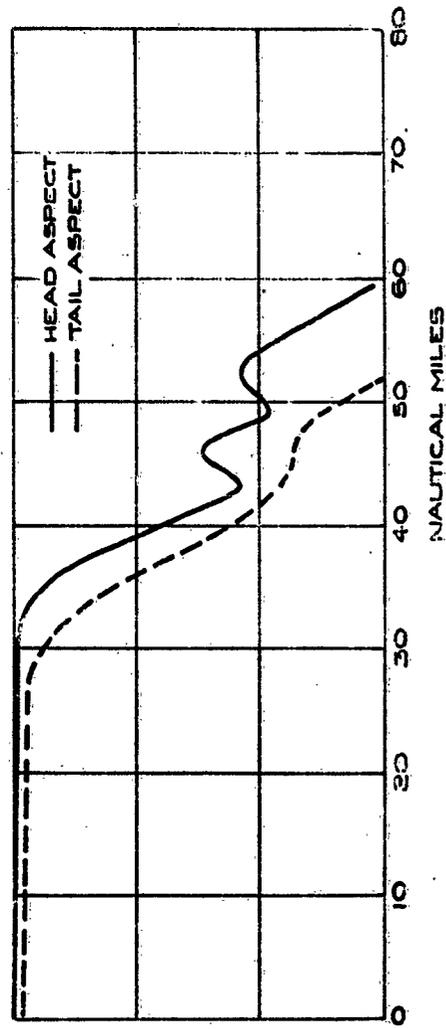
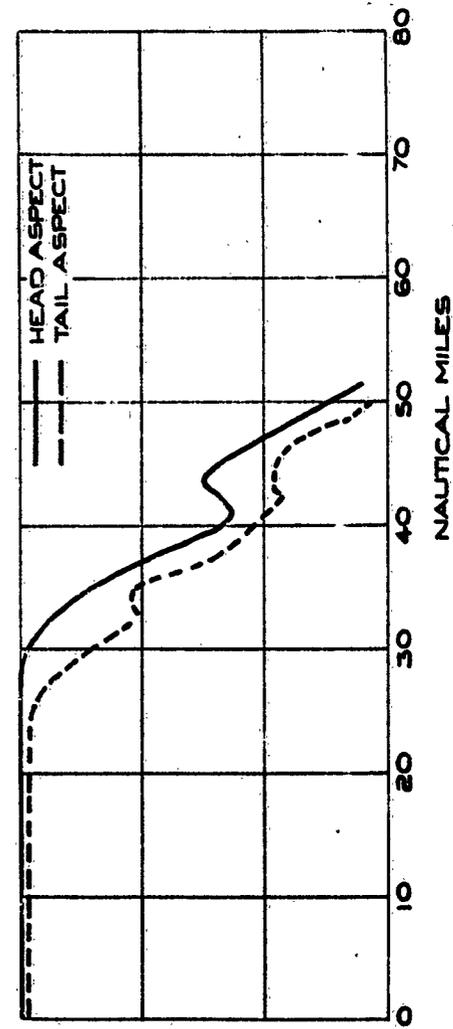
I.F.F. (AN/APX-1) 'A' & 'ROOSTER' BAND RANGE TEST.

4.3.1. 'A' Band Range Test. When interrogated by a standard I.F.F. ground equipment, with the aircraft flying at 4,000 feet, the maximum range on the tail aspect was 52 nautical miles, and on the head aspect 59 nautical miles; signal-to-noise ratio curves are shown in Fig. 12.

4.3.2. "Rooster" Range Test. When using a standard ground interrogator tuned to a frequency of 176 Mc/s., and the aircraft flying at 4,000 feet, the maximum range on the tail aspect was 49 nautical miles, and on the head aspect 52 nautical miles. The results are shown in Fig. 12.

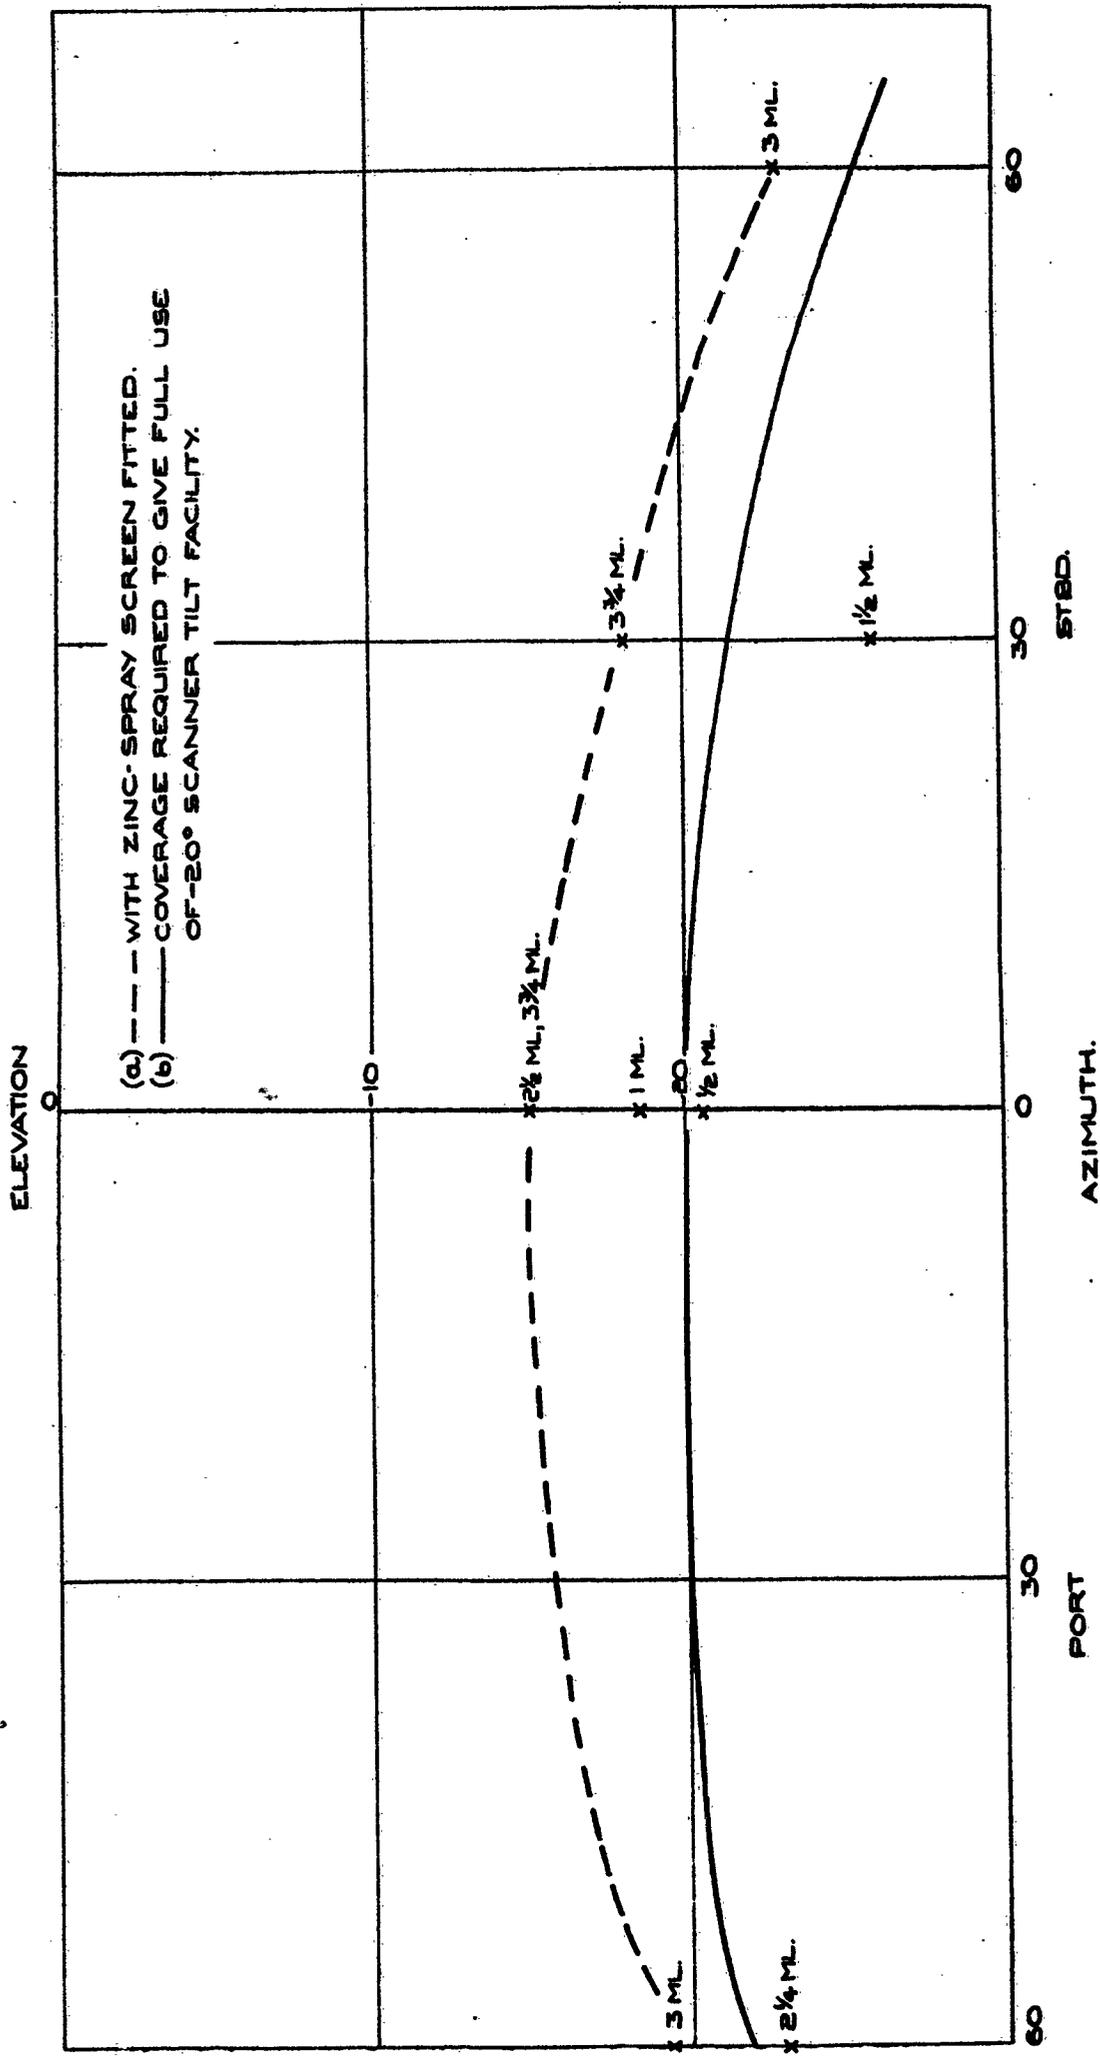
FIG. 13

These figures are shown in graphical form at Fig. 13, and show that the Zinc spray pattern causes a cut-off in radiation at -15°, preventing full use of the -20° scanner tilt facility.
