CRASH SURVIVAL STUDY:

**NATIONAL AIRLINES DC-6 ACCIDENT
AT ELIZABETH, N. J. ON FEBRUARY 11, 1952**

A. HOWARD HASBROOK

**CRASH INJURY RESEARCH
Cornell University Medical College
1300 York Avenue, New York 21, N. Y.**

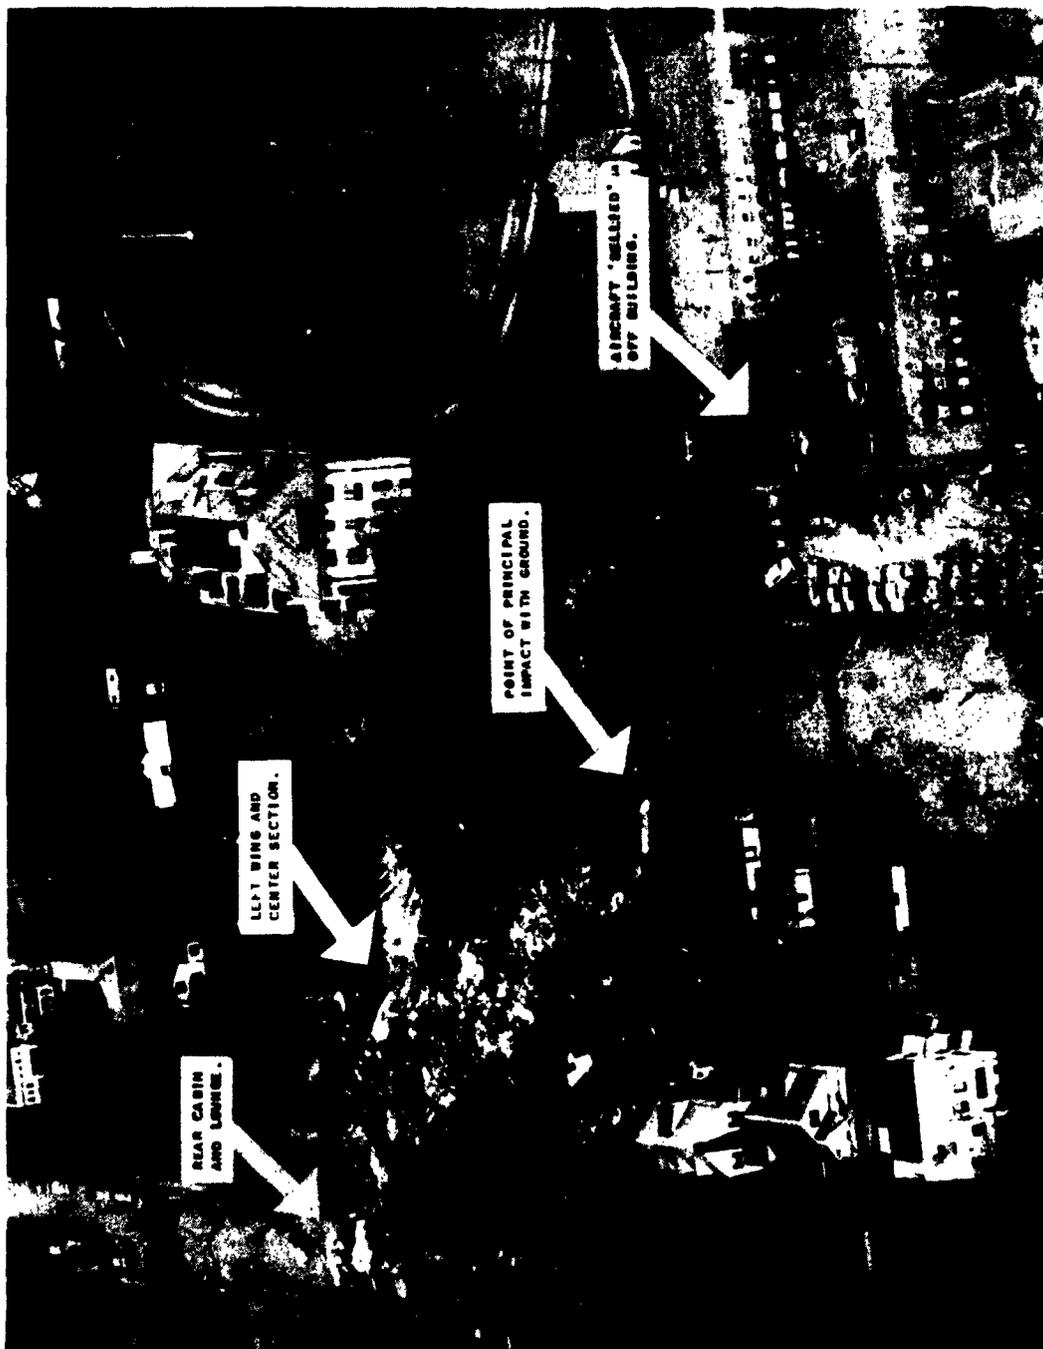
FIG. 1. UNITED PRESS AERIAL PHOTO SHOWING ACCIDENT SCENE.

Unable to climb or even maintain altitude, the pilot attempted to return to the airport but failed; the aircraft struck the roof of a three and one-half story apartment house, while in a partially controlled descent (Fig. 1). Skidding from the roof, the airplane rolled to the right and struck the ground of a school yard at approximately 140 mph, in a nose-down attitude of approximately 10 to 15 degrees.

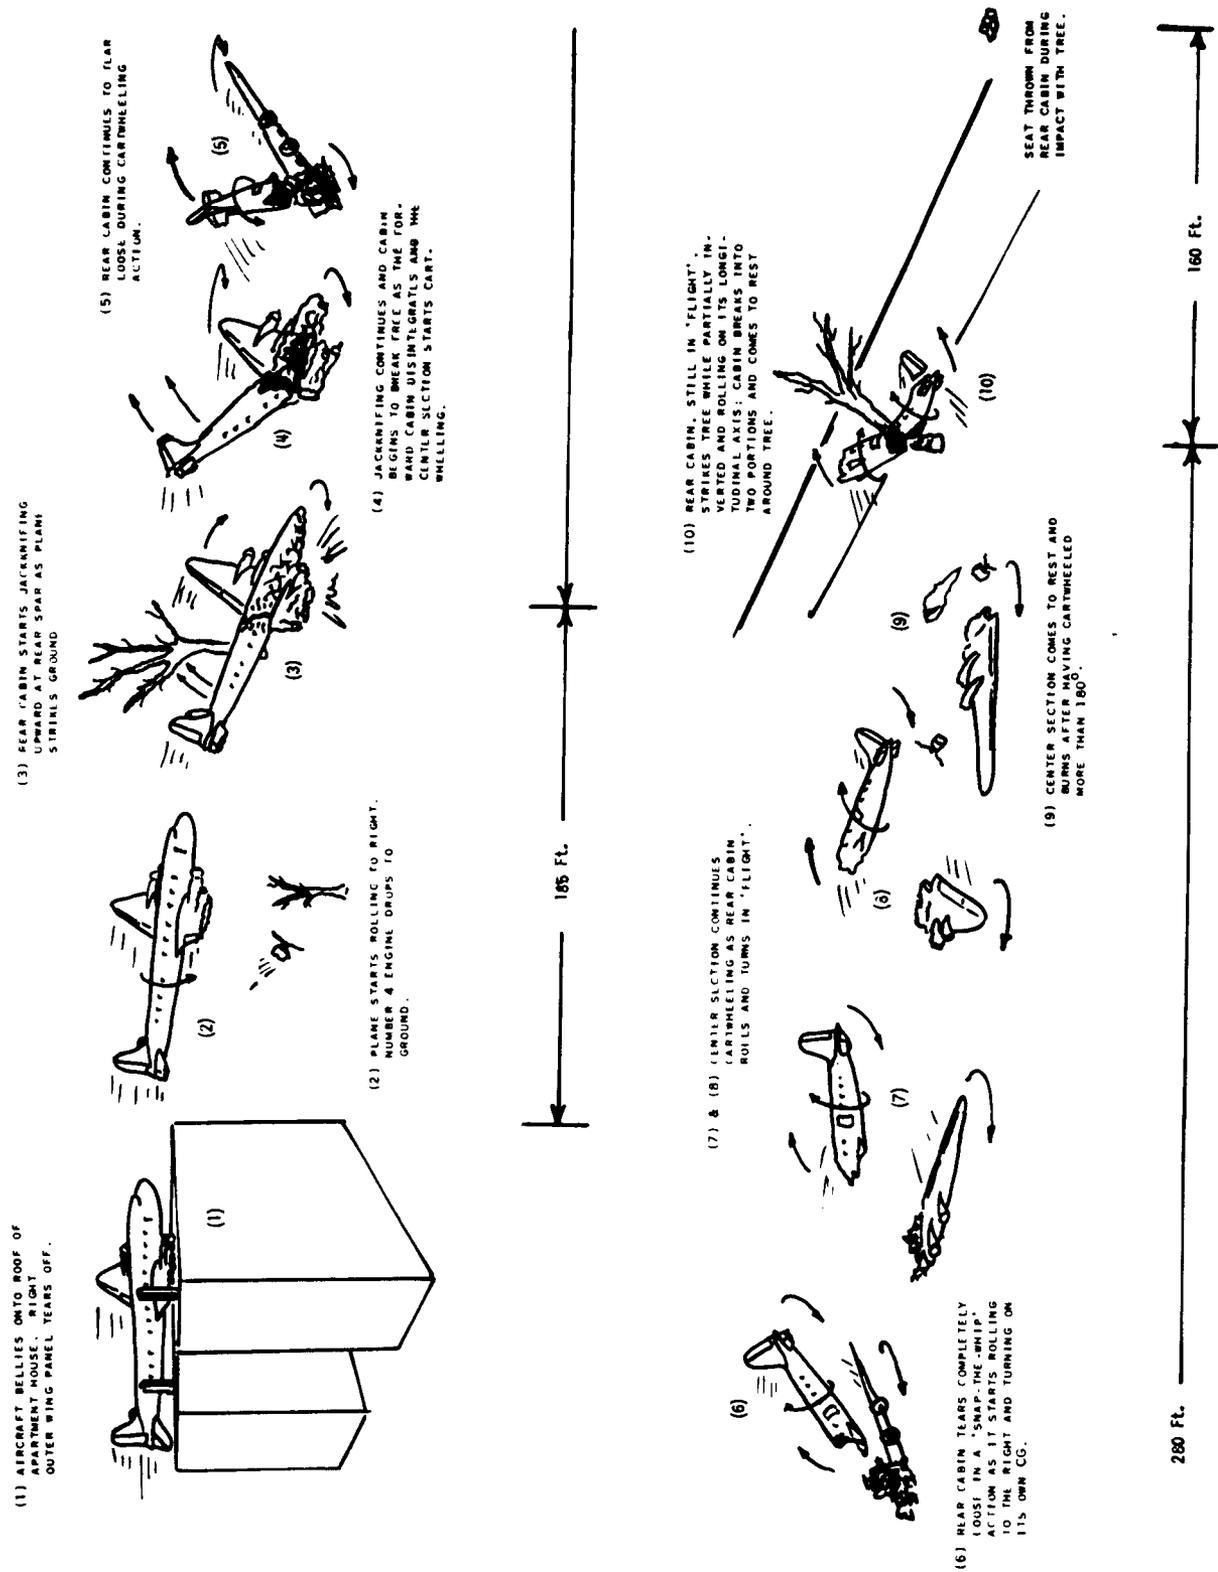
FIG. 2.

NATIONAL AIRLINES DC-6 FEBRUARY 11, 1952 ELIZABETH, N. J. CRASH.
ANALYSIS OF PROGRESSIVE DISINTEGRATION AND KINEMATICS OF AIRCRAFT.

The aircraft was in a slightly nose-high attitude with the right wing down about 15° when it "bellied" onto the roof of the building (Fig. 2). Skidding across the roof, the plane struck and levelled the low rear parapet of the building to the roof line. Simultaneously, the right outer wing panel was torn off against the front parapet; gasoline from the ruptured tanks cascaded onto the roof and ignited.

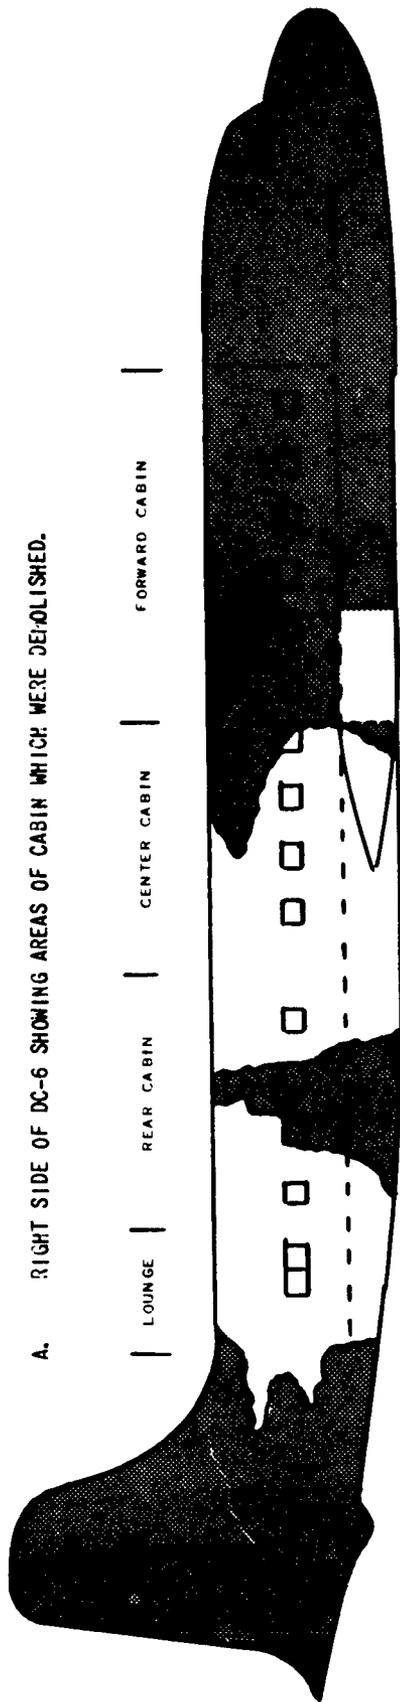
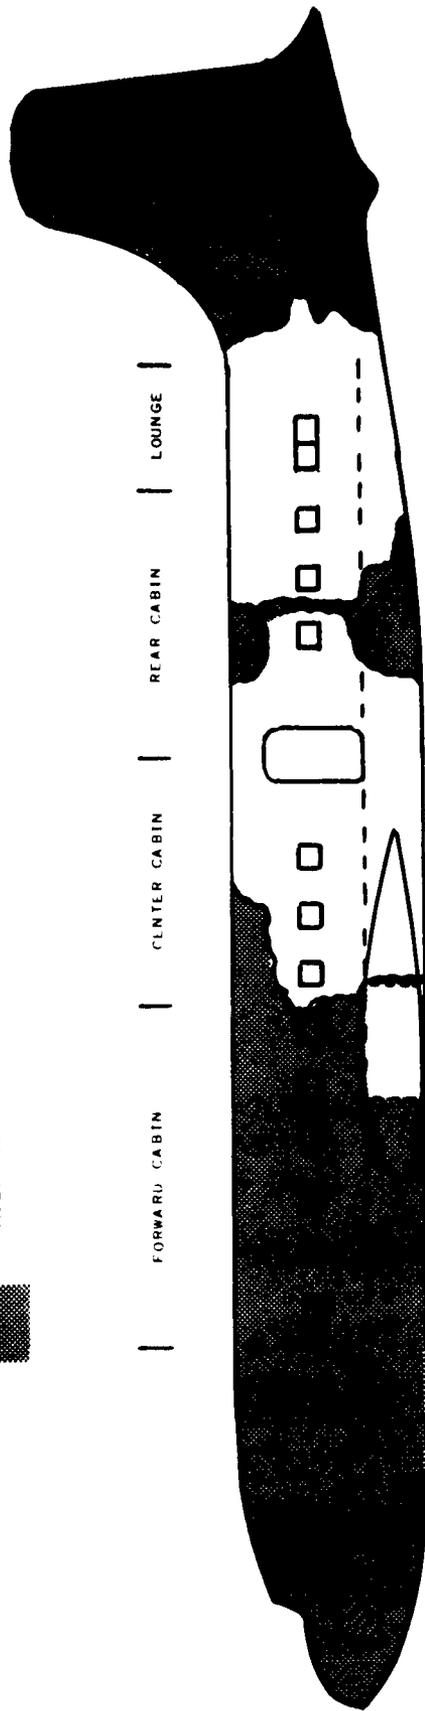
FIG. 4

A. RIGHT SIDE OF DC-6 SHOWING AREAS OF CABIN WHICH WERE DEMOLISHED.

B. LEFT SIDE OF DC-6 SHOWING AREAS OF CABIN WHICH WERE DEMOLISHED.

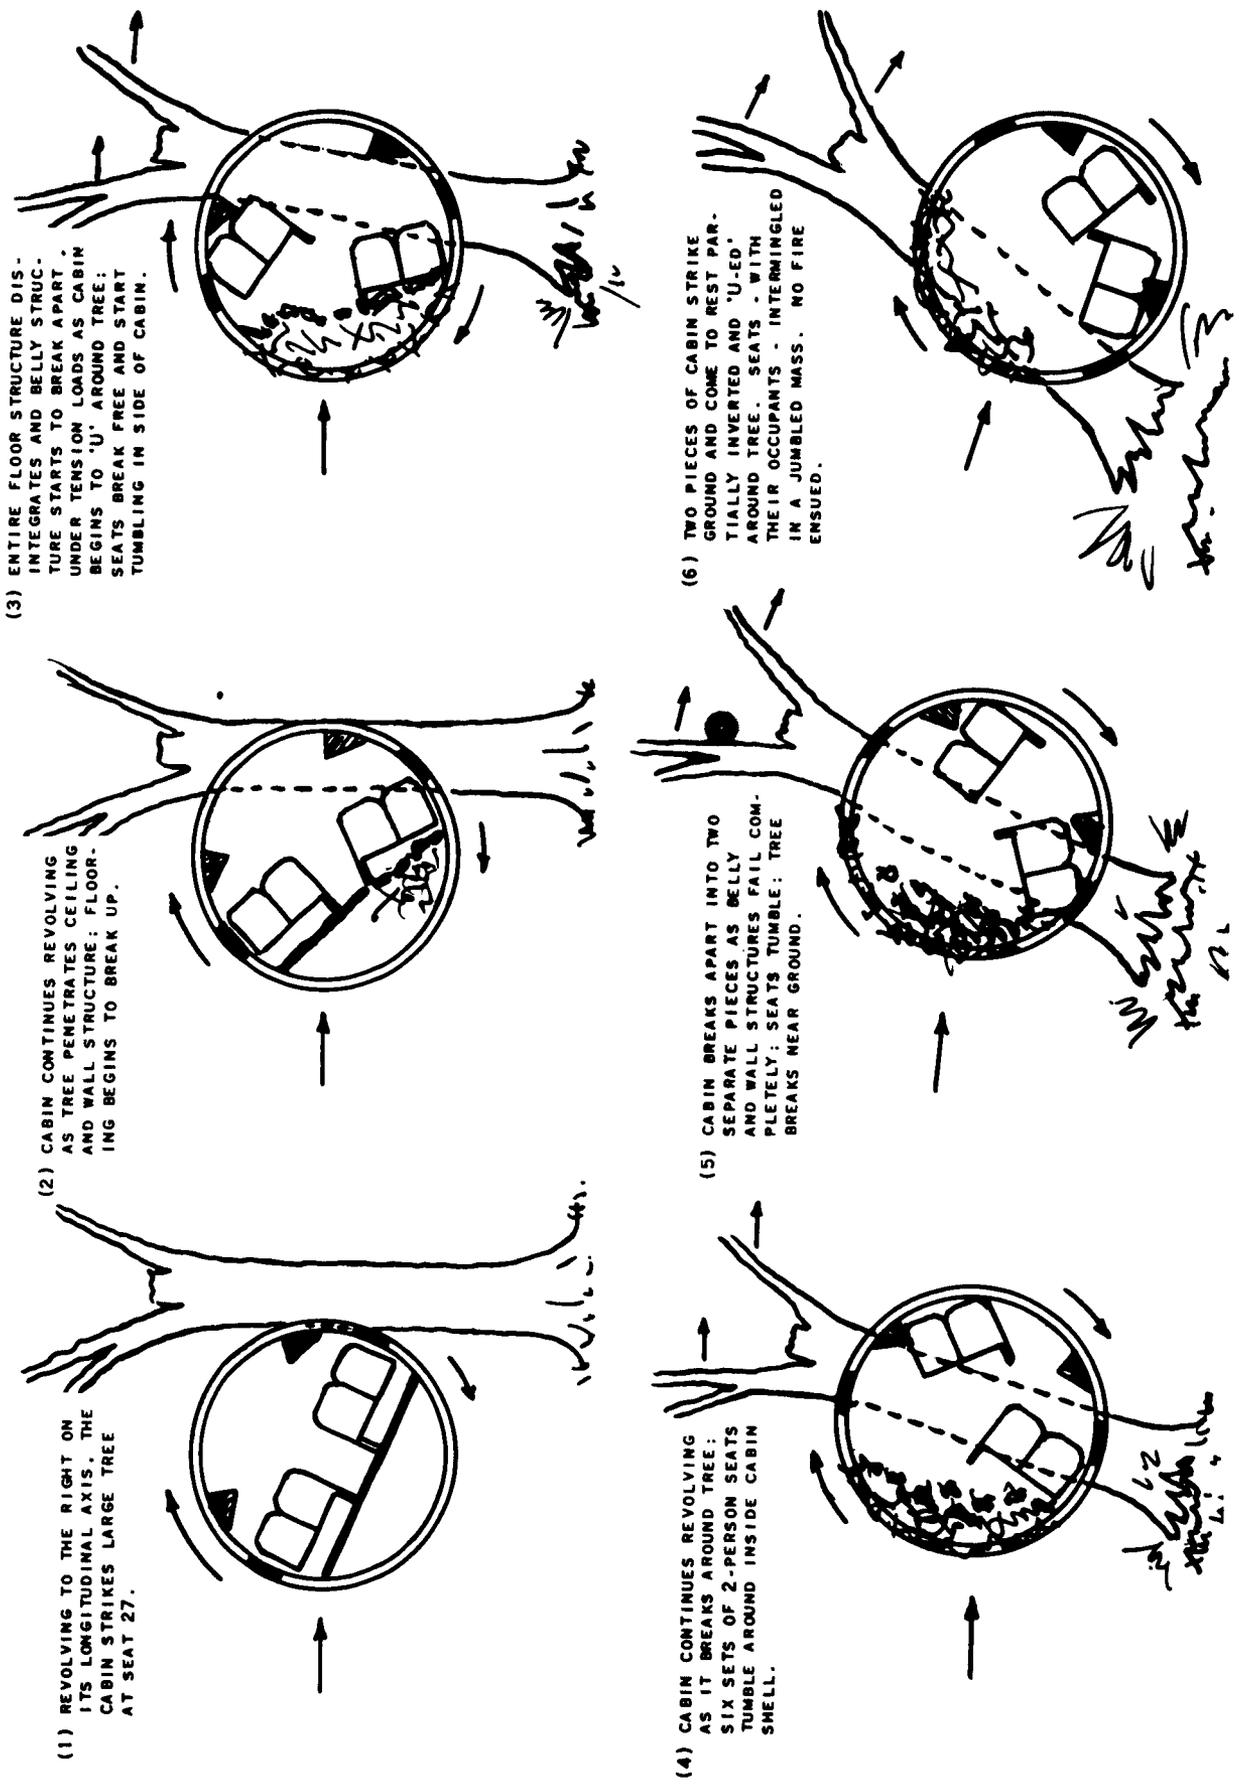
As can be seen from Fig. 7, clockwise rotation of the cabin (around its longitudinal axis) during impact with the tree trunk tended to pull the right hand seats "downward" and away from the tree - prior to failure of the floor structure. This may have had a marked effect in causing the seats - due to inertia - to initially "fall away" from the ceiling and tree as they came free from the disintegrating floor.

FIG. 7. VIEW (THROUGH SECTION A-A OF FIG. 8) LOOKING FORWARD THROUGH REAR CABIN AREA DURING IMPACT WITH TREE.

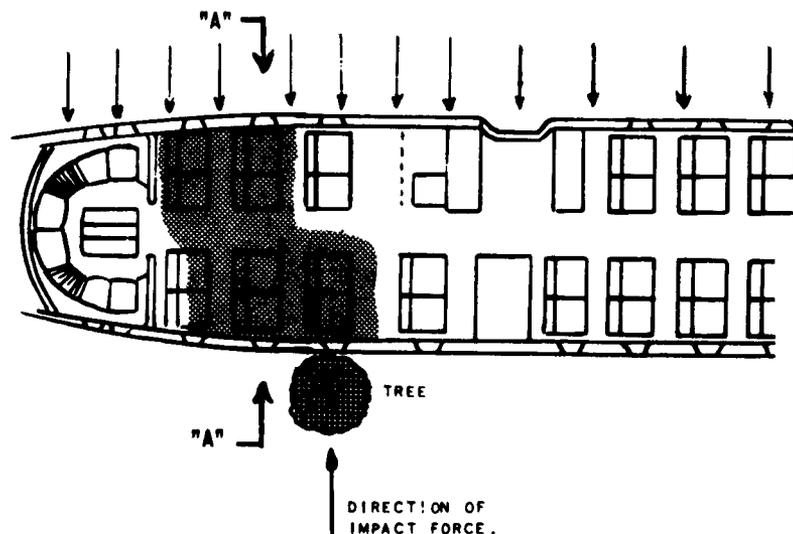
FIG. 8. VIEW SHOWING (1) POINT AND DIRECTION OF CONTACT OF REAR CABIN WITH TREE, AND (2) FLOOR AREA WHICH DISINTEGRATED AS CABIN BROKE IN TWO.

As shown in Fig. 8, the six lounge seats - with low seat-backs - were arranged in a semi-circle. Under the directional conditions of crash force which existed during impact with the tree, the passengers in the left-hand seats (L1, L2) were subjected to "forward facing" conditions and the upper attachments of their seats failed under tension loads, permitting the seats to pull partially away from the side-wall structure; however, the two passengers were uninjured. Those in the center seats (CL, CR) were subjected to "side-facing" loads; the passenger in CL had only minor injuries. The one in CR, however, was thrown heavily sideways against the unyielding armrest and sustained an injury of the lower spine.

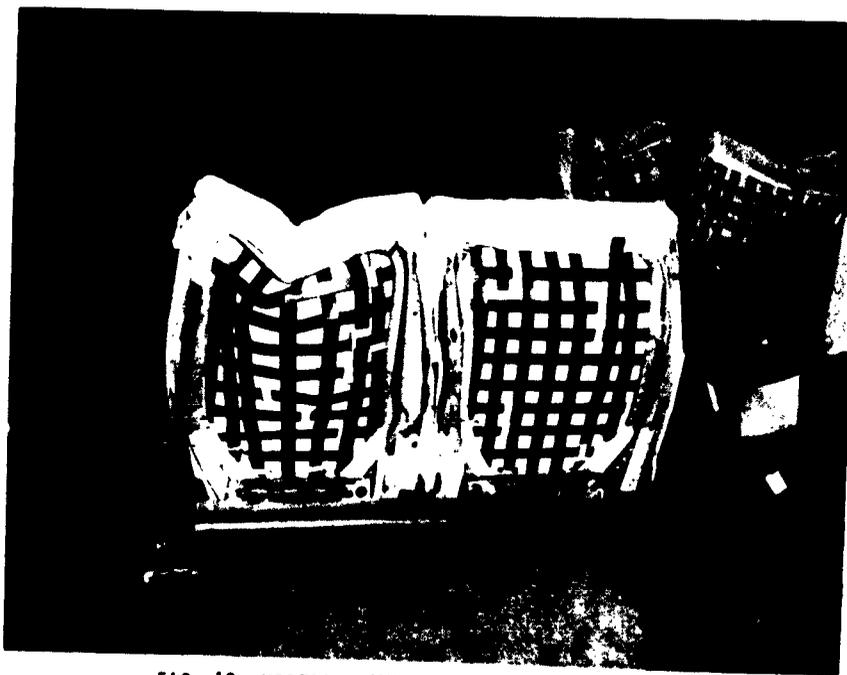
FIG. 12. VERTICAL 'V' DENT IN TOP OF SEAT-BACK CAUSED BY HATRACK STRUCTURE.

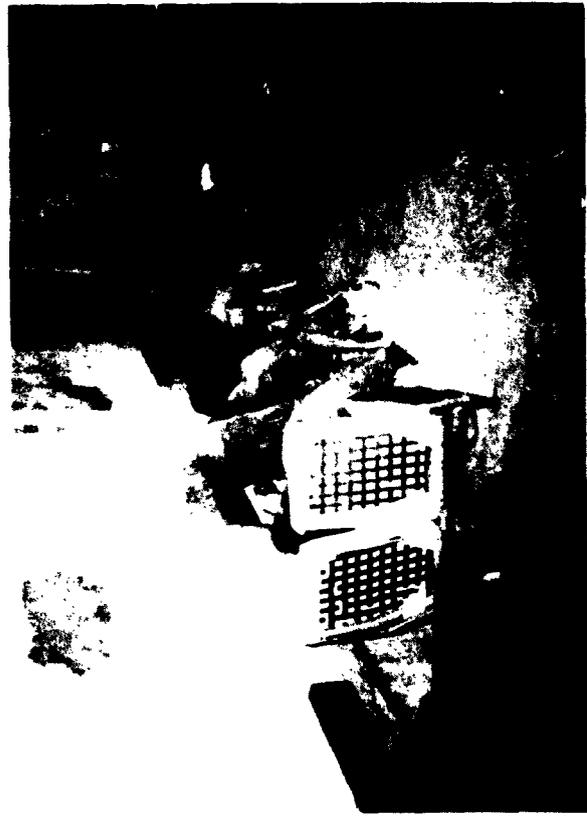
FIG. 19. VIEW LOOKING FORWARD OF LEFT-HAND SEATS (FROM FORWARD CABIN) WHICH TORE FREE.

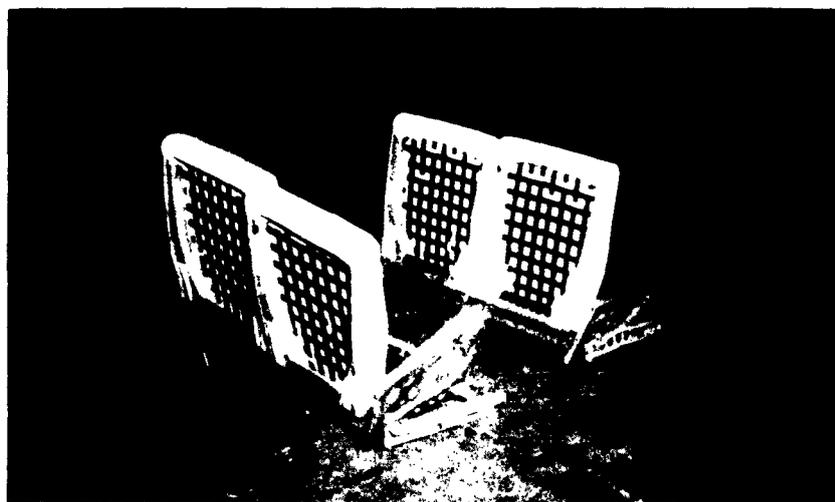
The outboard end of the seat was attached to the wall intercostal by means of two rod-like pins which fitted through slots in the intercostal. However, only one of these pins - the rear one - was threaded and secured to the intercostal by means of a nut. The forward pin was merely inserted in the intercostal slot.

FIG. 21. SEATS 19-19A AND 17-17A WITH RELATIVELY INTACT INTERCOSTALS STILL ATTACHED BY REAR PINS. FATALITIES OCCURRED IN SEATS 19 AND 17A.

Thus, in effect, although the seats had four points of attachment, only three of them provided resistance to loads in all directions. Failure of aisle attachments in combination with an aft load on the seat would permit the front pin to pull out of the intercostal. The seat would then be free to rotate around the rear wall attachment (Fig. 21 shows intercostals still attached to seats by rear pins only).

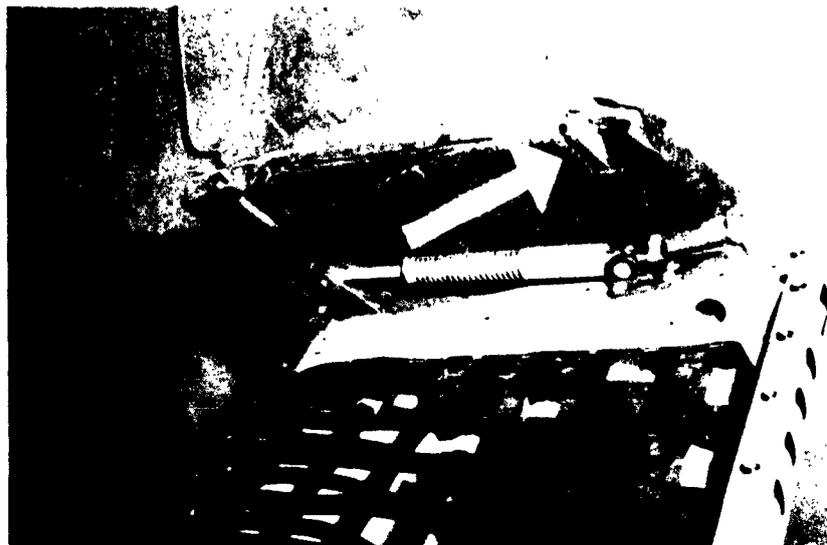
Inward flexion of the cabin walls caused the inboard side structure of the seats to bend toward the aisle. This bending produced high leverage loads on the U-shaped channel fittings, the attachment bolts and the floor structure. In some cases, the seat channel fittings fractured and failed across the rivet holes where the channel was riveted to the side seat unit (see Fig 22). However, in a few cases, the channel fittings pulled free - as complete units - from the sheet metal structure.

FIG. 22. FAILURE OF SEAT ATTACHMENT CHANNEL UNIT. NOTE FRACTURE ACROSS RIVET HOLES.

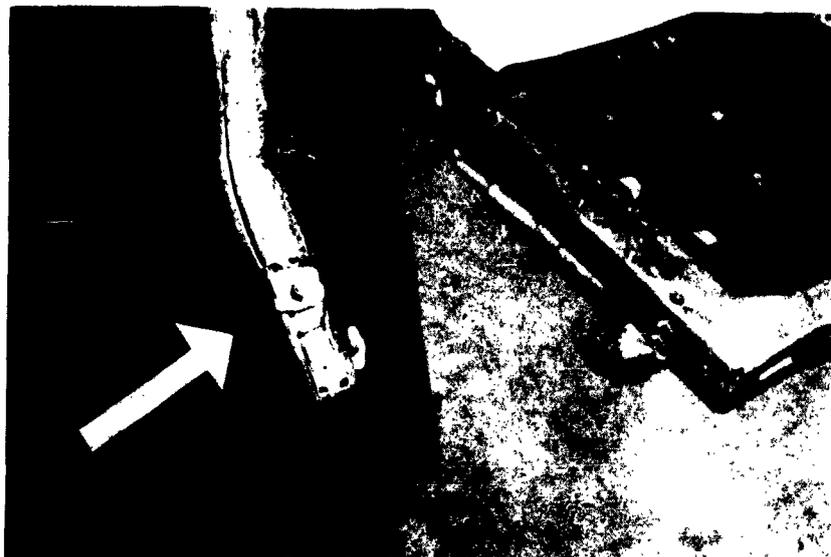
FIG. 24. PIECE OF FLOOR CHANNEL ATTACHED TO SEAT SIDE STRUCTURE.
