NAMC-AEL-1625 14 DEC 1959

CALIBRATION AND QUALIFICATION TESTS
OF McCULLOCH YO-100-4 ENGINE
FOR ROTORCYCLE USE

FINAL REPORT ON
BUAER PROJECT TED NAM-PP-2648.1
BY
C. W. SHEARER

Final Report NAMC-AEL-1625
on
BUAER Project TED NAM-PP-2648.1

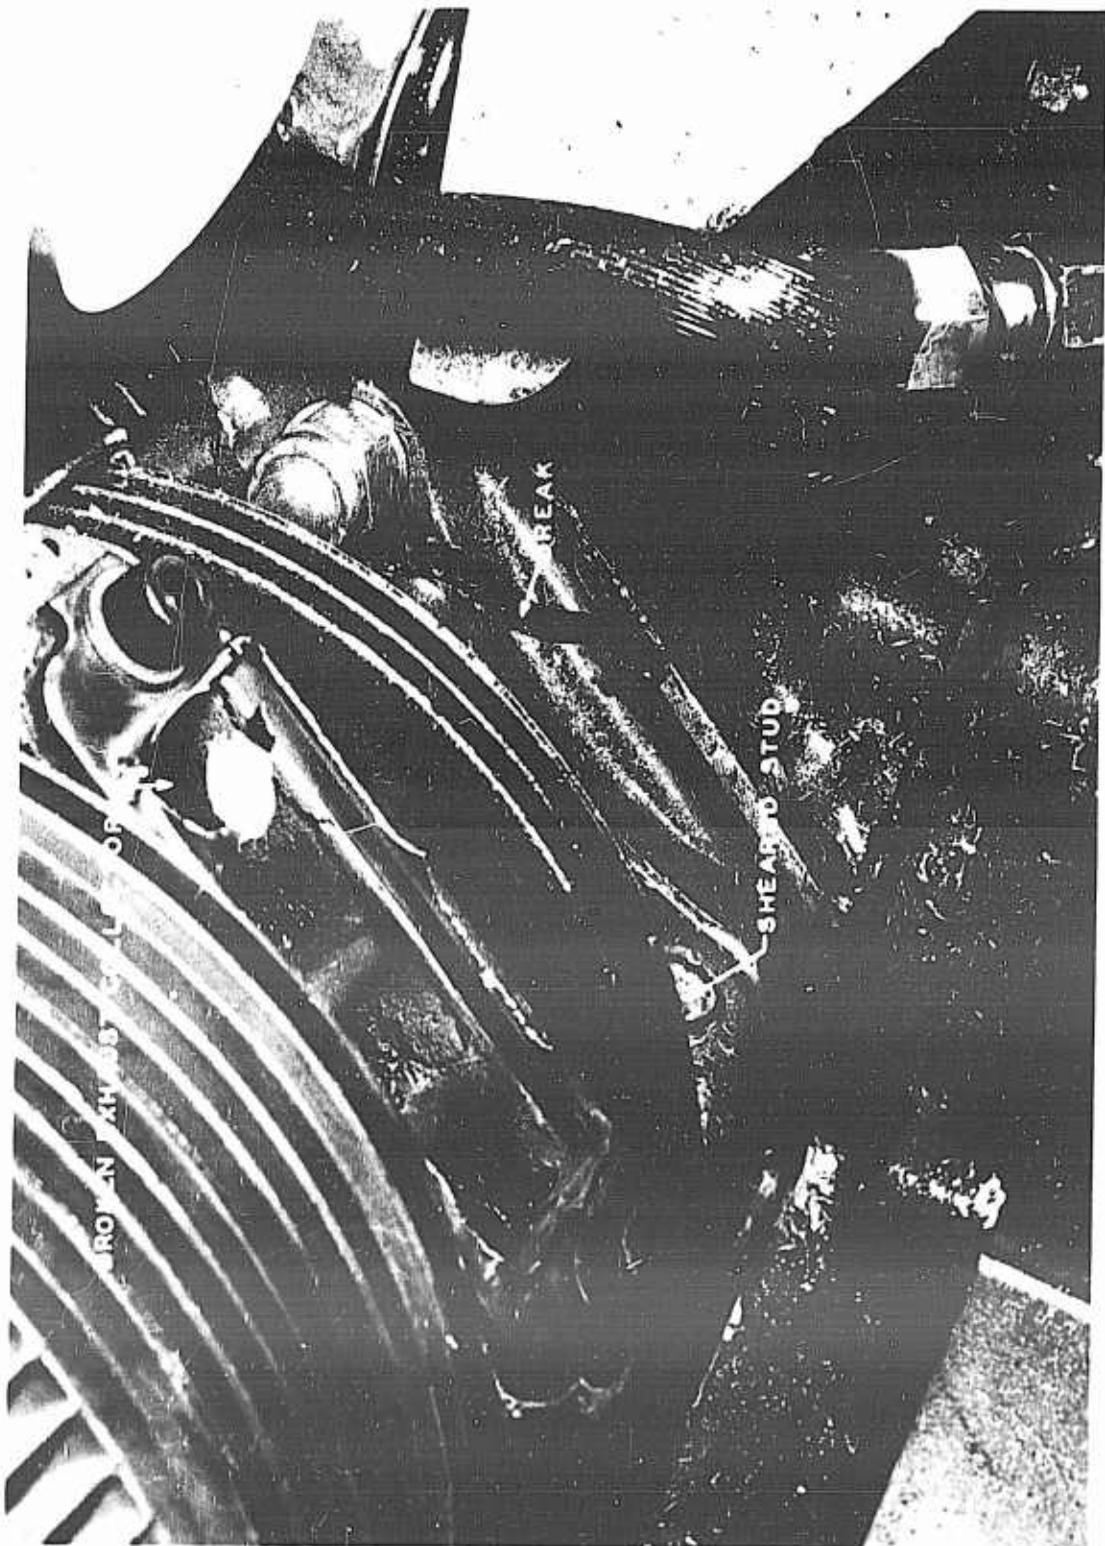
PLATE 8

(b) The second of these failures occurred on engine Serial No. 431-C-3 (rebuilt) (this engine was built-up at AEL of parts from the two engines, Serial Nos. 431-C-1 and 431-C-3, received for the test), after 28.3 hours total operating time (21.5 hours endurance time). In addition to a sheared stud, two fiber lock nuts were found loose on other studs, and the No. 4 cylinder was cracked at the base (see plates 8 and 9). A more positive locking device, possibly castellated nuts with safety wire or cotter pins, would be more effective than the fiber nuts. A secondary failure, the right hand cooling fan (see plate 10), also occurred at this time and it is believed directly attributable to the severe vibration induced by the cylinder failure. The sheared stud was replaced; another cylinder, rod, piston, and cooling fan were installed and tests were resumed.

SECOND FAILURE OF NO. 4 CYLINDER RETENTION

ENGINE S/N 431-C-3 (REBUILT)

(3) Because of the three failures of No. 4 cylinder retention system, corrective action is mandatory. The stiffening of the aluminum crankcase, as recommended by the manufacturer, is endorsed providing that the over-stresses of the studs are the result of crankcase deformations. In addition, it is believed that positive locking of the cylinder holddown nuts should be incorporated and stud installation methods improved to prevent stud loosening. One method of improving stud installation would be to incorporate helicoil or other steel inserts in the crankcase. These latter recommendations would not appreciably increase the cost or weight of the engine.

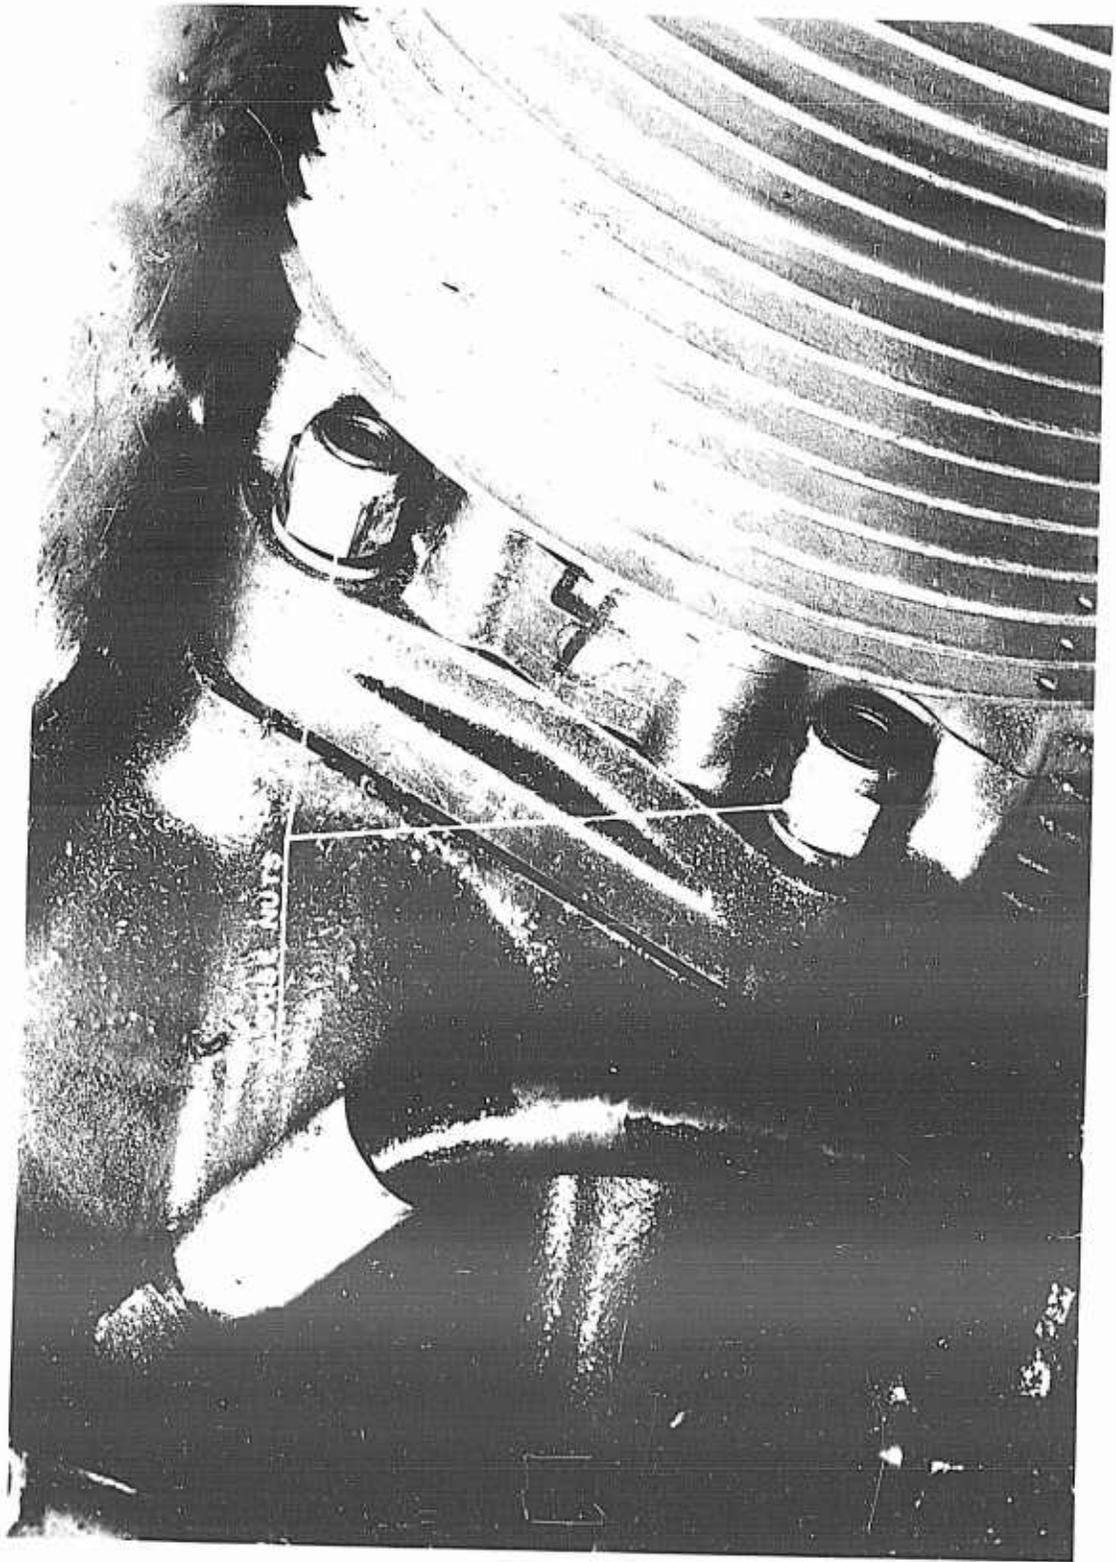
PLATE 9

SECOND FAILURE OF NO. 4 CYLINDER RETENTION

21.5 HOURS ENDURANCE (28.3 HRS. TOTAL) - ENGINE S/N 431-C-3 (REBUILT)

LOOSE CYL. HOLD DOWN NUTS

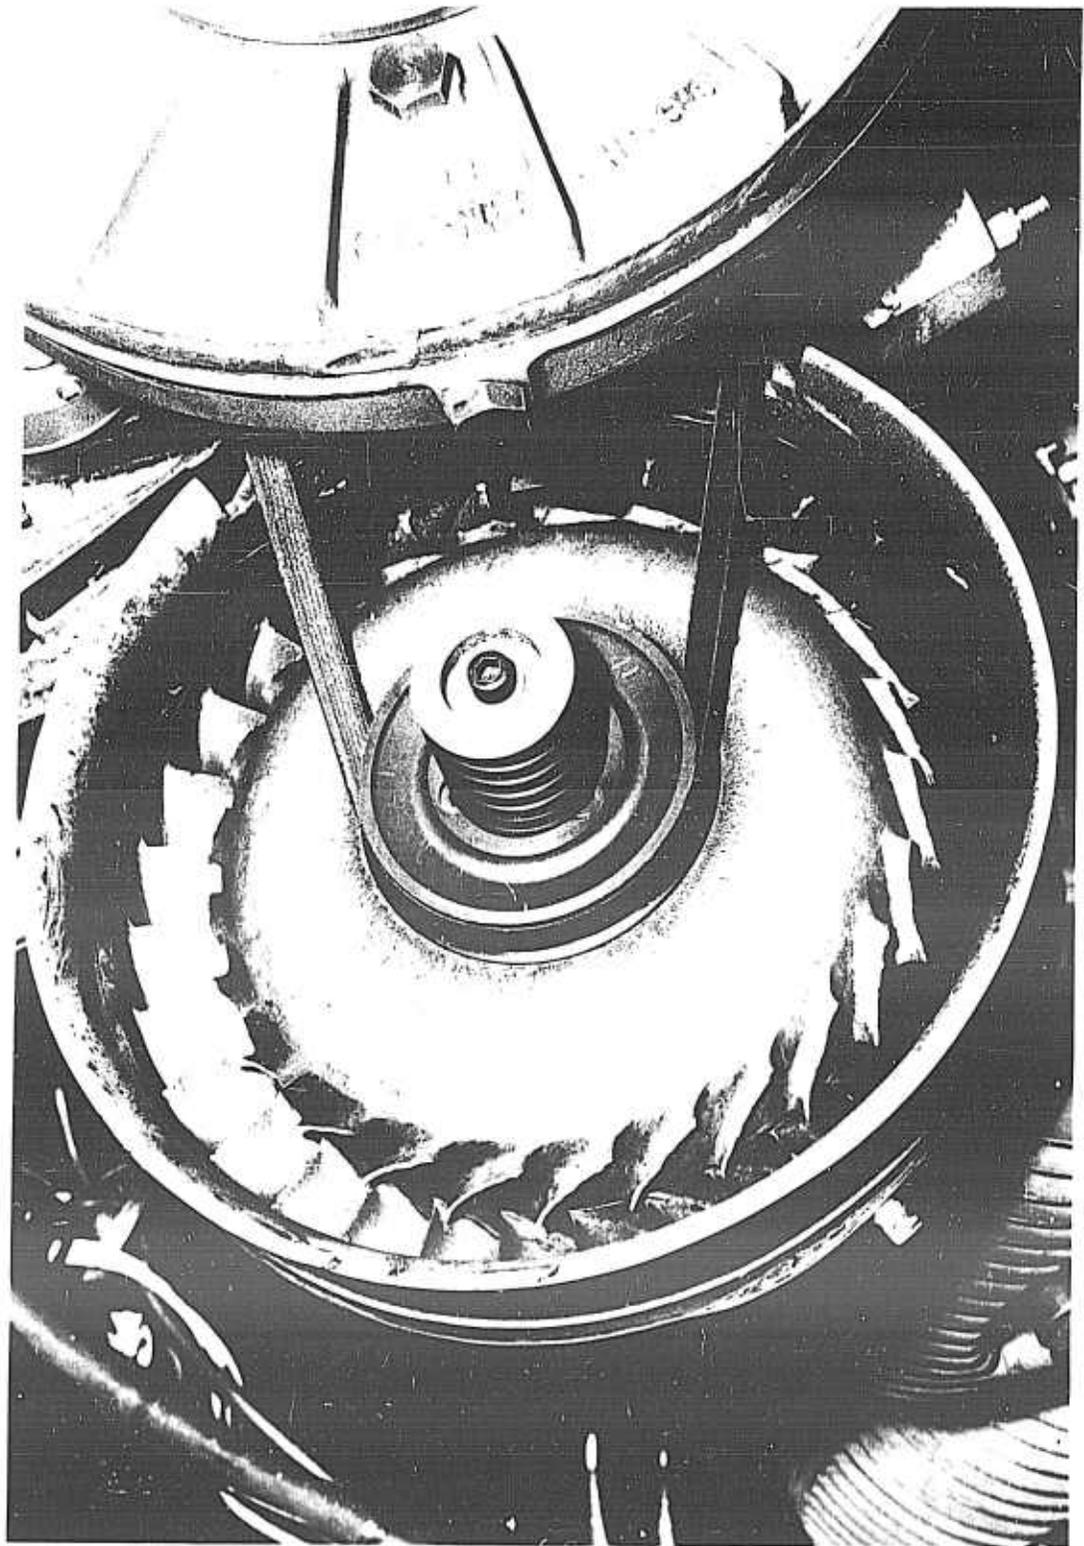
PLATE 10

FAILURE OF R.H. COOLING FAN

21.5 HOURS ENDURANCE (28.3 HRS. TOTAL) - ENGINE S/N 431-C-3 (REBUILT)
(Secondary to Cylinder Failure)

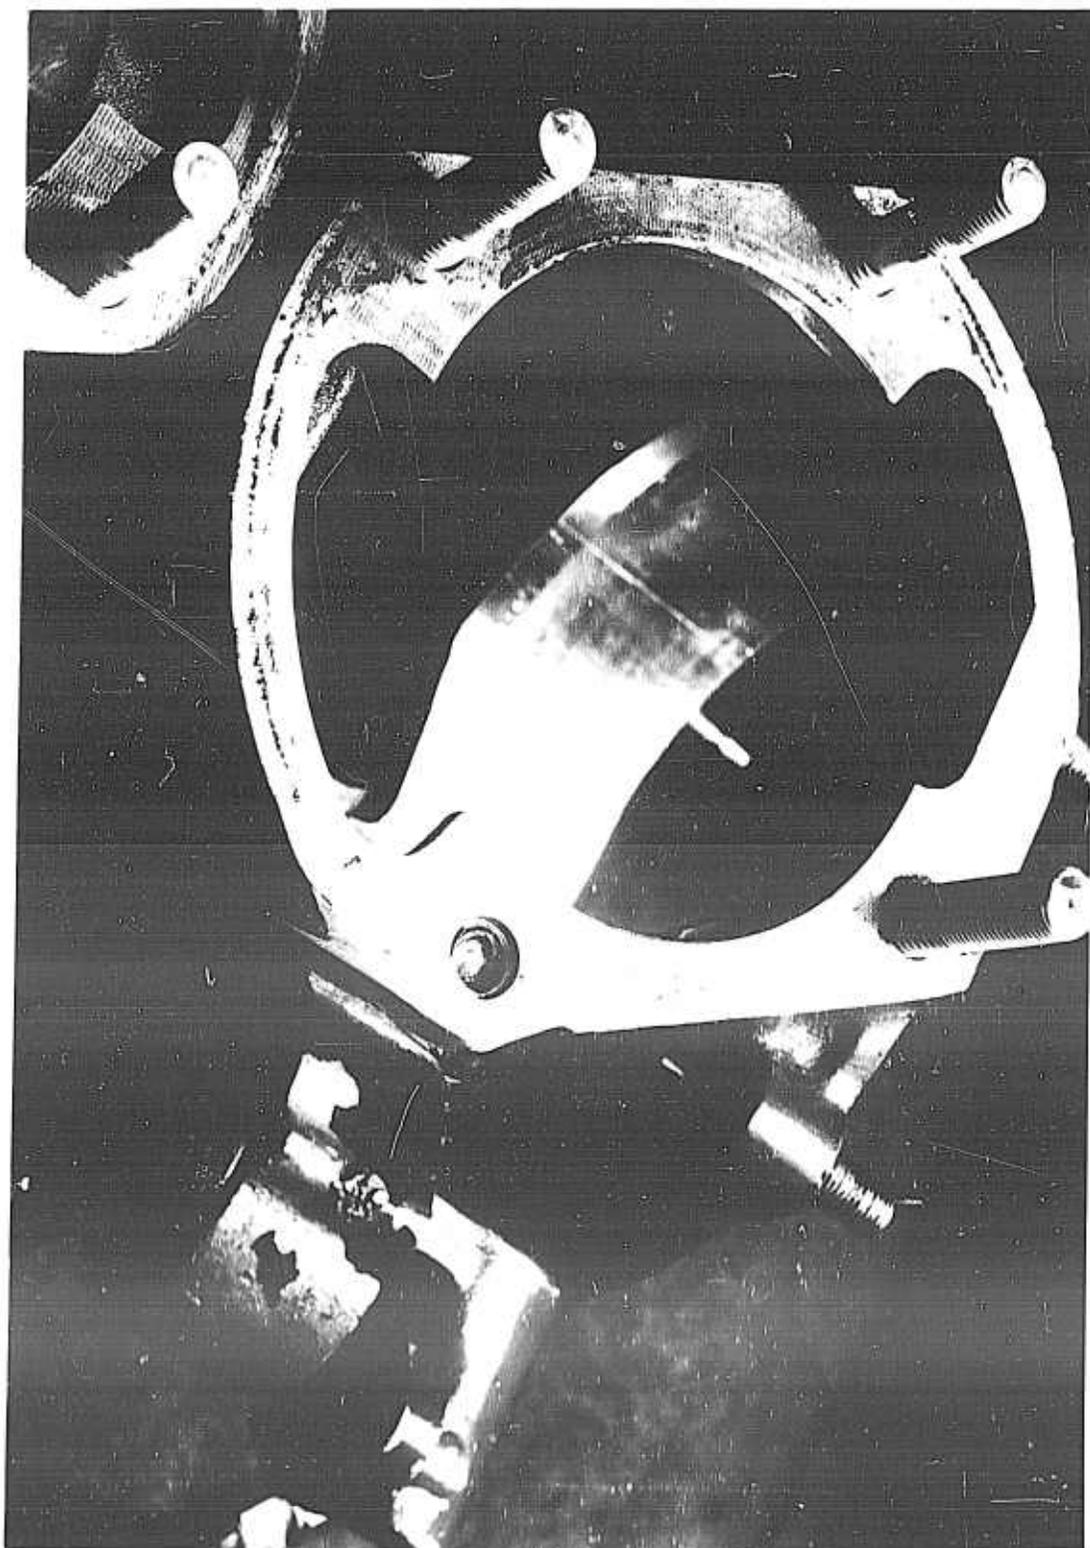
PLATE 11

(c) The third failure consisted of a single broken stud of No. 4 cylinder occurring after 25.5 additional hours of endurance time on the rebuilt, Serial No. 431-C-3, engine after the second failure. This stud failure was found during a periodic inspection, between runs of the engine, before damage progressed beyond the stud. The stud had sheared in the crankcase threads about two threads beneath the mating surface (see plate 11). It was observed upon removal of several studs from the crankcase that two studs backed out at approximately 30 inch-pounds torque. These studs should have been installed to at least 175 inch-pounds torque. Other stud breakaway torques measured approximately 200 inch-pounds. Obviously loose studs are highly unsatisfactory as they often cause deflections and oscillatory loads which greatly increase the stresses in the companion studs.

THIRD FAILURE OF NO. 4 CYLINDER RETENTION

25.5 HOURS ADDITIONAL ENDURANCE TIME - ENGINE S/N 431-C-3 (REBUILT)

(d) Structural experts of the Aeronautical Structures Laboratory were consulted for information of strength and materials of studs to seek recommendations for better material and stud design. Tests were conducted to determine the ultimate and shearing stresses of three studs removed from the crankcase. Spectrographic analysis of the studs by the Aeronautical Material Laboratory indicated the material is SAE 4140 steel; however, hardness tests indicate a tensile strength of only 120,000 psi, and static tensile stress tests were approximately of the same stress values. The stud threads appear to be rolled, a desirable feature which work-hardens the threaded areas and reduces notch effects. As all stud failures were of fatigue nature, the important feature is to increase the fatigue life of the stud. Handbook values of SAE 4140 steel, for this small diameter, indicate it can be easily heat-treated to 160,000 psi by tempering at 1000°F and quenching at 1525°F. From the standpoint of good fatigue life with good impact resistance, a value of approximately 150,000 psi is recommended. A smooth neck-down section, replacing the constant area between the threads, reduces the thread stresses and increases the fatigue life. Use of the neck-down section is common practice on high strength studs and cap screws. Increased radii at the thread roots also increase fatigue life of the studs.

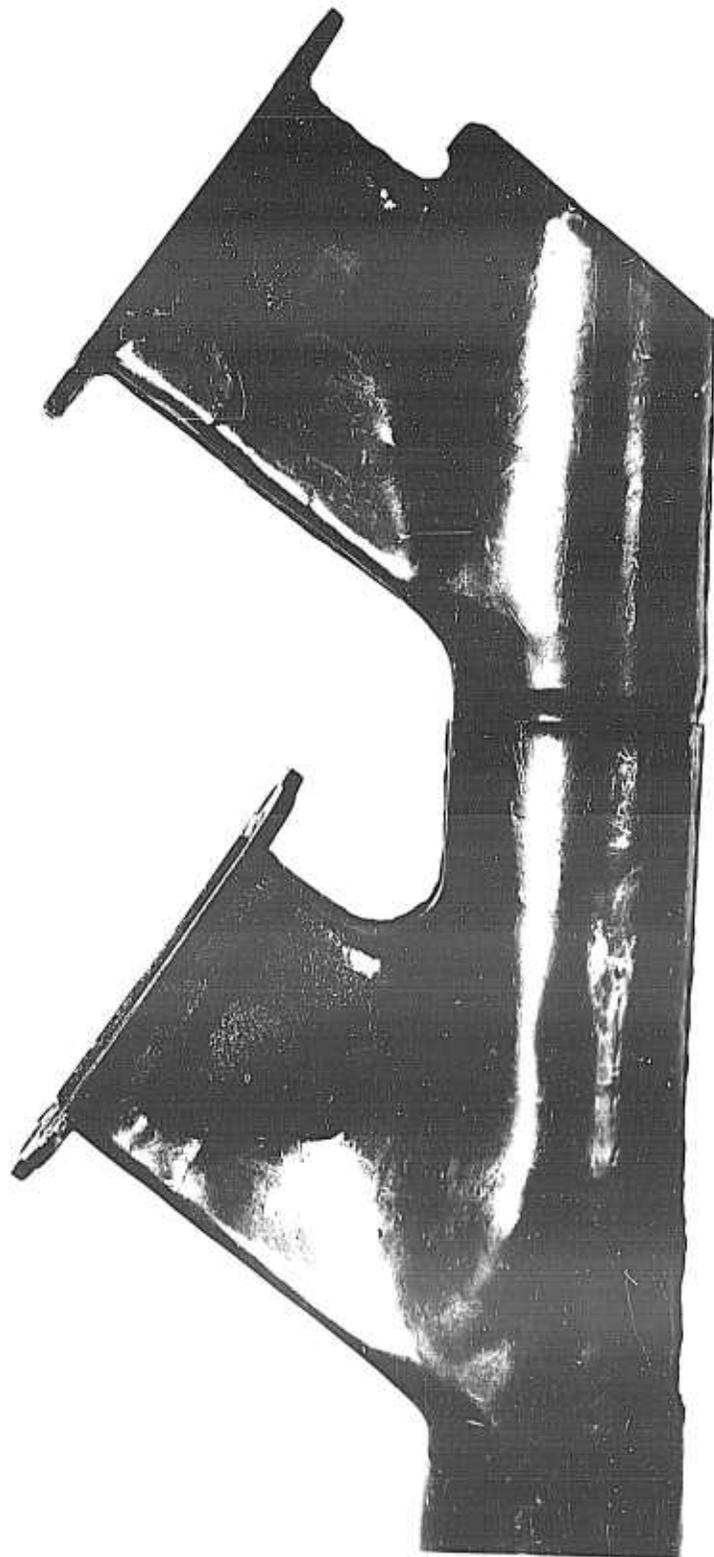
PLATE 12

(a) The exhaust manifolds cracked or ruptured several times. A typical failure is shown on plate 12.

TYPICAL FAILURE OF EXHAUST COLLECTOR MANIFOLD

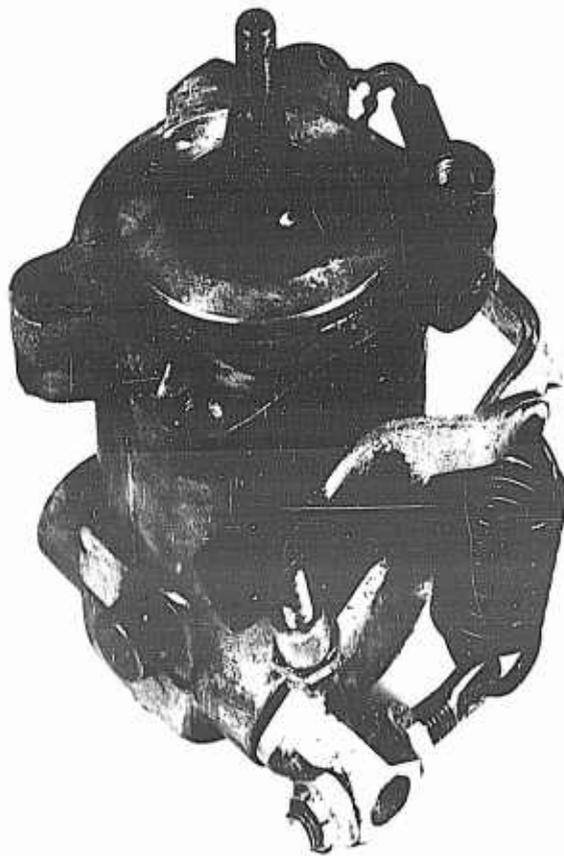
PLATE 13

(d) Two overspeed governor control failures were attributable to insufficient bearing lubrication. The overspeed governor control was designed for a horizontal mounting position of its shaft. Oil in the case up to the sight level permits adequate lubrication to a bearing facing forward, but with the engine in the near vertical position the oil in the control is at the opposite end of the case, away from the shaft bearing, and therefore, the bearing is inadequately lubricated. Filling the entire case with oil did not correct the situation because the added oil was forced out of the case by the rotating flyweights. The overspeed control simply limits the engine speeds higher than the setting of a spring tension adjustment by restricting the throttle opening and does not regulate the engine speed. Plate 13 is a photograph of the overspeed governor control.

VIEW OF OVERSPEED GOVERNOR CONTROL

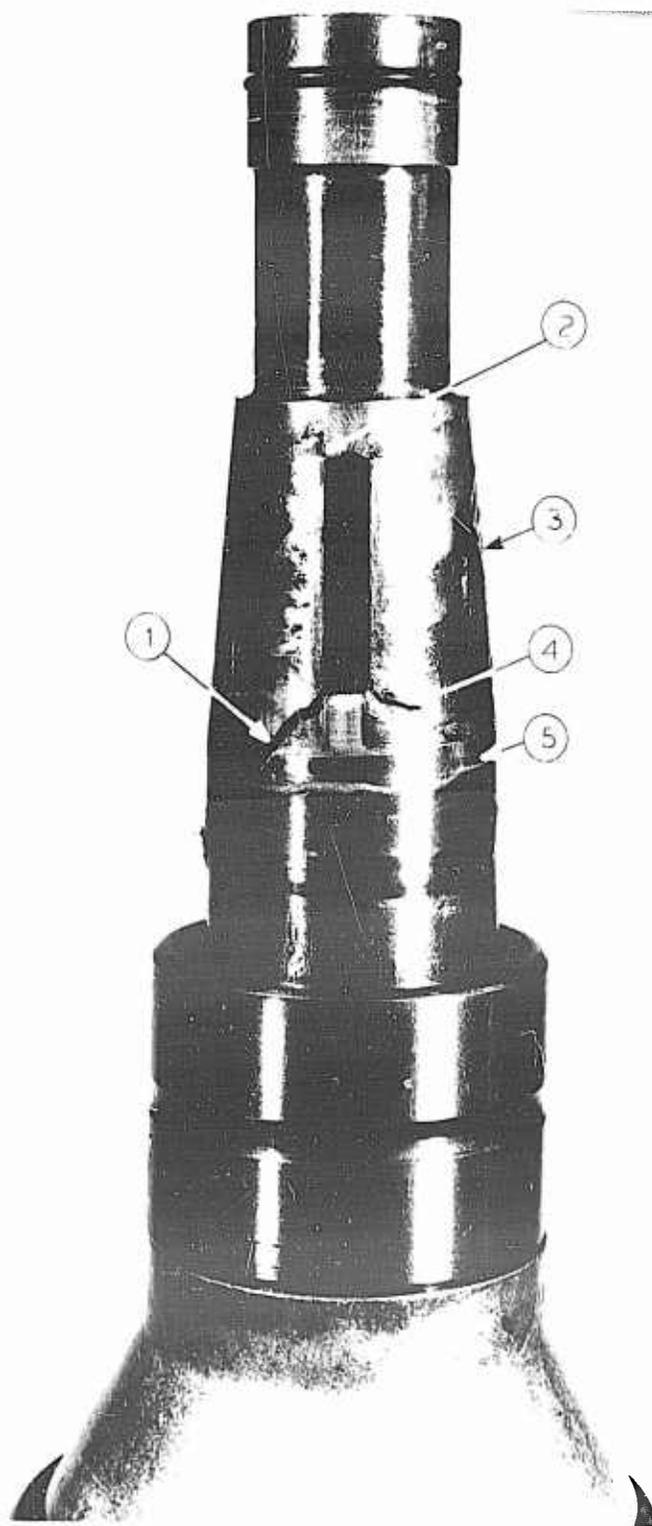
ENCLOSURE (2)

2. Visual examination of the cross-section of the crankshaft in the failed area revealed that the main fracture followed a path indicative of torsional shear. The incipient cracks at the corners of the Woodruff Key way opposite to the corner of the main fracture confirmed this observation as did the path of the failure about the circumferential cross-section of the crankshaft. Enclosure (1) shows the locale of the failure in reference to the crankshaft assembly. Enclosures (2), (3), (4) and (5) show a close up view of the path of fracture. Enclosures (4) and (5) reveal the galling which occurred at the crankshaft - fluid coupling assembly interface. On opening the fracture, the typical "oyster shell" markings indicative of the action of a fatigue mechanism were revealed. These marks indicated that the failure originated at the sharp corner between the lateral side and curve base of the Woodruff Keyway located approximately between the crankshaft surface and the base of the keyway. The lack of concentricity of the lightening hole in this portion of the crankshaft made the material cross-sectional thickness at the base of the keyway quite thin. Numerous tool marks were observed on the surface of the lightening hole.

4. From the foregoing examination, it is concluded that the failure occurred by the fatigue mechanism. This was initiated by the cyclic stresses concentrated in the sharp corner in the Woodruff keyway (described in Section 2 above and shown in enclosure (6)). The galled surfaces shown in enclosures (4) and (5) are indicative of poor bearing contact between the crankshaft and hydraulic coupling. In view of the detailed instructions found in the manufacturer's drawing #263253 with regard to the elimination of tool marks in the lightening hole and the emphasized details concerning the tolerance limits for fillet radii exclusive of the keyway, the sharp edges and contours found in the Woodruff keyway would seem to indicate a design oversight or possible poor fabrication practice. Whether or not design, fabrication, or assembly was deficient with regard to this engine is beyond the purview of this report. There is insufficient data available for determining the origin of the cyclic torsional stresses which produced the fatigue failure. However, since the metallurgical examination gave no evidence that the failure was due to a material deficiency, it is suggested that the vibrational effects of crankshaft rotation, as evidenced by the galling and the working stresses imposed by the operative stresses, added to the notch effect of the Woodruff keyway, triggered the failure.

| 1. Main path of failure | 2. Incipient cracks | 4. Secondary failure |
| torsion effects | | of failure |

FAILED AREA OF CRANKSHAFT SHOWING WOODRUFF KEY

5. It is, therefore, recommended that the design, fabrication, and assembly of the engine and its components be reviewed with regard to the elimination of notch effects, proper bearing contacts, and misalignment.

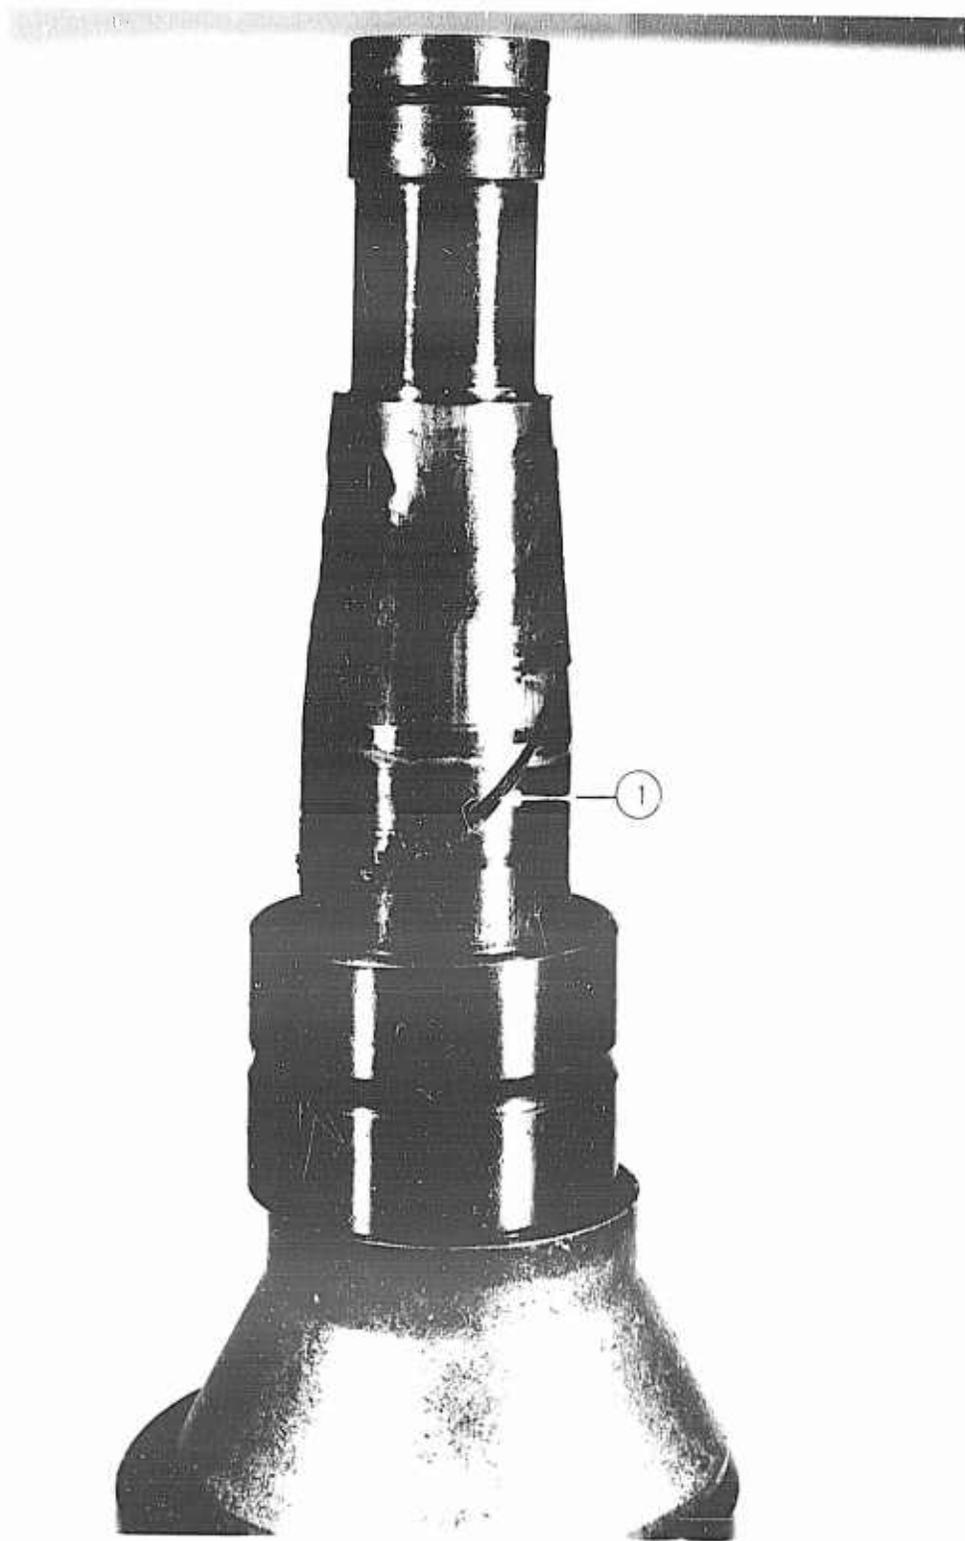
ENCLOSURE (3)

1. Main path of failure - angle of path indicates torsional effects

FAILED AREA OF CRANKSHAFT, ROTATED 90° TO RIGHT OF VIEW GIVEN IN ENCLOSURE (2)

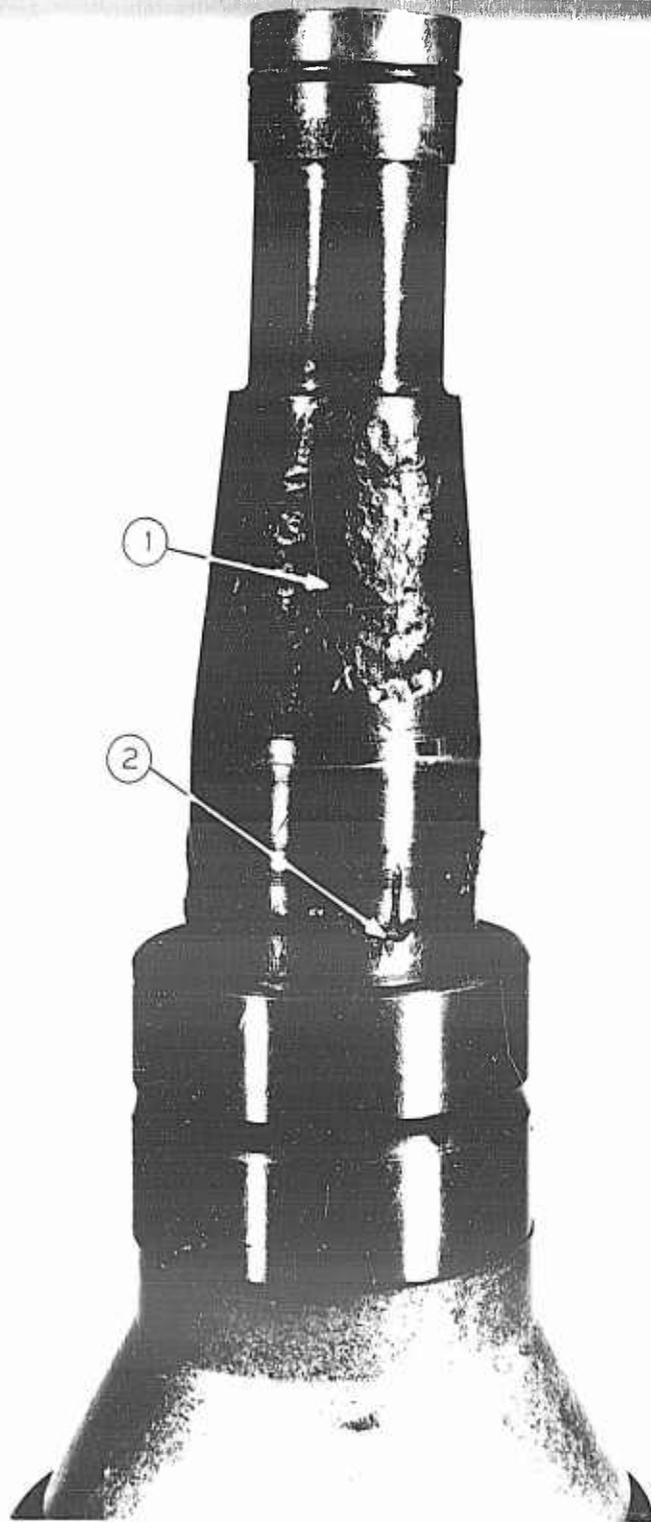
ENCLOSURE (4)

1. Galled Area 2. Path of Failure

FAILED AREA OF CRANKSHAFT, ROTATED 180° TO THE VIEW GIVEN IN ENCLOSURE (2)

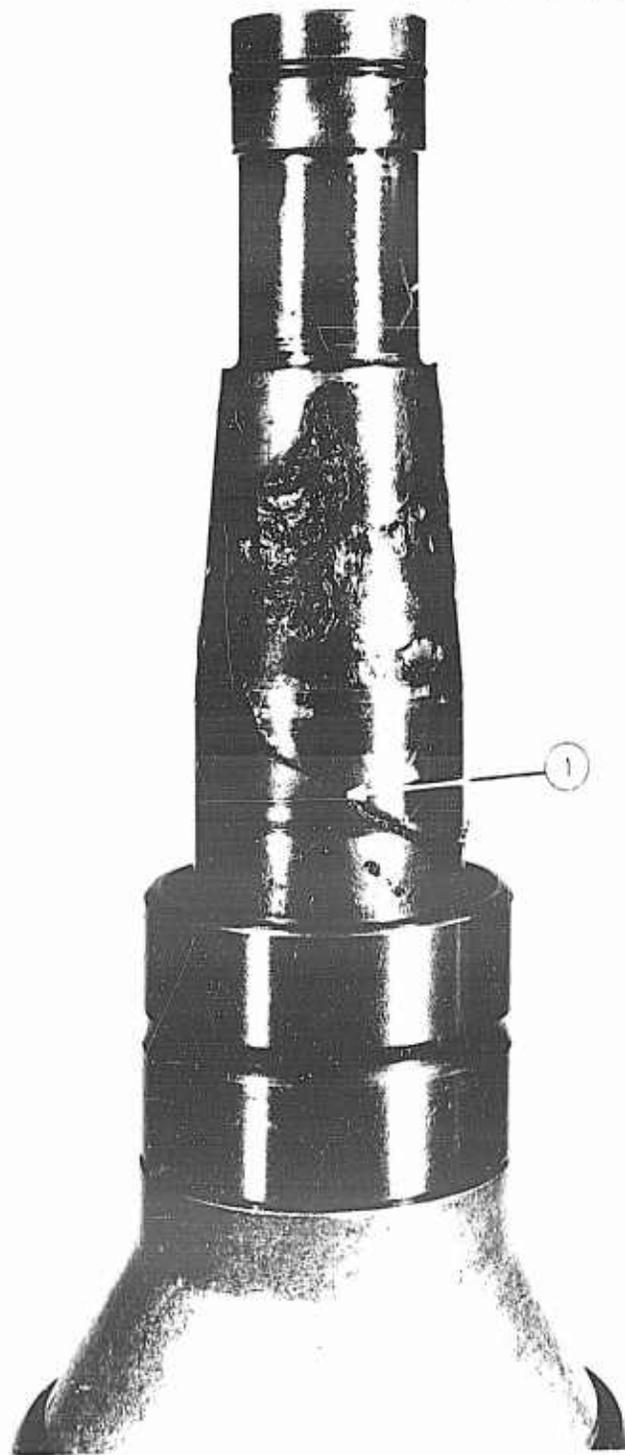
ENCLOSURE (5)

1. Path of failure

FAILED AREA OF CRANKSHAFT, ROTATED 270°
TO RIGHT OF VIEW GIVEN IN ENCLOSURE (2)

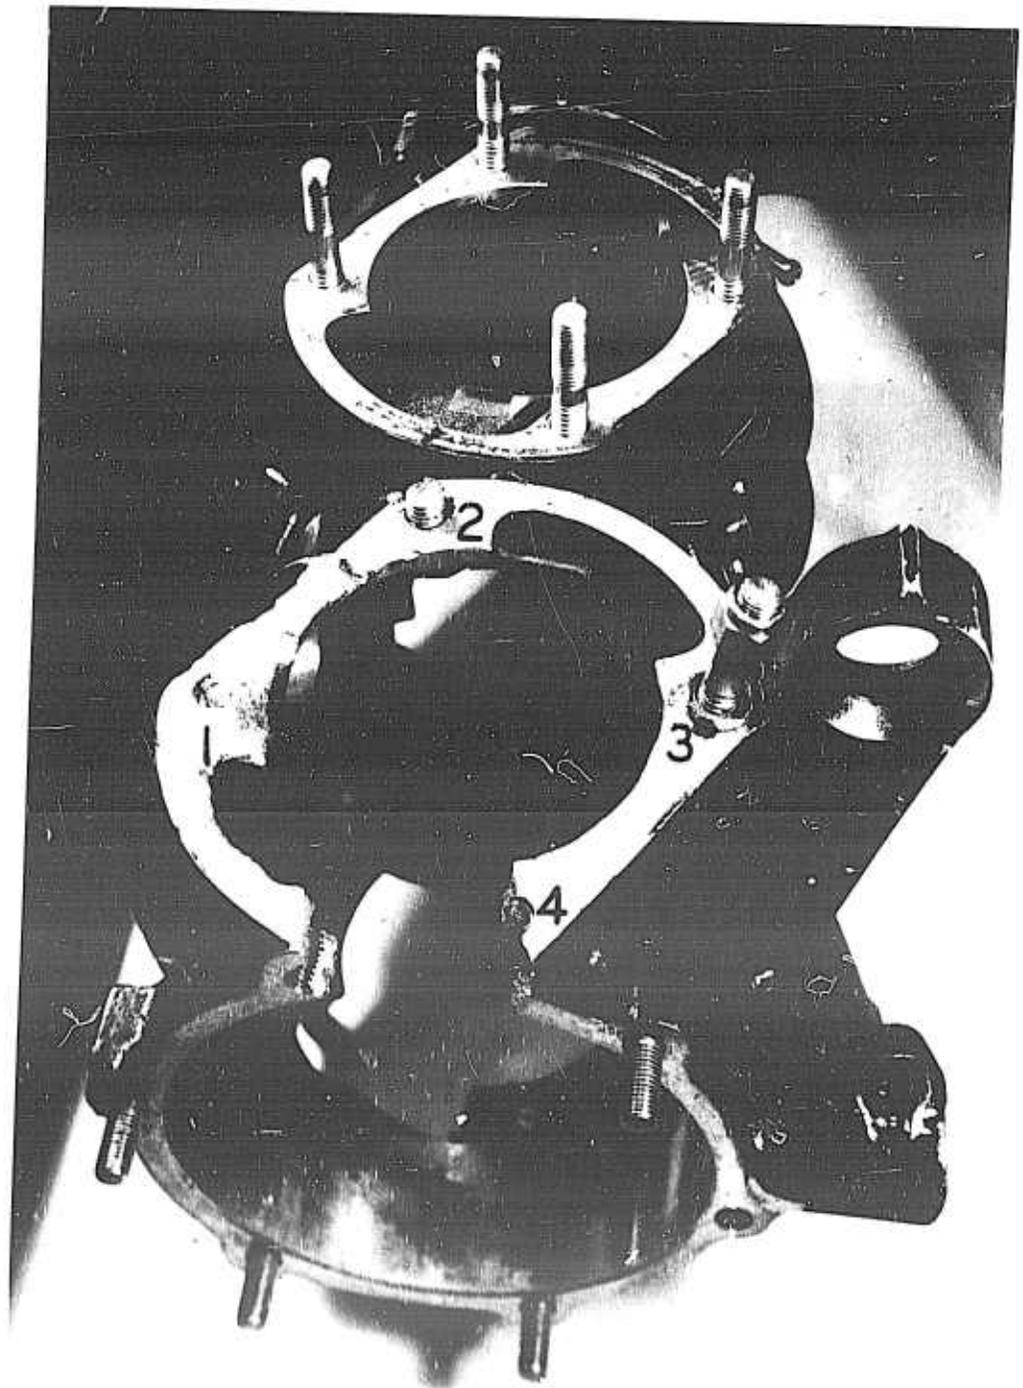
ENCLOSURE (1)

2. Visual examination revealed that failure occurred in the No. 4 cylinder. Further examination disclosed that the stud labeled No. 1 (enclosure (1)) had failed just below the top portion of the flange and had been partially covered by deformed material from the casing. Stud No. 2 (enclosure (1)) failed through the root of a thread. Stud No. 3 which was in contact with the broken out portion of the cylinder (enclosure (2)) did not break, but was bent along the plane of the diagonal between studs nos. 1 and 3. No damage other than a slight evidence of wear was apparent on stud no. 4, although chips of aluminum were found embedded in the threads.

6. While the case casting exhibited porosity, it is believed that the break-out in the flange area was a secondary failure. The primary failure is believed to be due to a fatigue failure in stud no. 1 (see enclosure (1)). Evidence for this may be seen in the cracks at the thread roots and fracture face of stud no. 1. In view of the fact that all the studs were found to be free from microstructural defects and were otherwise metallurgically sound, it is suggested that the fatigue failure of stud no. 1 was precipitated by the cyclic loads of engine operation. Following the failure of stud no. 1, and with the continuing operation of the engine, stud no. 2 and the case flange failed almost simultaneously. This is evidenced by the fact that stud no. 4 was not damaged but did have particles of aluminum embedded in the threads. The motion of the moving piston then imparted a bending moment to stud no. 3, which by this time was the only stud holding the cylinder head. As may be seen by reference to enclosure (2), this stud bent backwards and to the right away from studs nos. 2 and 4. When the bending moments became too great, the cylinder casting failed.

GENERAL VIEW OF FRACTURED ENGINE CASE

Note Wear on Left Side of Cylinder Mounting Flange

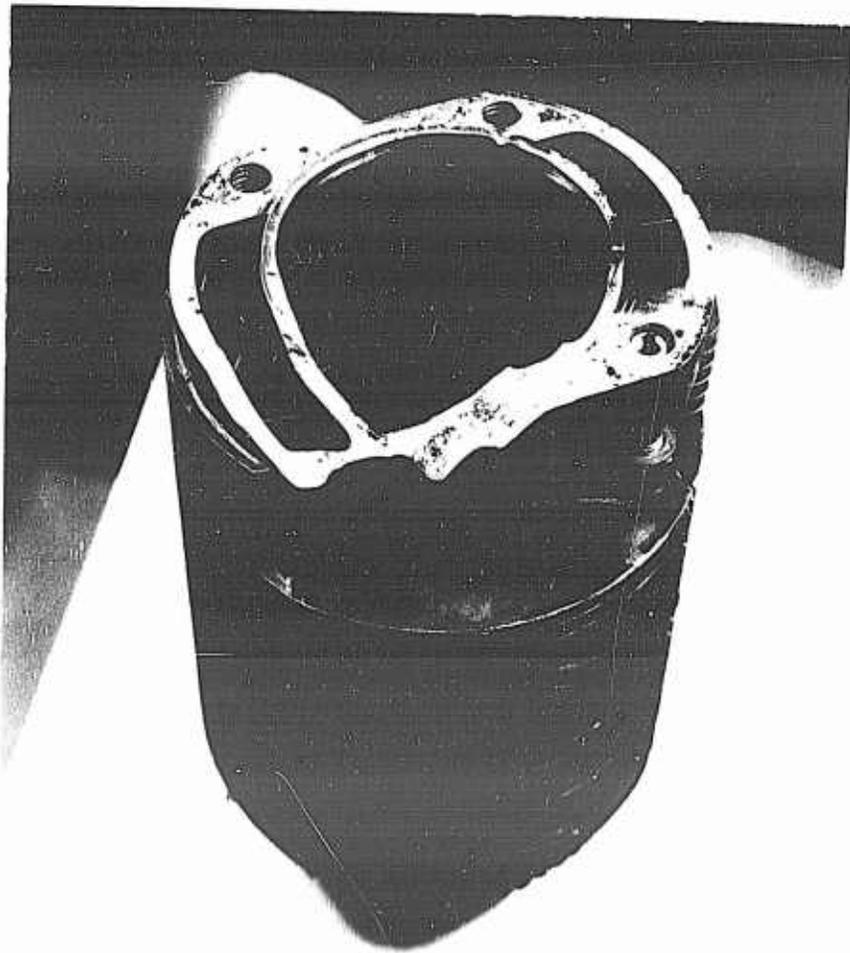
ENCLOSURE (2)

GENERAL VIEW OF FRACTURED CYLINDER

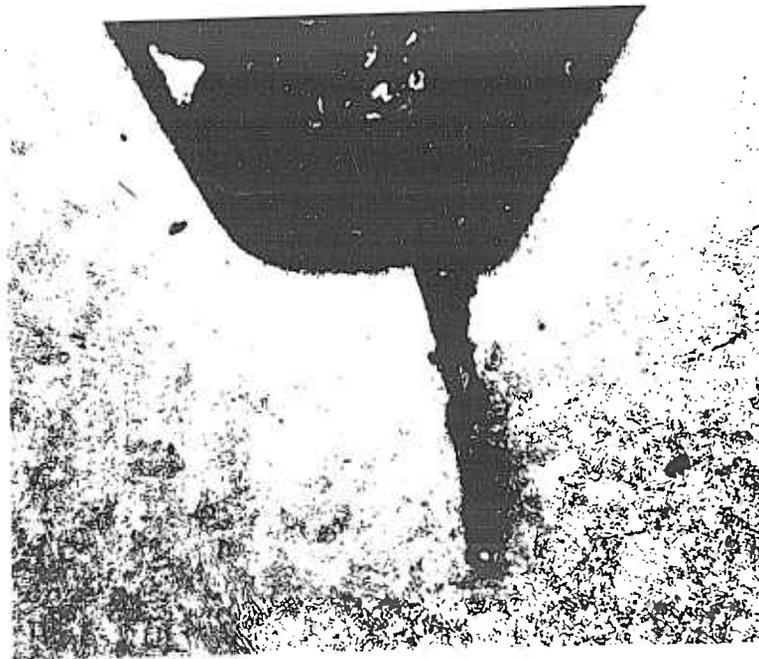
ENCLOSURE (7)

Plastic deformation may be seen on the extreme left side of the fracture face. The remainder of this face shows the characteristic oyster shell markings associated with fatigue failure. Microscopic examination of a longitudinal section of stud no. 1 revealed the presence of small cracks at the roots of several threads. This condition was not observed in a similar examination of the other studs. Enclosure no. 7 shows a crack located in the thread root adjacent to the thread through which failure occurred.

CRACK IN STUD THREAD ROOT

Note inclusion at base of crack

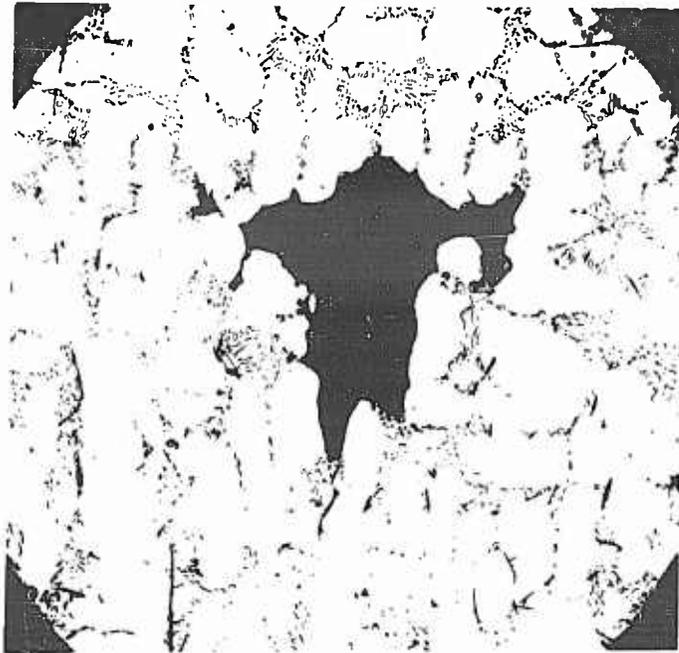
5. Enclosure (8) illustrates the microshrinkage porosity observed during the microscopic examination of the case casting.

MICROSTRUCTURE OF ENGINE CASE, SHRINKAGE CAVITY
