ATBBG P-2044

SUBJECT. Report of Project Nr 2044, Evaluation of Truck,
1/4-Ton, 4x4, M422

5. SUMMARY OF TESTS. Tests were conducted in the vicinity of Fort Knox, Kentucky, by Major Robert H. Harrington, Armor, in conformance with the plan of test referenced in paragraph 2g.

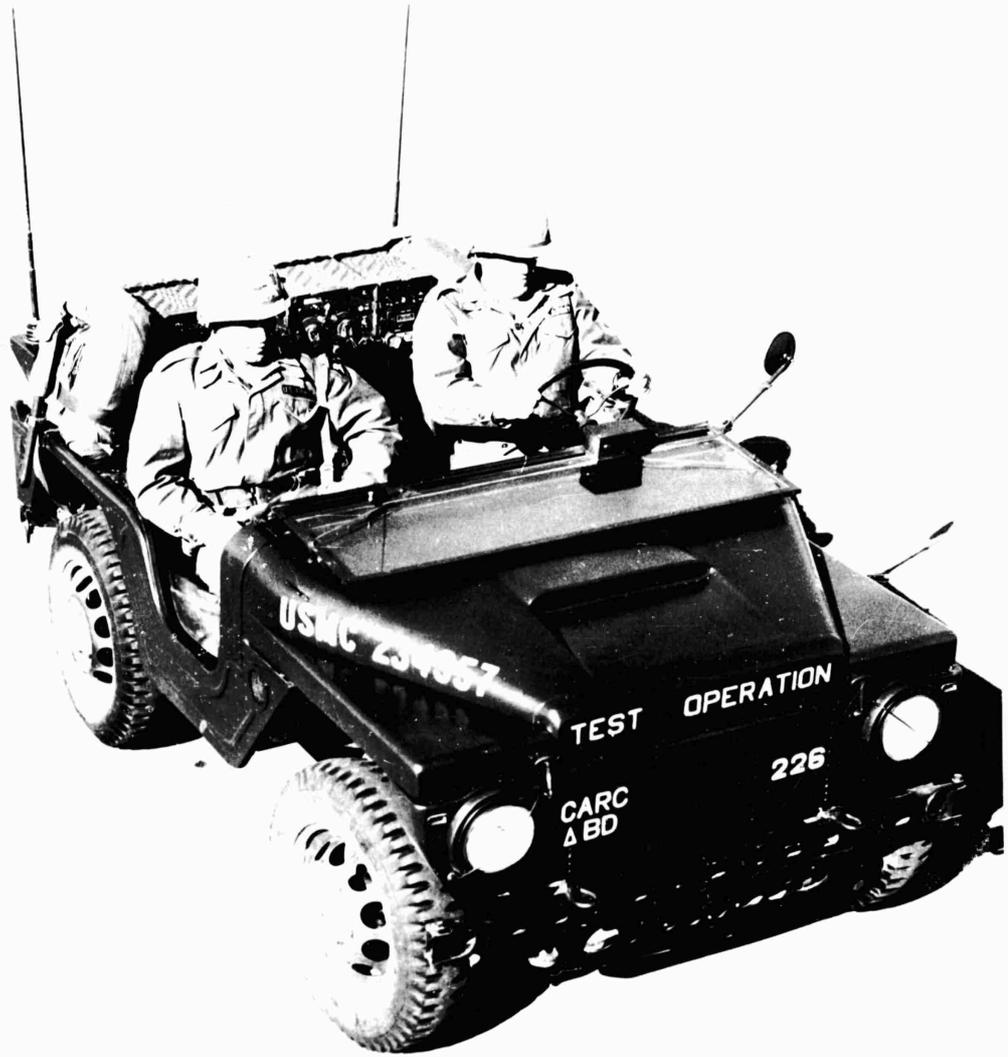
Incl 3

(3) Aside from the considerations discussed in paragraph (2), above, the test vehicle was considered adequate to accommodate the personnel and equipment called for in use of the vehicle as a command vehicle (inclosure 3). The test vehicle was considered inadequate for accommodation of personnel and equipment required in use of the vehicle as a reconnaissance platoon scout vehicle (inclosure 4). The loadings shown by both inclosures are common to all Army divisional units and are considered typical.

TRUCK, 1/4-TON, 4X4, M422 EQUIPPED AND MANNED FOR USE AS
PLATOON LEADER'S VEHICLE RECONNAISSANCE PLATOON.
