A SAMPLE TEST EXPOSURE
TO EXAMINE CORROSION
AND FOULING OF EQUIPMENT
INSTALLED IN THE DEEP OCEAN

U.S. NAVAL
UNDERWATER ORDNANCE STATION
NEWPORT, RHODE ISLAND

TECHNICAL MEMORANDUM

November 1962

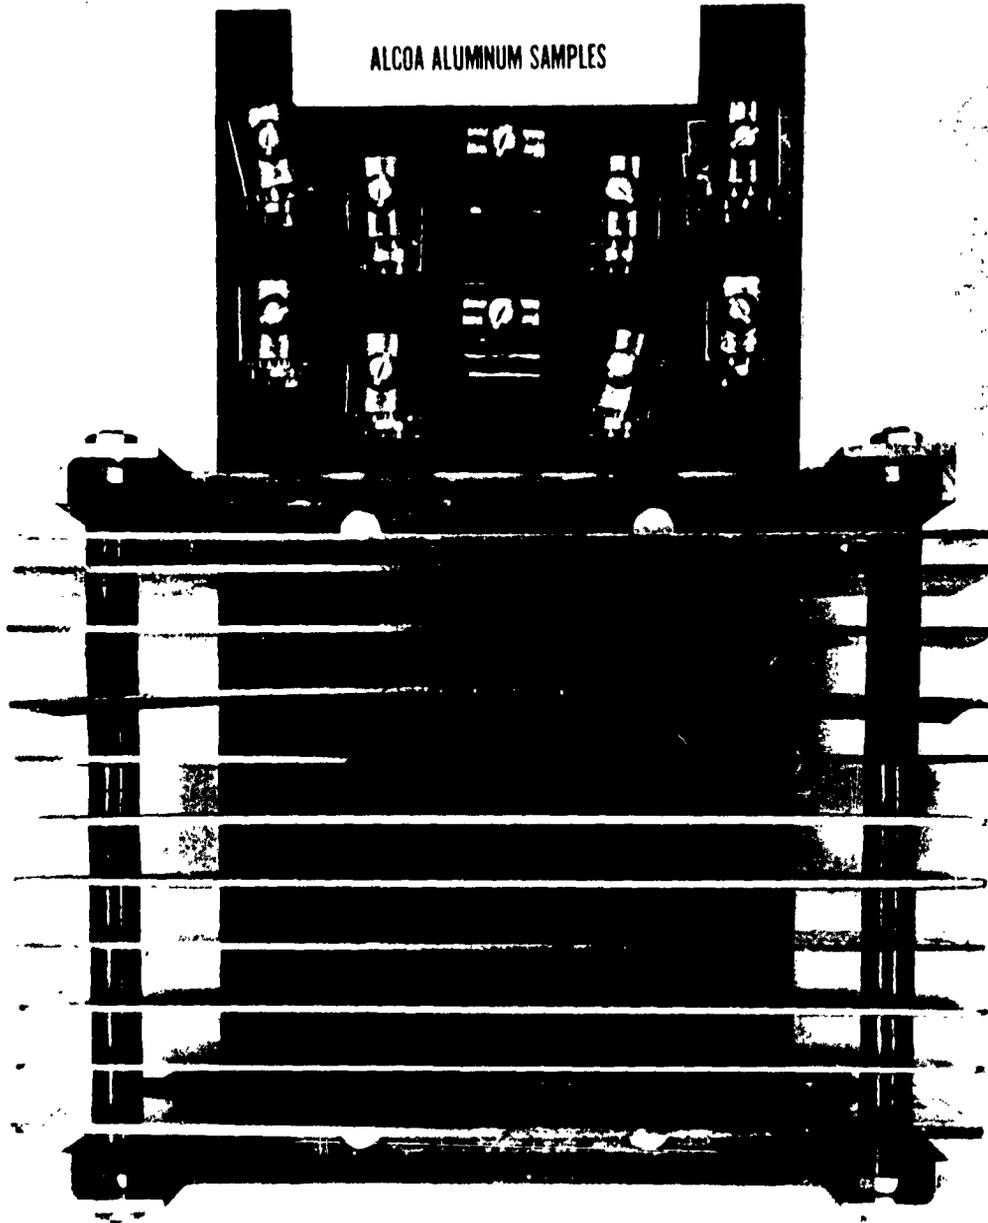
Figure 4

Aluminum Samples Before Exposure
