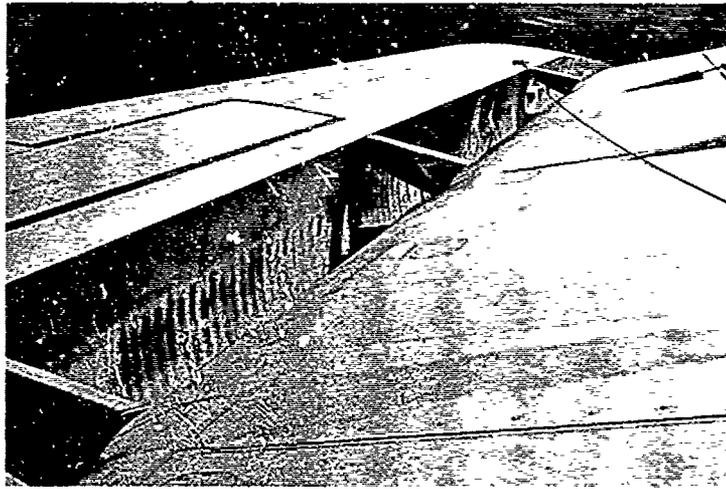
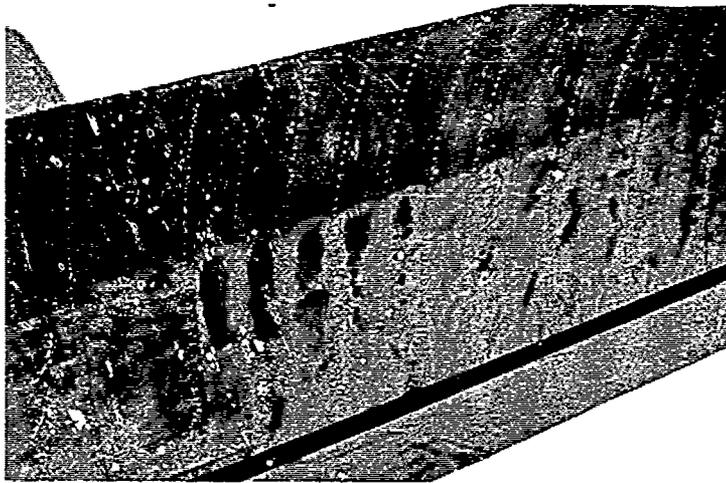
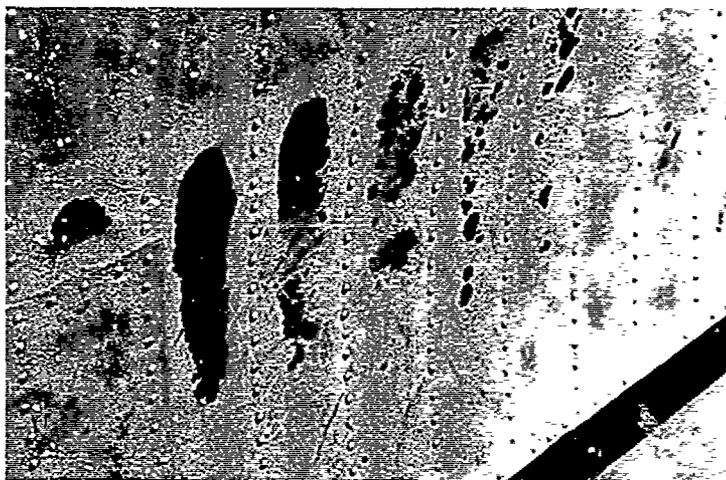
Figure 4.14 Shot 1 Thermal Damage to Trailing Edge Fairing of Right Stabilizer

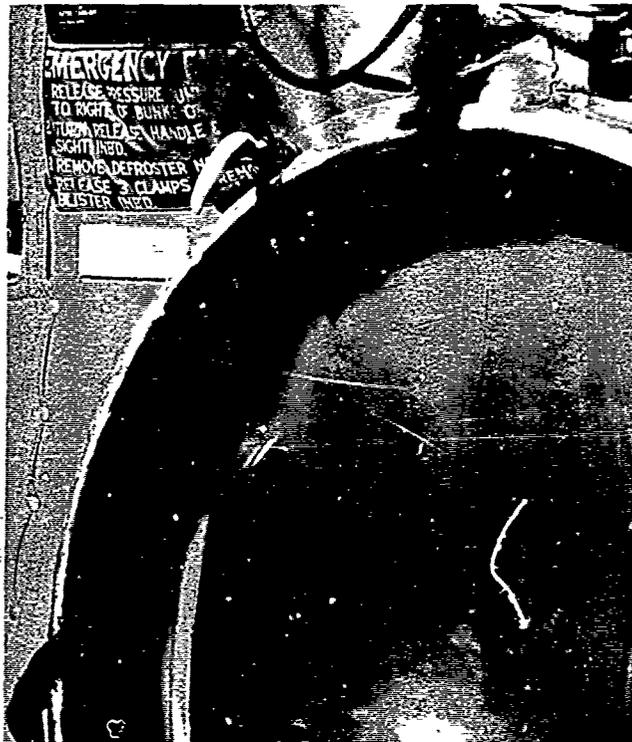
Figure 4.16 Shot 1 Thermal Damage to Rubber Pad on Rim of Aft Lower Right Blister

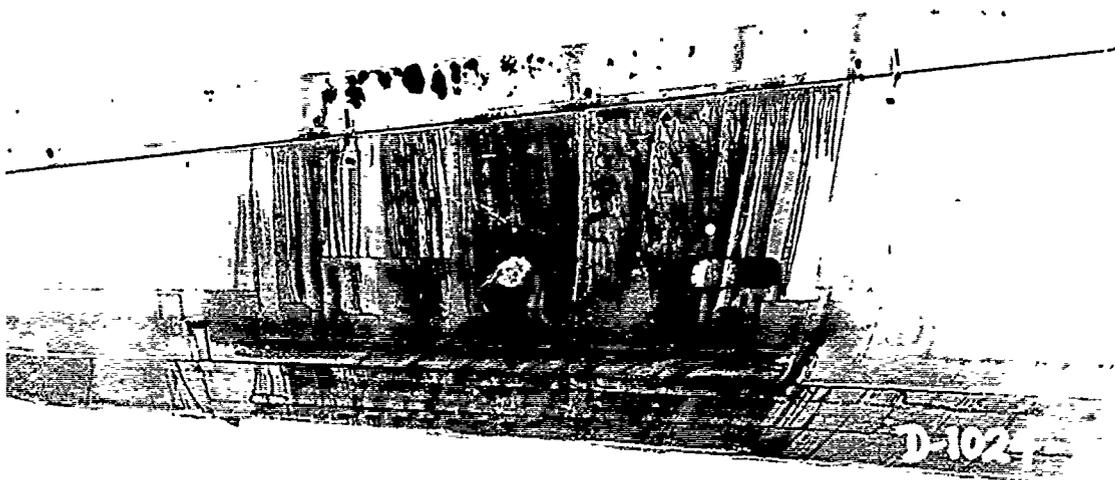
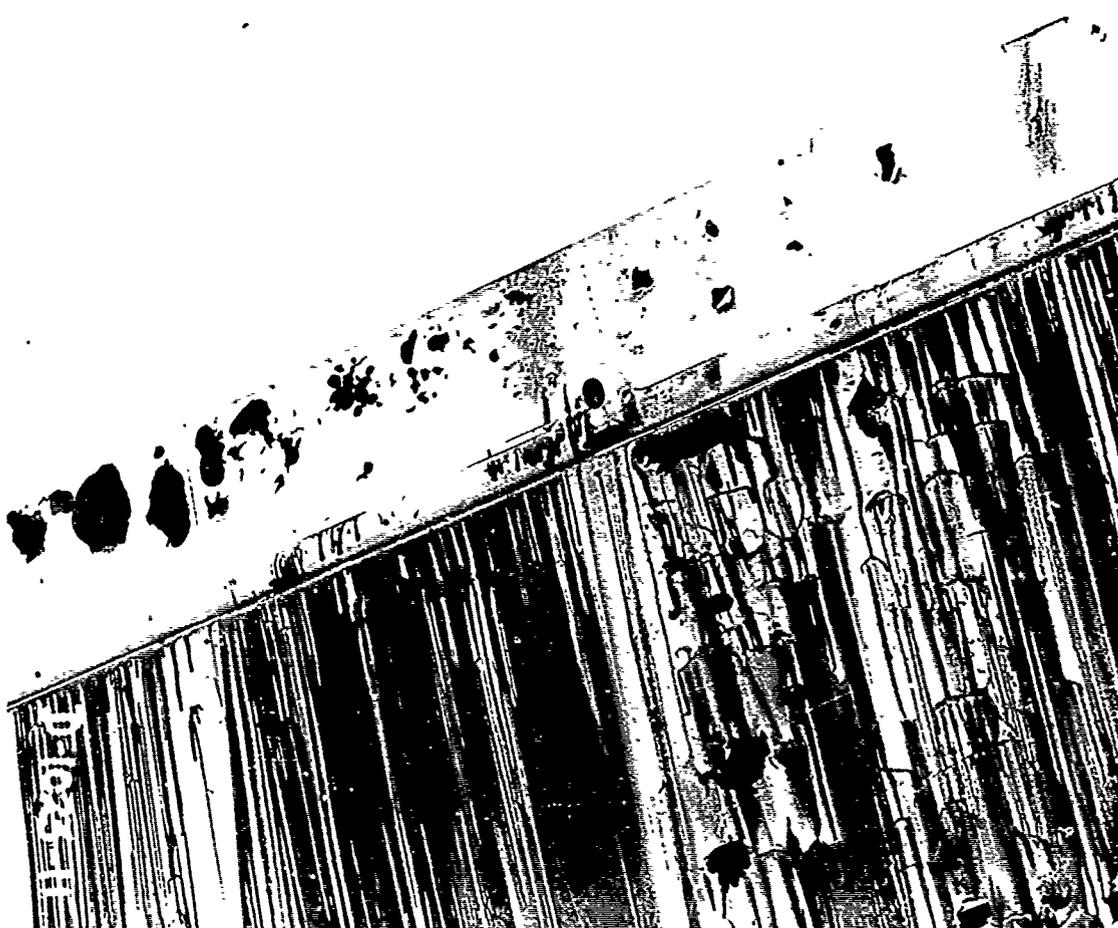
Fig. 4.17 Oil Deposit And Damaged Paint On Left Elevator After Shot 2

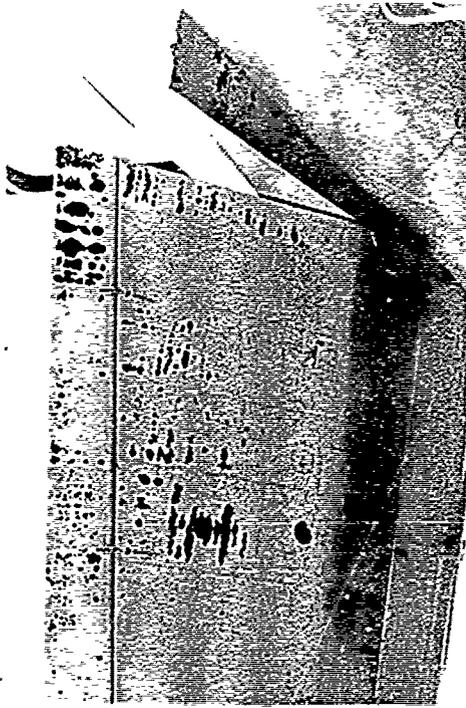
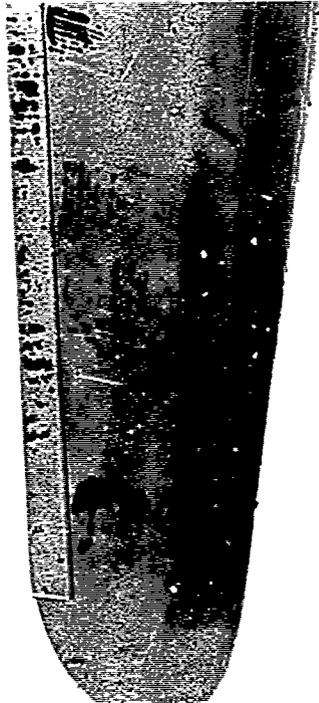
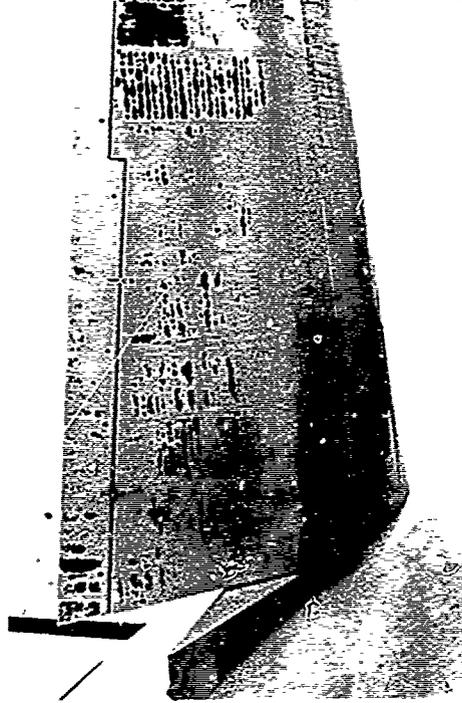
the aircraft during Shot 5. This was apparent from the extent of the thermal damage after Shot 5. The elevator skin was permanently buckled at four places, and a large percentage of the paint on the stabilizer and elevator was blistered and peeled.

Fig. 4.18 Left and Right Elevators After Shot 5

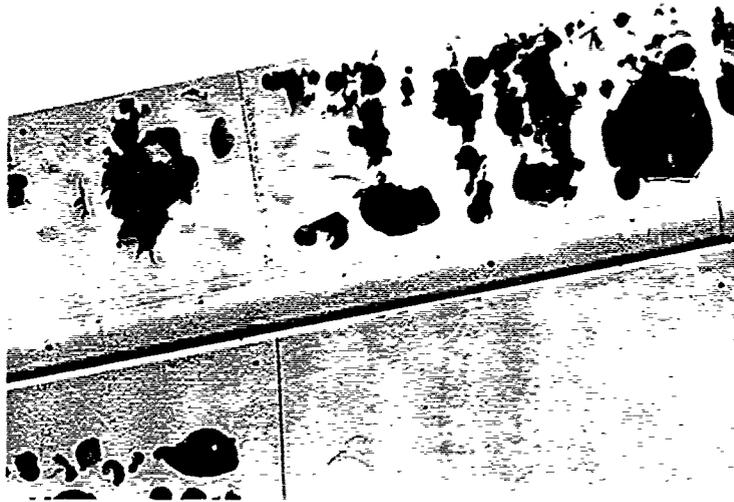
Fig. 4.19 Damaged Paint Of Left Elevator Tab After Shot 5

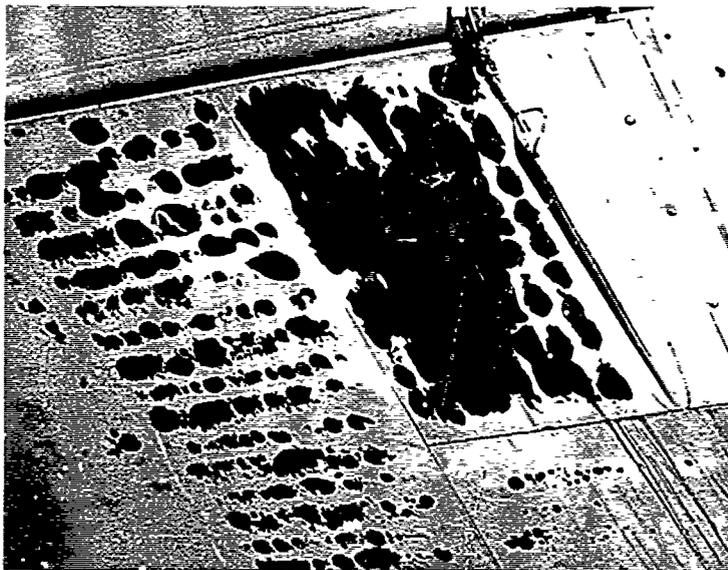
Fig. 4.20 Permanently Buckled Skin Of Ho Panel Section On Right Elevator After Shot 5

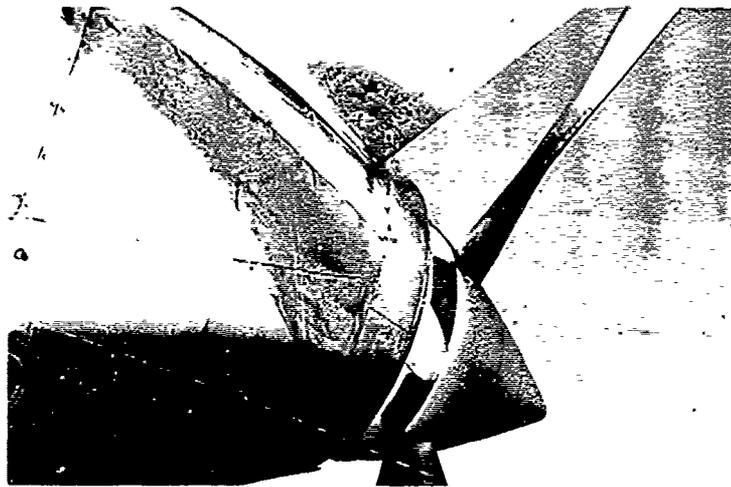
Fig. 4.21 Shot 5 Thermal Damage to Wing Flap Paint

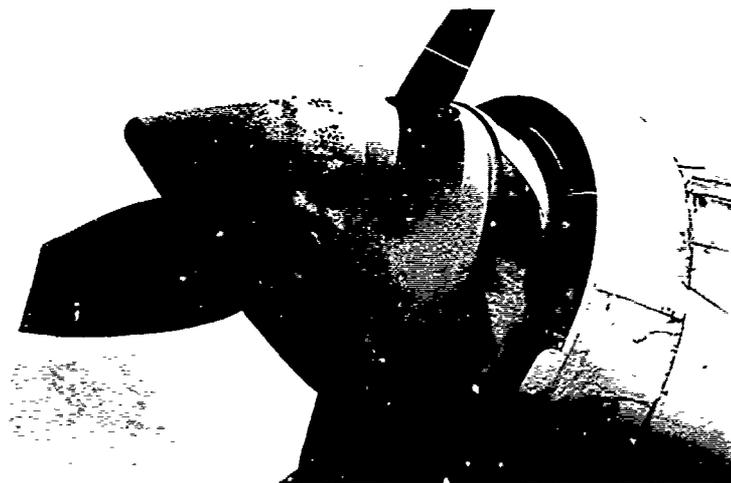
Fig. 4.22 Shot 1 Thermal Damage to Aluminized Lacquer on Propeller Spinner

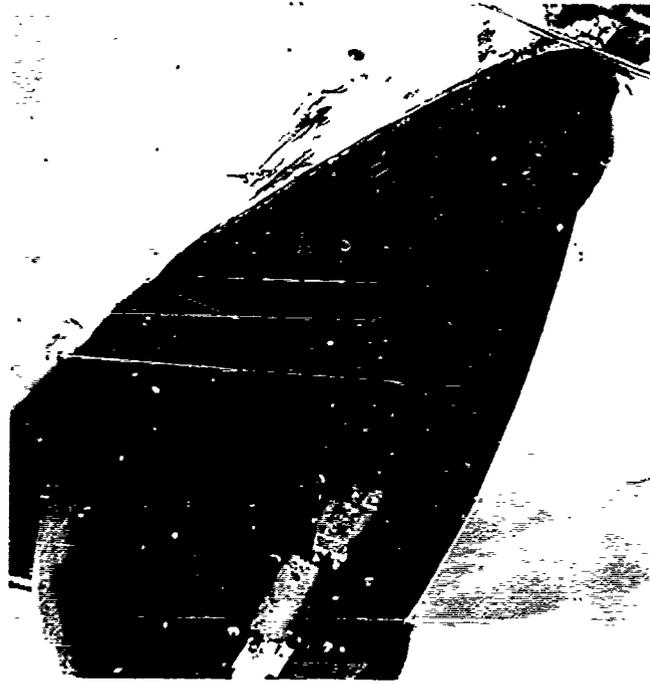
Figure 4.24 Shot 2 Thermal Damage to the Radic Antenna Cover

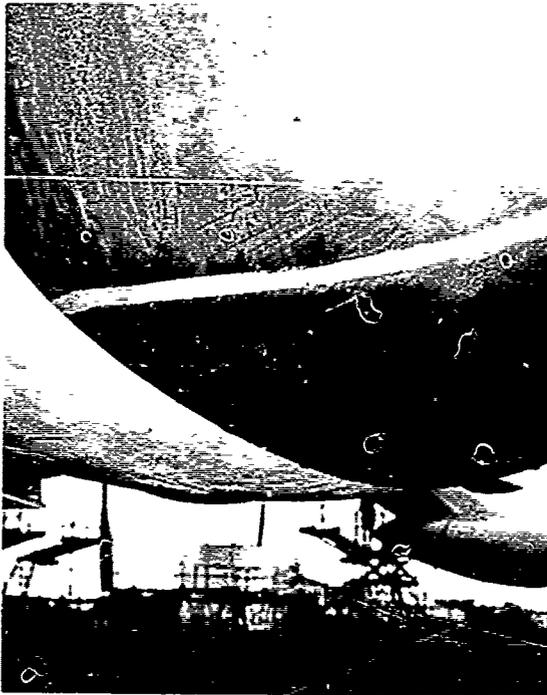
Figure 4.25 Shot 5 Thermal Damage to the Rubberized Coating of the Radome

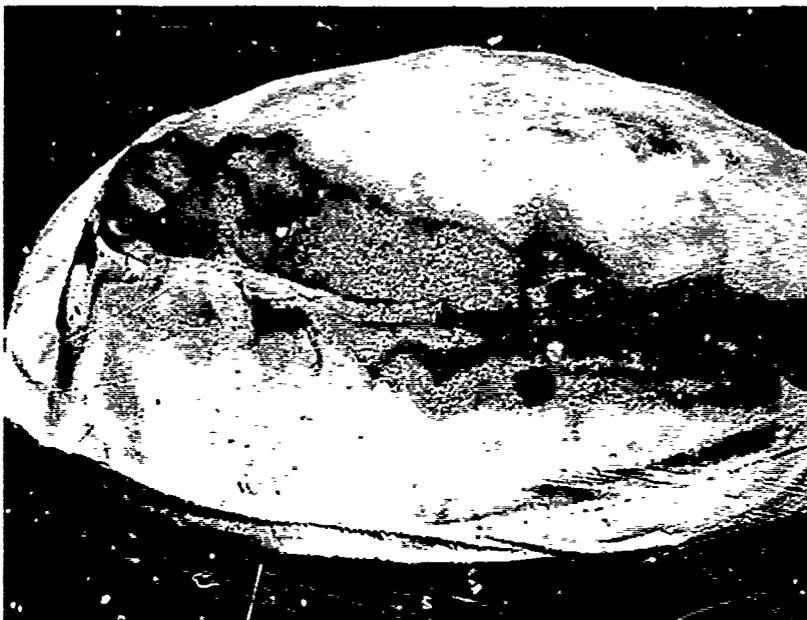
Fig. 4.26 Shot 5 Thermal Damage To Asbeston Shield
Located In Aft Lower Right Blister

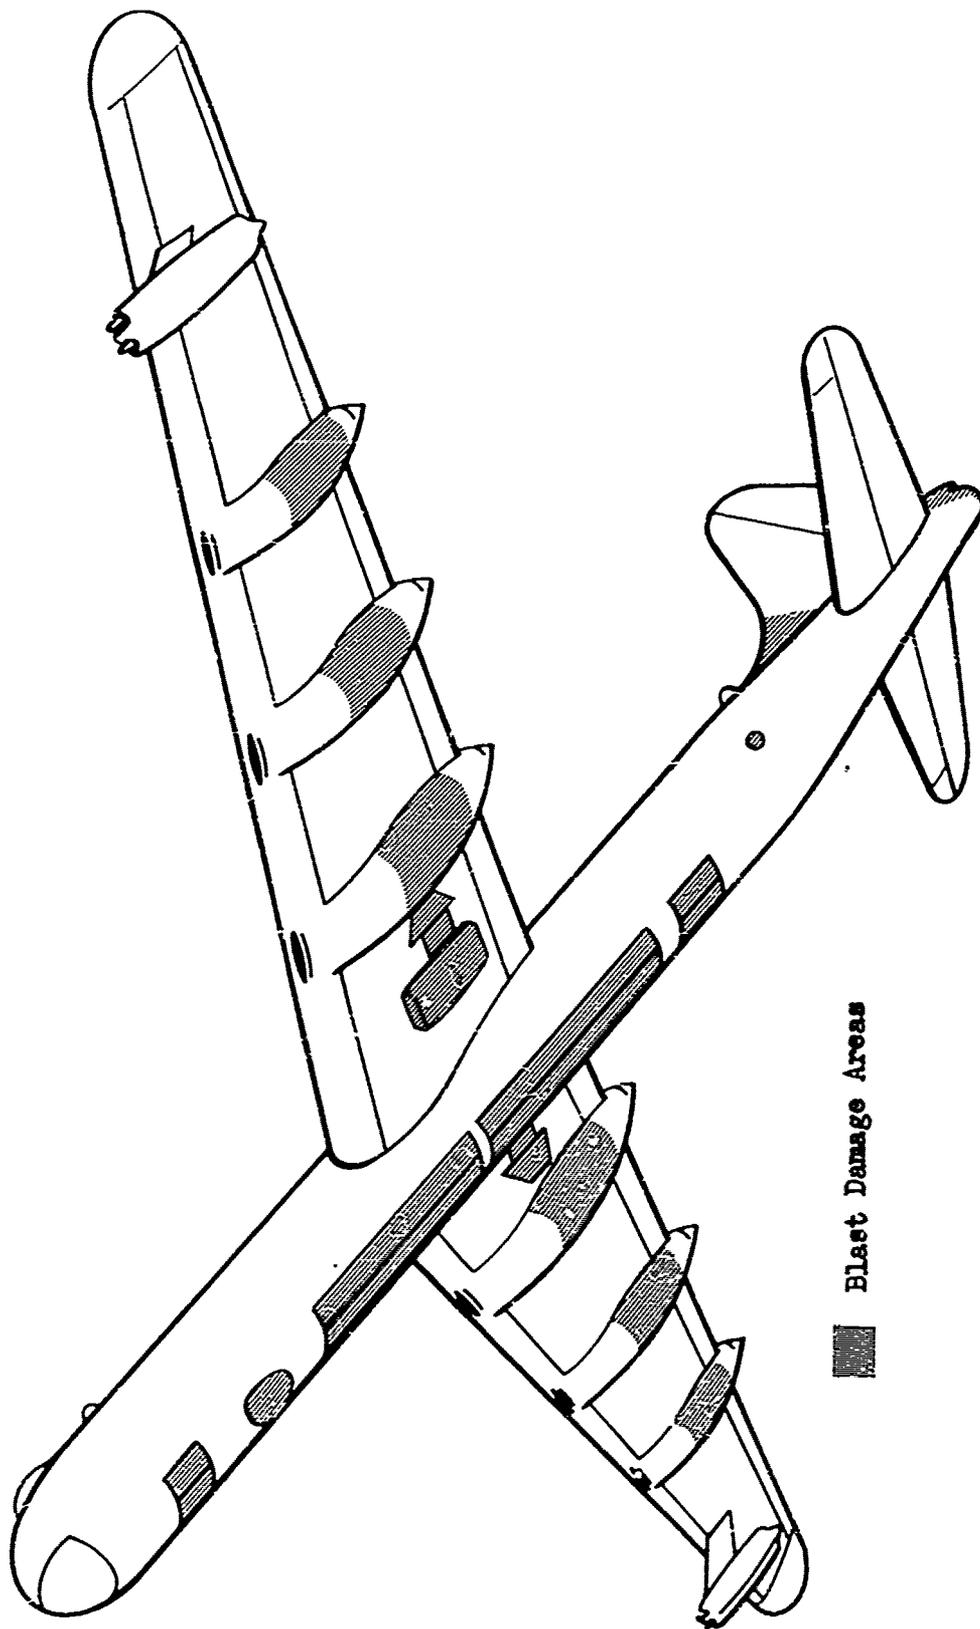
Fig. 4.62 General Areas of Blast Damage To The B-36D
