R.A.E. Report No. PBW.2

May, 1963

EXPLOSION OF A TITANIUM FURNACE
AT THE JESSOP-SAVILLE WORKS, SHEFFIELD

An investigation into the explosion of a titanium arc-furnace is briefly described, and photographs of the more important pieces of wreckage are given.

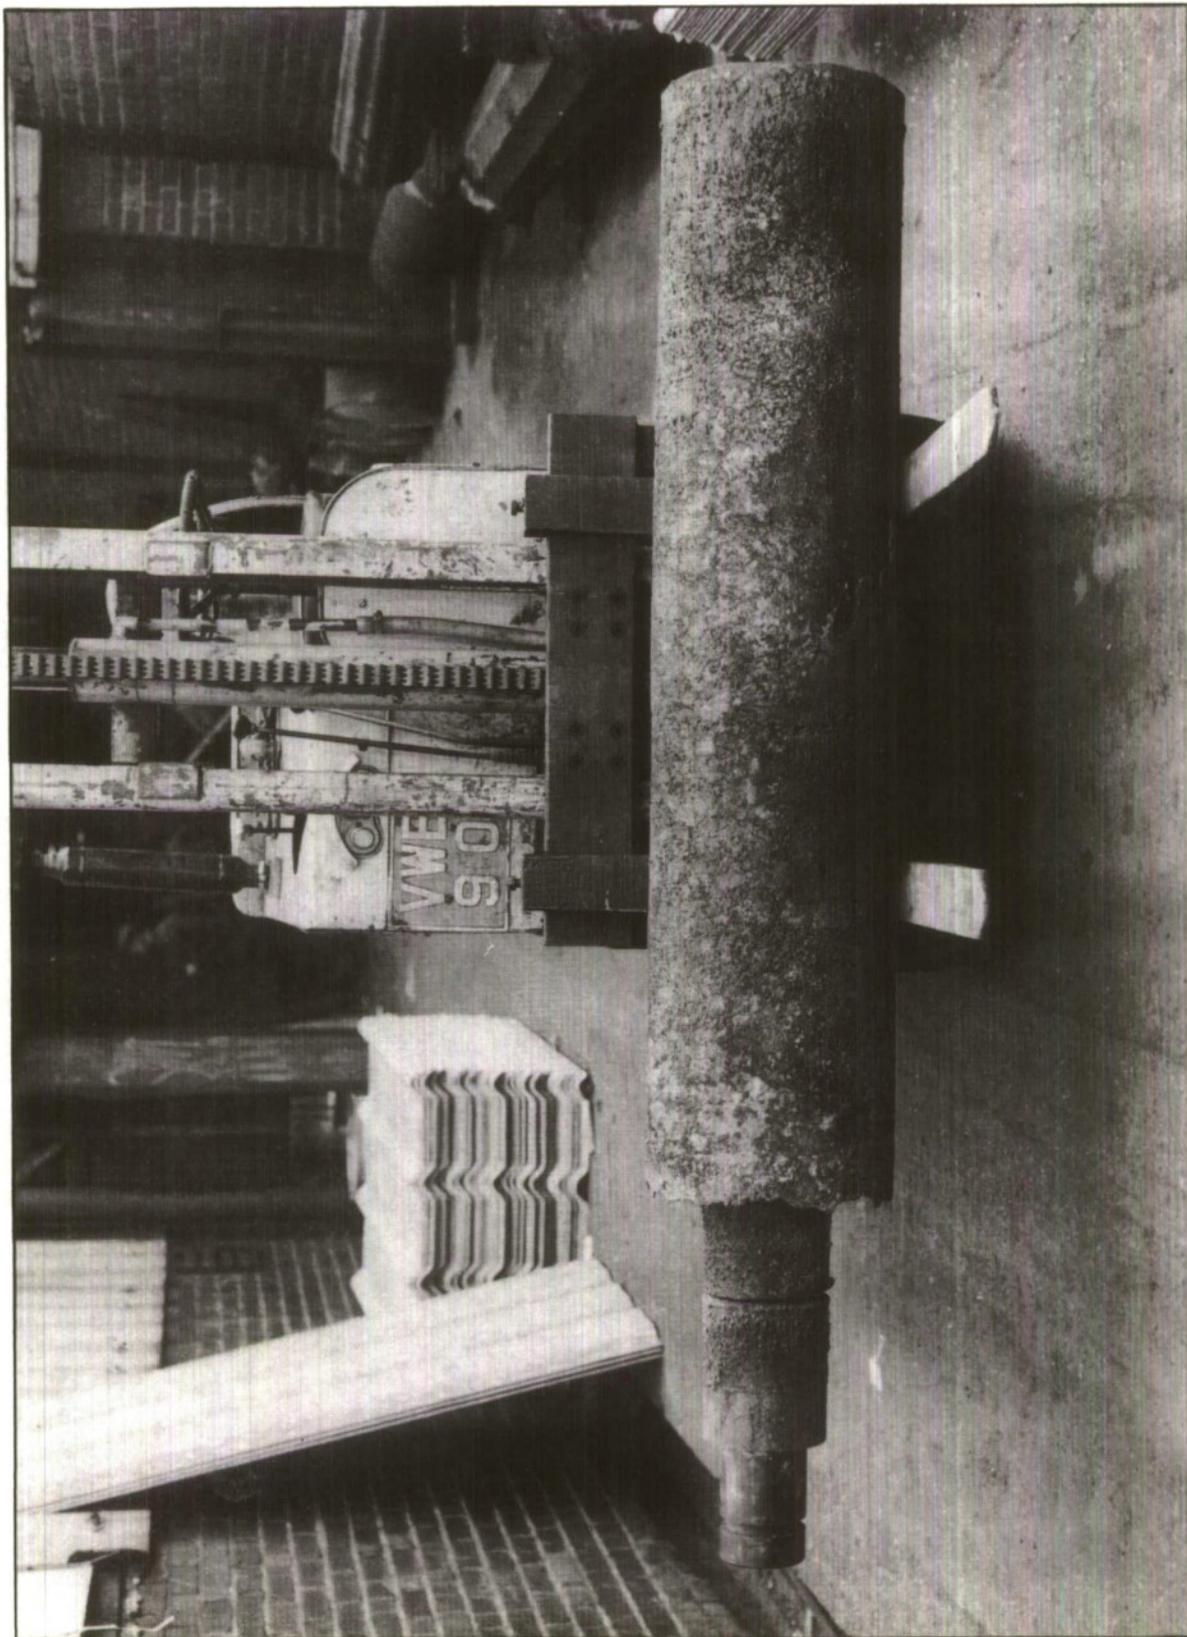
FIG.2. TITANIUM BILLET WITH ITS ELECTRICAL COUPLING

The explosion occurred shortly after the "melt" had been started, and there would have been about 100 lb of titanium in the bottom of the crucible. About three tons of control gear together with the block of titanium (Fig.2) were projected upwards through several feet. Hundreds of square feet of glass and panelling were removed from the roof and walls of the building. The water jacket, made of quarter inch steel, was blown apart (Fig.3).

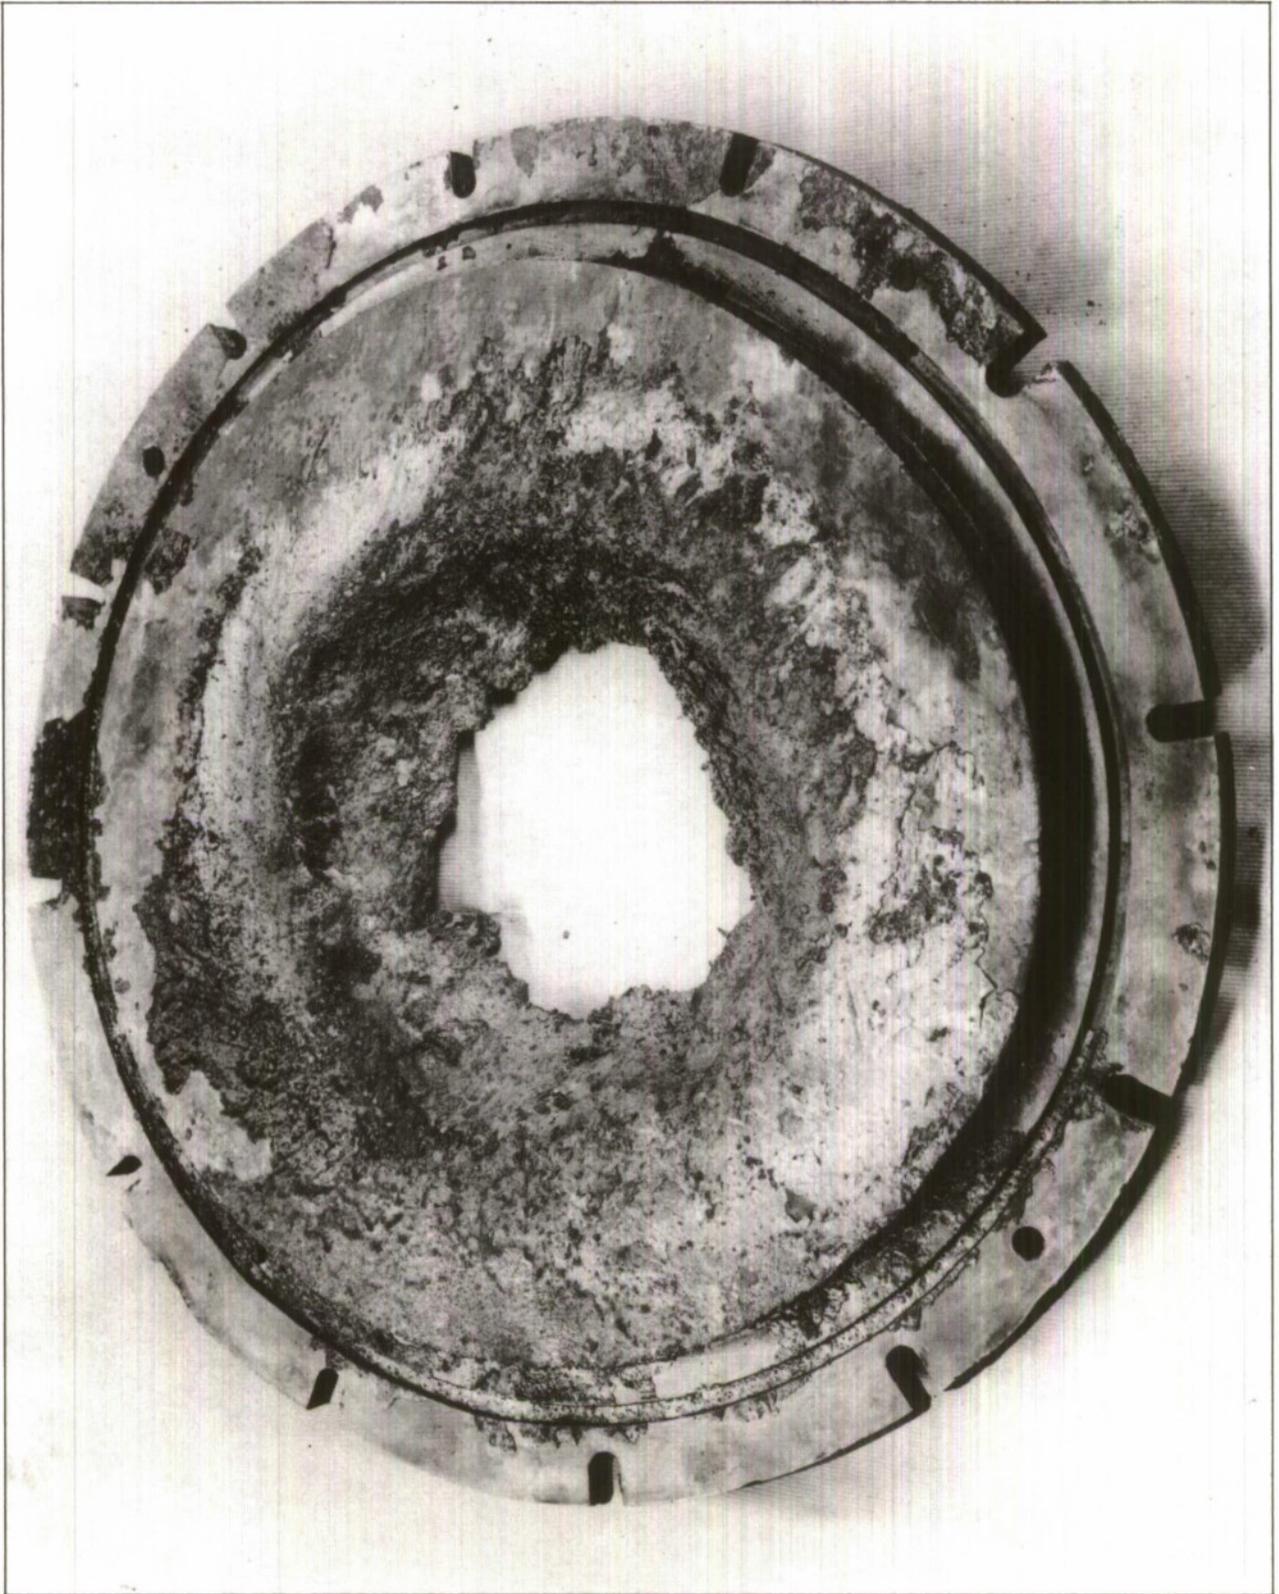
FIG.4. DETACHABLE BOTTOM OF CRUCIBLE

Despite the evidence of violence, injuries to personnel were minor, and caused mainly by falling debris and flying dust. After a preliminary examination, the complete wreckage was sent to Farnborough for investigation. A most significant item in the wreckage was the bottom of the crucible. This was made of copper two inches thick, and had clearly been melted right through (Fig.4).

The primary cause of the explosion is considered to be defective circulation of cooling-water immediately underneath the bottom of the copper crucible. It is probable that a bubble of steam or air collected there and allowed the copper to reach an excessively high temperature.

It is believed that the electric arc, in the early stages of melting, pushed aside the molten titanium and penetrated the copper base. The evidence of such penetration (Fig.4) is regarded as conclusive.

- (a) The water circulation must clearly cover all parts of the outside of the crucible, with water specially directed to the centre of the base.
- (b) Failure or impairment of the supply of cooling water should automatically switch-off the electric current.
- (c) Special care should be taken in design, manufacture and assembly of the joints in the crucible.
- (d) The crucible should be provided with a substantial escape route for hydrogen and steam, with a valve that opens at a small excess pressure and closes again before air can enter the crucible.
- (e) If practicable, opening of the release valve or abnormal rise in internal pressure should automatically switch-off the current. In any event a warning signal should be given to the operator.

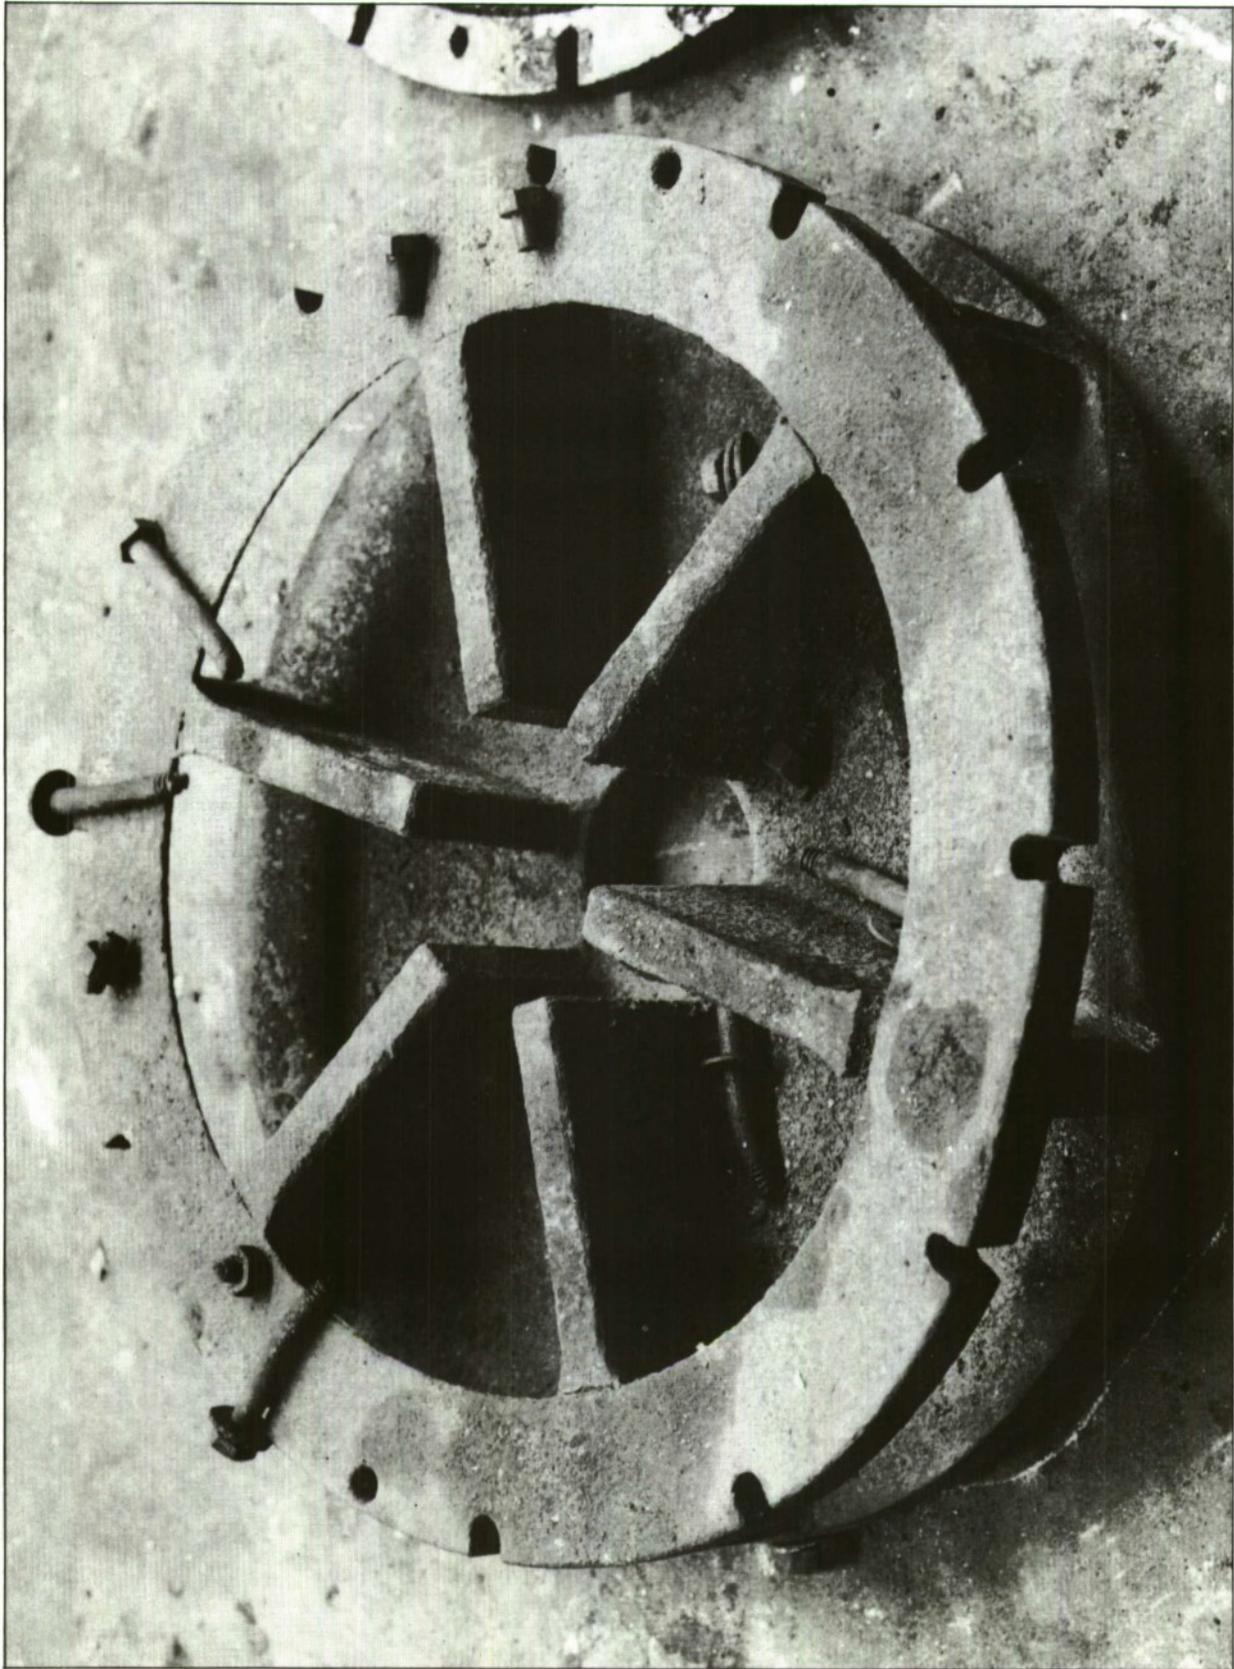
FIG.5. SPIDER GUIDE-VANE UNIT SUPPORT FOR THE CRUCIBLE BOTTOM

The overall supply of water is thought to have been adequate and to have been properly circulated everywhere except at the bottom of the crucible. Failure to protect the bottom is attributed to some modifications to the original equipment, and in particular to the use of a "spider" guide-vane system (Fig.5) without the water jets appropriate to it. The spider as fitted must inevitably have checked the flow of water in the critical region, and caused this to be by-passed. Furthermore, the geometry was such that the rim of the spider and the bottom of the crucible formed a shallow inverted bowl calculated to produce a steam or air lock.

The primary purpose of the spider was to give mechanical support to the copper bottom of the crucible, but it had originally been designed to do so without prejudicing the essential cooling. In this respect it would have been successful if water had been injected directly between the radial vanes. In this particular assembly, however, the entry holes or jets were not opposite the spider and so were relatively ineffective in the critical region.
