WT-1132

The primary purpose of Project 5.1 of Operation TEAPOT was to determine the structural responses and progression of failure in the post-buckling range of aircraft structures when subjected to destructive gust loads produced by a nuclear explosion. Three QF-80 drones, chosen as the test vehicles, participated in full-scale field tests conducted at the Nevada Test Site during Shot 12.

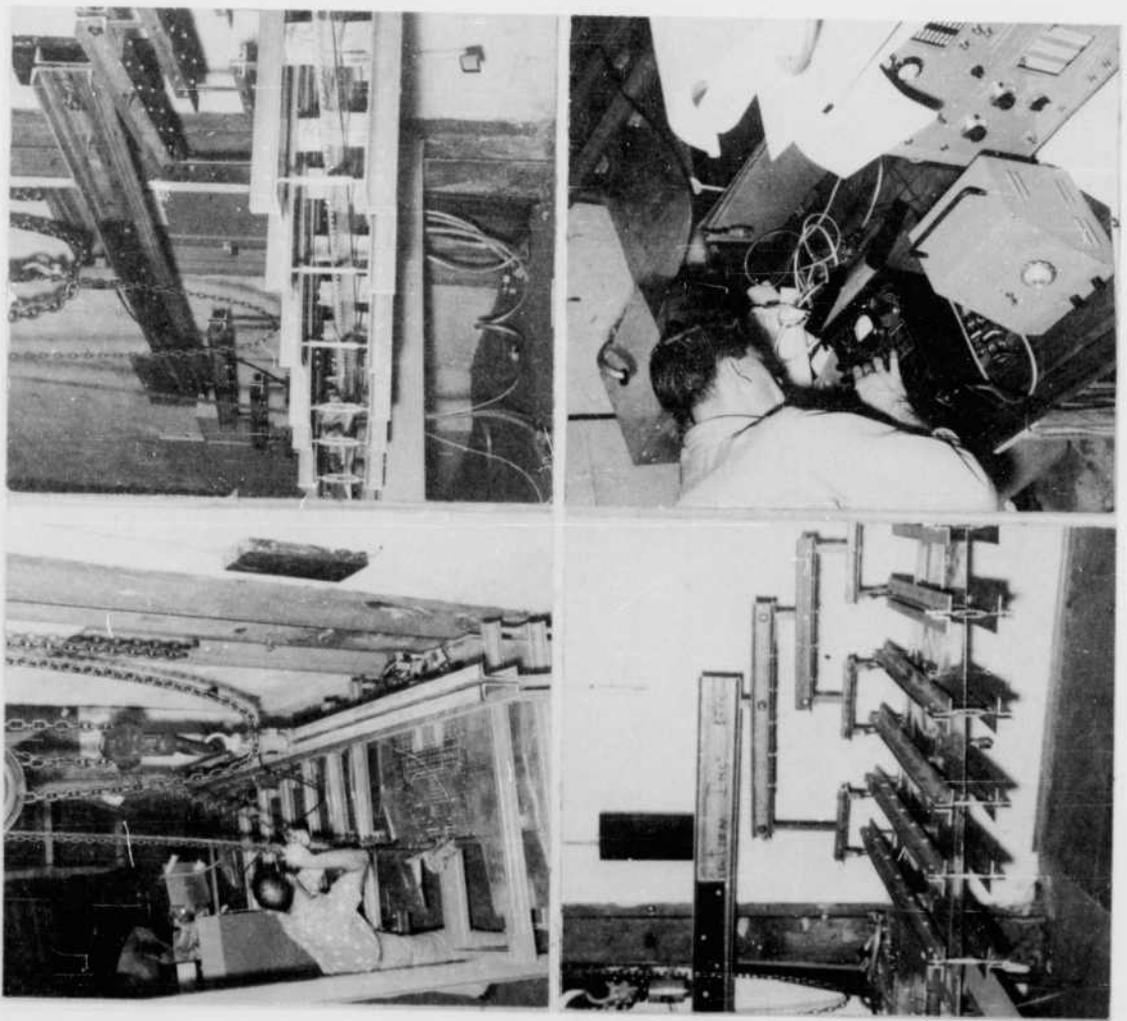
Figure 3.6 Horizontal Stabilizer Calibration. Upper Left, Applying Load; Upper Right, Deflection; Lower Left, Skin Wrinkles; Lower Right, Reading Strain Indicator.

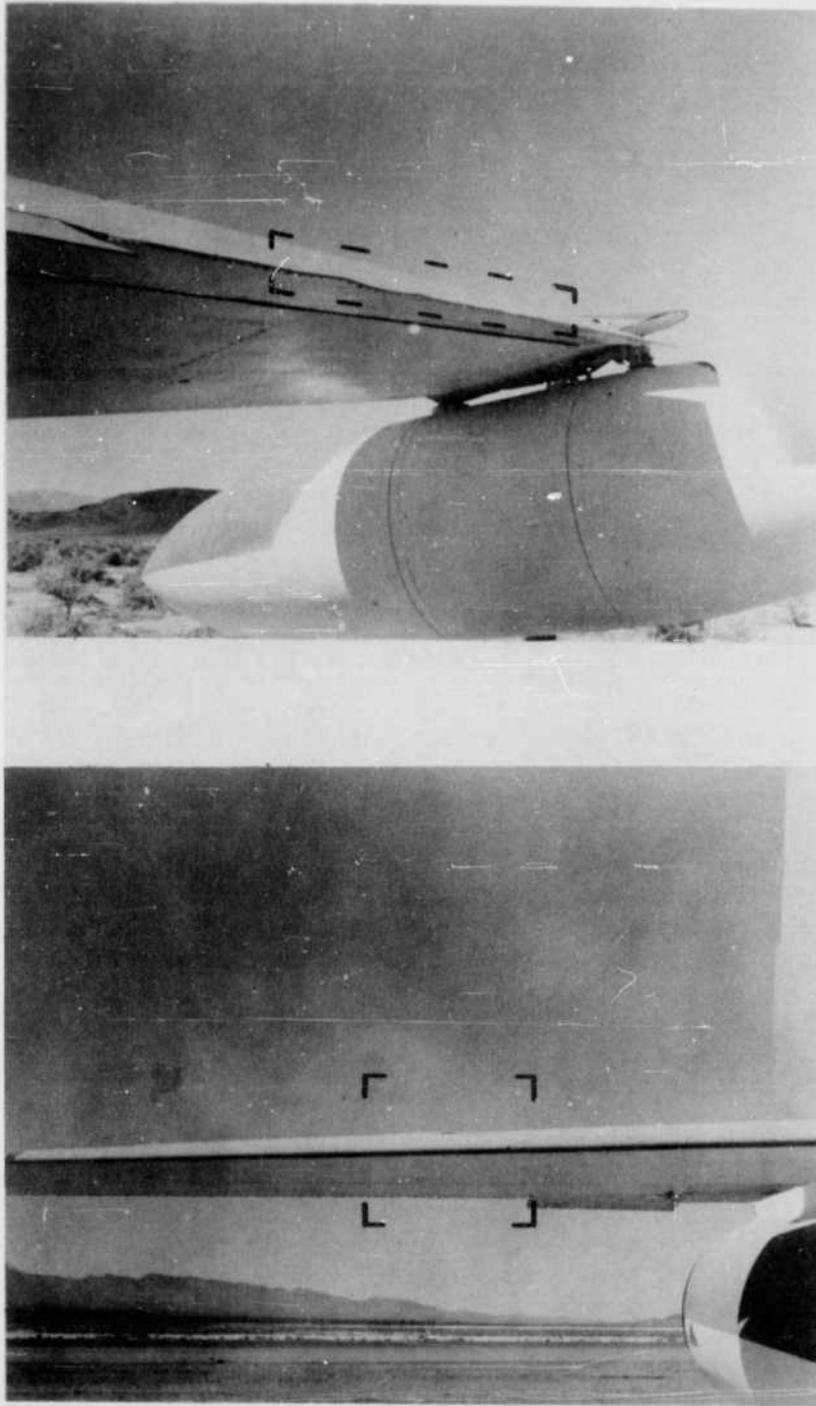
The thermal damage consisted only of slight scorching and blistering of dark or blackened areas. These areas consisted of the black deflection-

Figure 5.16 Visual Damage, Drone 1

calibration markers and some areas around the elevator leading edge, where a dark protective coating had been applied to the elevator-position pots.

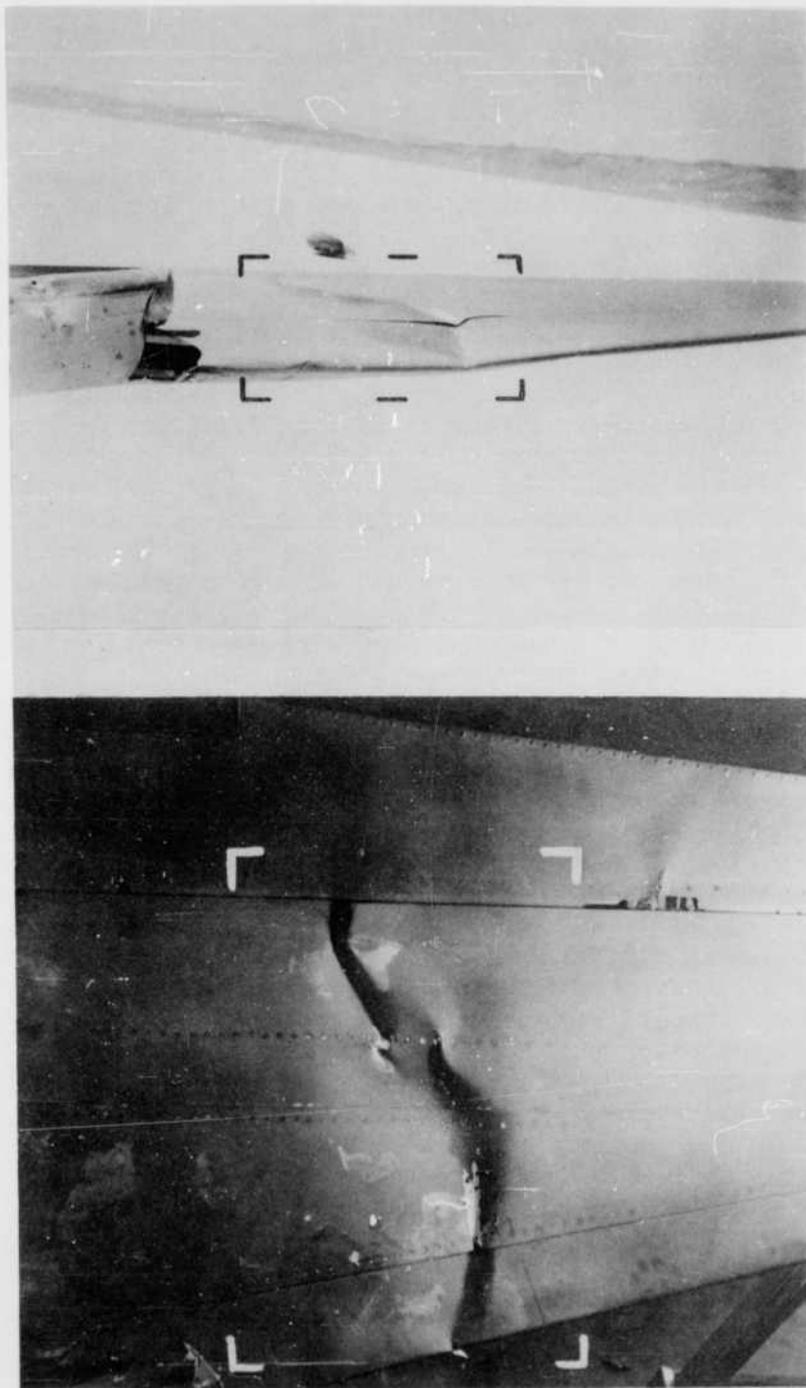
Figure 5.17 Visual Damage, Drone 2

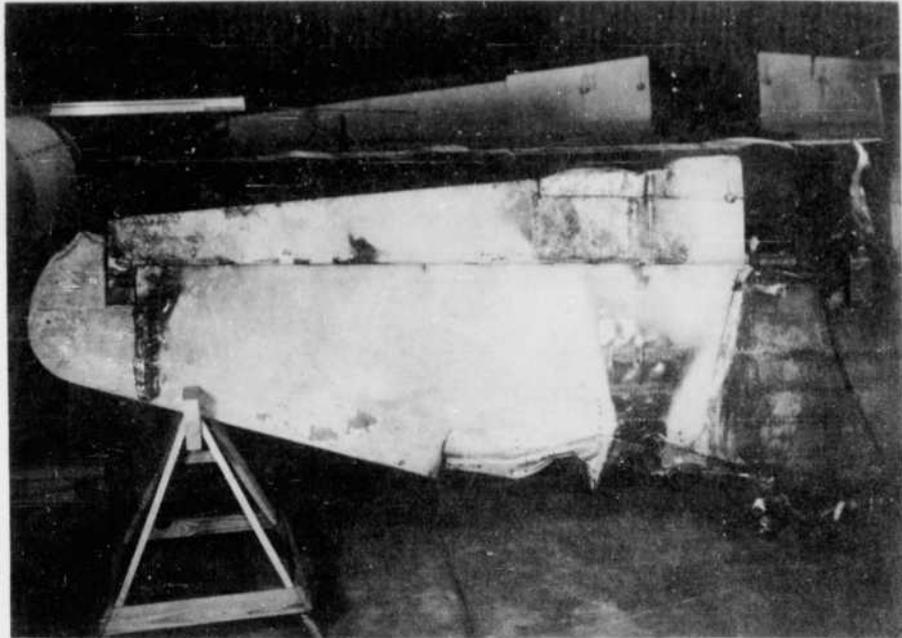
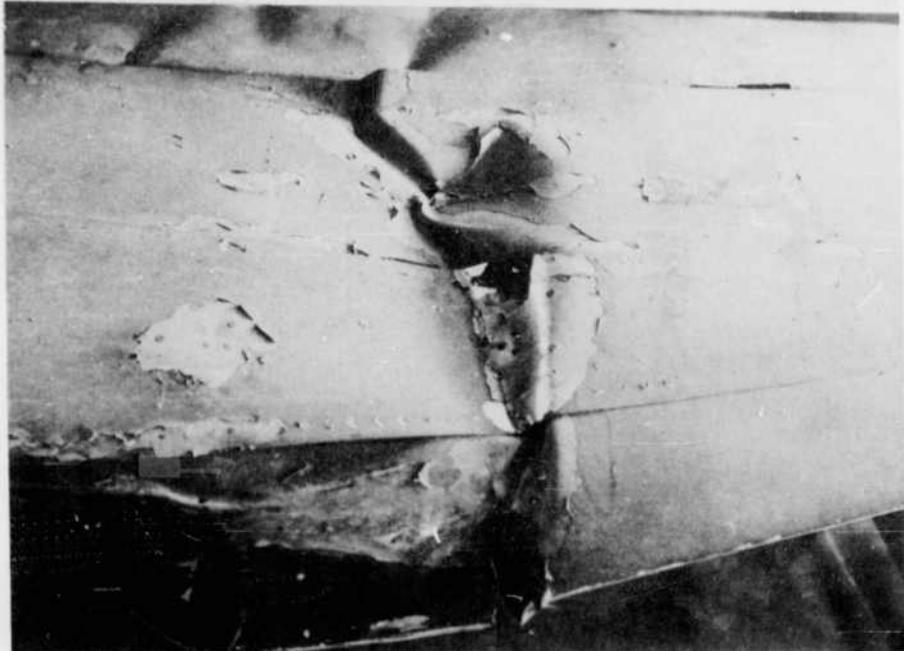
Performance. Drone 3 also survived the blast but lost some altitude. When intercepted by the director, both tip tanks were gone, the elevators, stabilizers, and ailerons were damaged, and there was some heat damage

evident on the drone lower surface. The horizontal stabilizer was seriously damaged.

Figure 5.18 Visual Damage, Drone 3
