BUREAU OF SHIPS GROUP TECHNICAL INSPECTION REPORT

OPERATION CROSSROADS.
U.S.S. CONYNGHAM (DD371)
TEST ABLE [U].

USS CONYNGHAM (DD371)

TECHNICAL INSPECTION REPORT

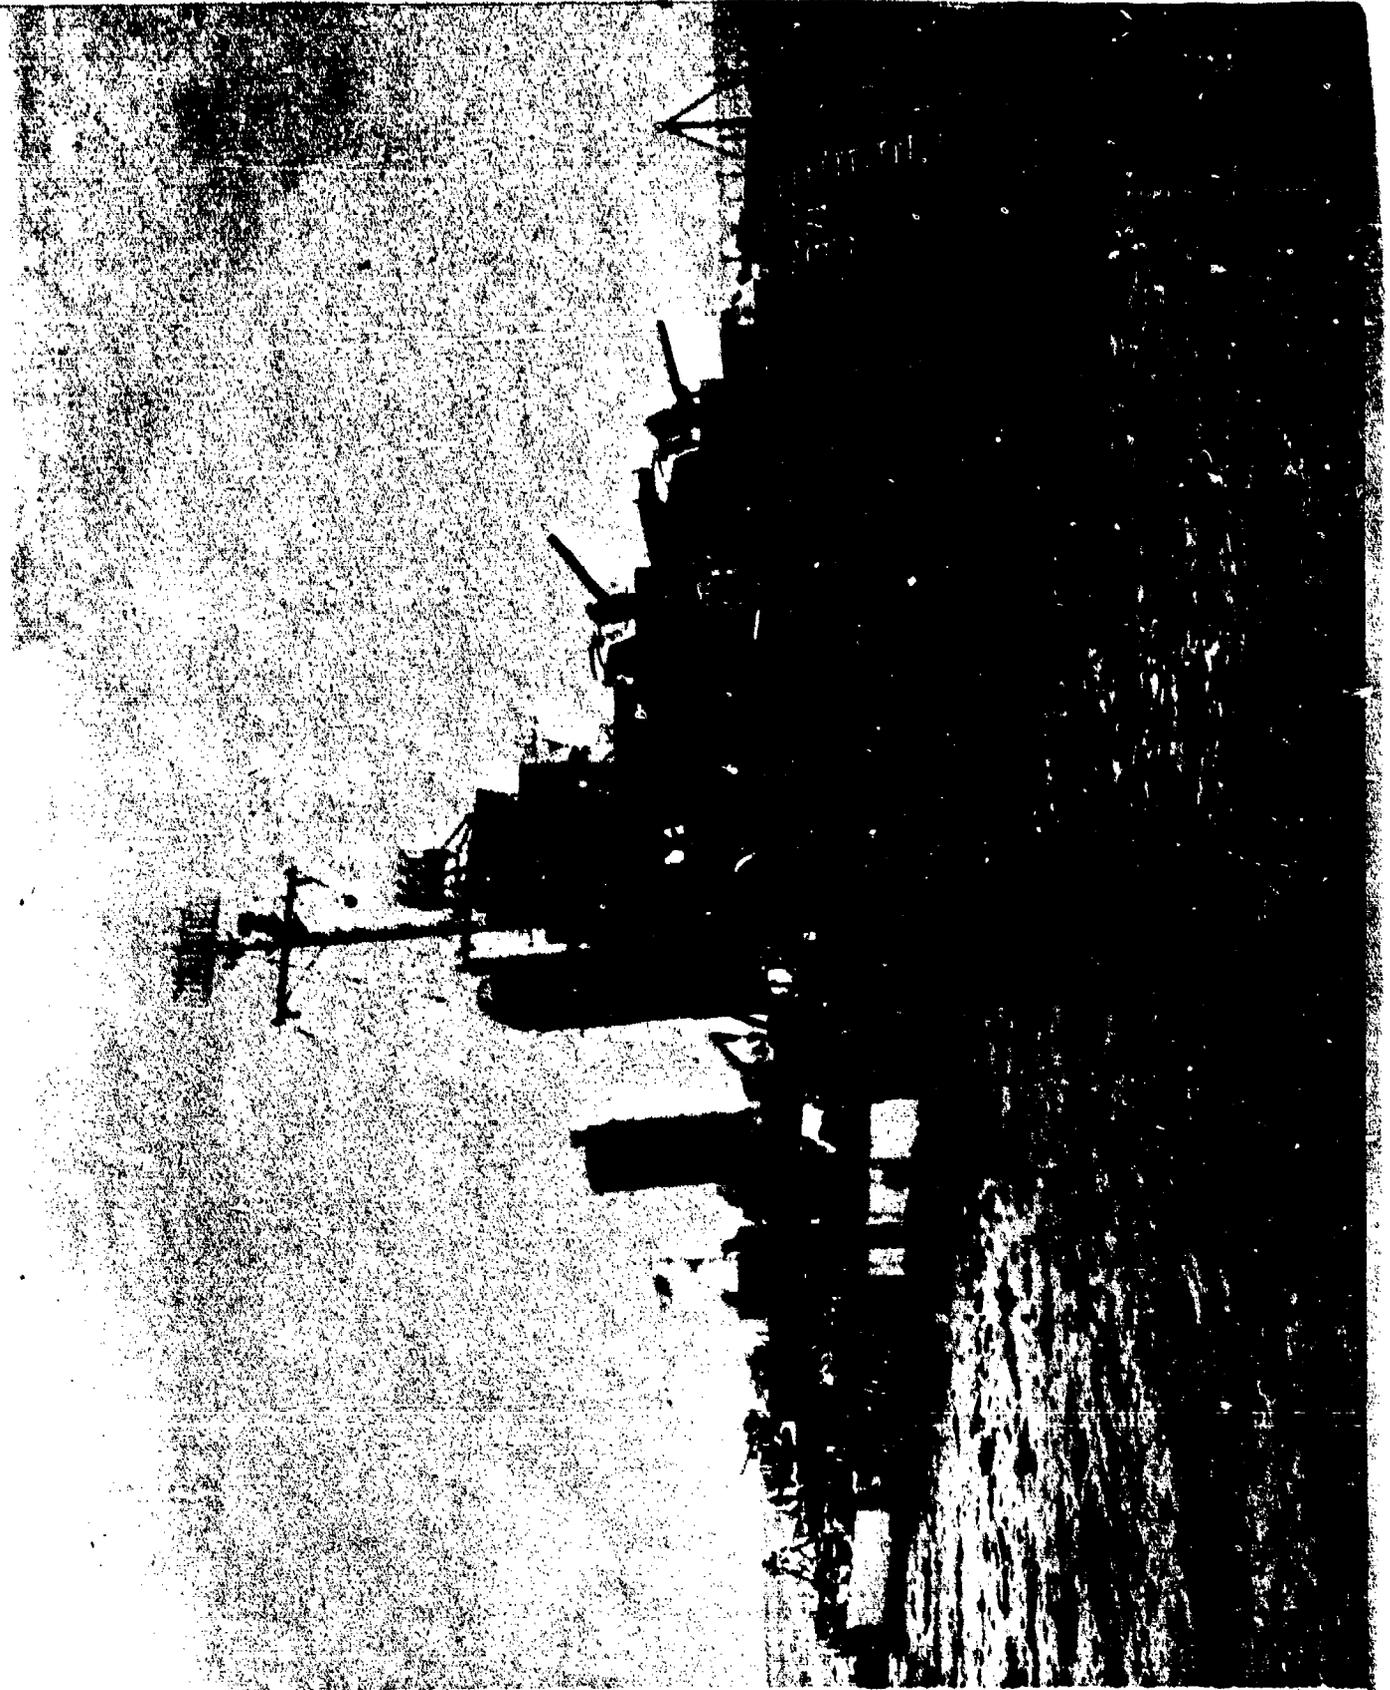
AA-CR-227-87-59. View from off starboard bow. (Spotting and re-painting of shell started.

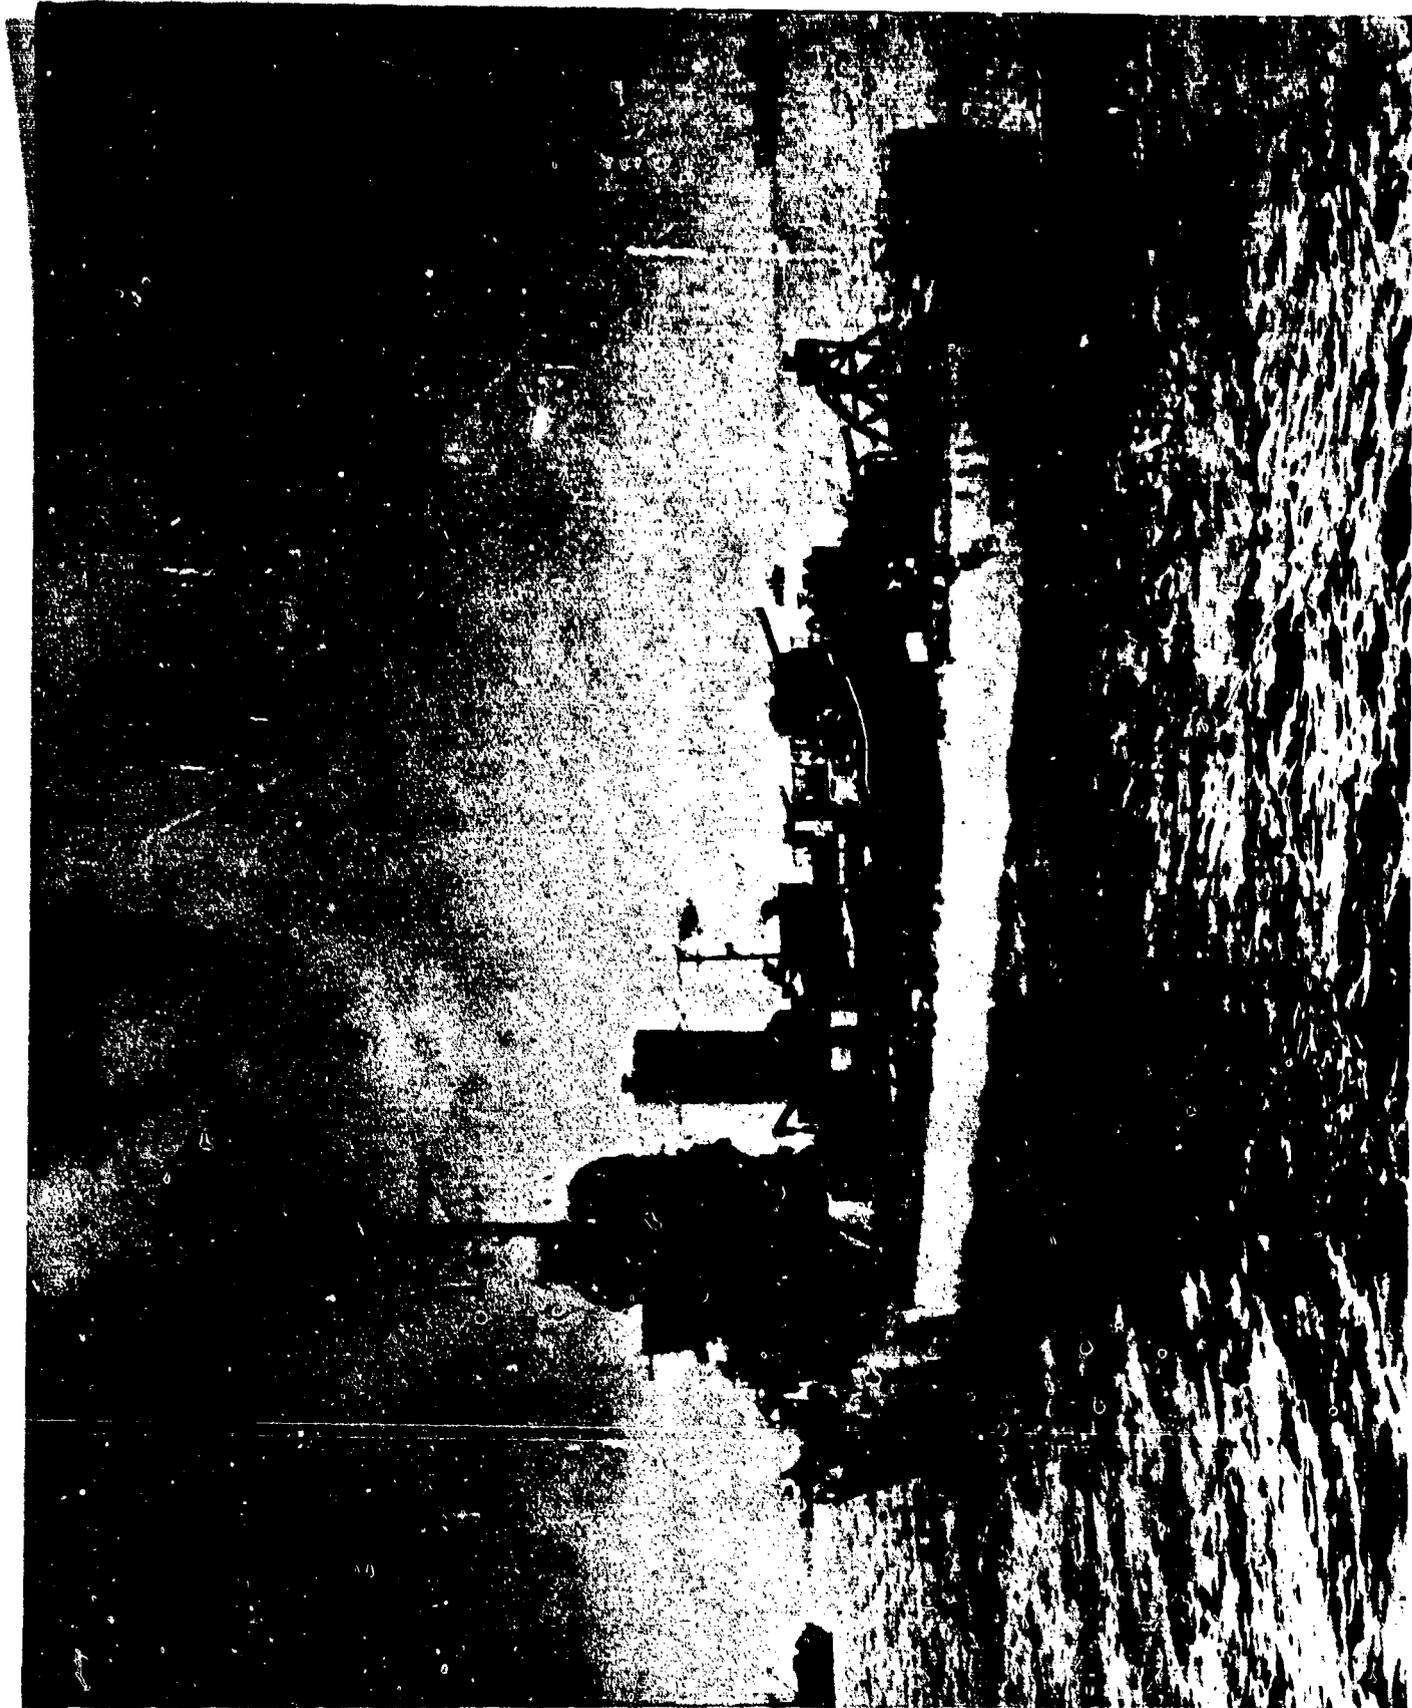
AA-CR-227-87-56. View from off port quarter. (Repainting of shell started.)
