TECHNICAL INSPECTION REPORT

U.S.S. TUNA (SS 203)

TEST ABLE [U].*8*

6 OPERATION CROSSROADS

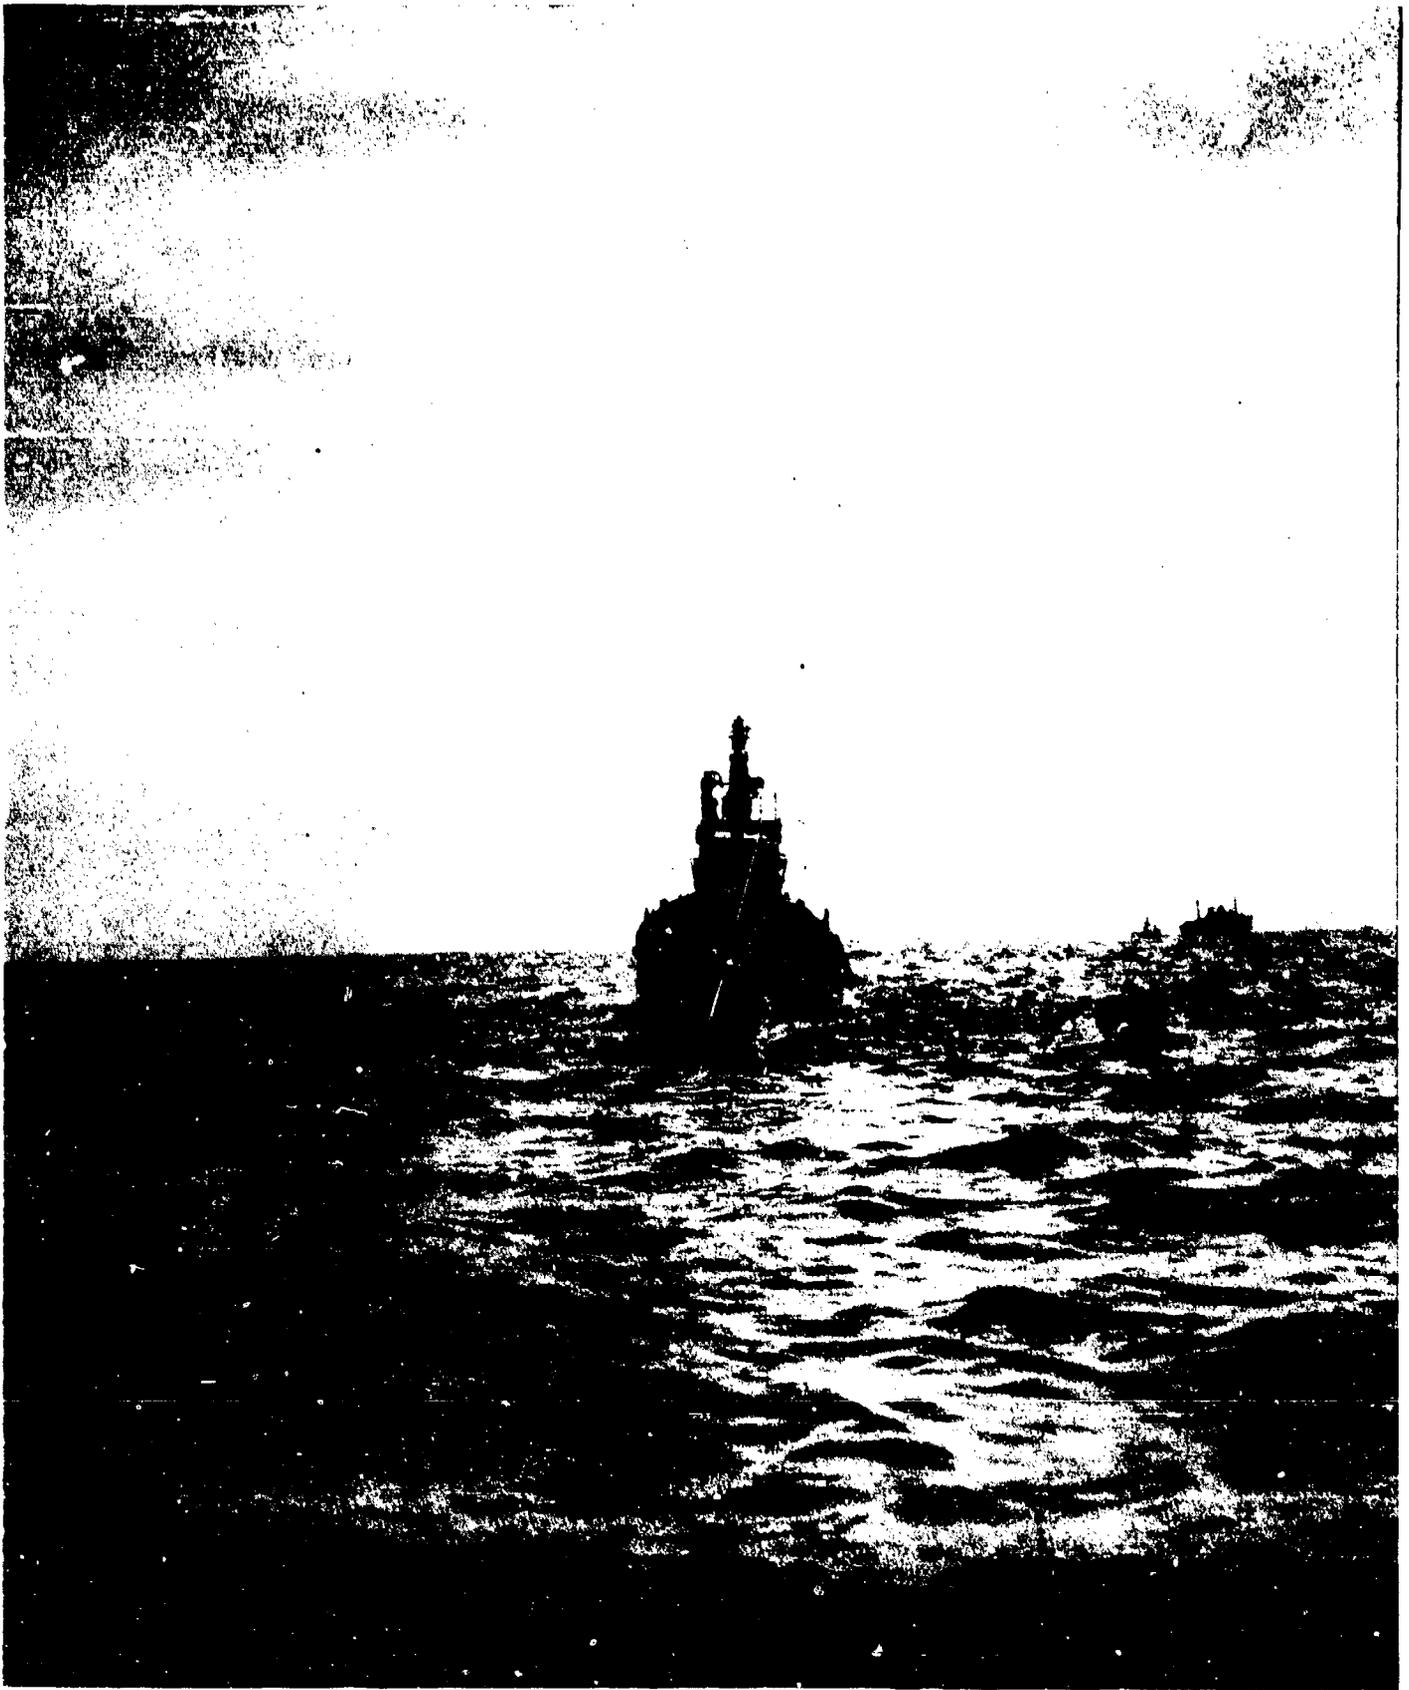
AA-CR-227-92-46. General view from ahead.

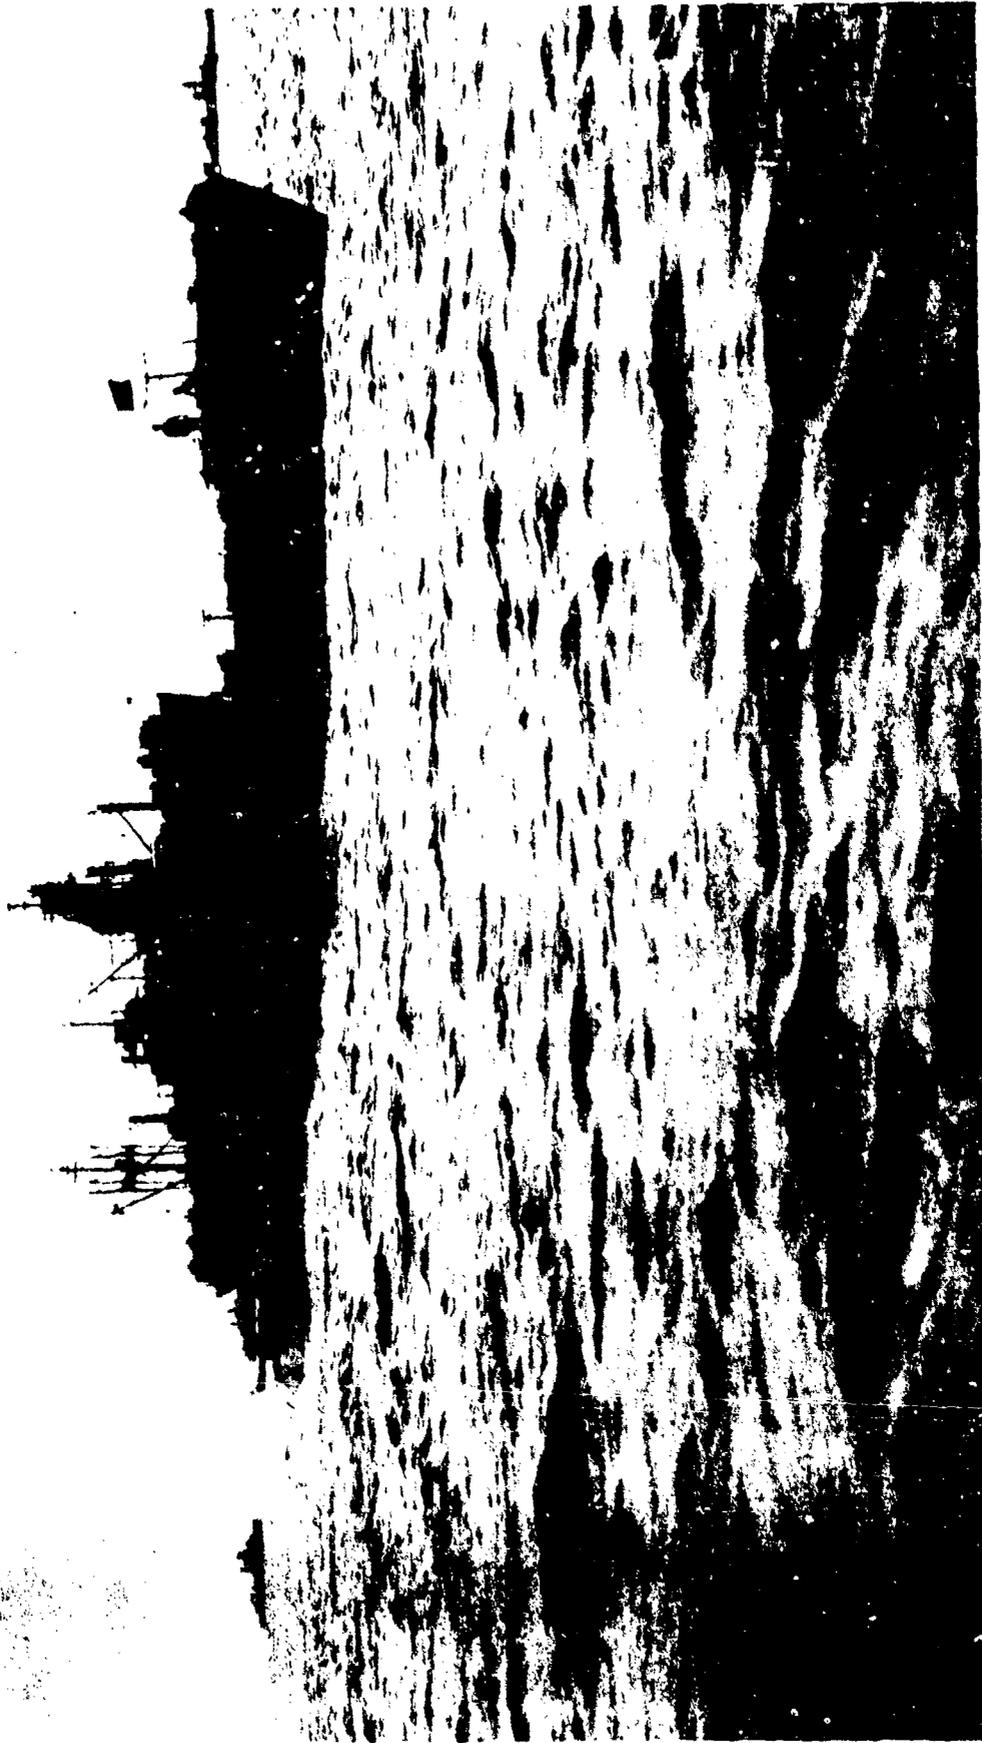
AACR-227-92-47 - General view from starboard bow.

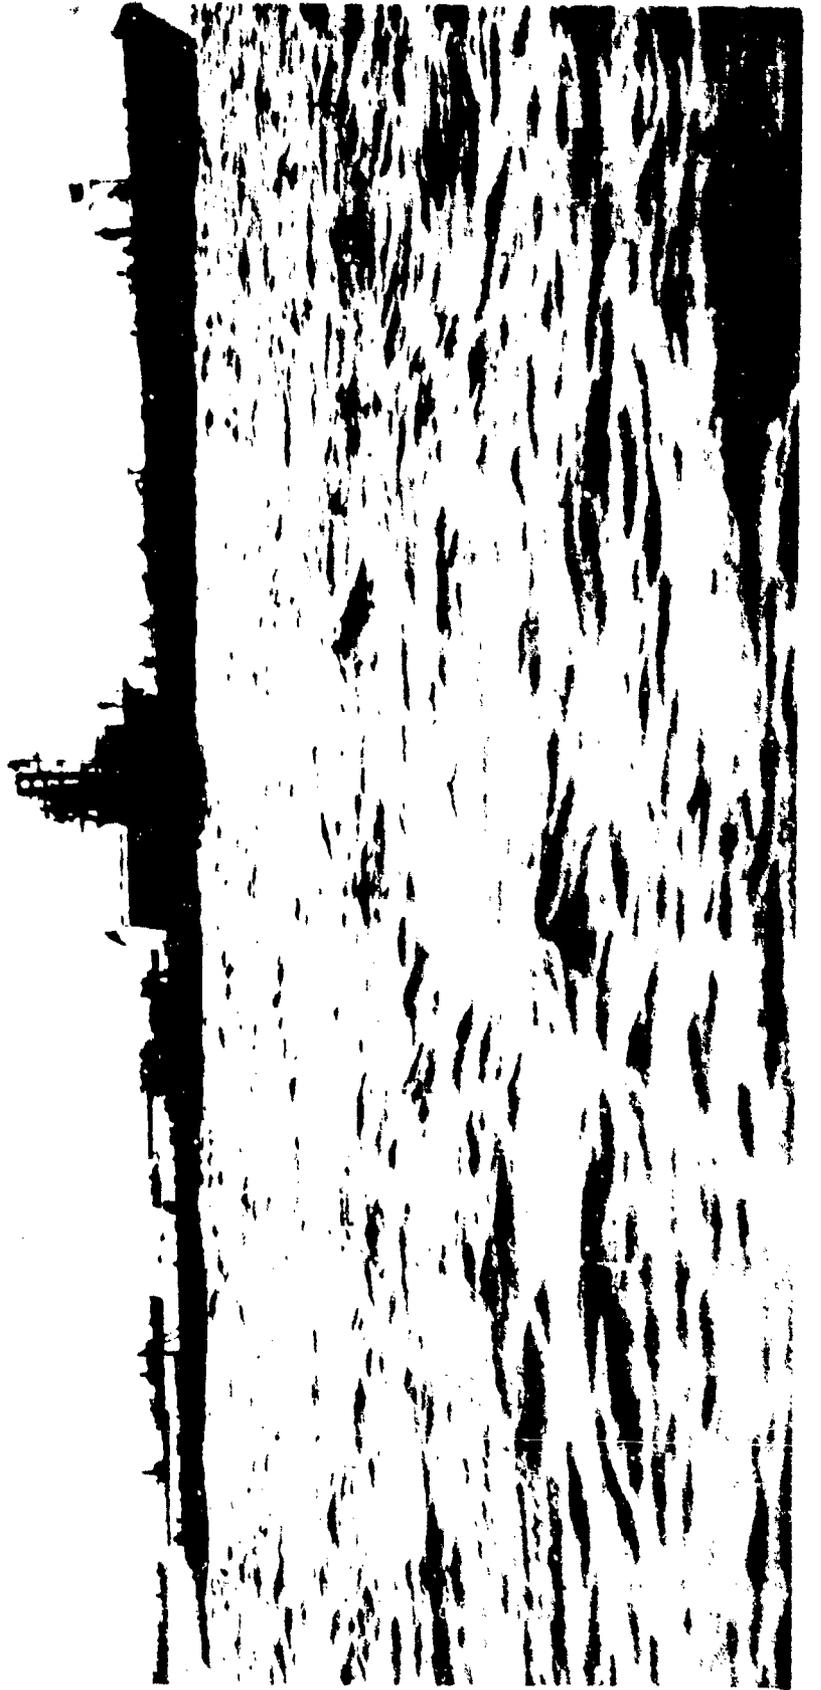
AA-CR-227-92-48. General view from starboard beam.

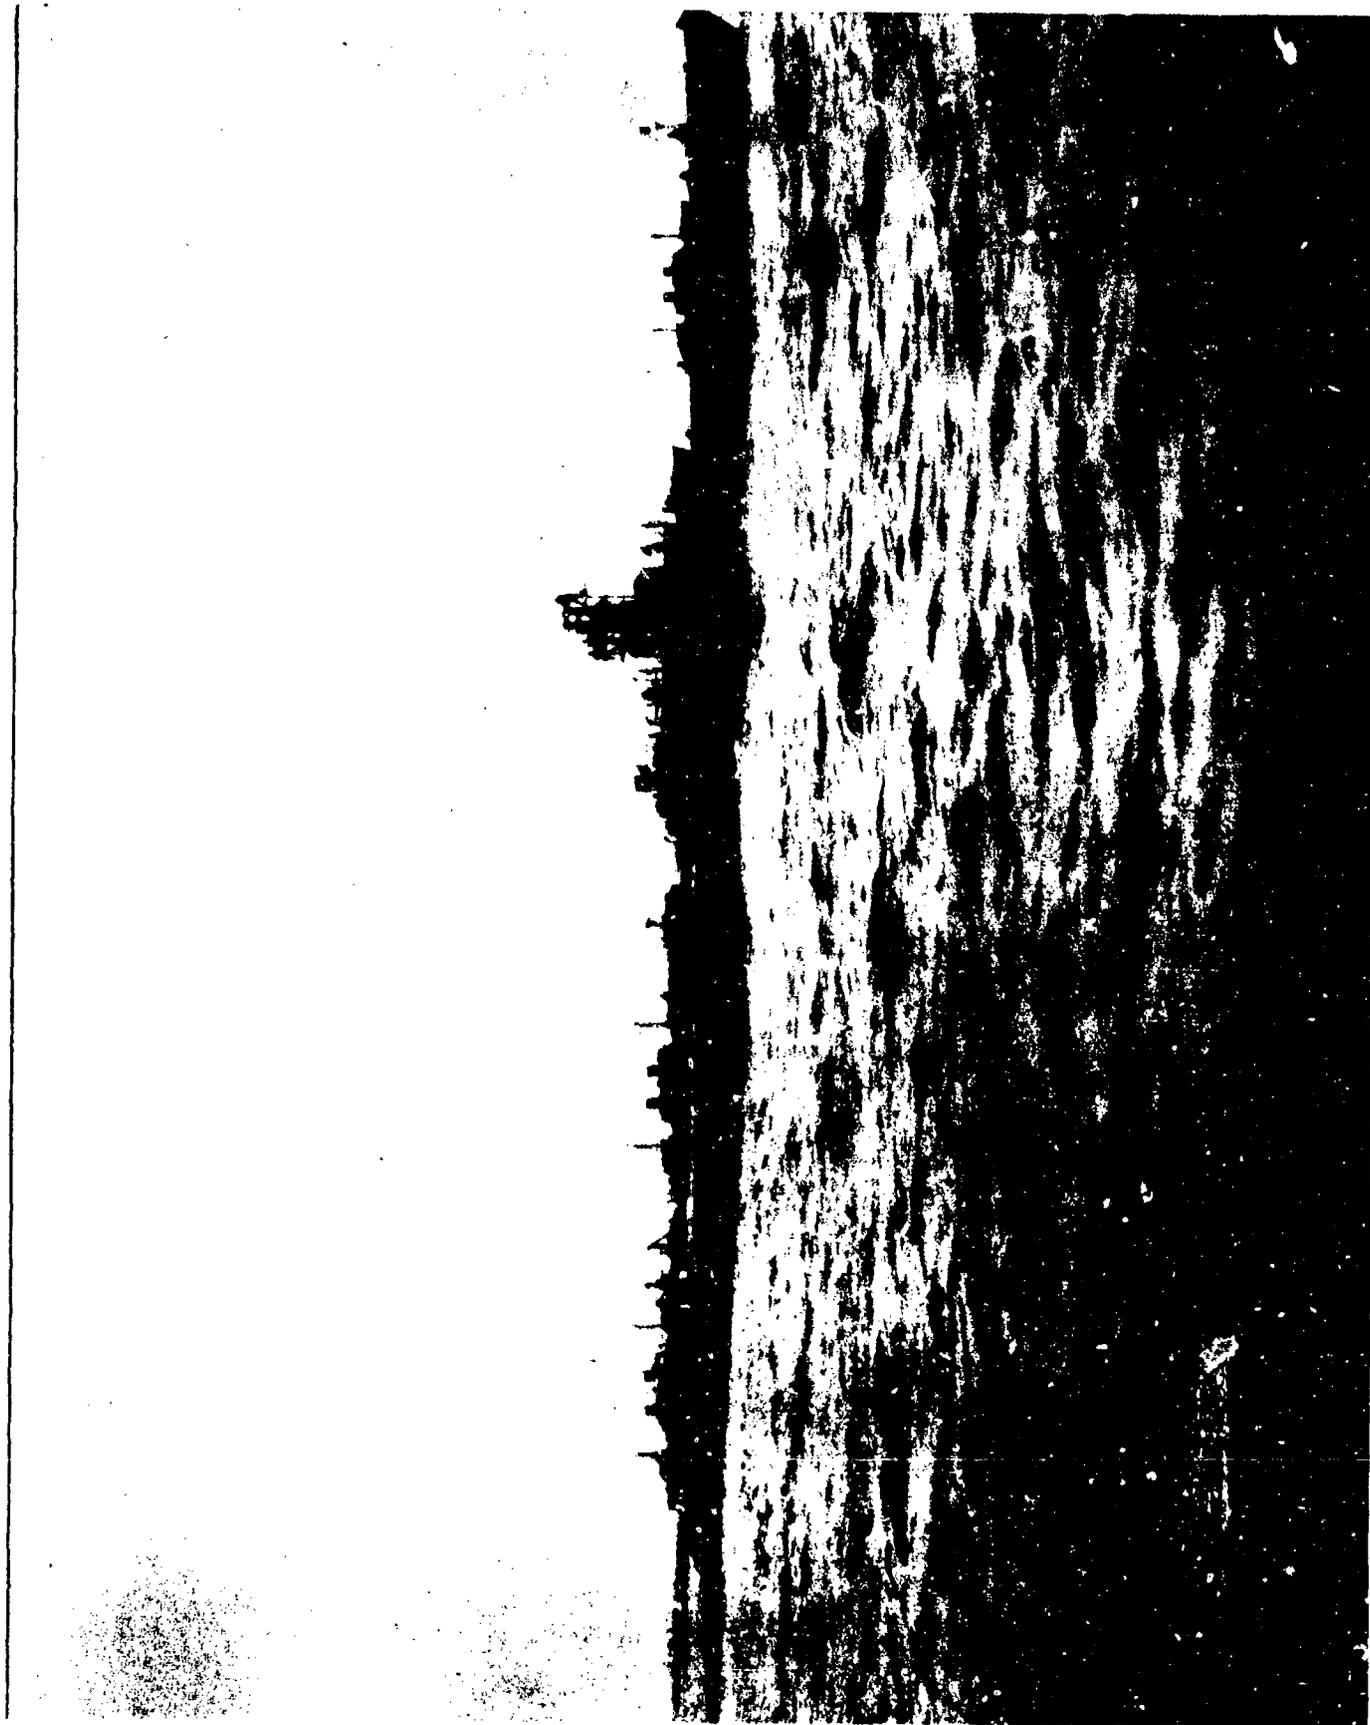
AA-CR-227-92-49. General view from starboard quarter.

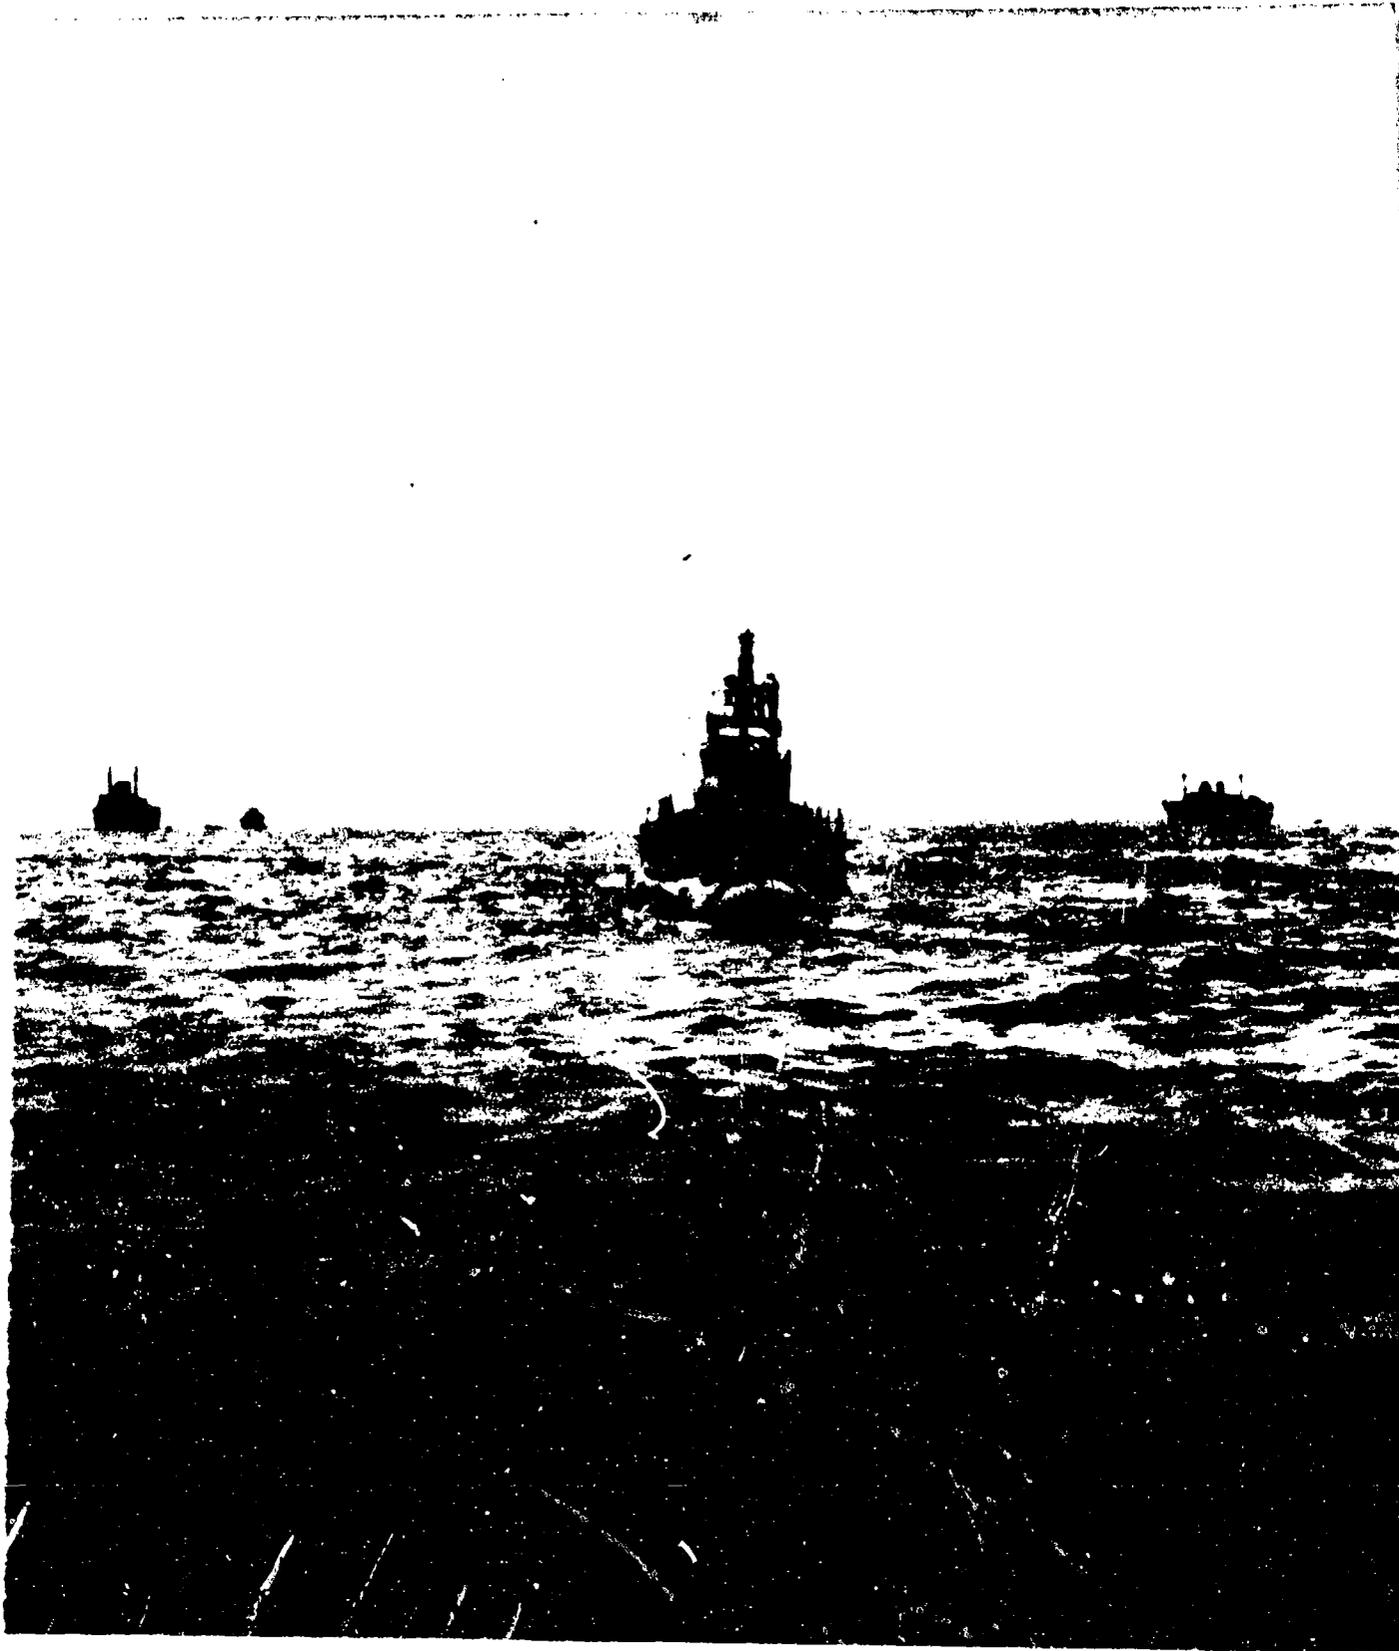
AACR-227-92-50 - General view from astern.

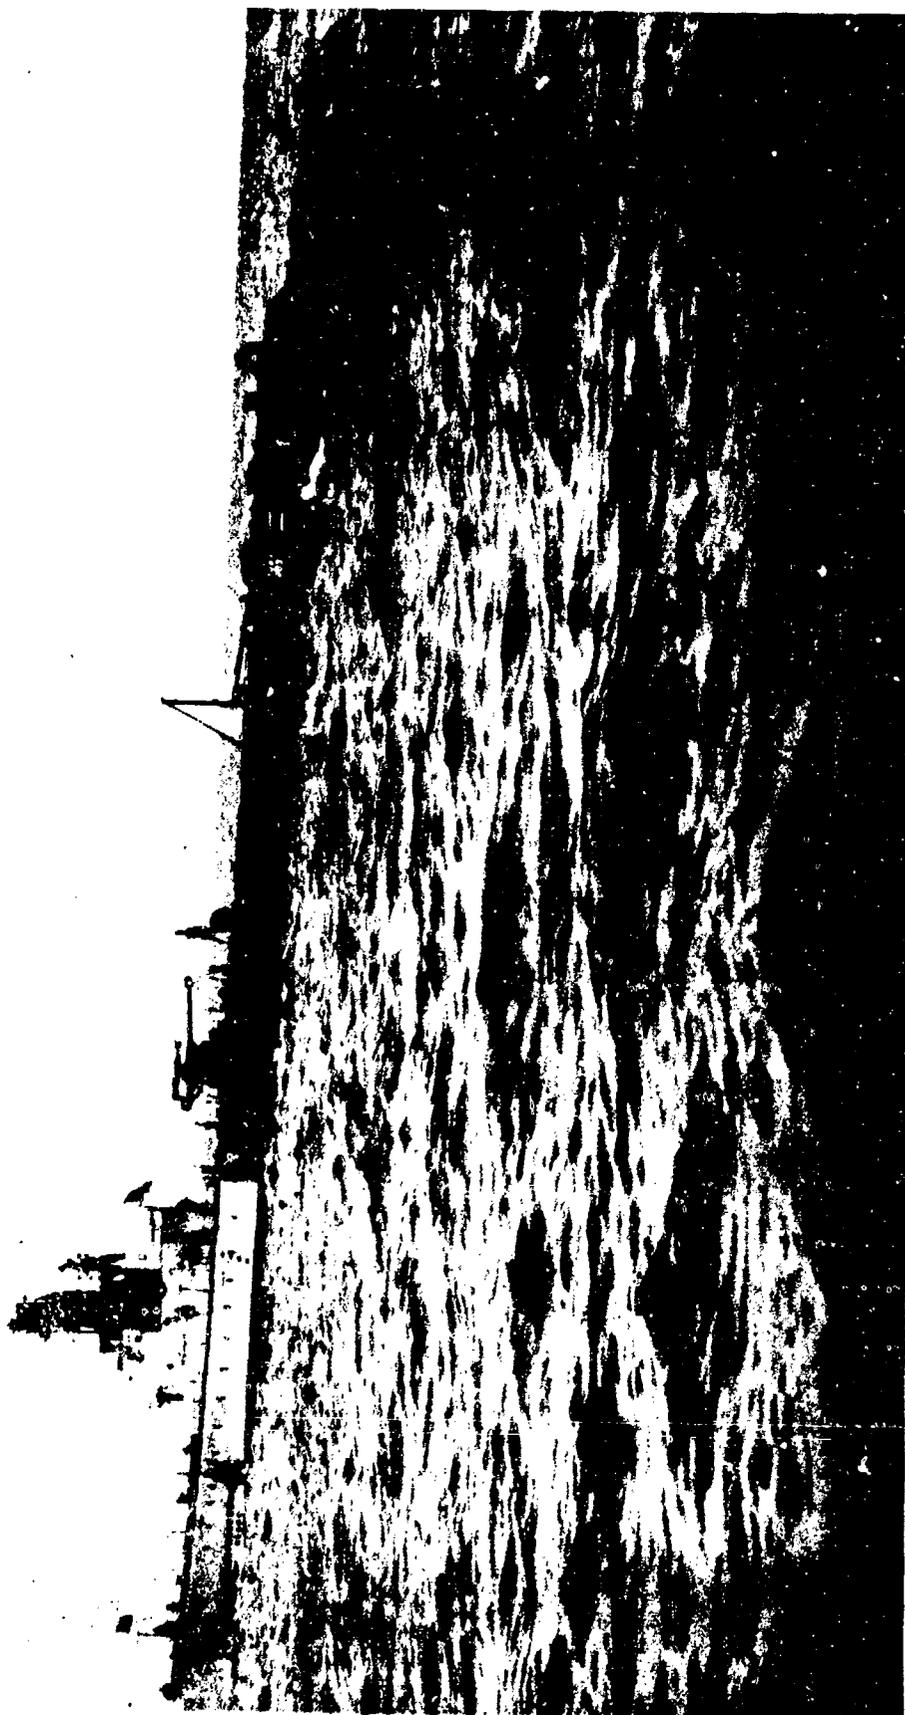
AACR-227-92-51 - General view from port quarter.

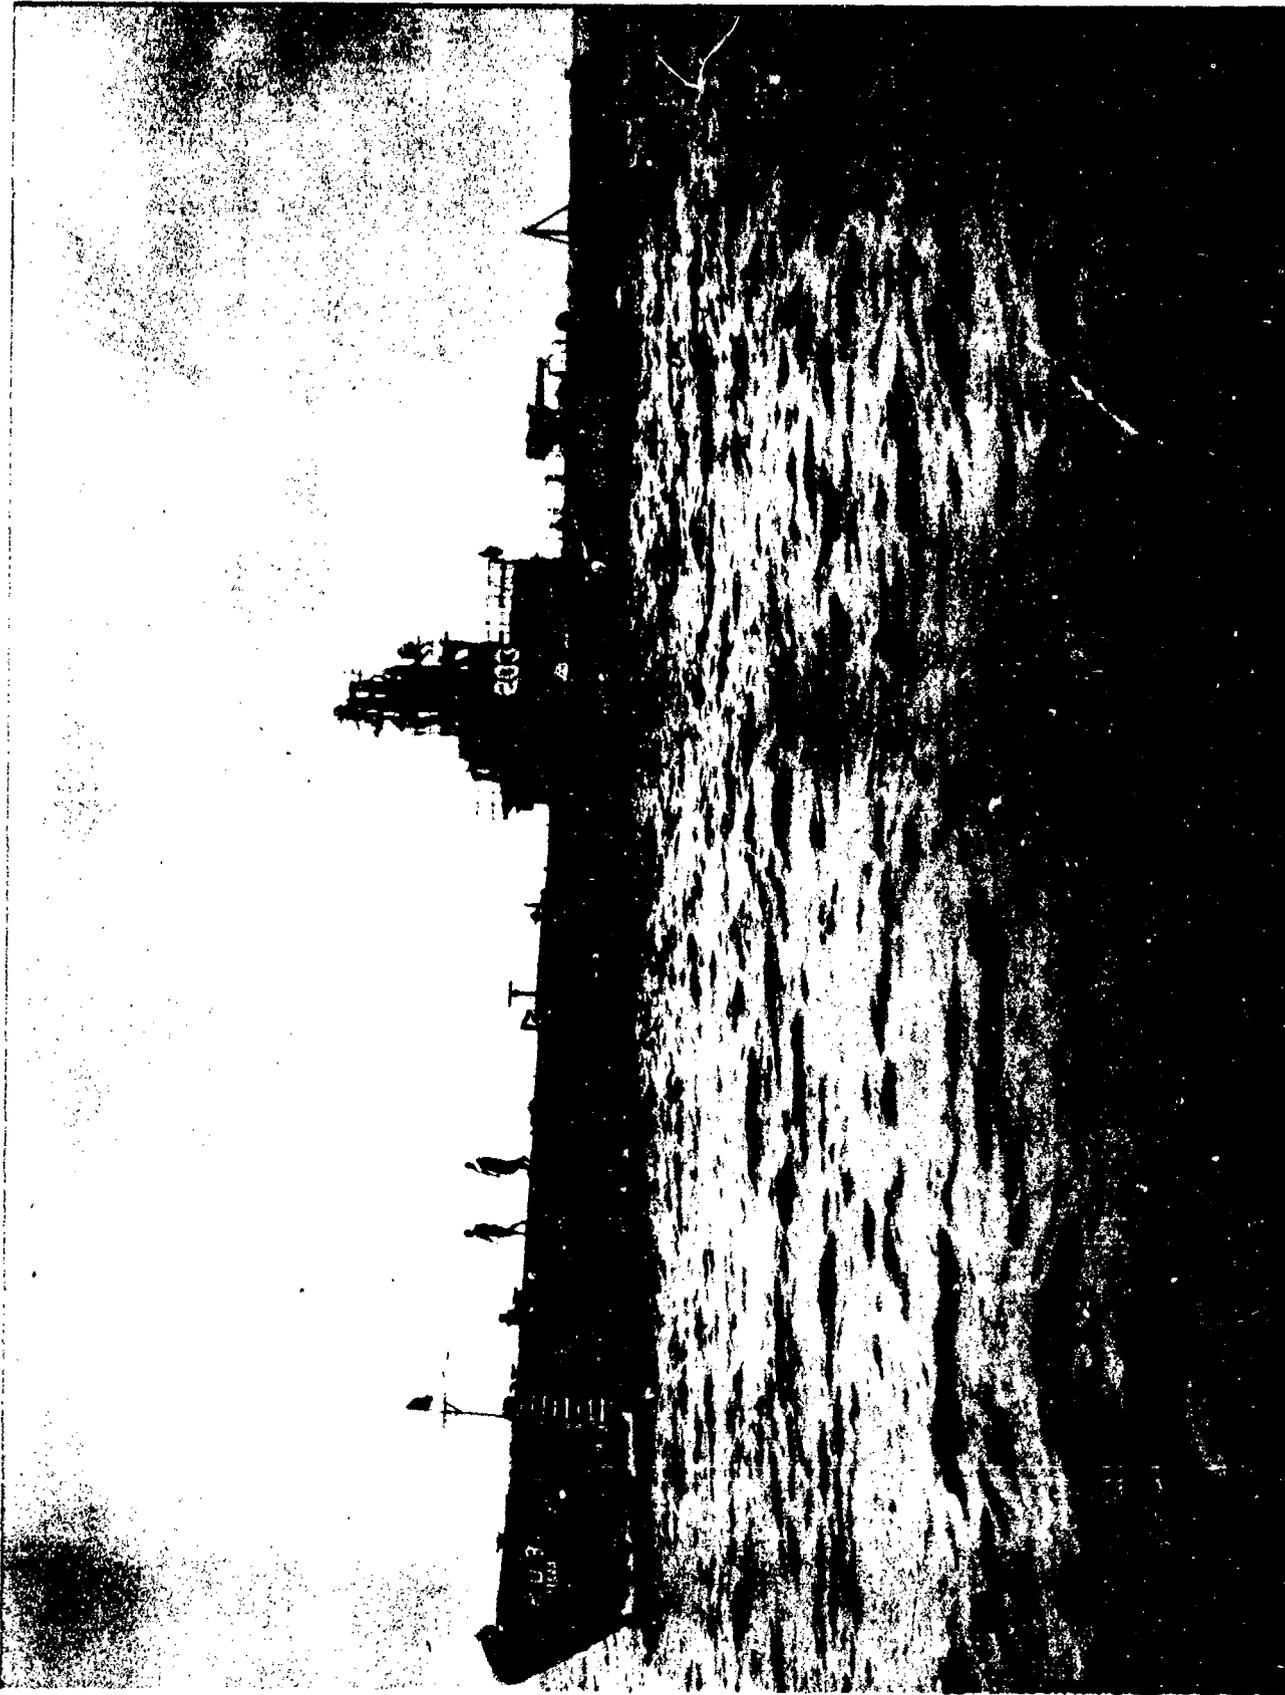
AACR-227-92-45 - General view from port bow.
