(9) BUREAU OF SHIPS GROUP
TECHNICAL INSPECTION REPORT

(6) OPERATION CROSSROADS,
U.S.S. GENEVA (APA86).
TEST ABLE [U.S.]

USS GENEVA (APA86)

TECHNICAL INSPECTION REPORT

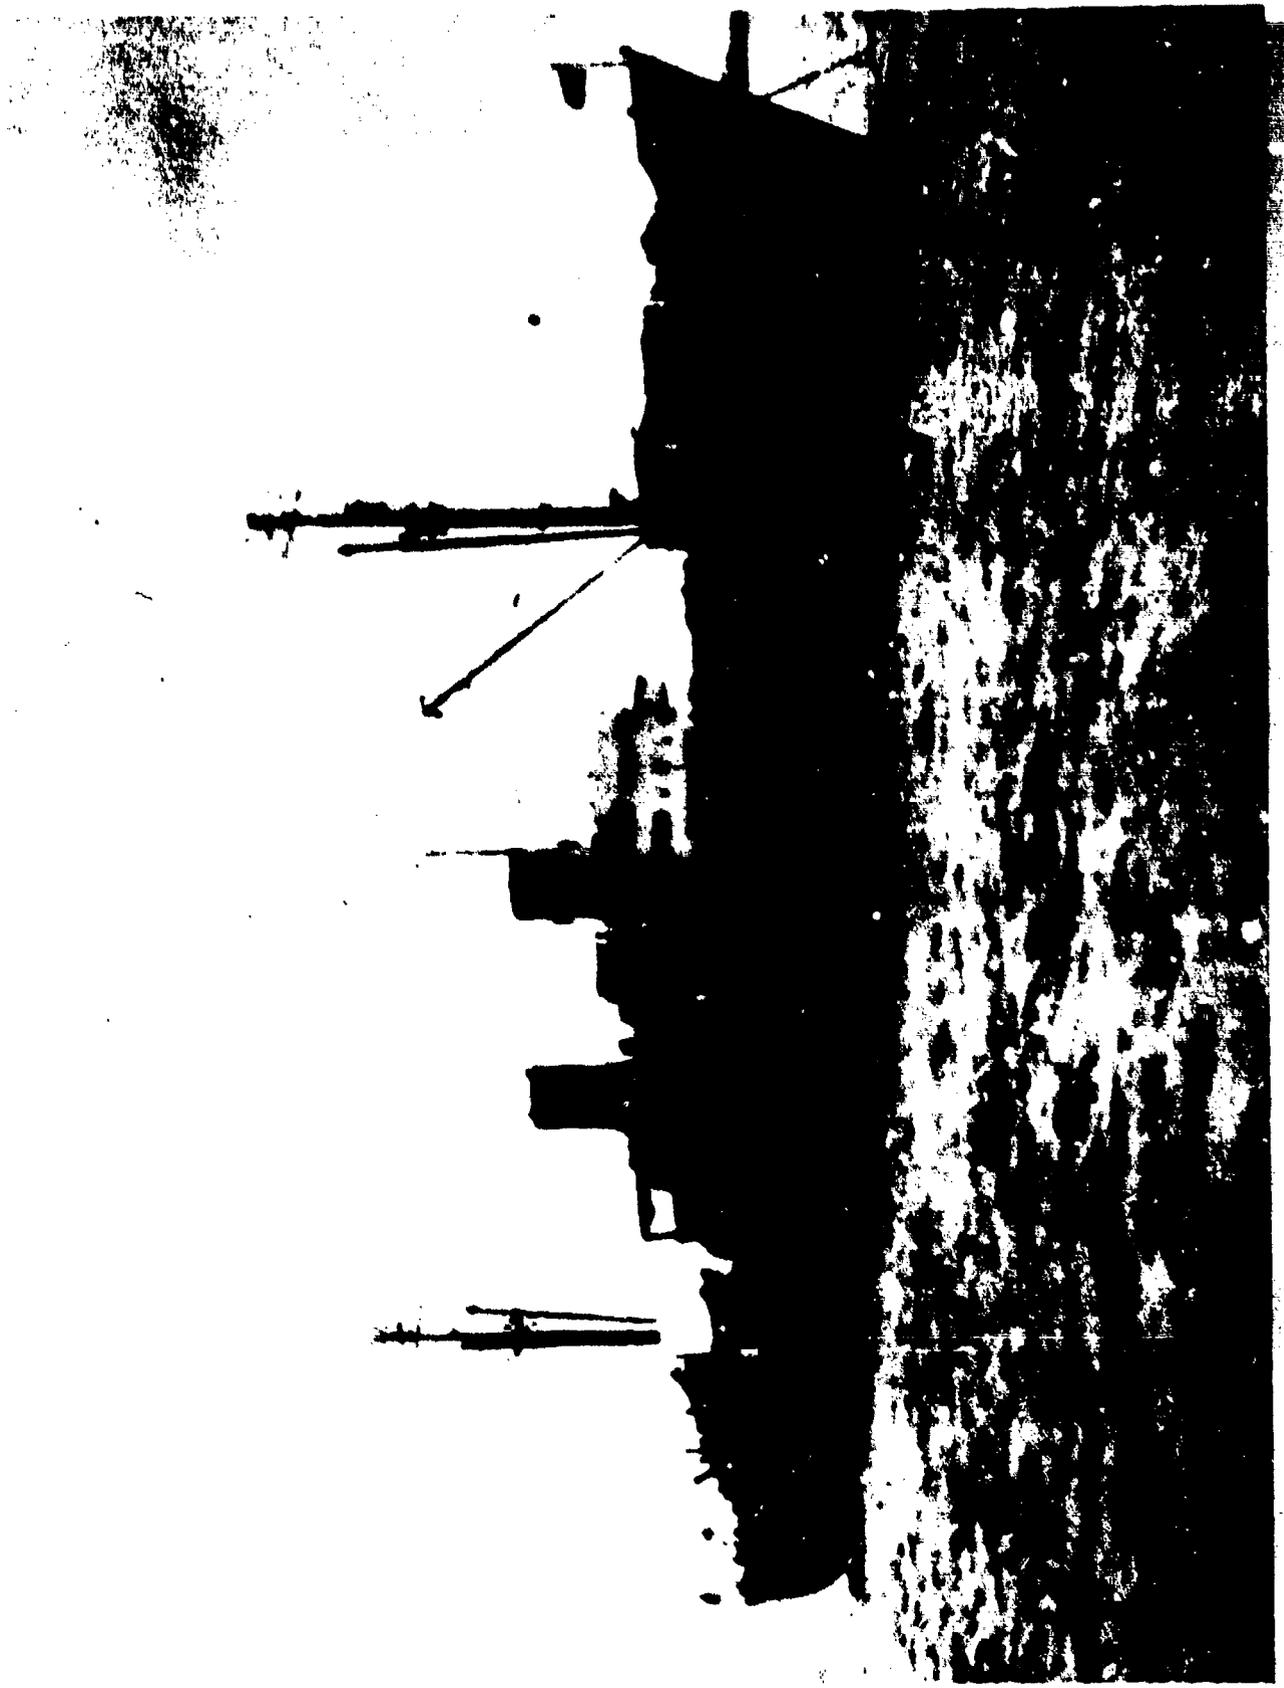
AA-CR-227-49-37. Starboard bow after Test A.

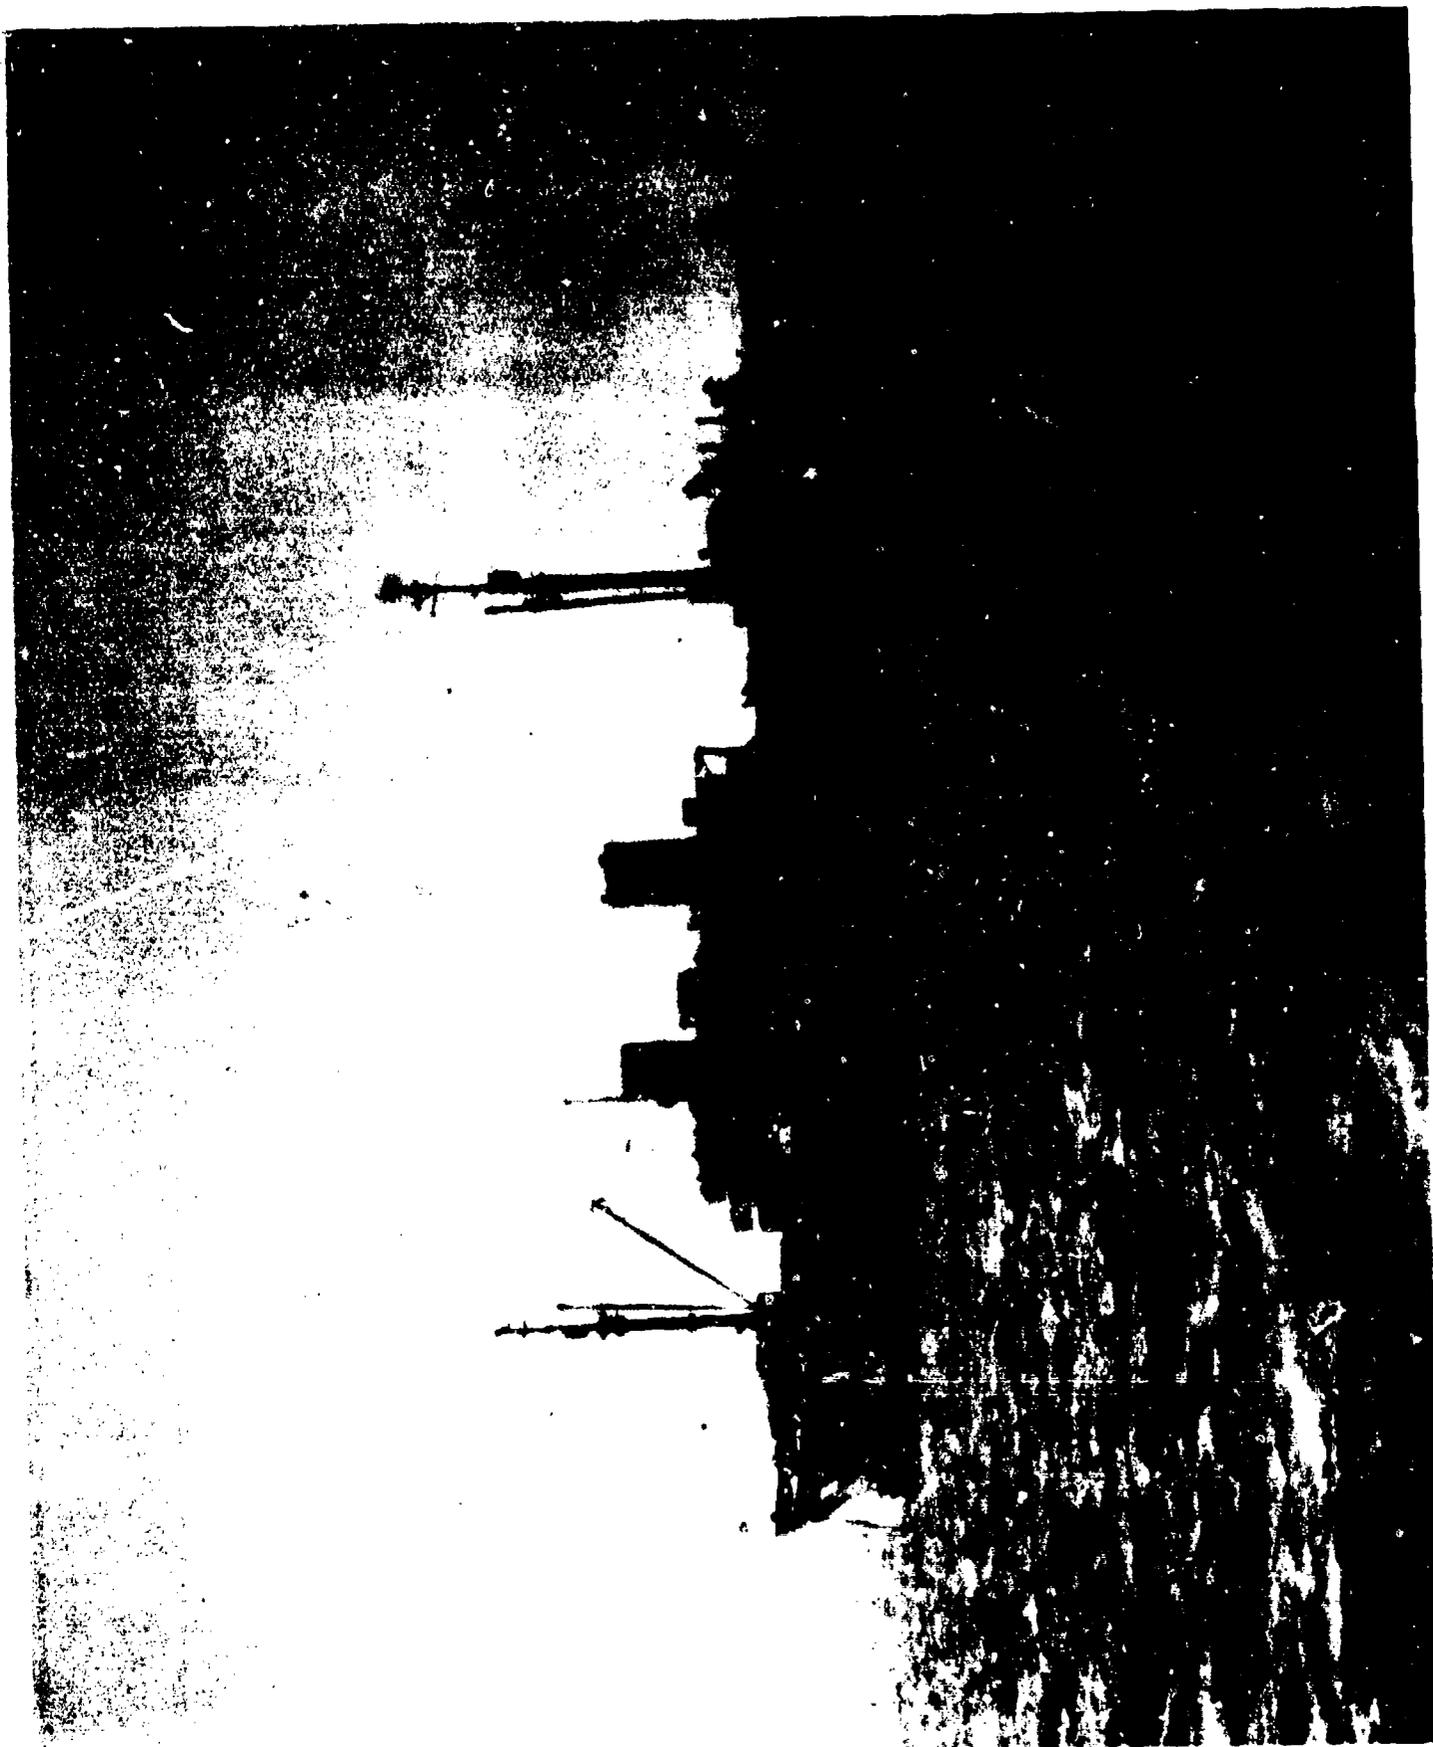
AA-CR-227-49-41. Port quarter after Test A.
