BUREAU OF SHIPS GROUP
TECHNICAL INSPECTION REPORT

6 OPERATION CROSSROADS.
U.S.S. PENNSYLVANIA (BB 38).
TEST BAKER [u].

OPERATION CROSSROADS

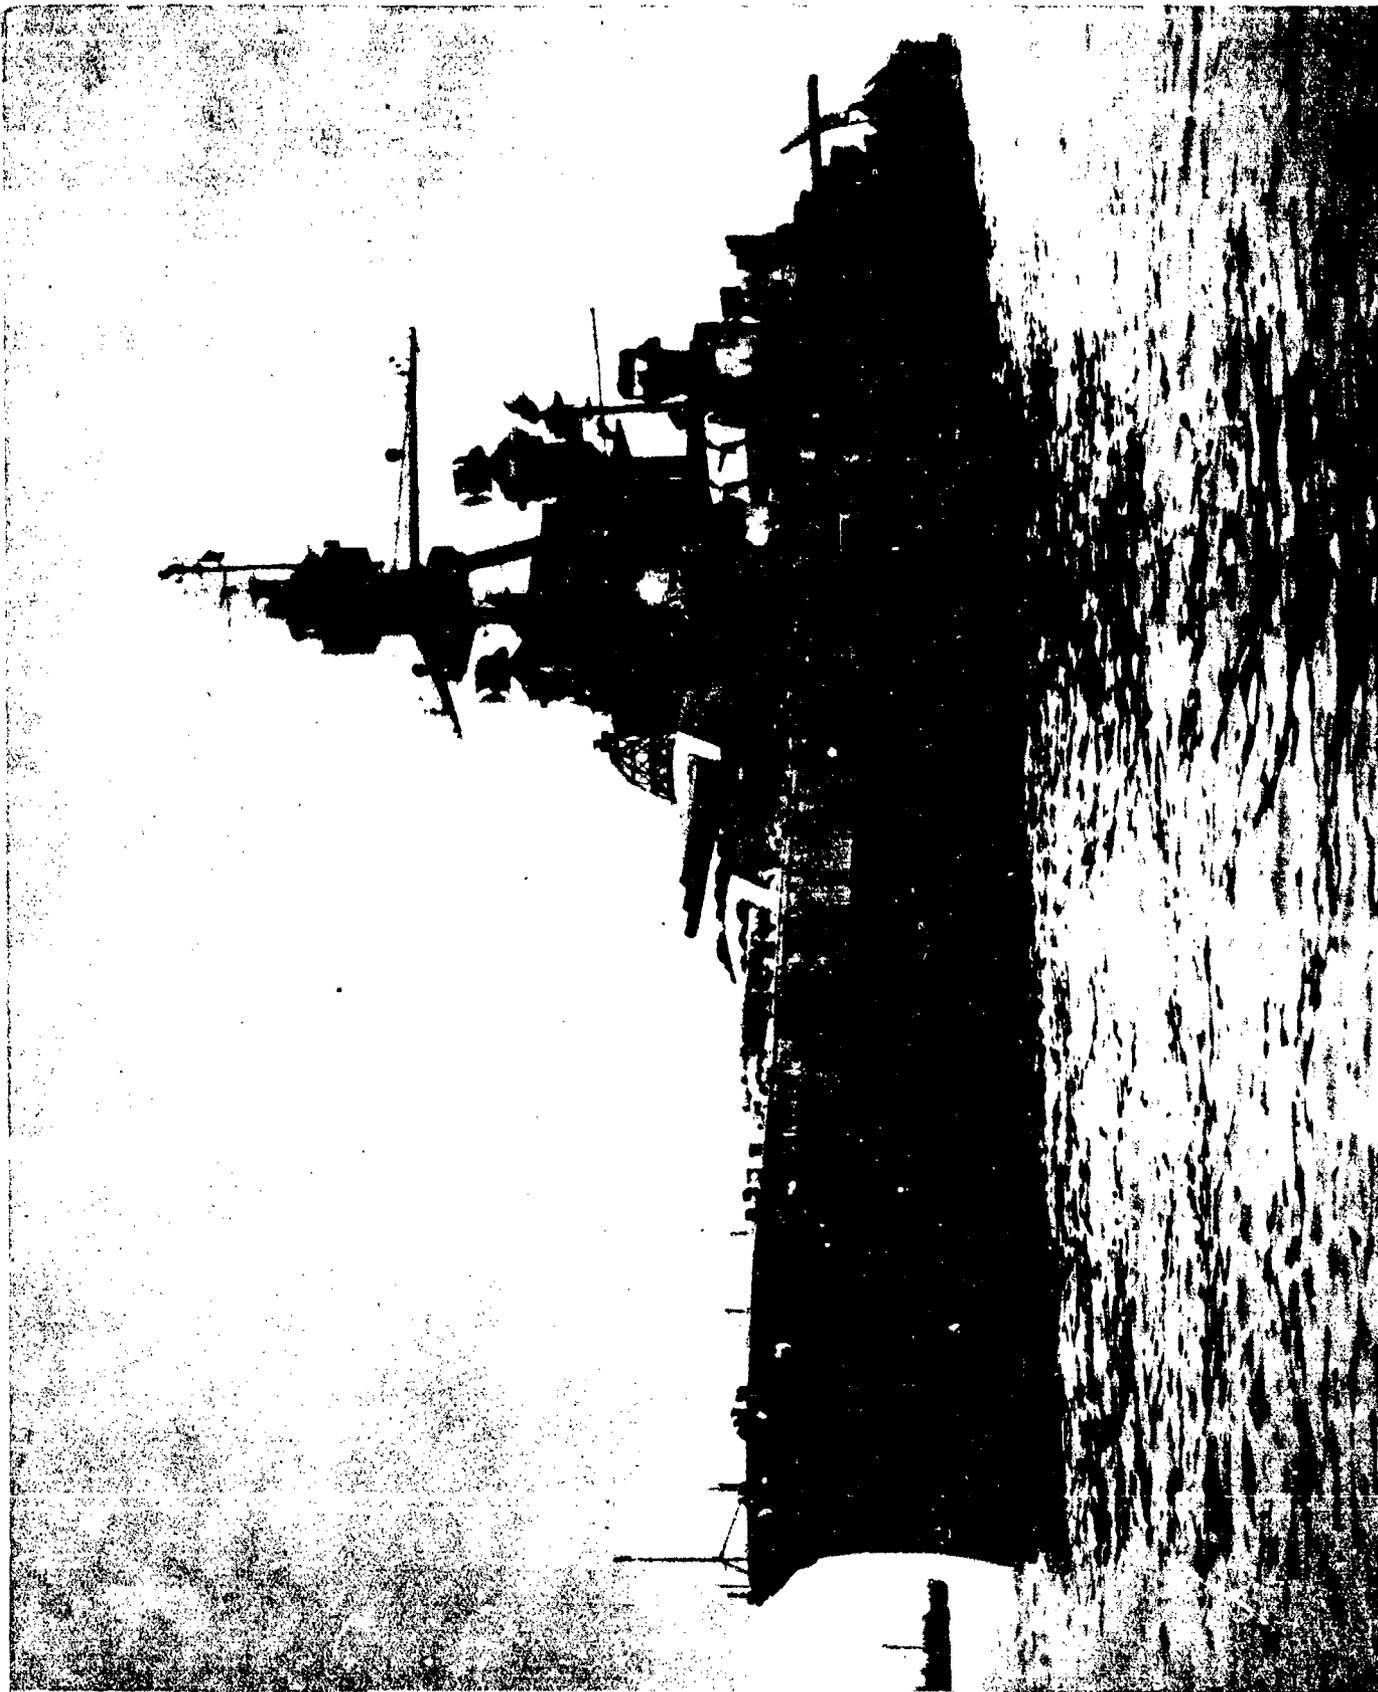
AB-CR-227-289-36. View from off port bow after Test B.

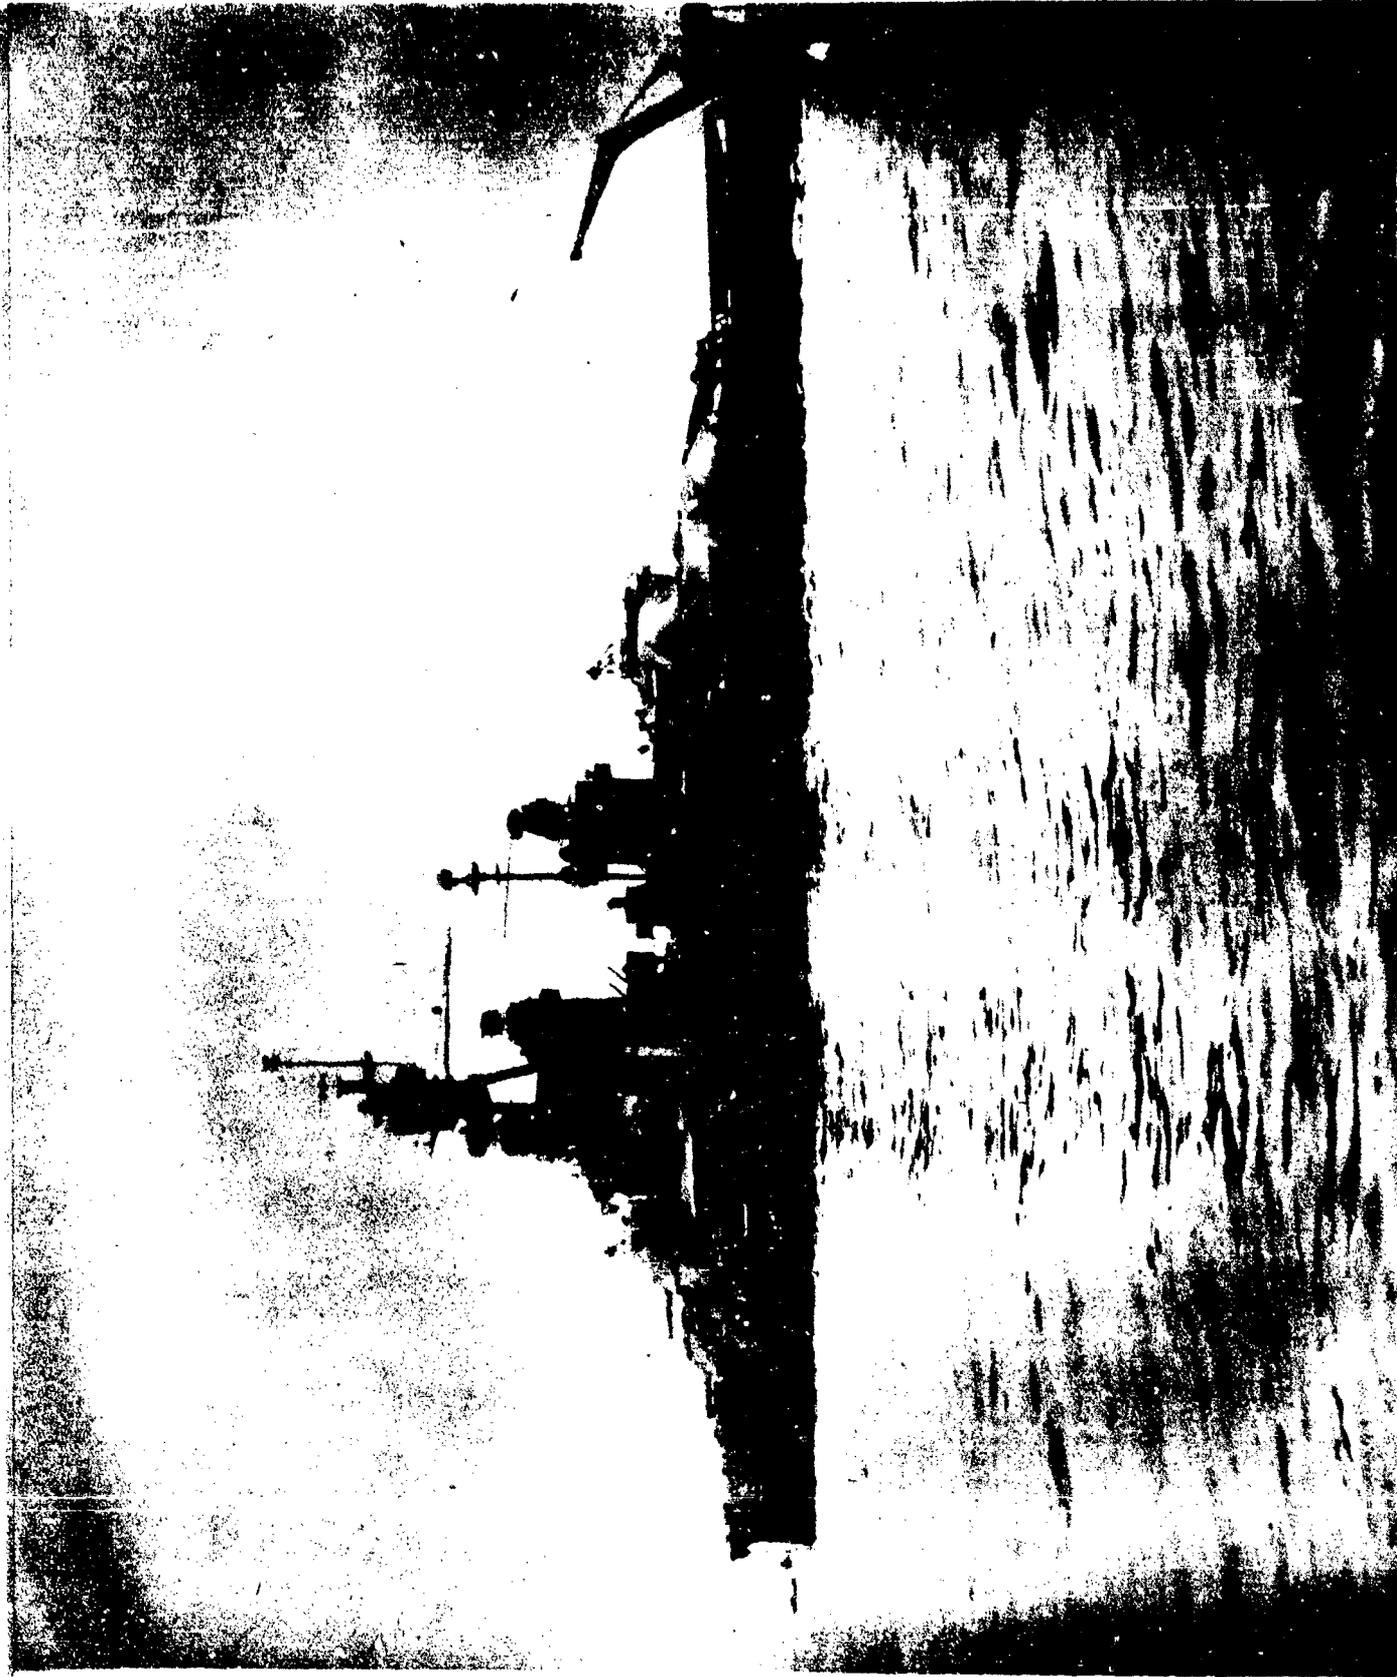
AB-CR-227-289-34. View from off port quarter after Test B.

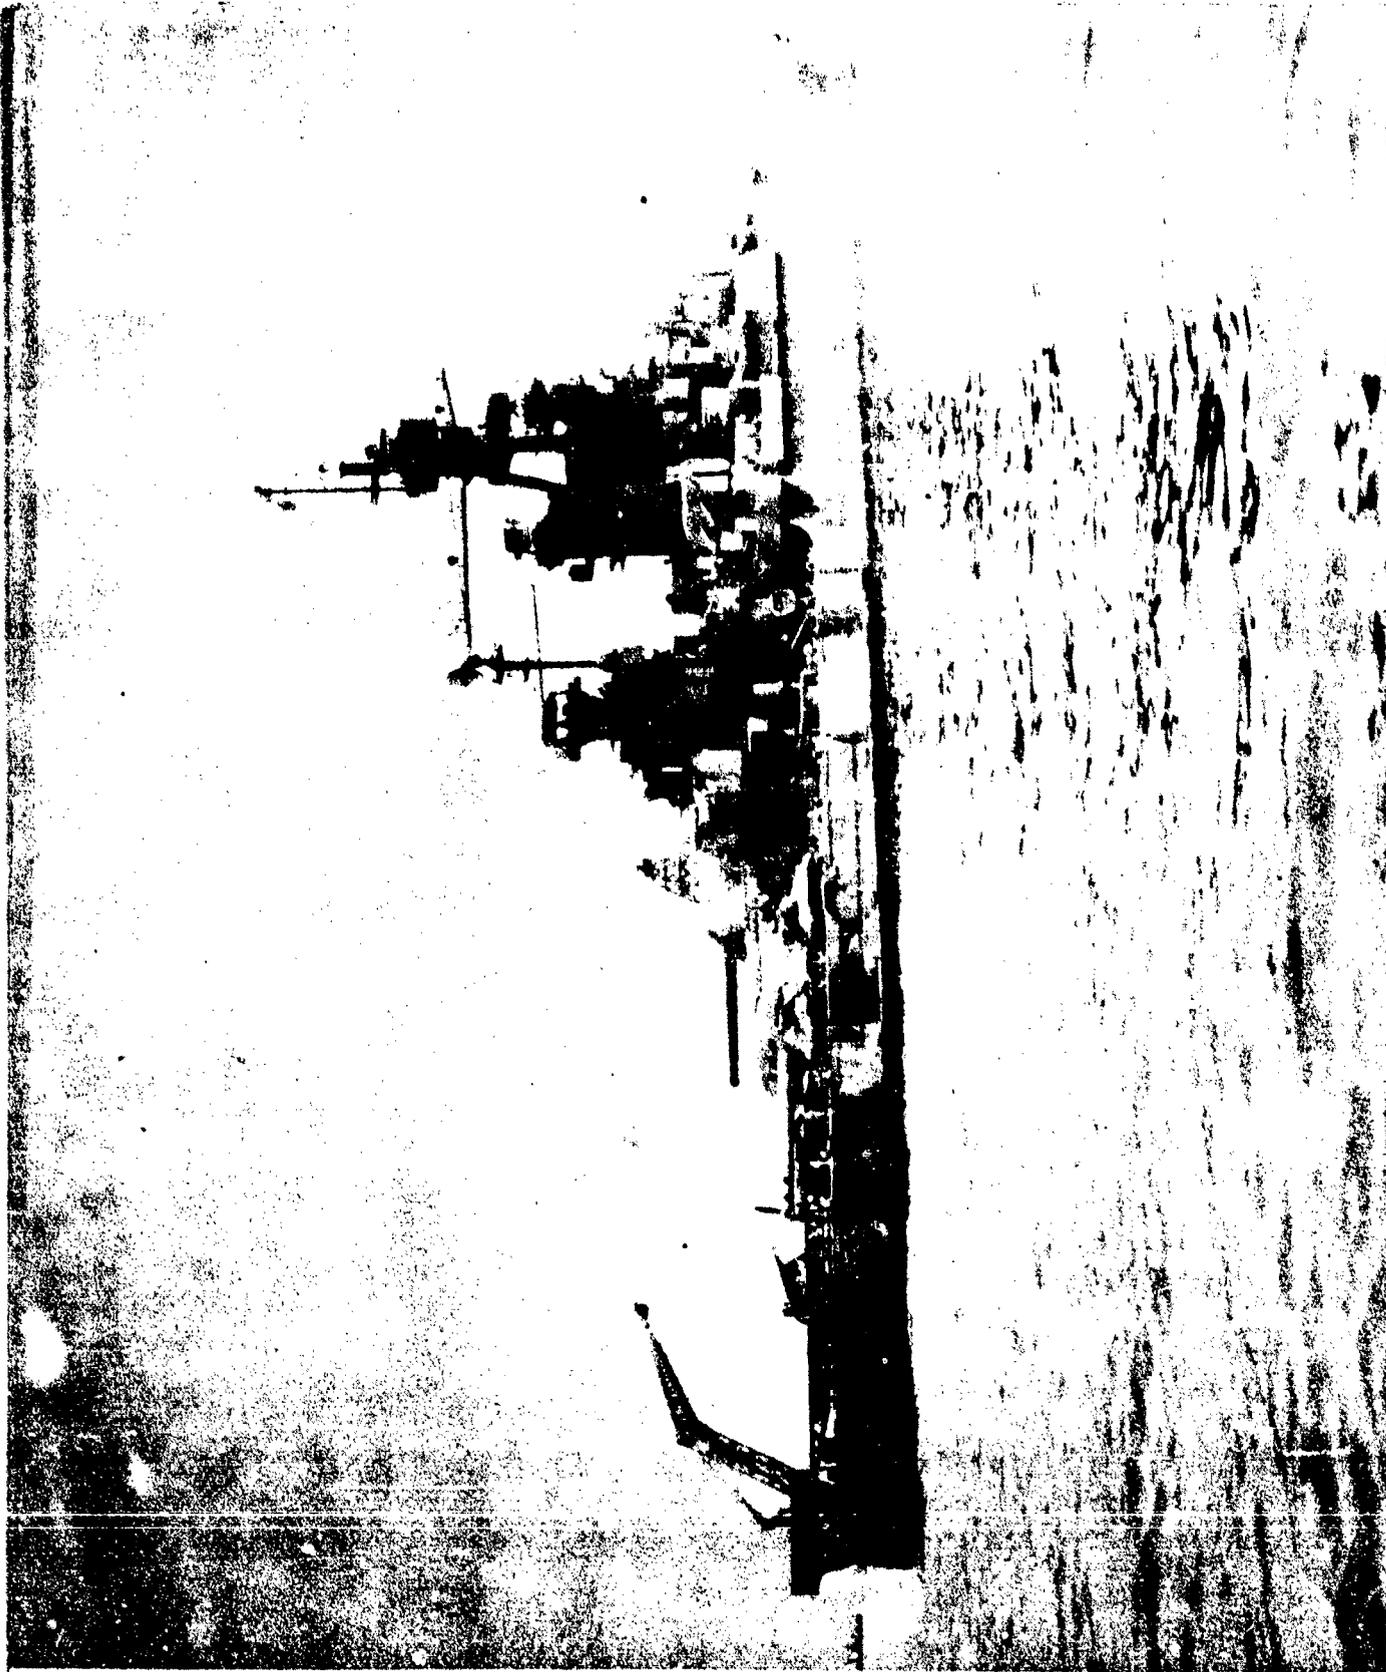
AB-CR-227-289-40. View from off starboard quarter after Test B.

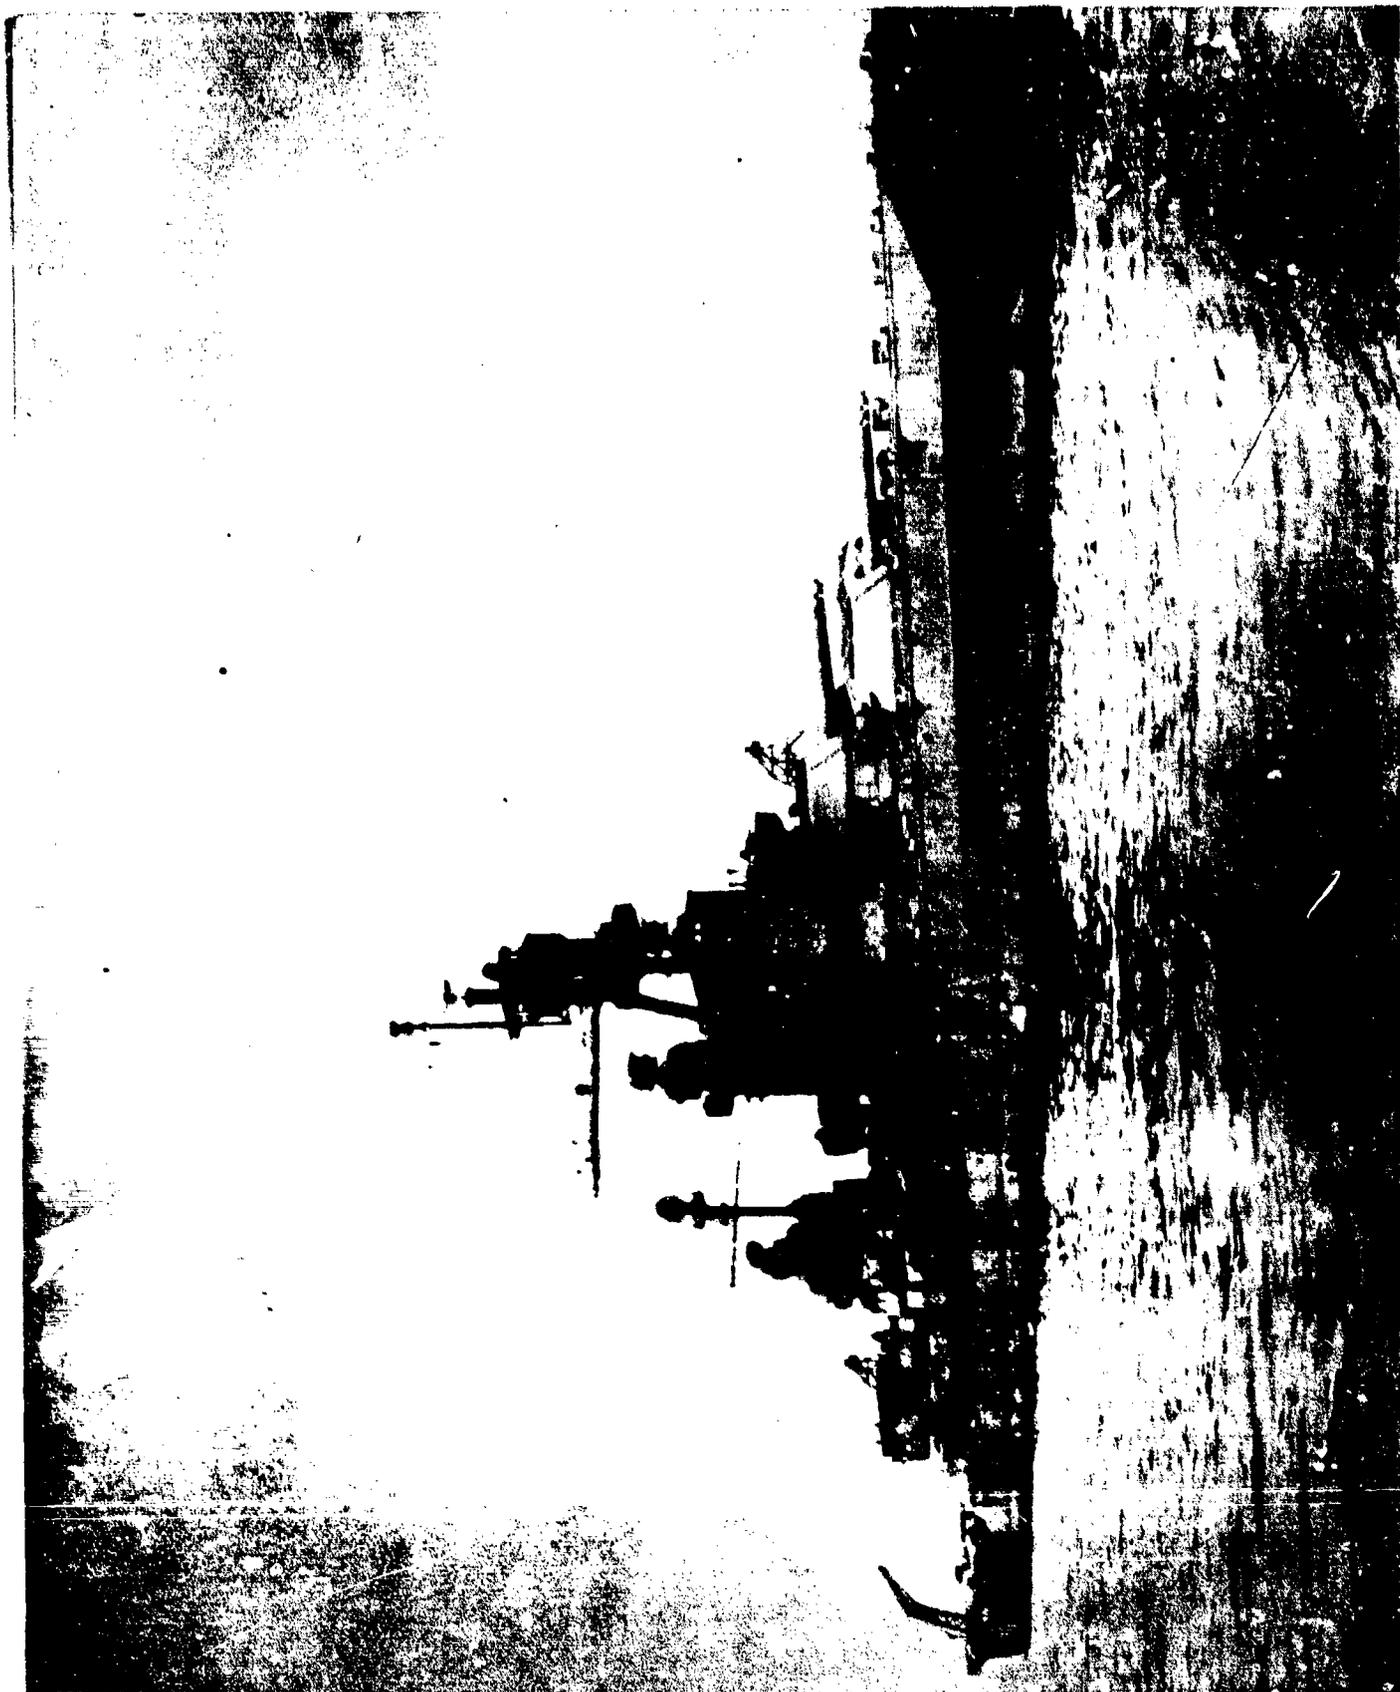
AB-CR-227-289-38. View from off starboard bow after Test B.
