Monthly Progress Report for September 1961
on the Continuation of the 3-KW Stirling
Cycle Solar Power Systems Program

Contract No. AF33(615)-8332

Engineering Department Report No. 2323

Allison Division
General Motors Corporation
Indianapolis, Indiana

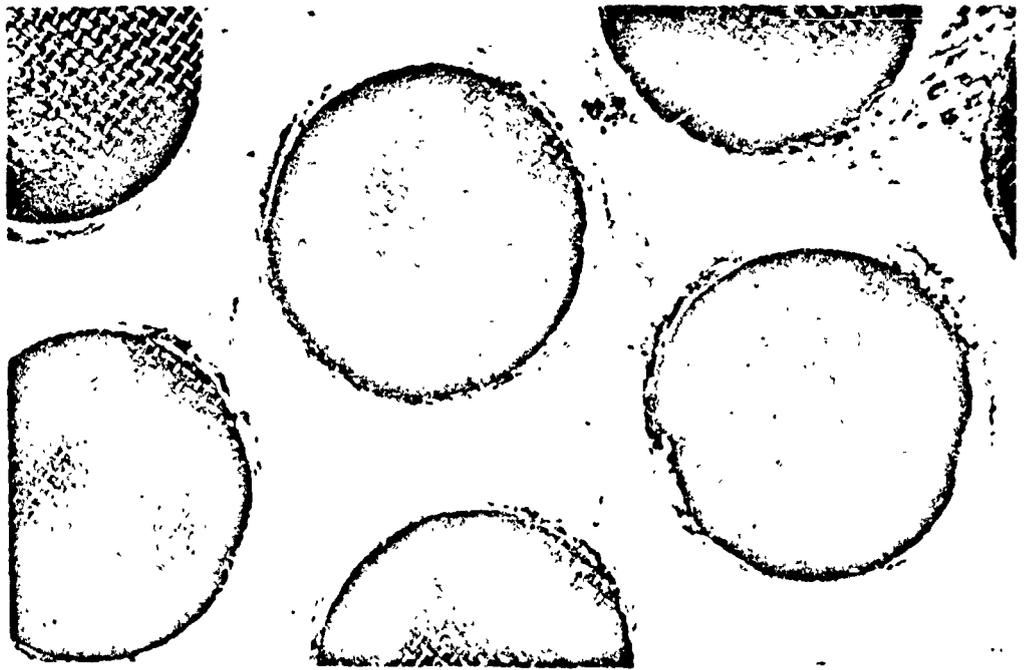
Visual inspection revealed a deposit on the screen mesh on the cold side of each regenerator. See Figure 1. This deposit is believed to be a combination of oil and wear residue from the Teflon K-30 piston rings. A flow test at teardown indicated that the pressure drop through the side arm circuit increased approximately seven percent when compared with the check made at Build-up 7. This deposit was removed by ultrasonic cleaning followed by conventional cleaning processes.

Figure 1. Deposits on Screen Mesh on Cold Side of Regenerator
