TECHNICAL REPORT 3058

MALFUNCTION INVESTIGATION  
OF  
CARTRIDGE, 81 - MILLIMETER: HE, M43A1  
AND  
M43A1B1, W/VARIOUS FUZES  
AND

CARTRIDGE, 81 - MILLIMETER: SMOKE, WP, M57A1,  
W/FUZE, TSQ, M77

PICATINNY ARSENAL  
DOVER, NEW JERSEY

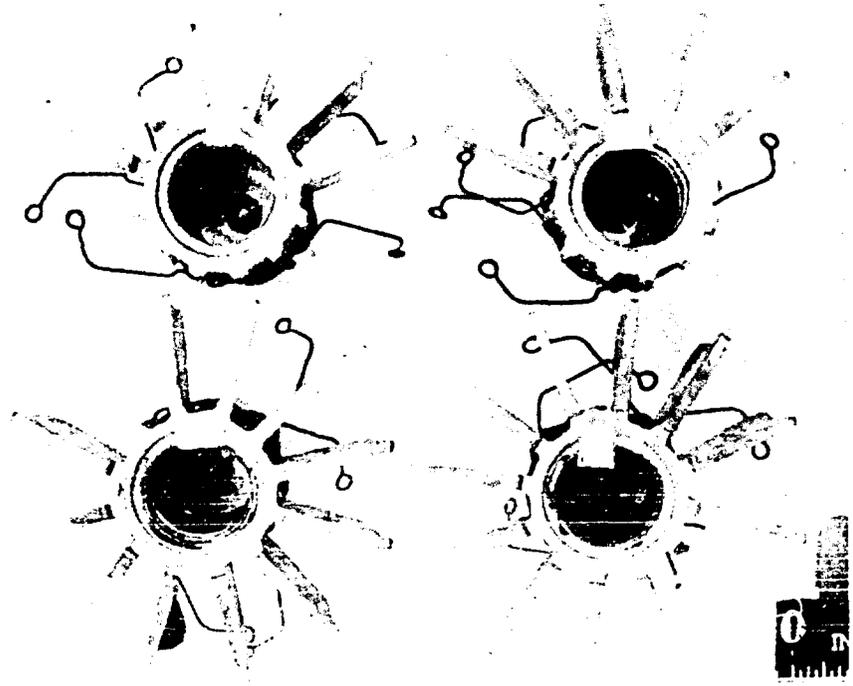
Figure 3. Condition of Fin Assemblies Recovered from Short-Range Rounds (Test Round Numbers Are Indicated)

3. A photograph taken of a short round when it was ten feet from the muzzle of the weapon did not show broken fins, although broken fins were found when the round was recovered. Most rounds have their fins broken off upon impact (Figure 3 & 4). It is therefore concluded that the broken fins did not cause the five short-range rounds at Aberdeen.

4. These five short rounds were not caused by broken fins.
