NUMBER D2-80092

UNCLASSIFIED TITLE Cryogenic Tanks Development -  
(Dyna Soar)

MODEL NO. X-20A CONTRACT NO. AF33(657)-7132

NUMBER D2-80092 MODEL NO. X-20  
TITLE Section 1: EWA 5-749, "Structural Development  
Tests of Cryogenic Subsize Tanks"

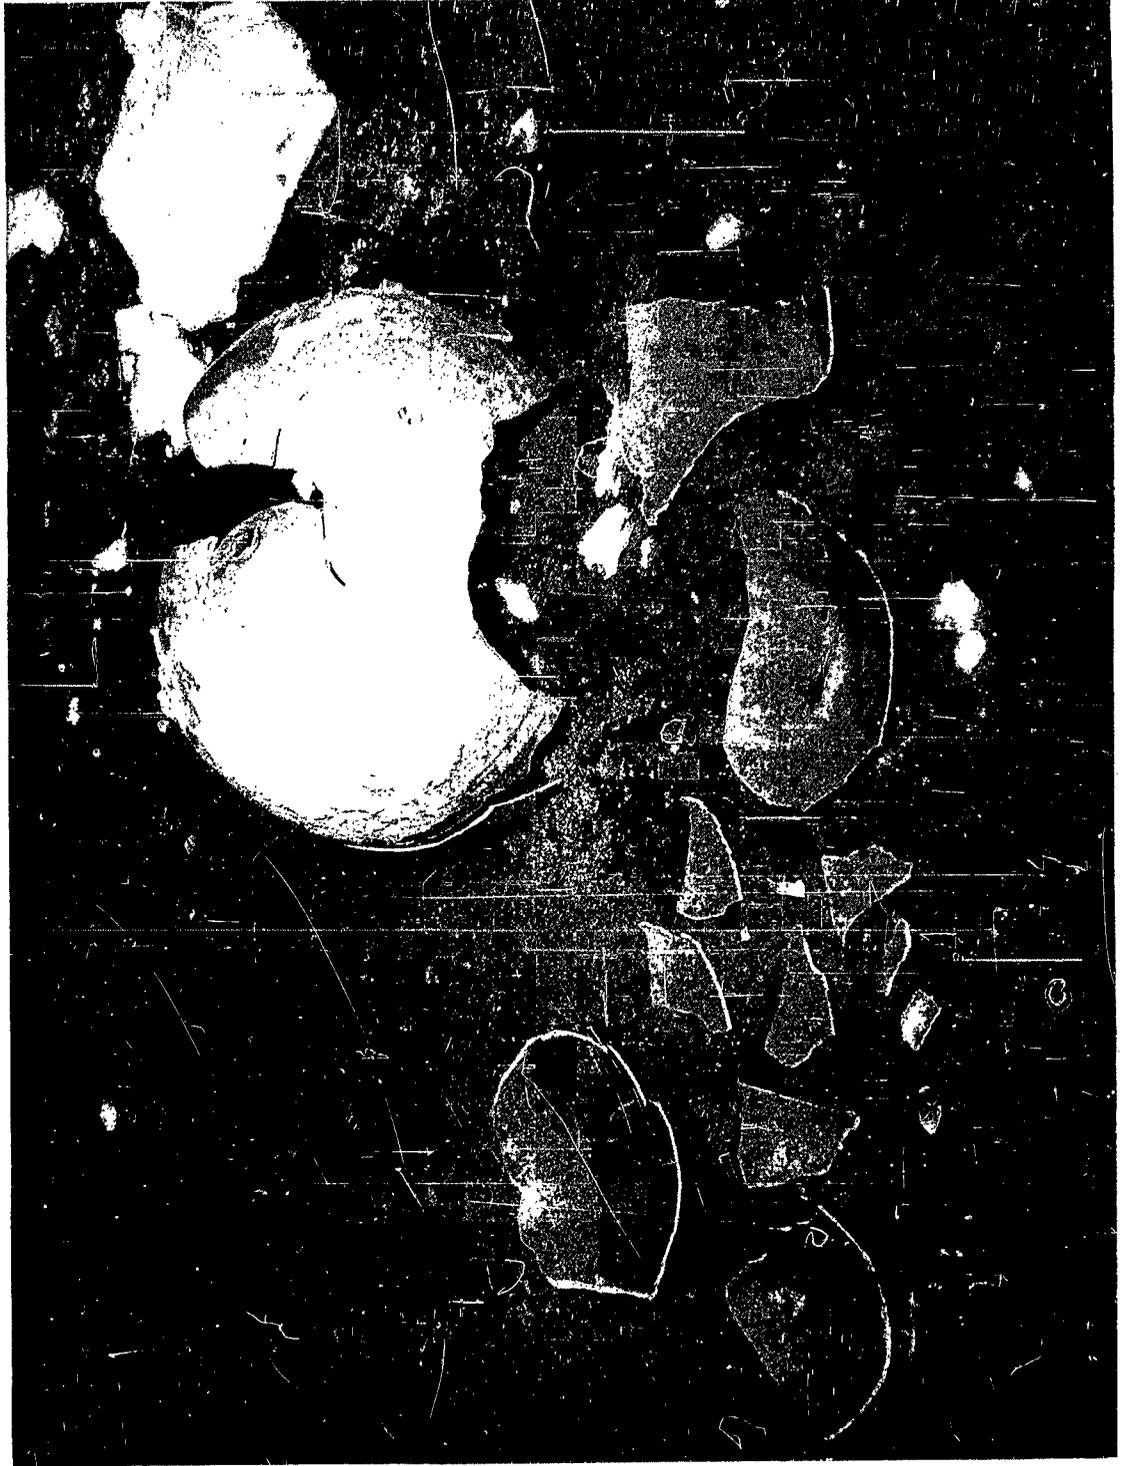
FIG. 1.10 TANK No. 1 AFTER BURST

All three tanks were full of LH<sub>2</sub> at the time of burst as indicated by temperature measurements and the nature of the burst itself. Very little scattering of tank fragments was in evidence (See Figures 1.10, 1.11, and 1.12).

The tank failed in a ductile manner at an area of minimum wall thickness. No material defect was found at the point of origin of the failure. The pitting and intergranular attack on the inside of the tank did not contribute significantly to the failure but did influence the fracture path and the resultant breaking into numerous small pieces.

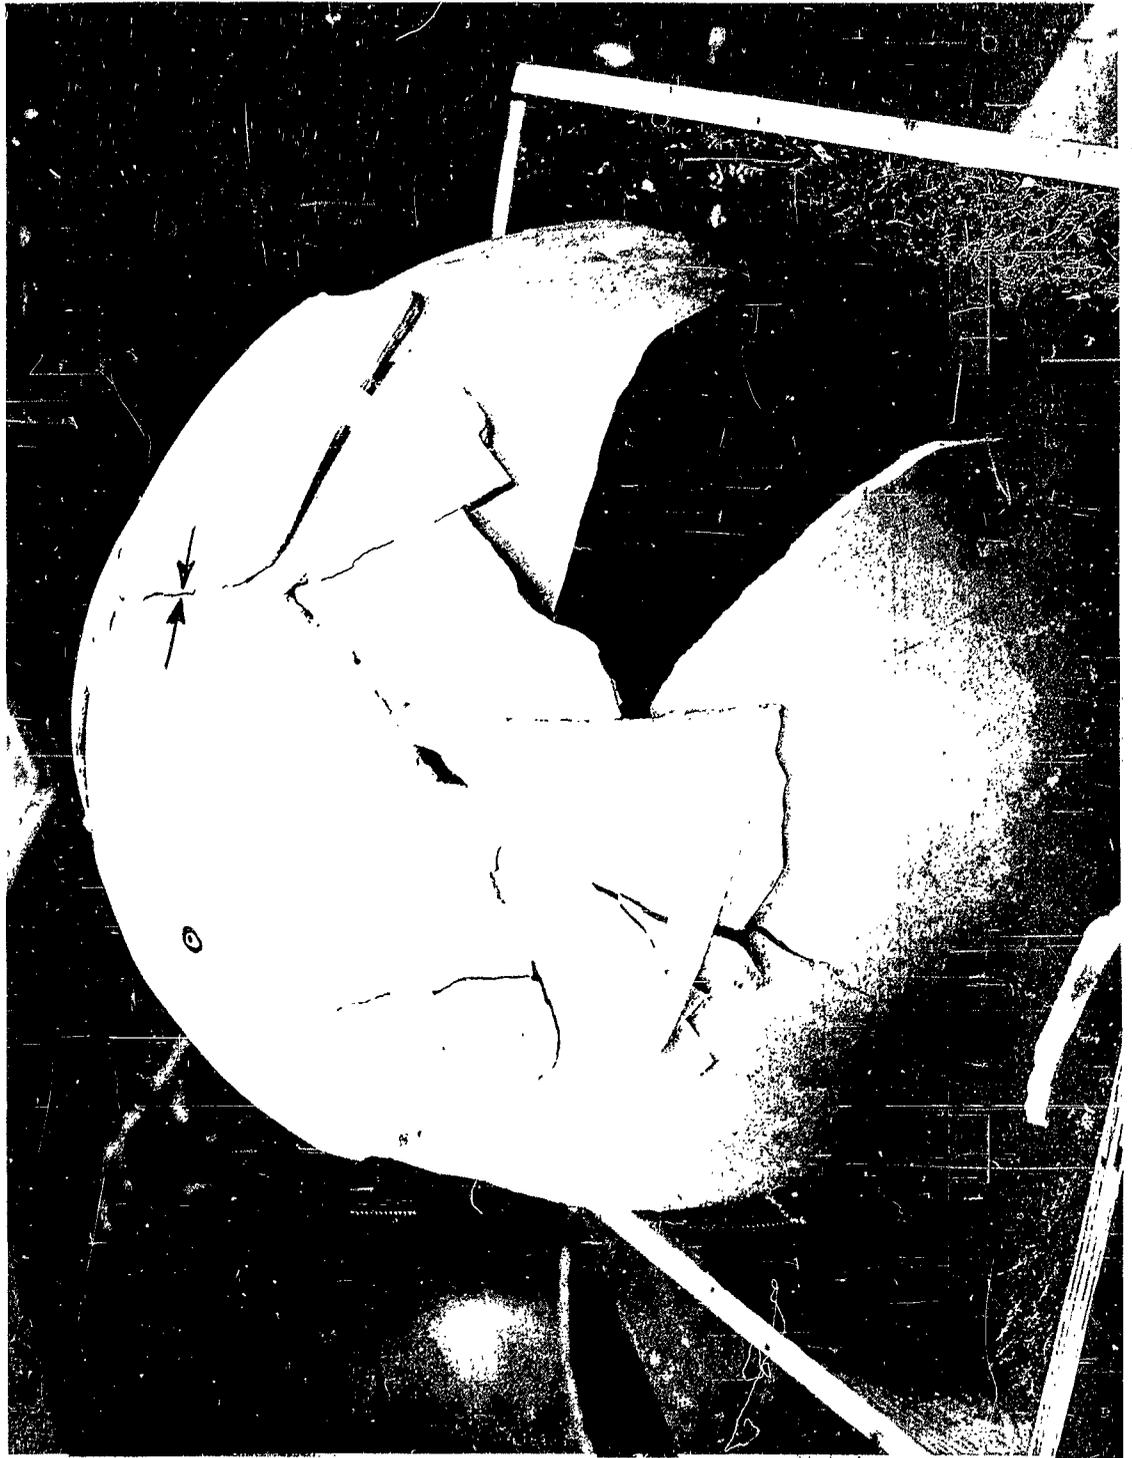
FIG. 1.13  
TEST TANK NO. 1 REASSEMBLED  
WITH FAILURE AREA NOTED

The broken pieces were re-assembled and the approximate point of origin determined. Figure 1.13 shows the parts re-assembled using the largest piece as a form. The center of the bottom is shown marked with a circle. The point of origin is marked with arrows.

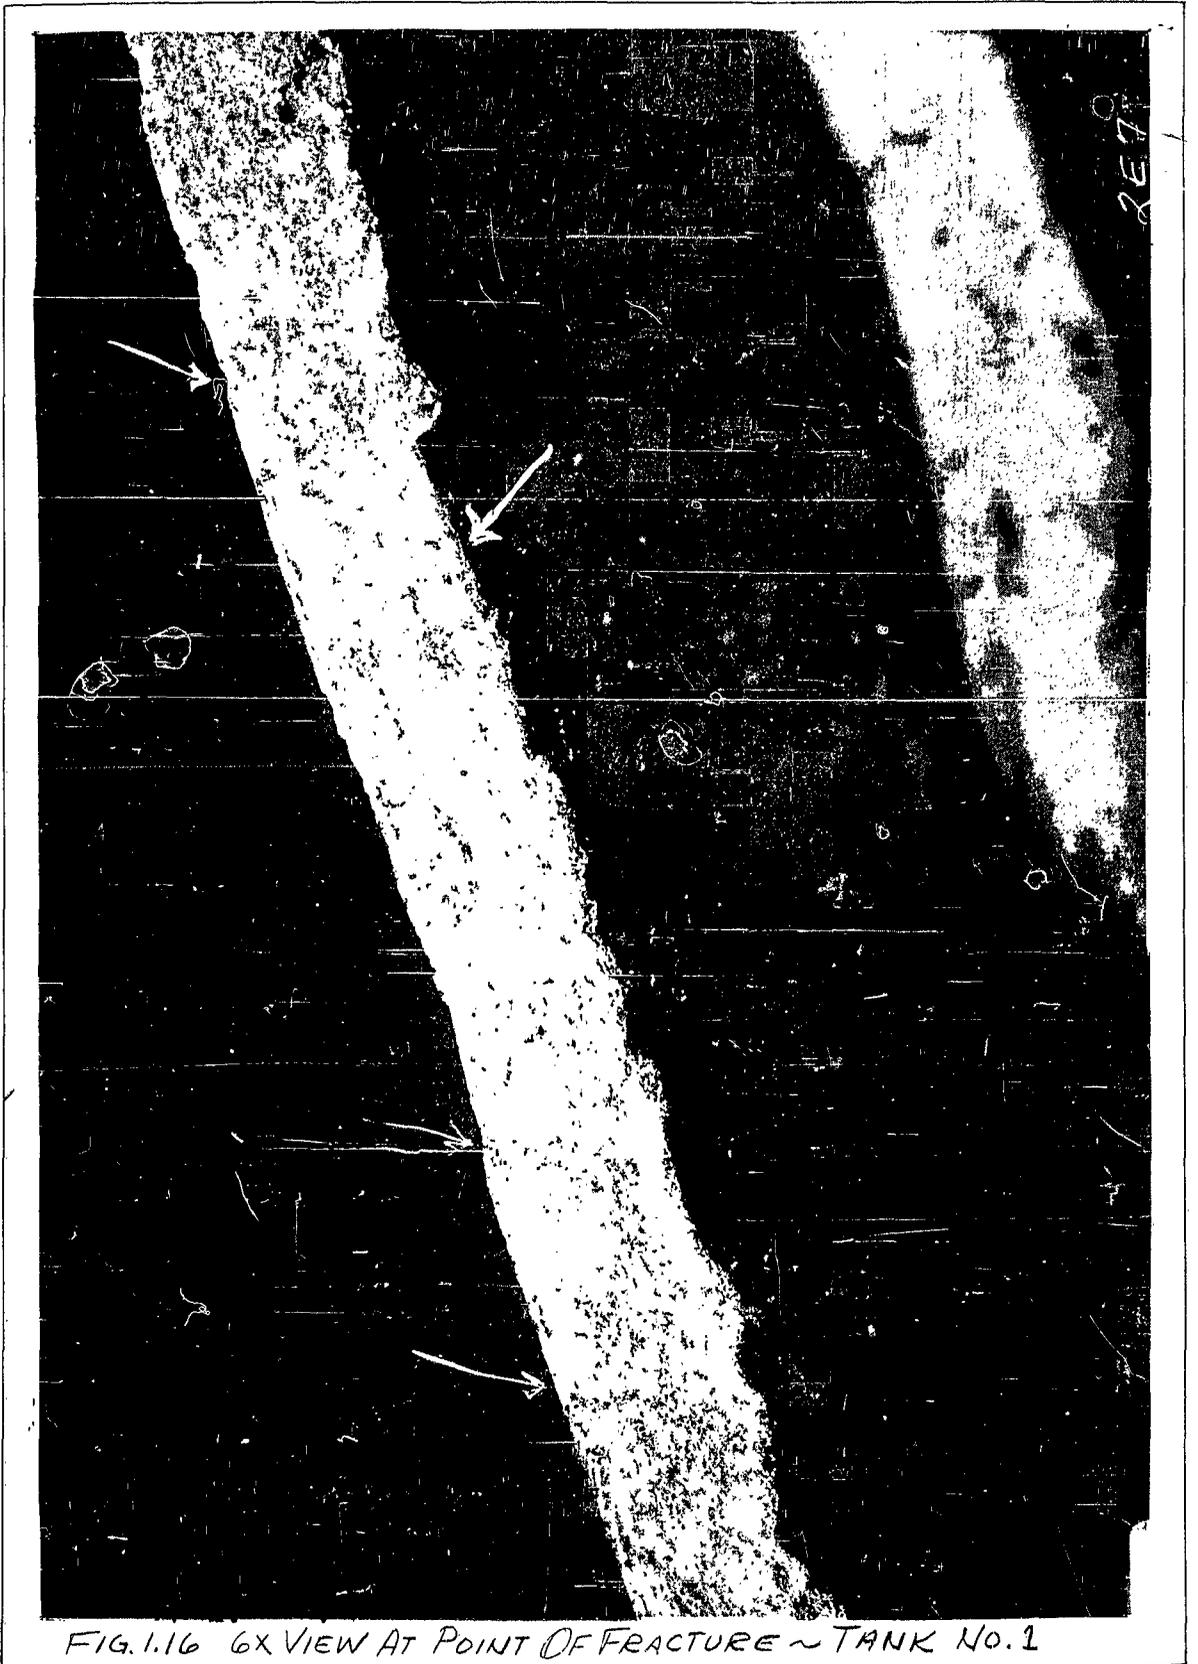
FIG. 1.16 6X VIEW AT POINT OF FRACTURE ~ TANK No. 1

The point of origin of the failure was approximately 10° up from the bottom of the tank (or 6.5" down from the girth weld). Figure 1.16 shows the fracture face at the point of origin. The arrows indicate the location of growth rings or hesitation points in the growth. Beyond the outer arrows, growth was catastrophic. Critical crack length (area of slow growth) was .100" at the surface and .200" at the center of the wall thickness.

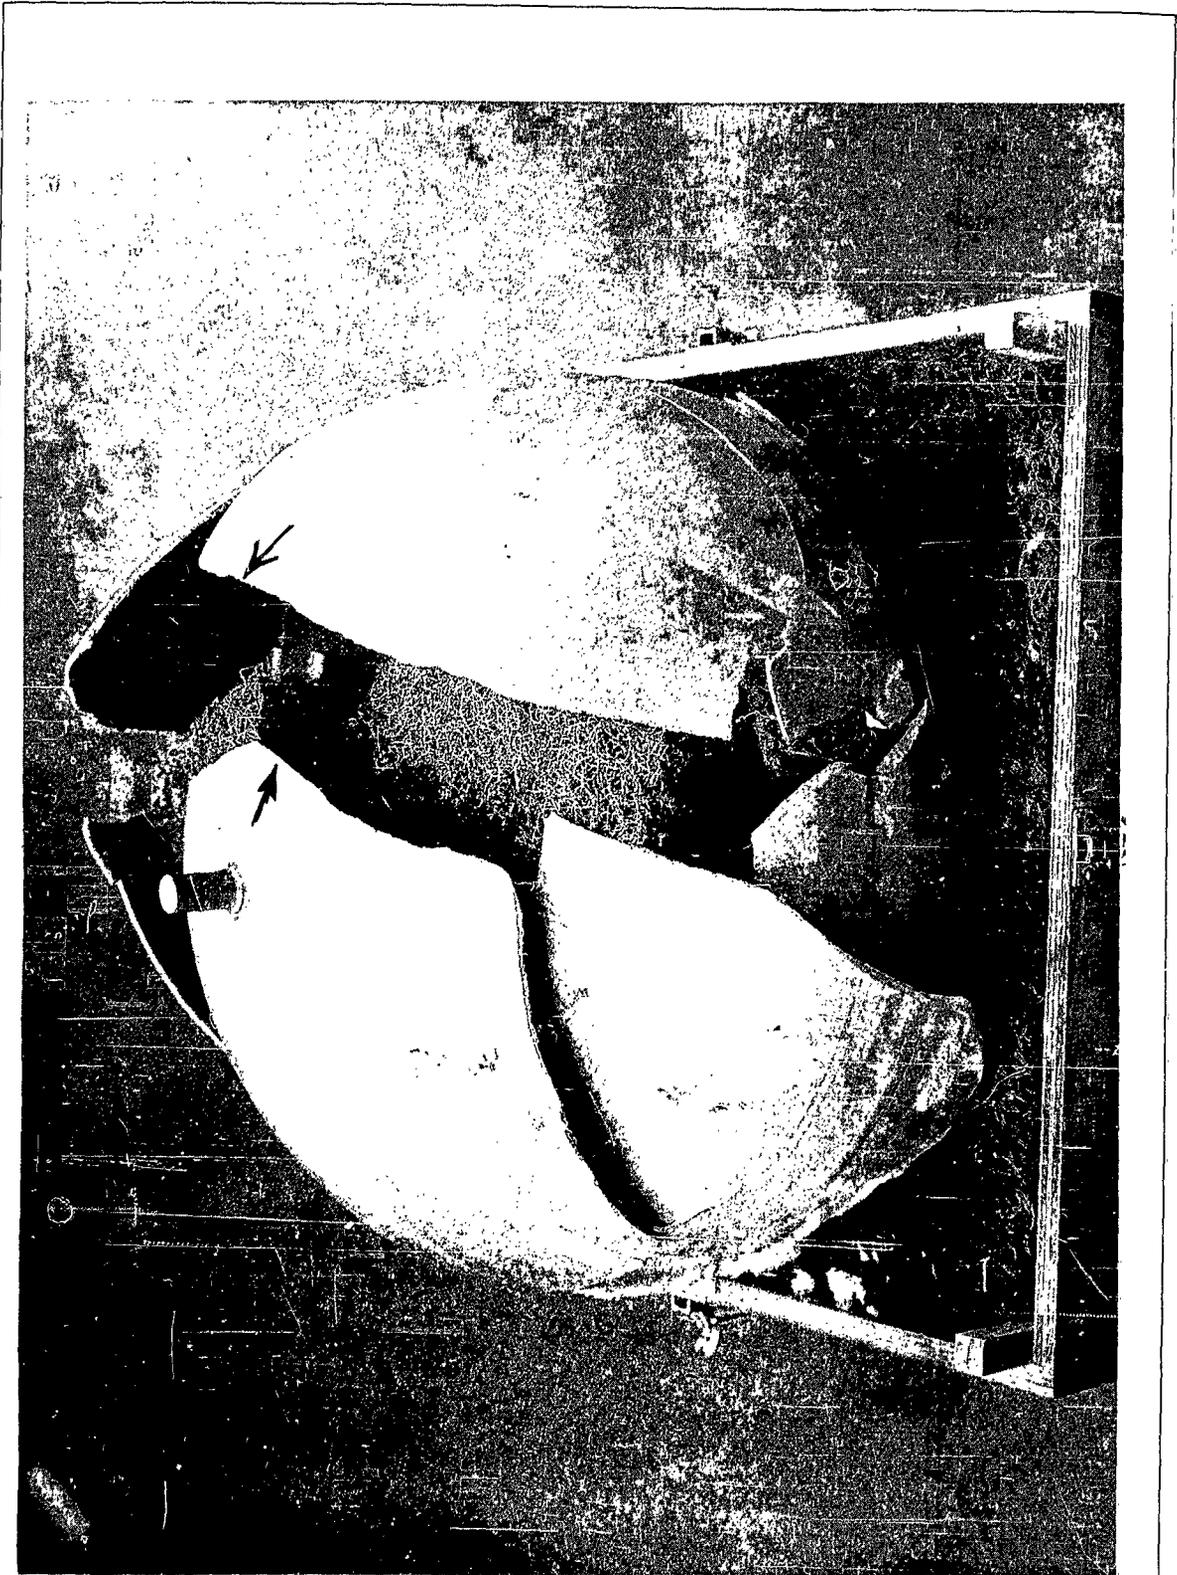
FIG. 1.17  
TEST TANK NO. 2 REASSEMBLED WITH FAILURE AREA NOTED

Figure 1.17 shows the broken tank after reconstruction. The point of origin was found to be 2.5" from the center of the boss. From this point in toward the boss the shell thickness increased abruptly. Thickness at the origin of failure was .108".

The outside contour in this region was a uniform sphere. The increase in wall thickness around the boss resulted in a flattening of the interior contour. It was at this change of contour that the failure originated. Critical crack length (area of slow growth) was .100" at the surface and .200" at the center of the wall thickness. Figure 1.18 shows the fracture with the point of origin bracketed.

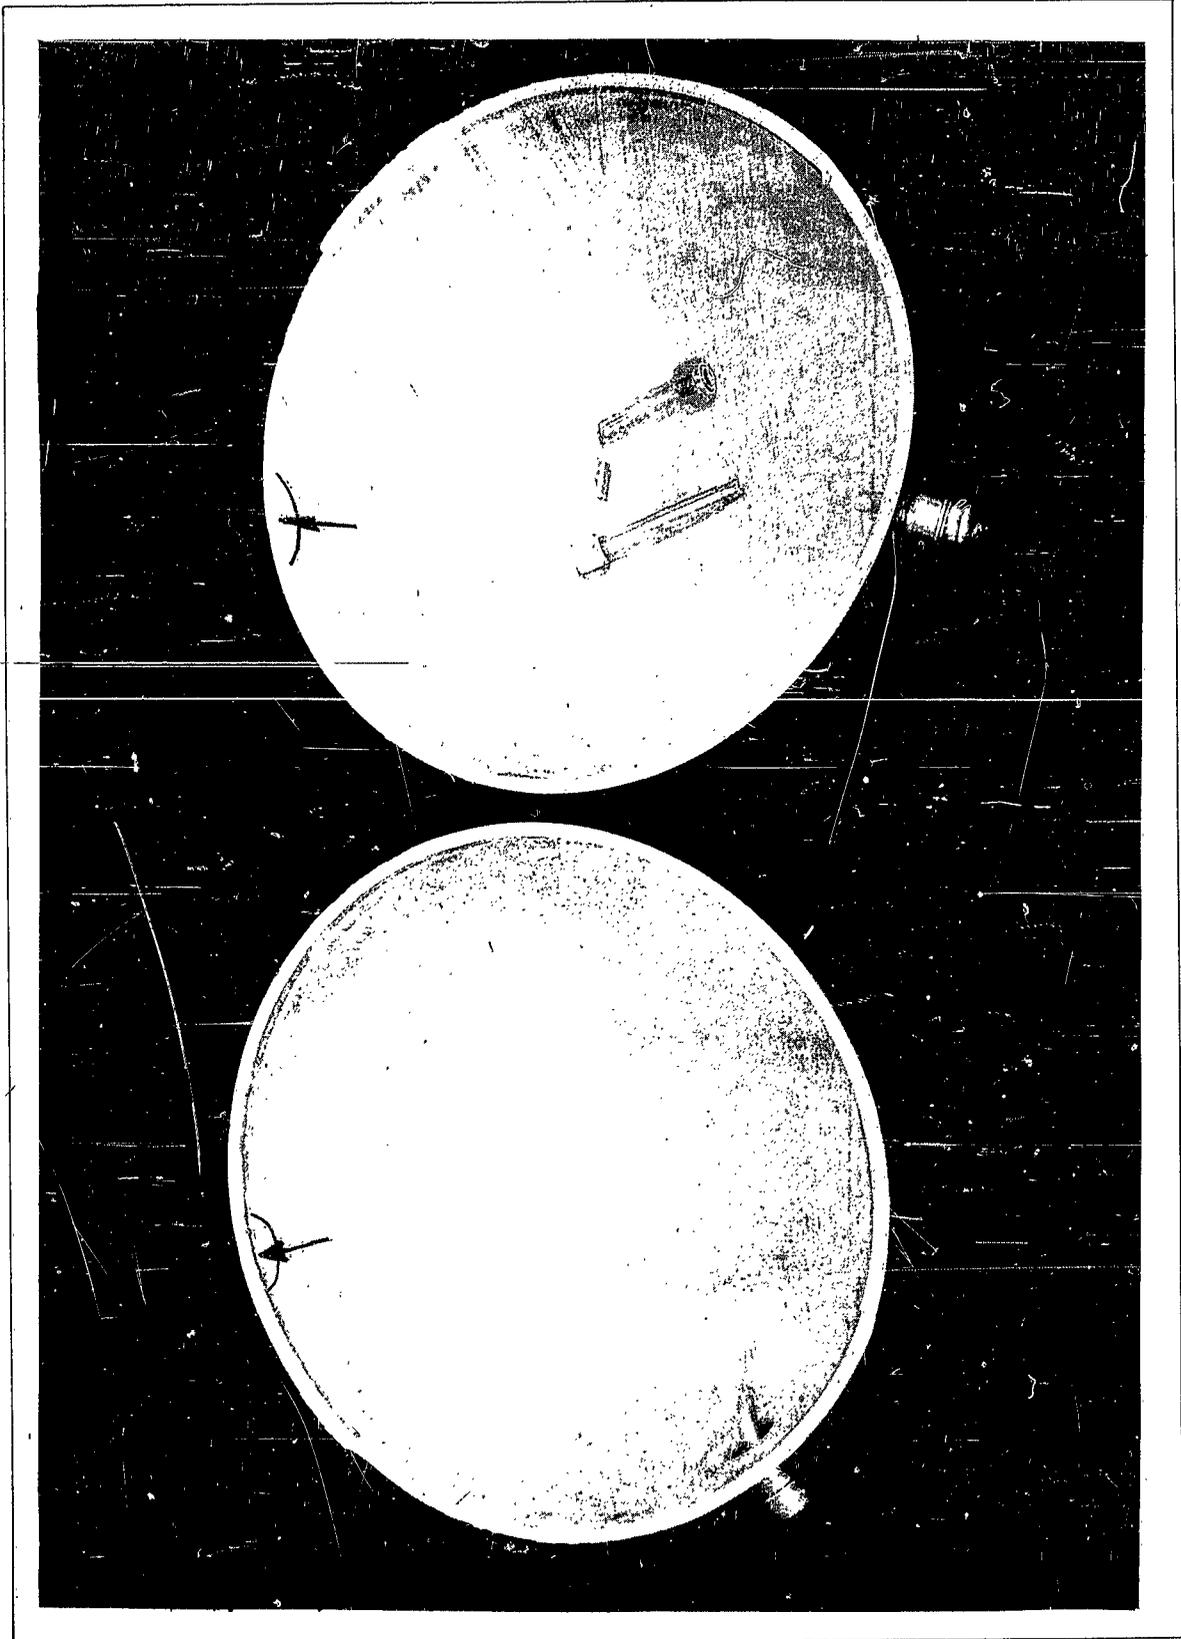
FIG 2.6  
LN<sub>2</sub> TANK INNER SHELL  
AFTER BURST

Burst occurred as a mild detonation due to two factors. (1) There was no fragmentation, and (2) the burst energy was absorbed by the immersion liquid. Figure 2.6 is a photo of the test specimen after failure. As is noted, the failure occurred as a clean circumferential break adjacent to the girth weld neatly separating the tank into halves.

The following data is based on information provided in reference 2.3.3 by the Materials and Process Unit. The failure occurred along the girth weld. The arrows in Figure 2.6 and 2.7 indicate the origin of failure which corresponded with a deep, sharp weld undercut on the outer surface of the tank. Figure 2.8 is a cross section through the weld showing the .0055" deep undercut with a root radius of .012". This undercut was evident on both sides of the weld and varied in depth from .005" to .006".

In conclusion it can be stated that the notch effects at the weld undercut and the underbead drop-through acted as stress risers and caused failure in that zone.

Production tanks will not have "as welded" joints in the shells, nor will such obvious stress raiser be tolerated.
