INTERIM RESEARCH REPORT NO. 16A
for
**HIGH-SPEED DATA PROCESSOR
SYSTEM RESEARCH**

Project LIGHTNING

This report covers the period of
August 31, 1962 to November 30, 1962

RADIO CORPORATION OF AMERICA

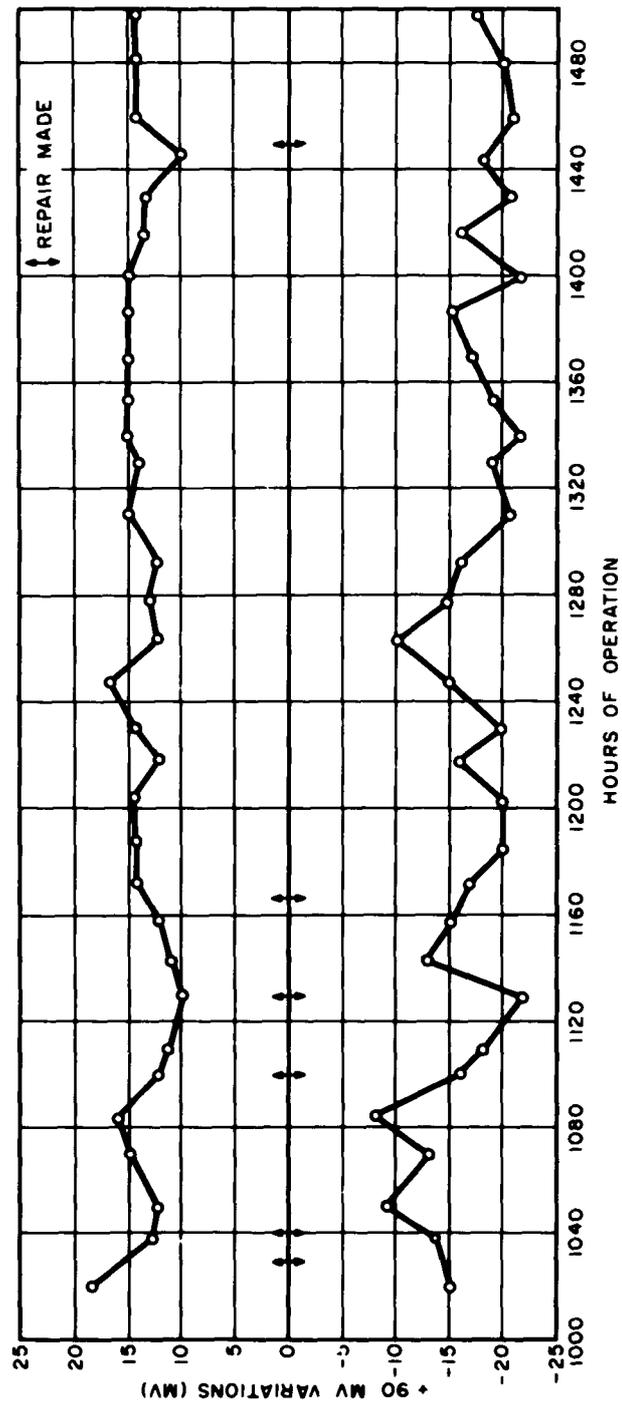
Figure 2-1. +90MV Variation of Logic Subsystem vs. Hours of Operation in its Normal Operating Mode

The graphs of Figures 2-1, 2-2 and 2-3 indicate the variation in the +90 mv, +6.0 v, and -6.0 v power supplies of the Logic Subsystem, up to the point where the system produces a malfunction. These variations were taken while the subsystem was running in its normal mode of operation. (INT, STEP, REP.)

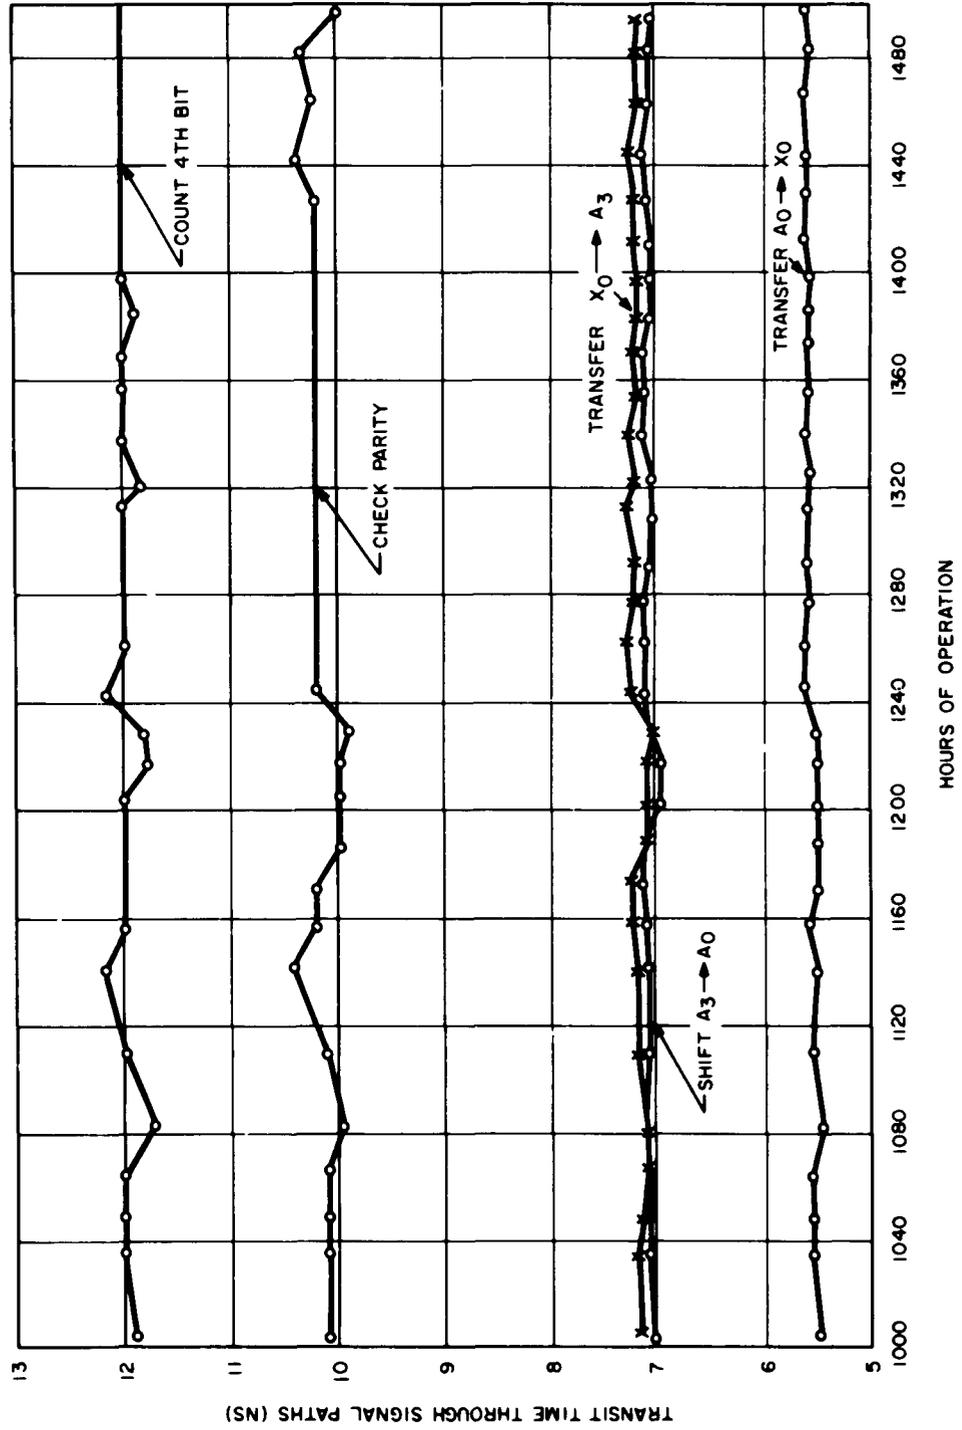
Figure 2-4. Plot of Time to Complete Control Commands vs. Hours of Operation in the Logic Subsystem at Nominal Voltages

Figure 2-4 shows the time it takes to complete commands from the control logic vs. hours of operation. There is no indication of any change in these times. The variations are due to measurement discrepancies. These curves are typical of other measurements made; for instance, the period of the control program vs. hours of operation; and the transit time through a typical signal path vs. hours of operation, which also show no distinct changes.

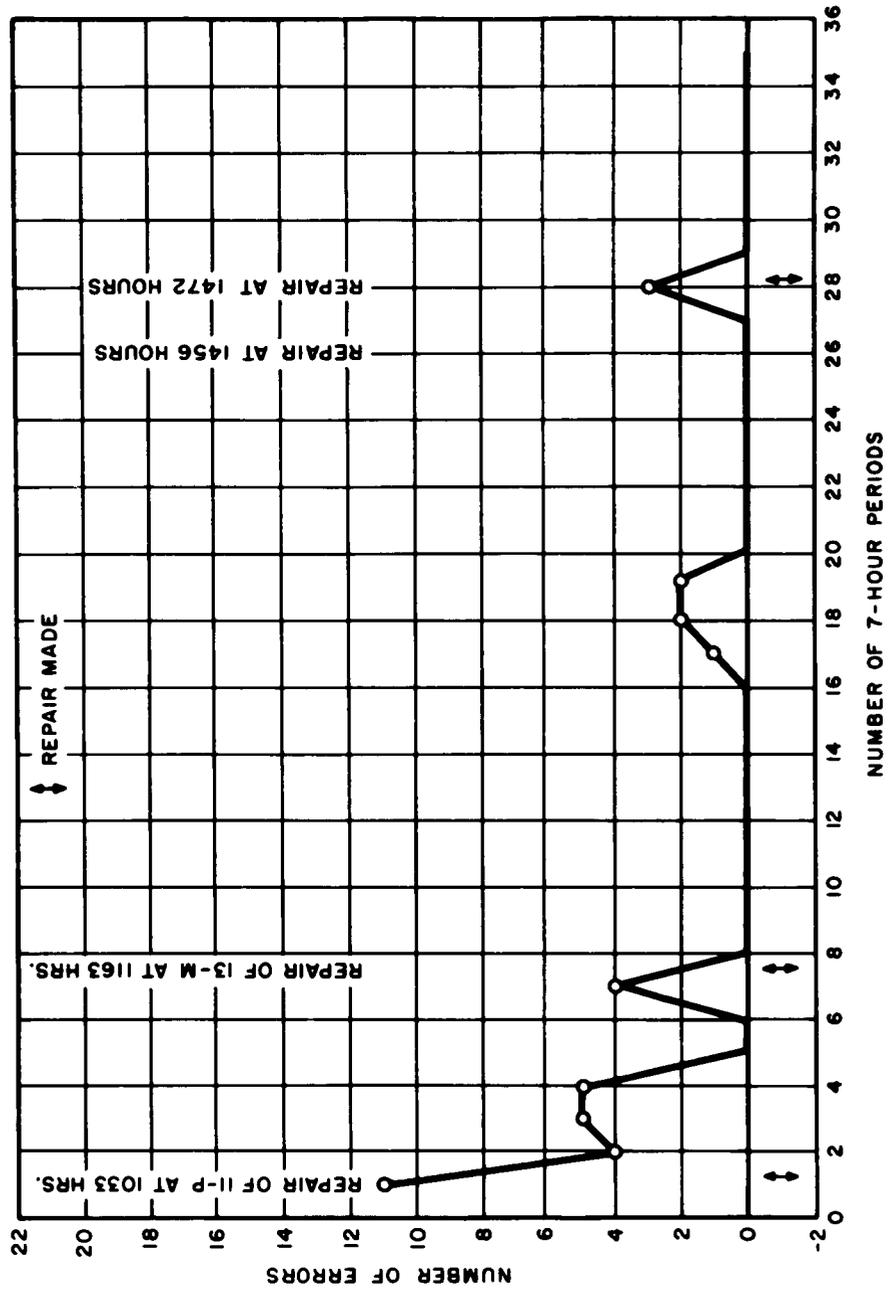
Figure 2-5. Number of Errors vs. Number of 7-Hour Periods of Logic Subsystem Operation

All errors made by the subsystem were recorded during the second half of the 16-hour daily periods. There is no indication of malfunctions due to noise sensitivity. All malfunctions were due to intermittent conditions which eventually resulted in a major repair. Figure 2-5 shows a curve of the number of errors made versus a 7-hour period of observation. The errors were detected individually by removing the PEO in the Logic Subsystem, thereby stopping the system for each malfunction.
