**AN ACCIDENTAL EXPLOSION
INVOLVING THE USE OF OXYGEN
DIFLUORIDE**

Contract AF33(657)-9162
Project No. 62-2899-7381, Task No. 783103
November 1963

ASTROPOWER, INC.

Prepared By
Dr. N. A. Tiner
Dr. W. D. English
Mr. S. W. Pohl

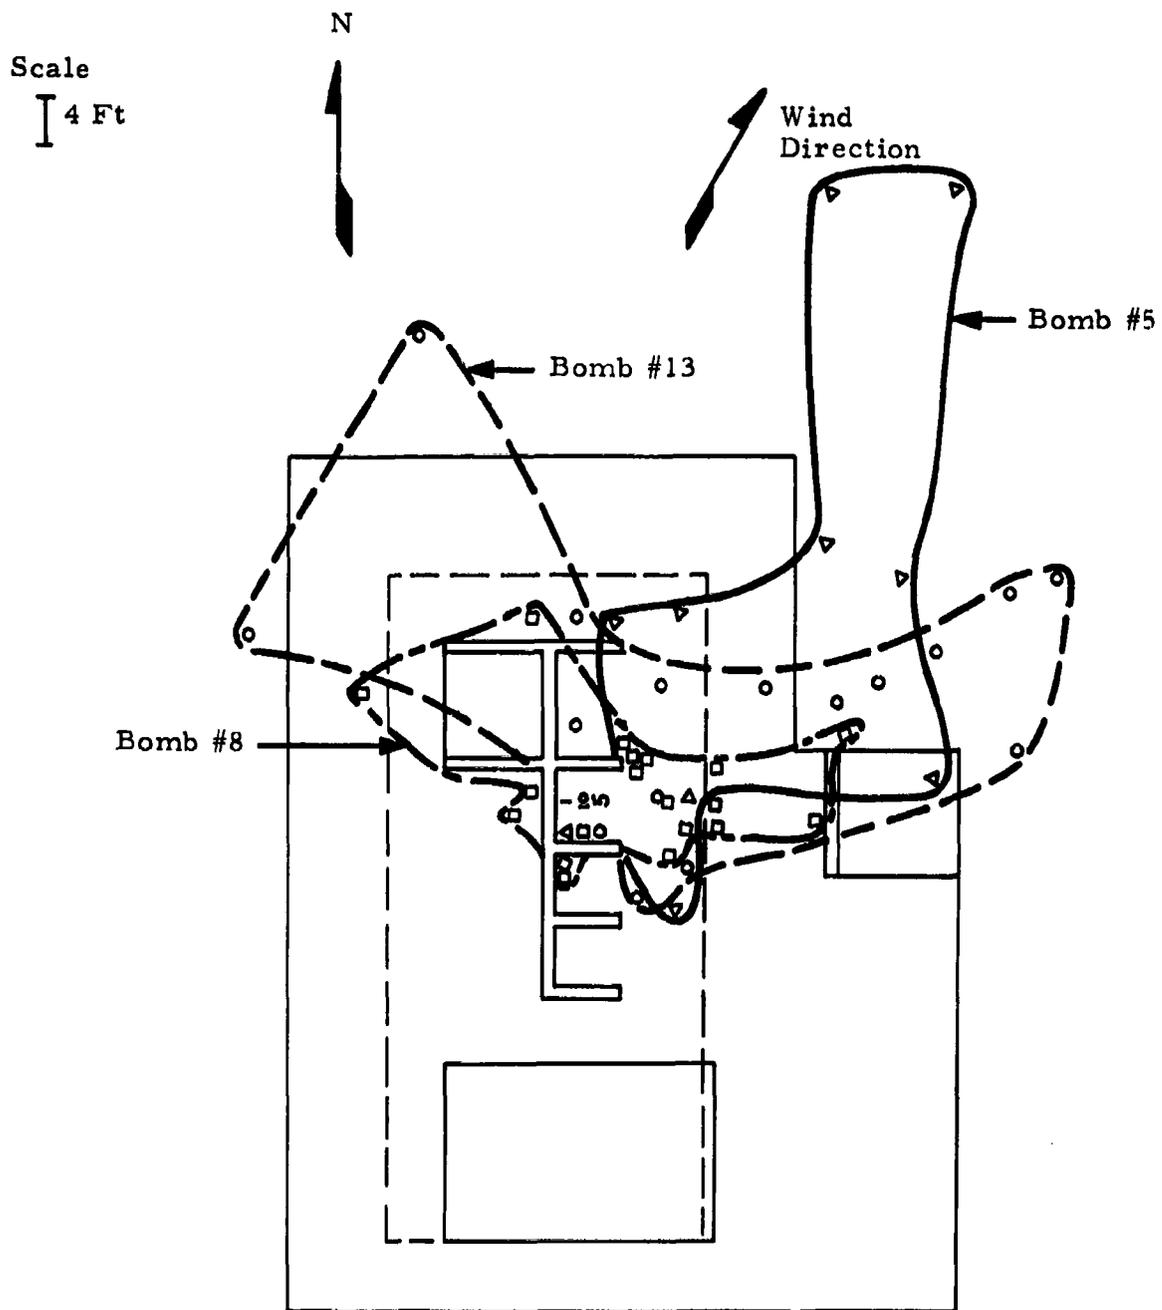
The test specimens from bomb No. 5 (Test FO-17), which were basically Al alloy and Teflon, were found 10% in the bay and 90% scattered in the wind direction (see Figure 11). The Teflon showed reaction and considerable deterioration. Some Al-5456 and Al-6061 specimens showed considerable distortion of a mechanical nature; other specimens from the same alloys (D, F) were reasonably straight (Figure 13).

Figure 11. Scattering Pattern of Specimens from Test FO-17

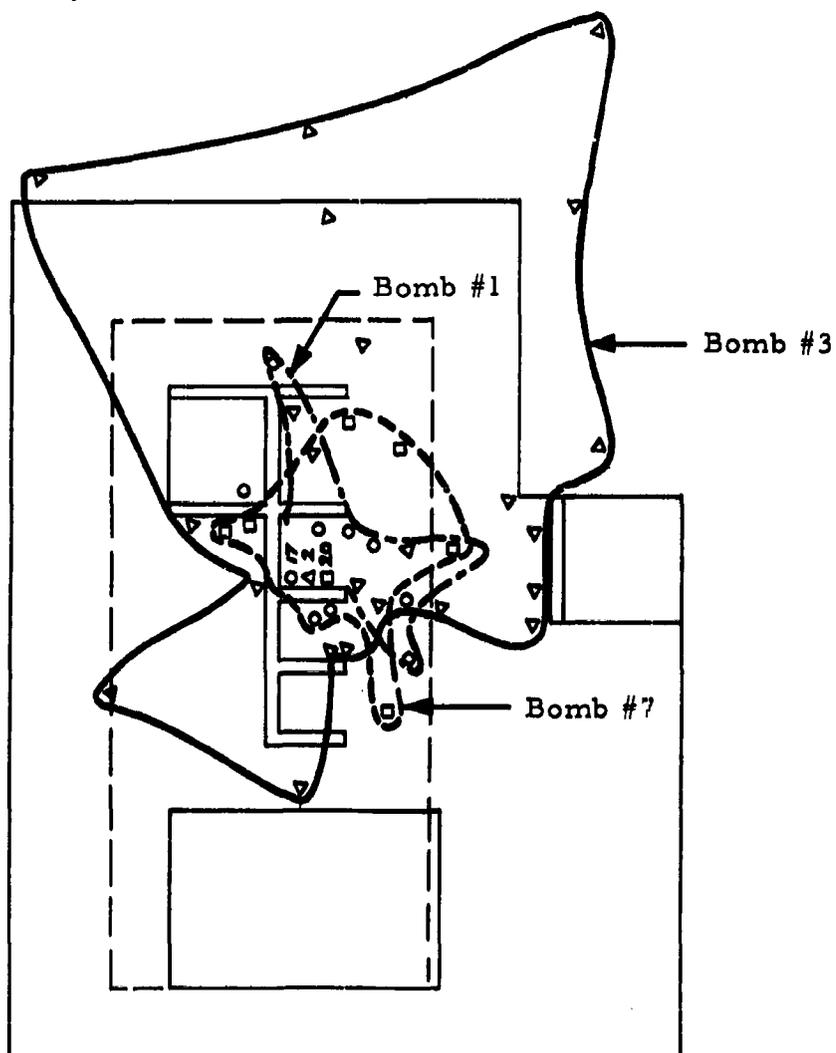
The scattering of specimens from Test FO-10 is shown in Figure 12, and the appearance of test specimens from three bombs in Figures 16 to 18. The scattering of aluminum alloy samples from bomb No. 3 was very extensive. Al-1100 samples showed excessive mechanical damage, particularly in the gas phase. This bomb also contained columbium samples (Y) which exhibited severe distortion and heating on the edges.

Figure 12. Scattering Pattern of Specimens from Test FO-10

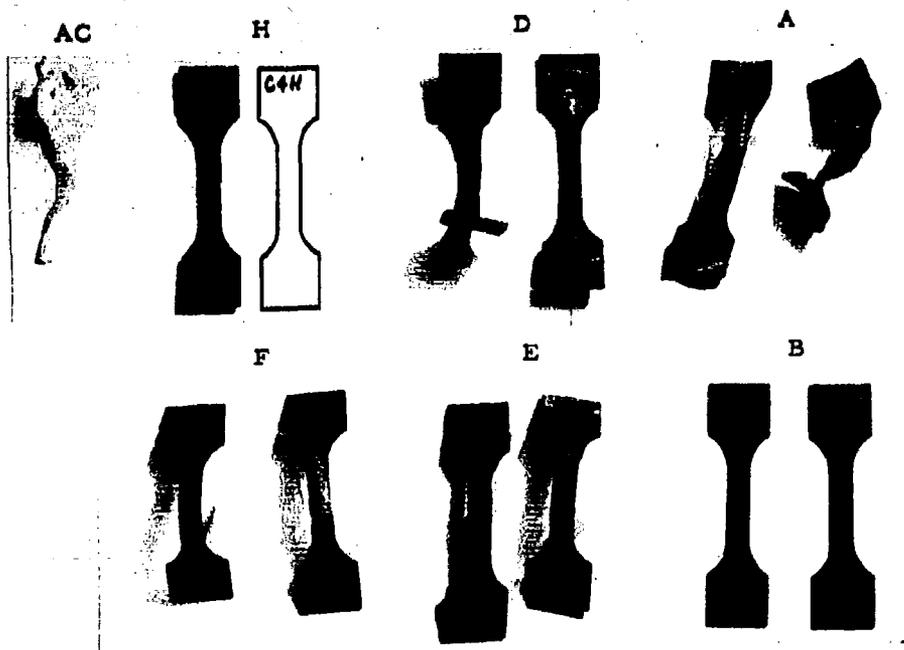
FO-17 BOMB 5

Figure 13. Appearance of Specimens from Bomb No. 5, Test FO-17.
All Specimens immersed in gaseous phase.

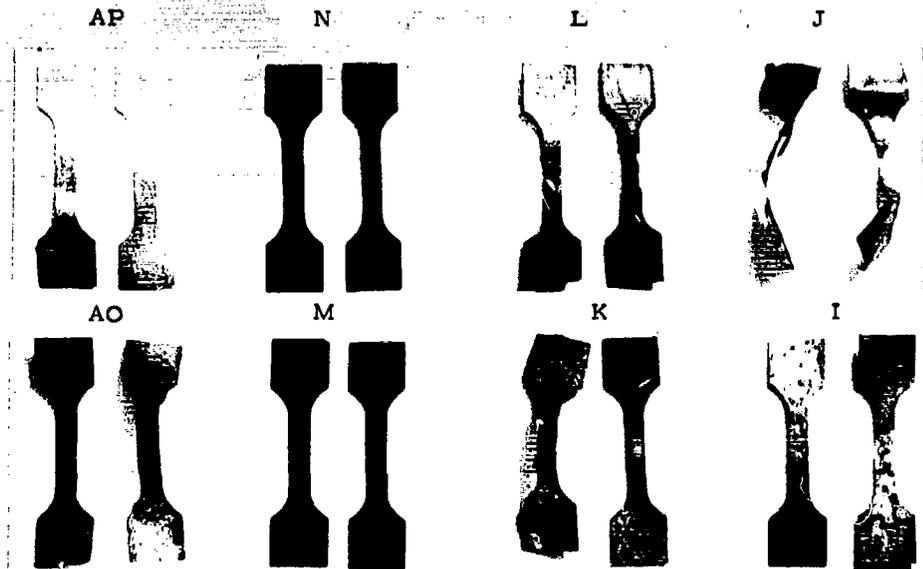
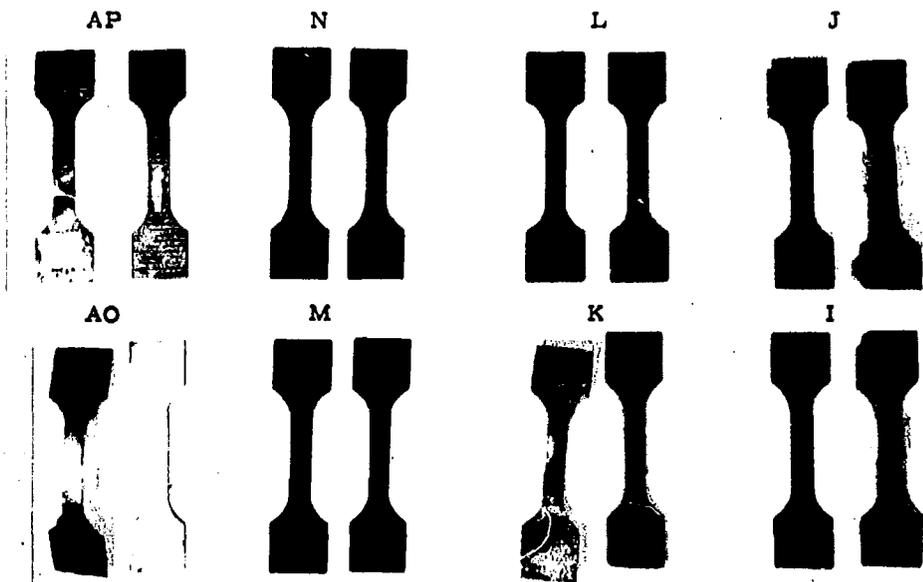
FO-17 BOMB 8

The test specimens from bomb No. 8 (Test FO-17), which were basically stainless steel, were recovered 31% in the bay and 69% at nearby locations. The specimens were reasonably unaffected, except those of stainless steel Type 316 (J), which showed mechanical distortion. The test specimens from bomb No. 13 (Test FO-17) were recovered 17% in the bay and 83% at considerable distances, the majority being found on the roof. The nickel-base alloy specimens did not show any damage. Titanium alloy Al10AT (T) exhibited self-sustained burning on the edges. Columbium and tantalum were badly distorted and exhibited excessive heating on the edge surfaces (Y, AA). Of the four specimens of graphite A, G, K, S, P, only three small pieces were recovered in the bay. They crumbled easily under pressure, as compared to the "as-received" specimens. X-ray diffraction analysis of the basal (0002) planes of "as-received" material had a 2θ angle of 26.30 radians (3.386 Å), and immersion test material had a 2θ angle of 26.40-26.42 radians (3.371-3.369 Å). The slight contraction of the d-spacings noted might be attributed to the formation of fluoride bonds in the basal planes.

Figure 14. Appearance of Specimens from Bomb No. 8, Test FO-17

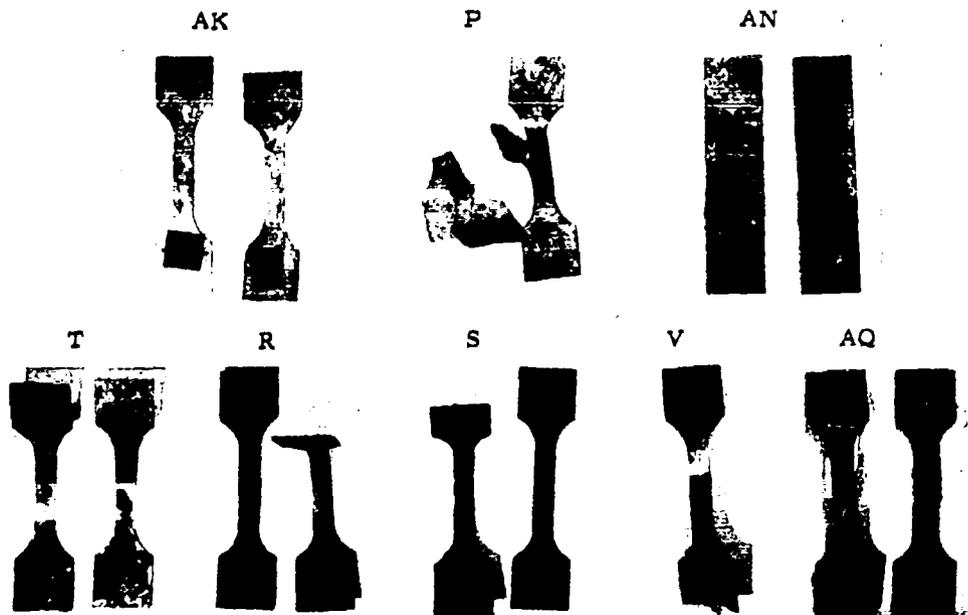
FO-10 BOMB 7

distortion and edge burning, but those in the liquid phase were not severely distorted. Titanium All0AT specimens exhibited sustained burning, particularly in the gas phase (T, Figure 18).

Figure 18. Appearance of Specimens from Bomb No. 7, Test FO-10
