Technical Note N-622

TSUNAMI DAMAGE AT KODIAK, ALASKA, AND CRESCENT CITY,  
CALIFORNIA, FROM ALASKAN EARTHQUAKE OF 27 MARCH 1964

W. J. Tudor

November 1964

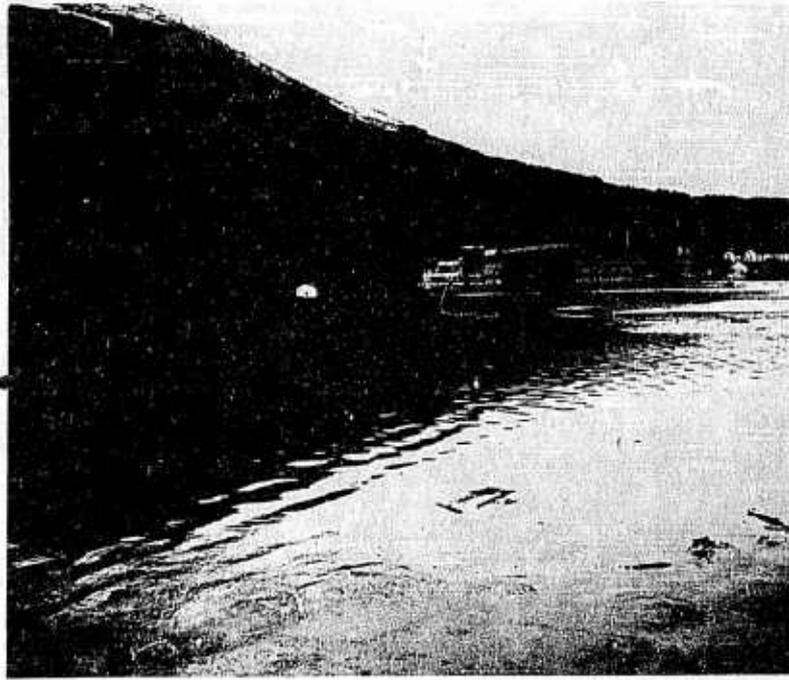
**Fig. 4** View of first tsunami wave which crested at 16 ft above the old MLLW deluged the seaplane ramp leading from Old Woman's Bay. The two PV2 aircraft in front of Hanger #3 were saved by moving them to higher ground. (Photo by PIO, Kodiak NAVSTA)

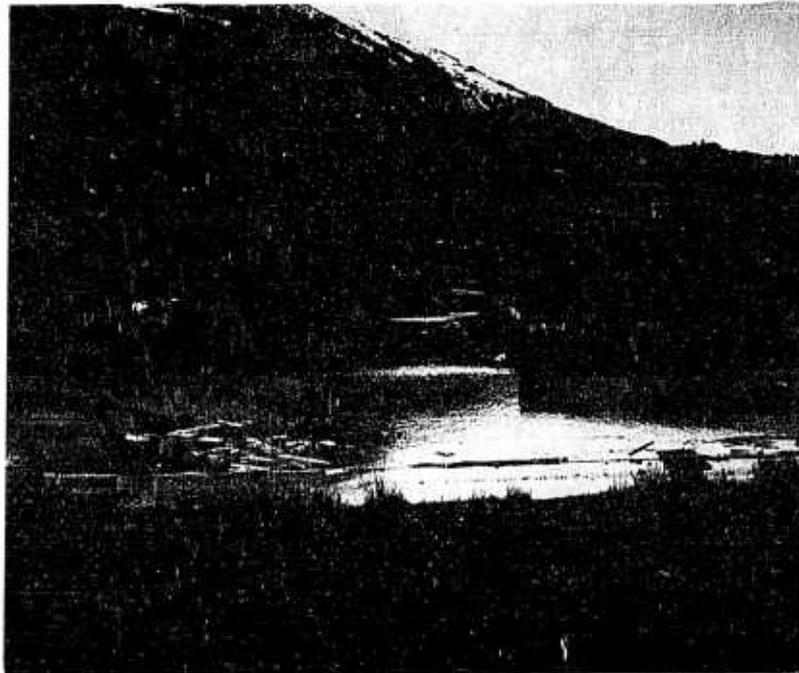
**Fig. 5** Debris and ice cakes are deposited on the seaplane taxiways after recession of first crest. Damage to the Stations three hangers is placed at more than \$1 million dollars. (Photo by PIO, Kodiak NAVSTA)

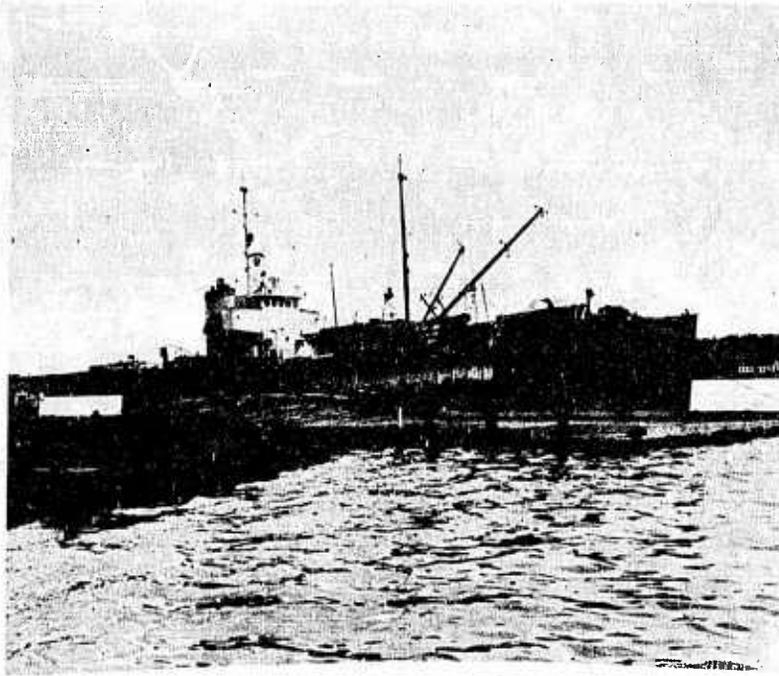
The Cargo Dock, Structure No. 454, which was in a deteriorated condition, was completely damaged by the tsunami. Prior to the earthquake all ship and cargo supplies were loaded and unloaded at this dock. The tsunami-induced motion of moored ships raised the bollards and damaged some fendering (Figure 6). A more extensive analysis of failure to fenders by moored ships is reported by O'Brien (1963) in an analysis of damage to Apra Harbor, Guam, during Typhoon Karen. There it was found that the fender damage was due to thrashing by vessels moored alongside. All occupied fenders there suffered damage. The 5-1/2-foot tectonic settlements of NAVSTA enables the high tides to nearly inundate the Cargo Dock.

Figure 6. Cargo Pier deck nearly inundated by high tide after tectonic settlement of NAVSTA. Tsunami-induced motion of moored ships raised bollards.

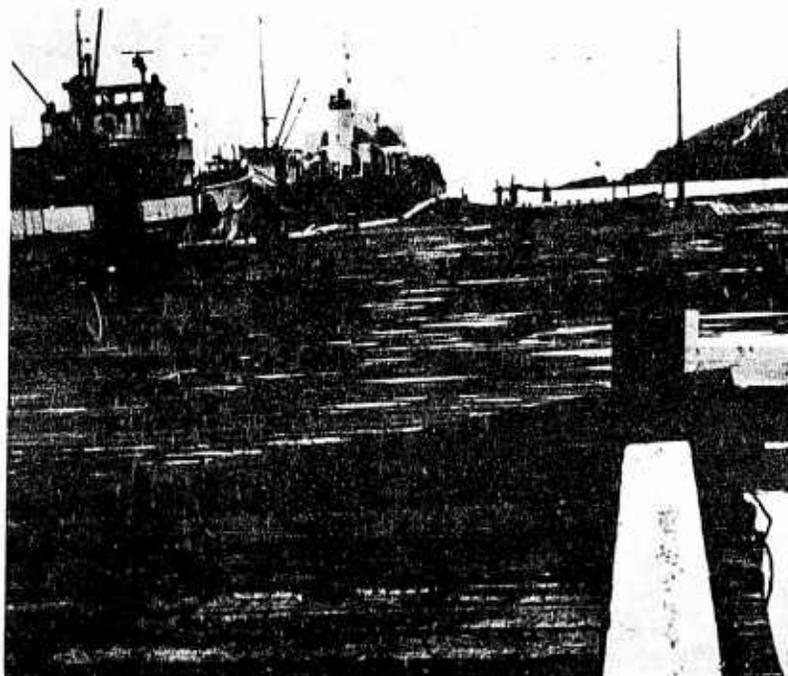
The elevated waters lifted (buoyed) sections of the pier decking off the piling and moved it laterally. This shifting caused failure of many framing and bracing members. Several piles were pulled from their pile-holes along with the elevated decking. The reason is that great difficulty is experienced upon driving piles in the rocky bottom, and in some instances, the pile-holes have to be augered. When the water receded, the buoyed decking and extracted piles did not return to their original positions (Figures 7 and 8). This resulted in differential elevations of several feet in the decking. The Marginal Pier suffered minor damage such as that on the approach (Figure 9) where a moored barge under tsunami action loosened a bollard and some decking.

Figure 7. Local elevation of Cargo Pier deck caused when tsunami-extracted piles did not return to augered pile holes in rocky bottom.

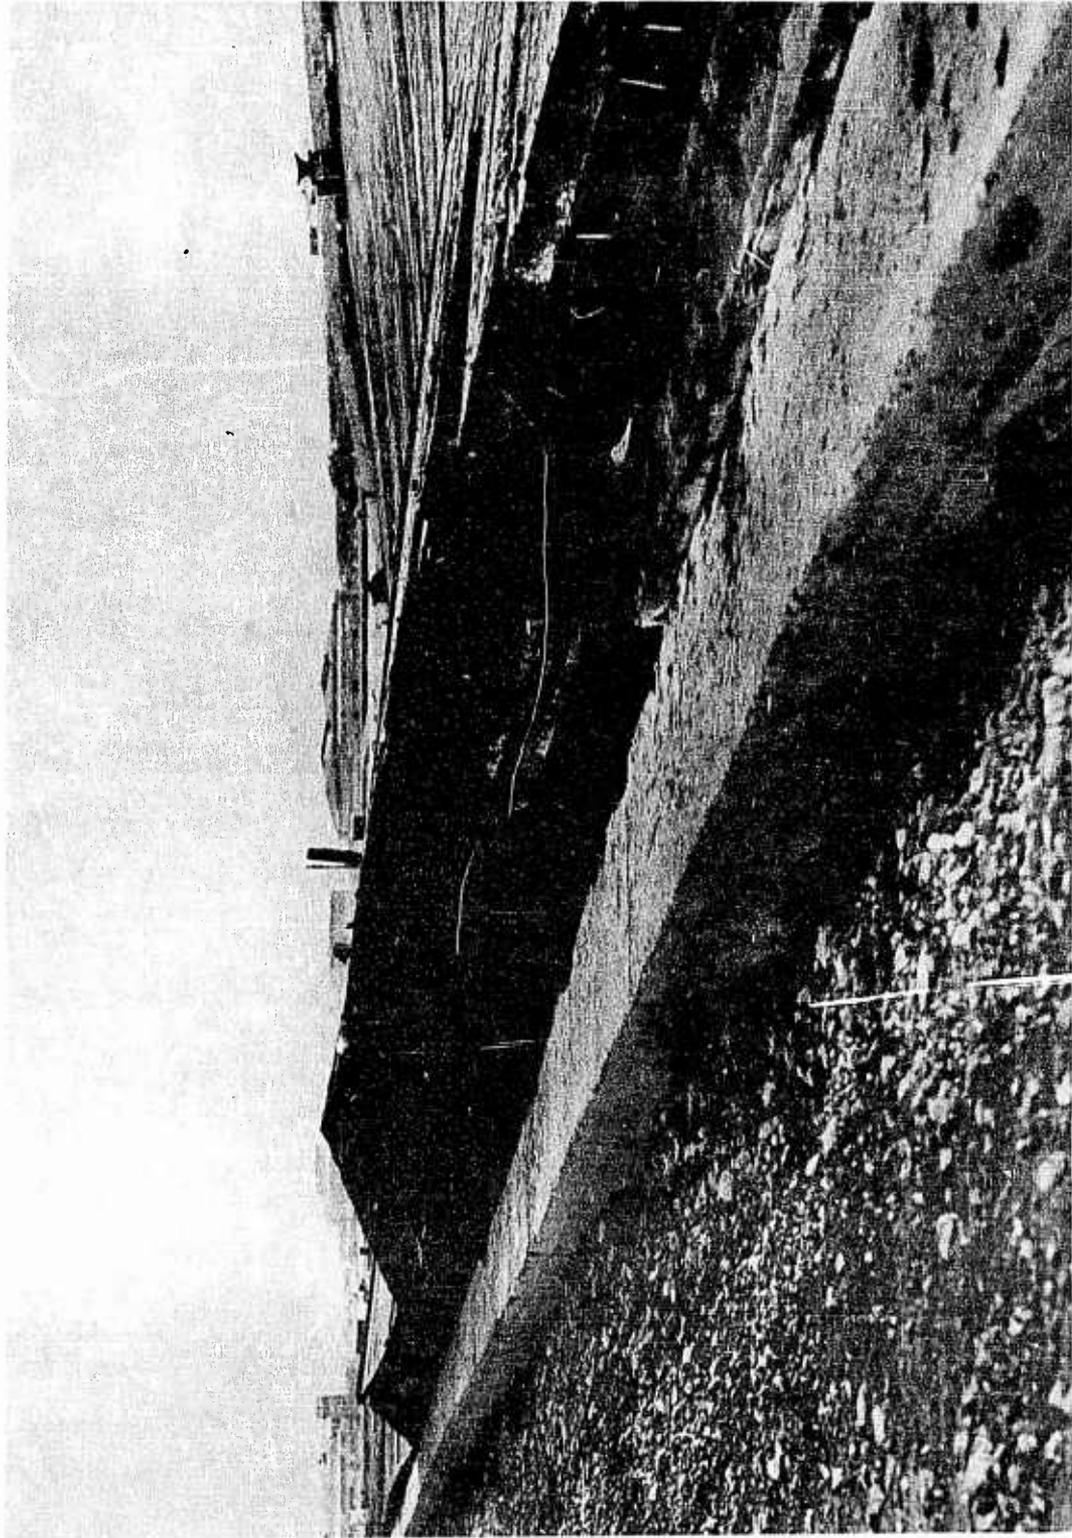
Figure 8. Waviness of Cargo Pier deck resulted when decking buoyed by tsunami failed to return to original location. (Photo by PIO, NAVSTA)

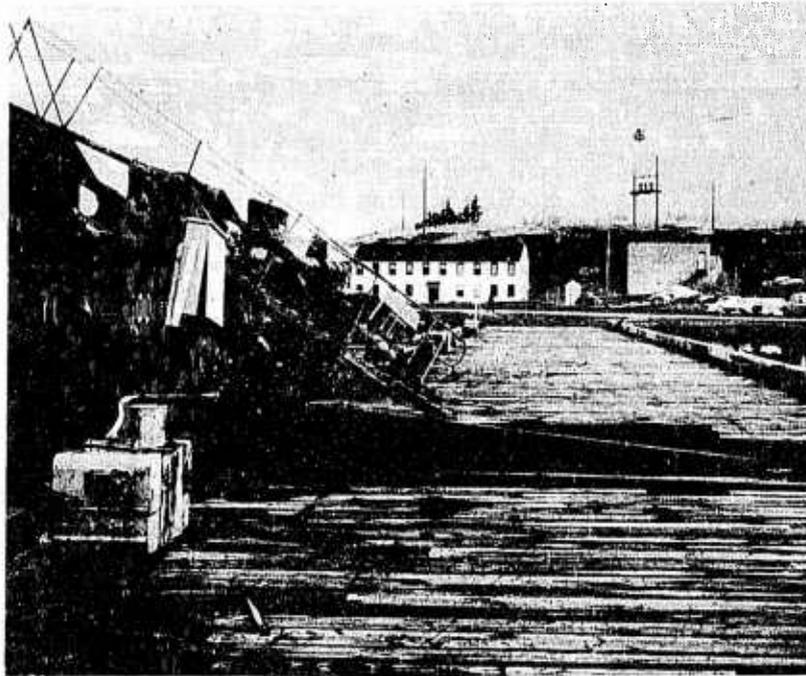
Figure 9. Moored barge under tsunami action pulled decking and bollard loose from marginal pier.

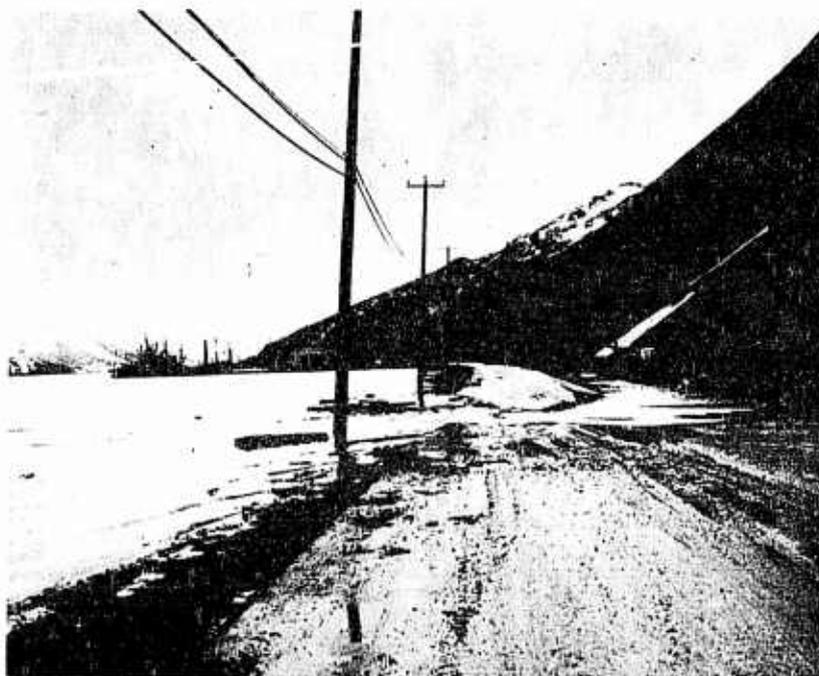
The two bridges and Chiniak Road between the Naval Station and Holiday Beach were washed out causing loss of vehicular contact with the NAVRADSTA (Figure 10). The power line in the swamp flat 4 miles to the south was damaged. NAVRADSTA (T), Buskin Lake, and NAVRADSTA (R), Holiday Beach, stand on high ground and were not damaged. The Holiday Beach barracks cracked open along a line separating the mess hall and the dormitory area.

Figure 10. Kodiak Island subsidence of 5-1/2 feet allows high tide to wash over road to NRS(R) Holiday Beach. Cargo Pier in background.

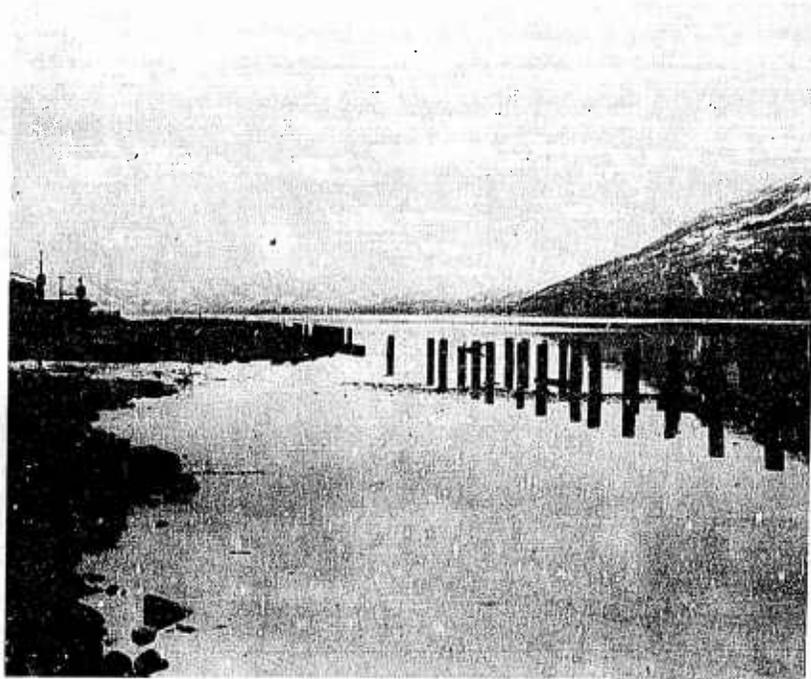
Two small waterfront structures, the Hobby Shop and Engine Generator (TACAN) Building, located on the edge of Old Woman's Bay were completely swept away except for the foundation pilings (Figure 11). Lack of adequate ties between floor beams and piling made the structure vulnerable to water uplift and lateral forces.

Figure 11. Piling is all that remains of the Hobby Shop and Engine Generator (TACAN) Buildings on edge of Old Women's Bay. Fuel Pier in background.

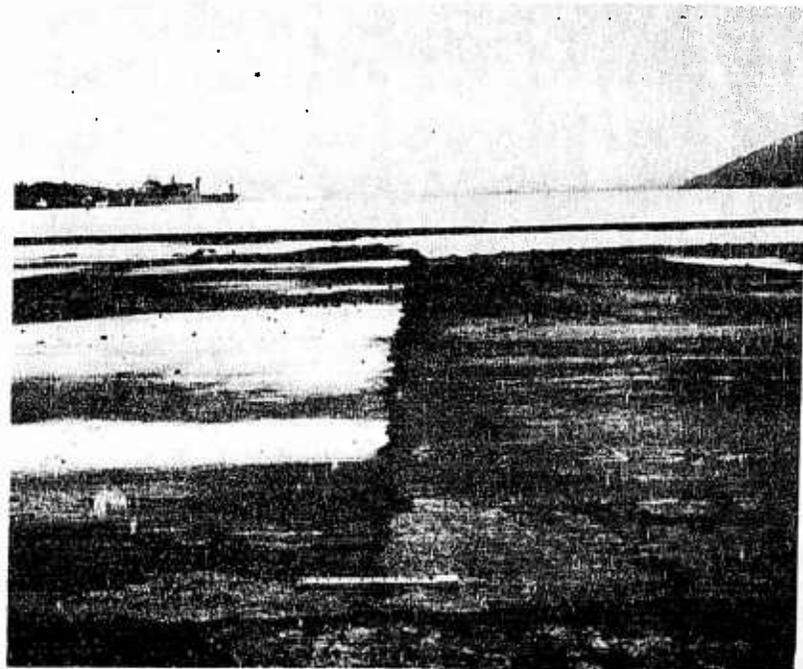
The asphalt pavement covering the taxiways between the hangars and seaplane ramps were cracked under the seismic action (Figure 12). In the hangar there was differential settlement between the pile-supported columns and fill-supported hangar deck (Figure 13) and settlement between the hangar deck and hangar structural footings around the perimeter of the hangar. The hangars were constructed on approximately 15-20 feet of glacial till fill which was consolidated under the tectonic shock and loading action of the subsequent tsunami waves. This subsidence was further accompanied by ripple and surface erosion near the hangars. The differential settlement of several inches between the slabs and hangar door footing produced an obstacle step for aircraft entering and leaving the hangar. Some of the hangars suffered slight bracing deformation and broken glass from subsidence.

Figure 12. Seismic action produced 1" cracks in asphalt pavement of taxiway. Fuel Pier in background.

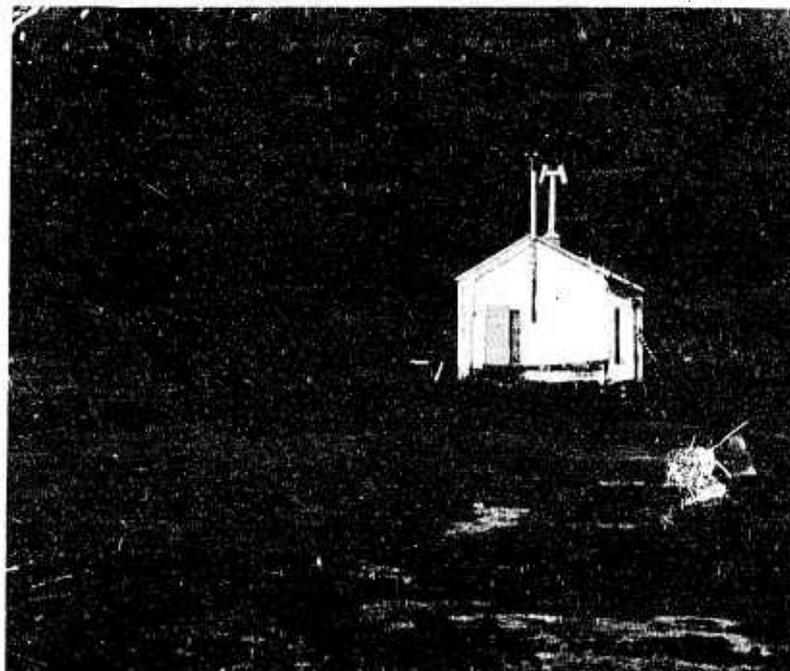
Figure 14. Little white house on end of taxiway was held in place by three hold down cables to roof. Water in foreground left by high tide.

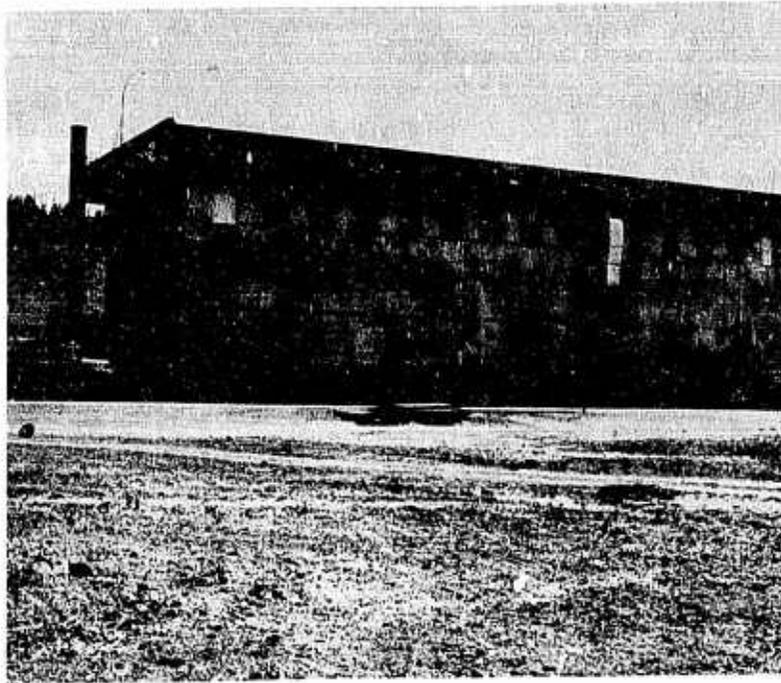
Figure 15. Power plant repeatedly flooded. Note black oil-slick level. Generator flat not flooded. Boilers and auxiliary flats were pumped dry.

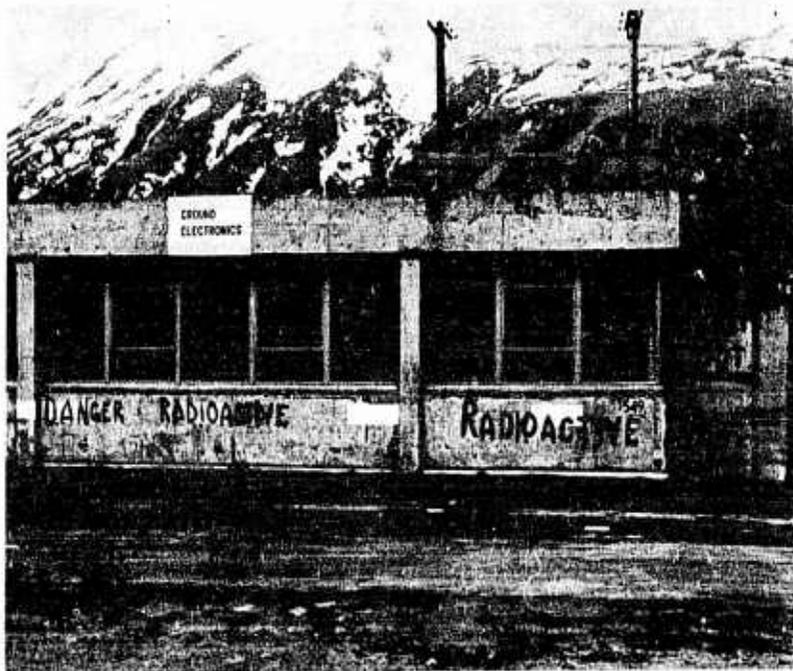
Figure 16. Low-level radioactivity from wave-damaged electronic tubes and radioisotopes in Ground Electronics Building was detected and posted.

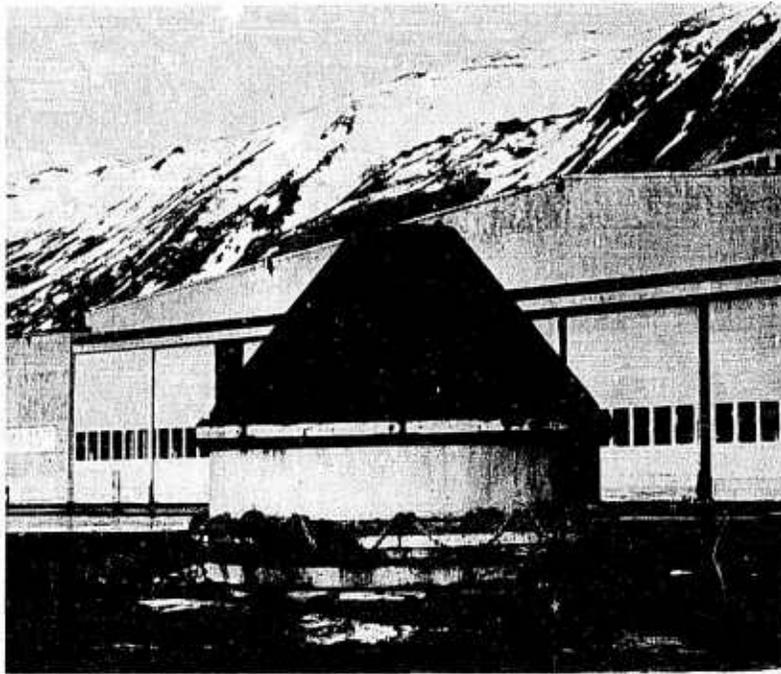
Near the Crash Boat Harbor, sea shells brought in from the harbor by the tsunami were found deposited on land 10 to 15 feet above MLLW. Adjacent to the supply building a 16-foot-diameter mooring buoy (Figure 17A) was washed ashore after being torn from its offshore anchorage. The magnitude of the force on the buoy when submerged is estimated in Figure 17B. This estimate indicates that where the buoy is fully submerged, as it was by the tsunami, the added load is approximately 36 times the load from an assumed mooring chain while neutrally floating. This would seem enough to tear the mooring from its anchorage.

Figure 17A. Mooring buoy weighing over 10 tons now rests on the Station taxiway. Third tsunami wave cresting at 24 ft. above old MLLW drove this buoy inshore.

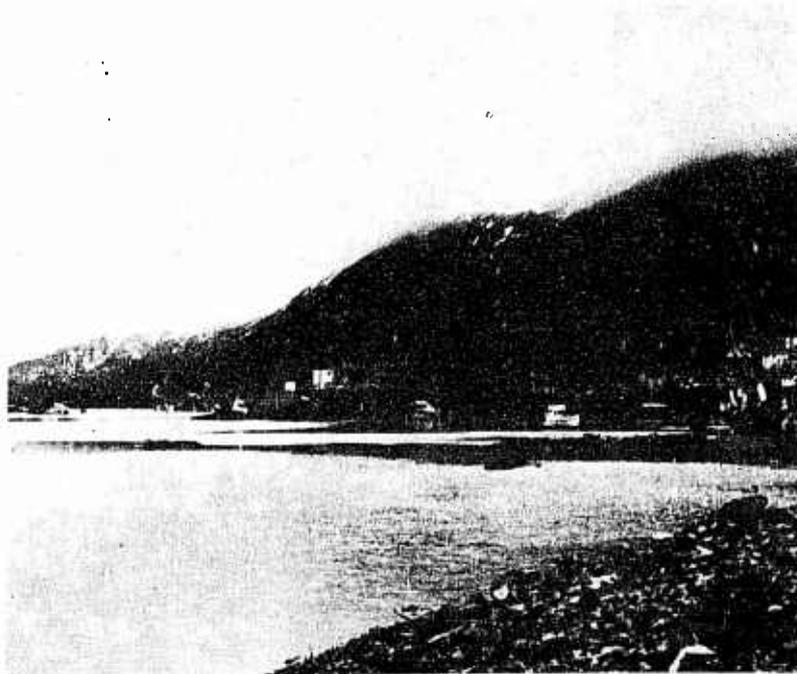
Figure 25. View of harbor after four successive waves filled and emptied the harbor demolishing the piers and sweeping away the fishing boats.

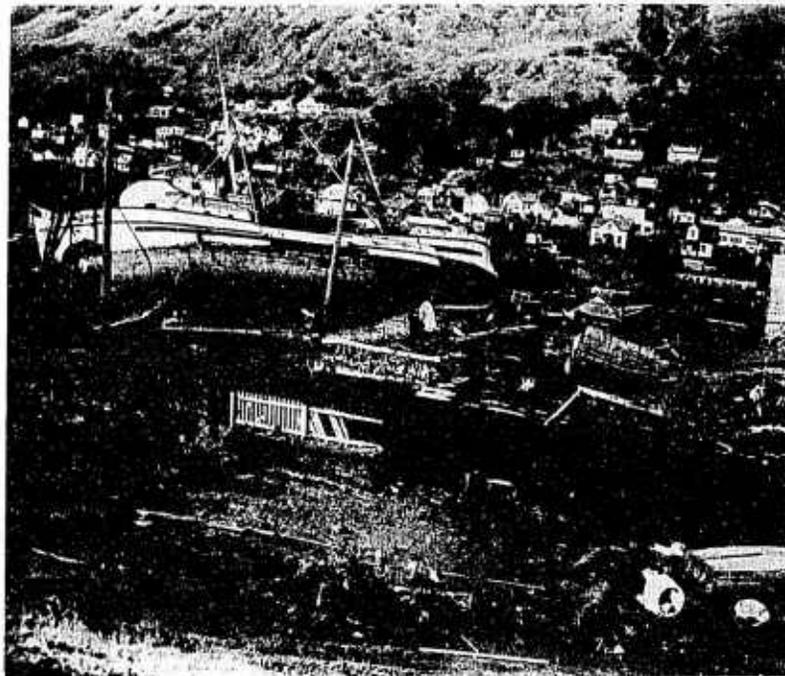
Figure 26. Arrows point to reinforcing rods from foundation of bowling alley at edge of harbor. Buildings were removed by ship impact and buoyancy force

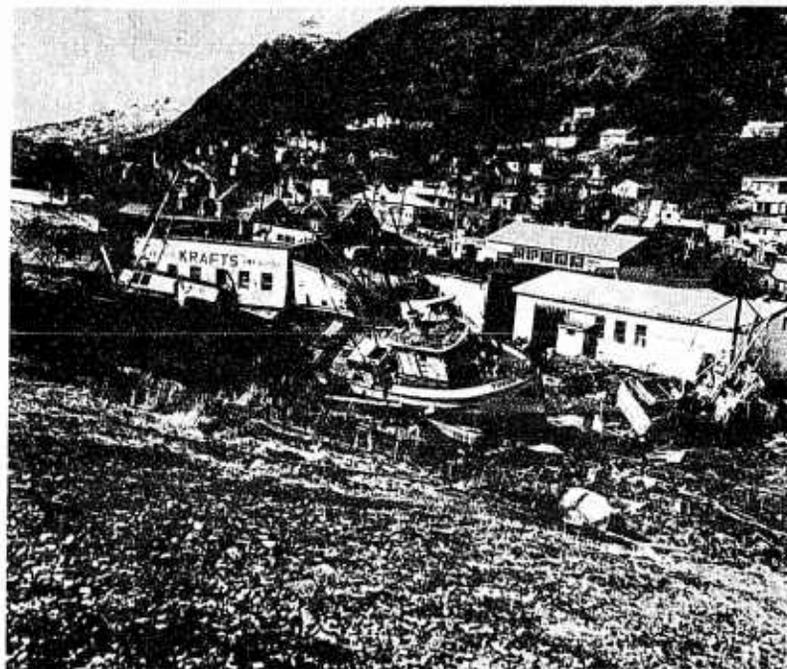
Figure 27. Fishing boats buoyed-in more than one-half mile on tsunami waves are scrambled together with city buildings.

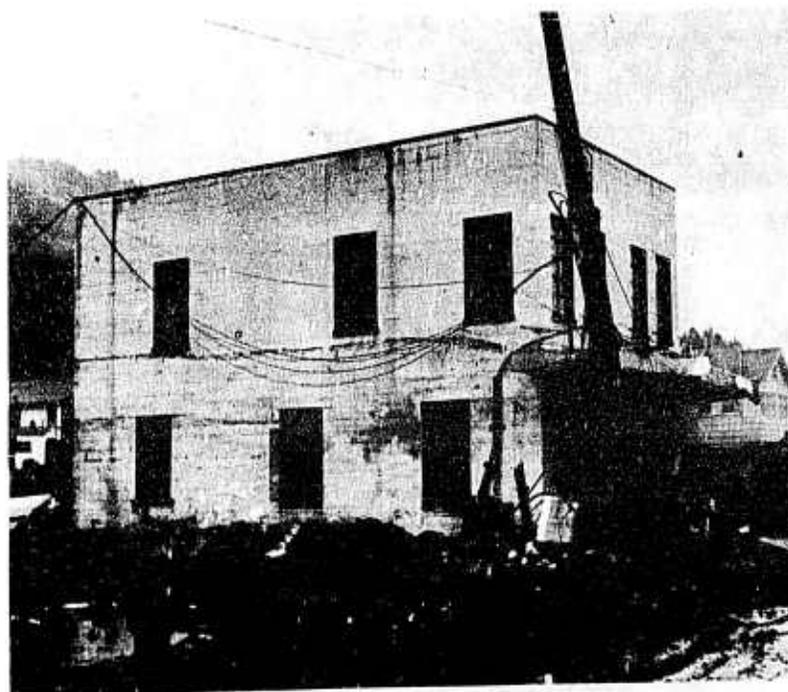
Figure 29. Canopy and utility pole acting as a fender and dolphin helped save concrete block building. Six foot and ten foot high water marks visible.

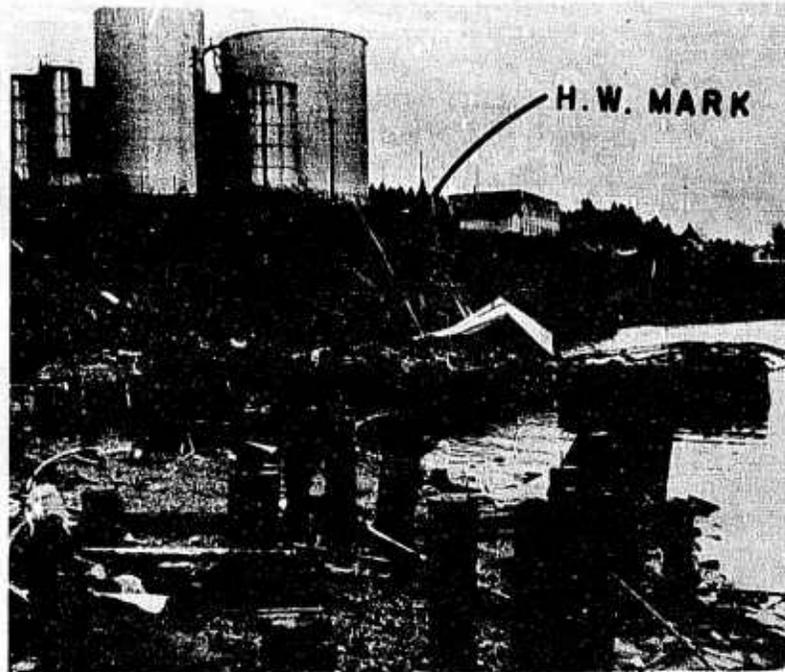
Figure 30. Skeleton-like timber piling marks former site of cannery. Steel drift-pins point direction in which cannery was swept away by second wave.

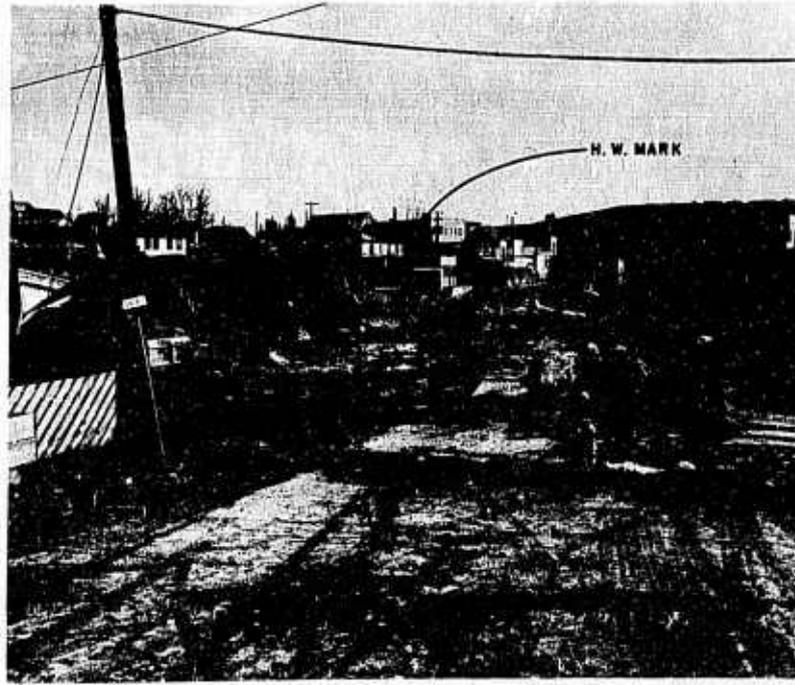
Figure 33. View of the main street shows erosion under roads and sidewalks (middle of photo) caused by tsunami wave inundation. (PIO, Kodiak NAVSTA)

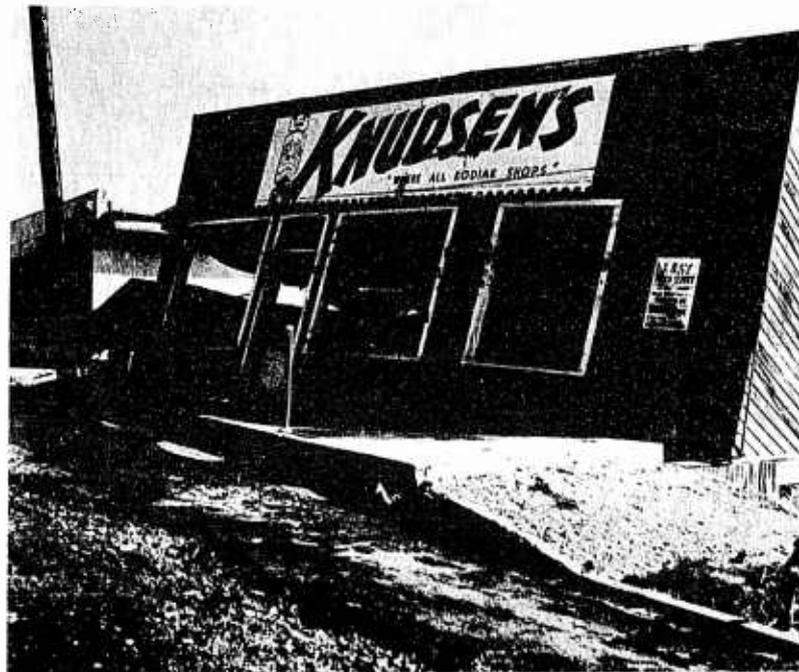
Figure 34. Haberdashery was washed right off its foundation and rested with its rear portion in the harbor.

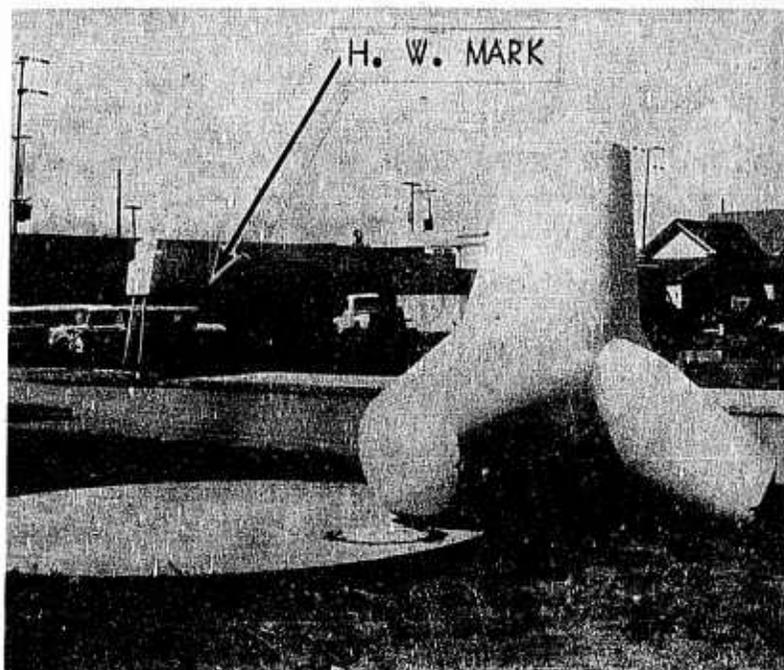
Figure 37A. 25 ton tetrapod monument at Front Street and US 101 was moved from base by water forces and log impact.

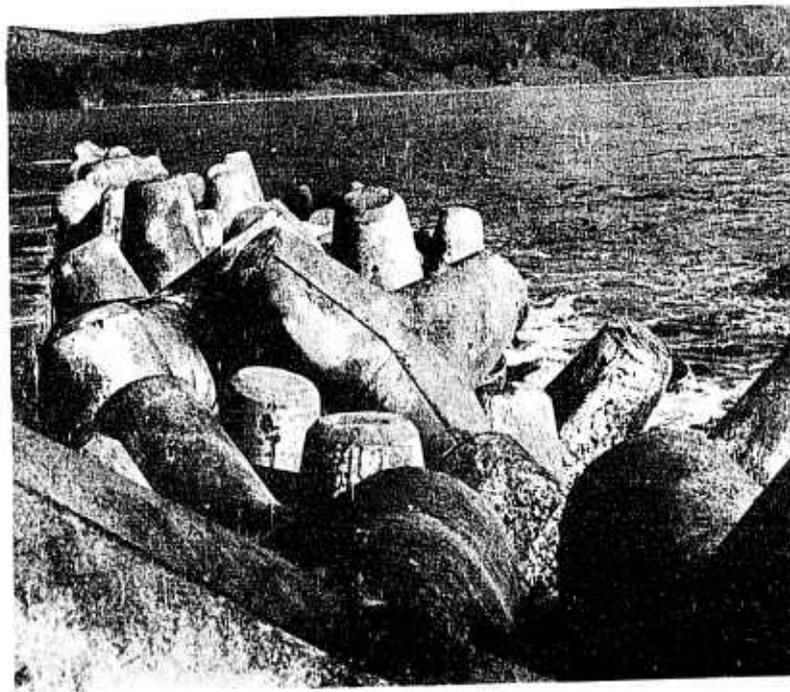
Figure 39. Tetrapods on outer harbor breakwater stayed in place when submerged by the tsunami wave.

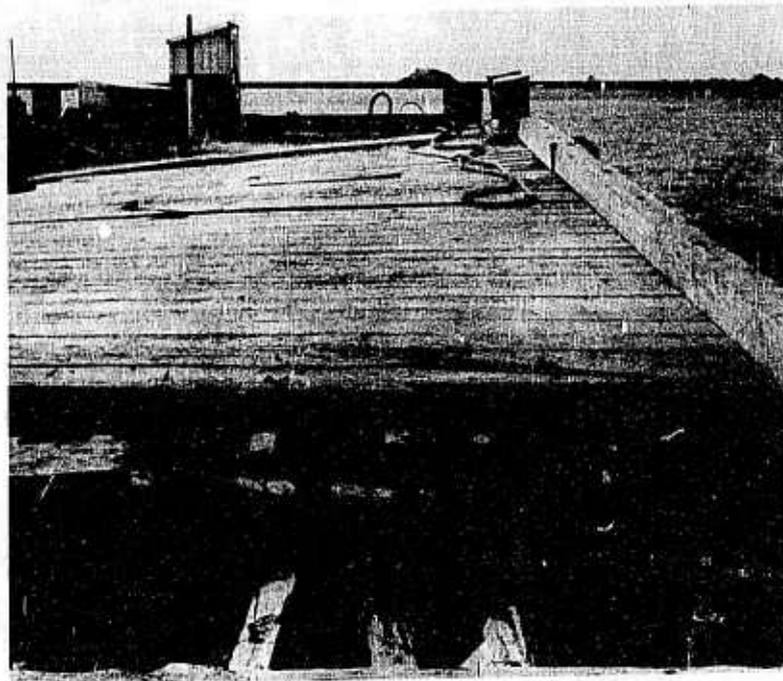
Figure 46. Tide shack on Citizens Dock was fully submerged. Decking is elevated towards one of bollards mooring a lumber barge.

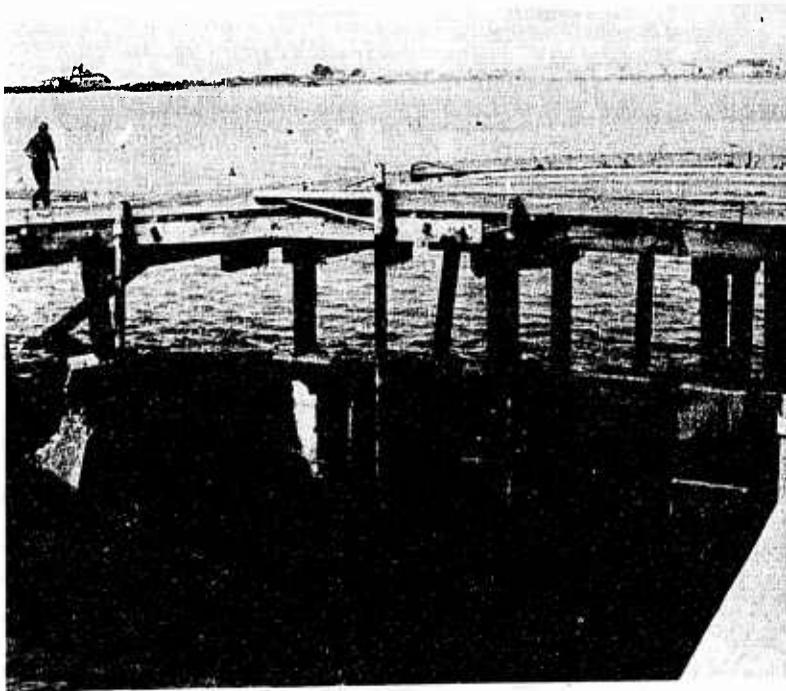
Figure 48. Concrete wave barrier under Citizens Dock approach was broken by log impact and water forces as the harbor filled and emptied. Encased piling was removed with the wall.

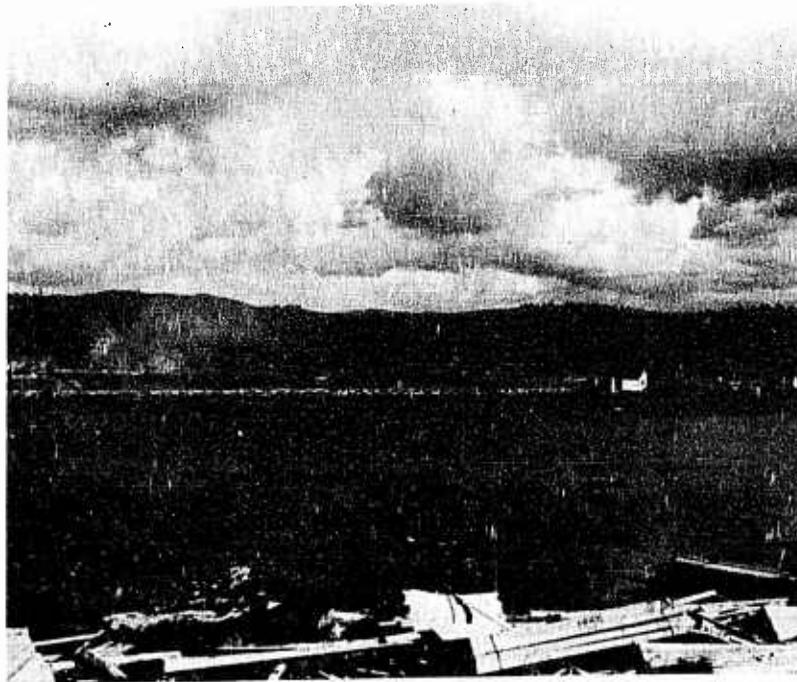
Figure 49. Dutton Dock unharmed when submerged 5 to 6 feet under largest tsunami wave. Lumber debris in foreground is from dock.

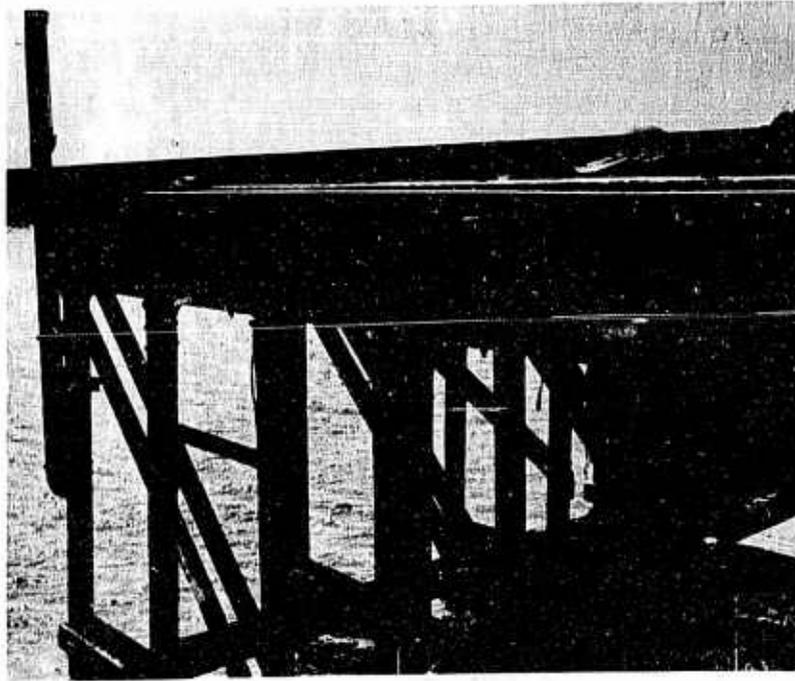
Figure 50. Steel straps, bolted connections, and abundant cross bracing helped Dutton Dock survive virtually without a scratch.

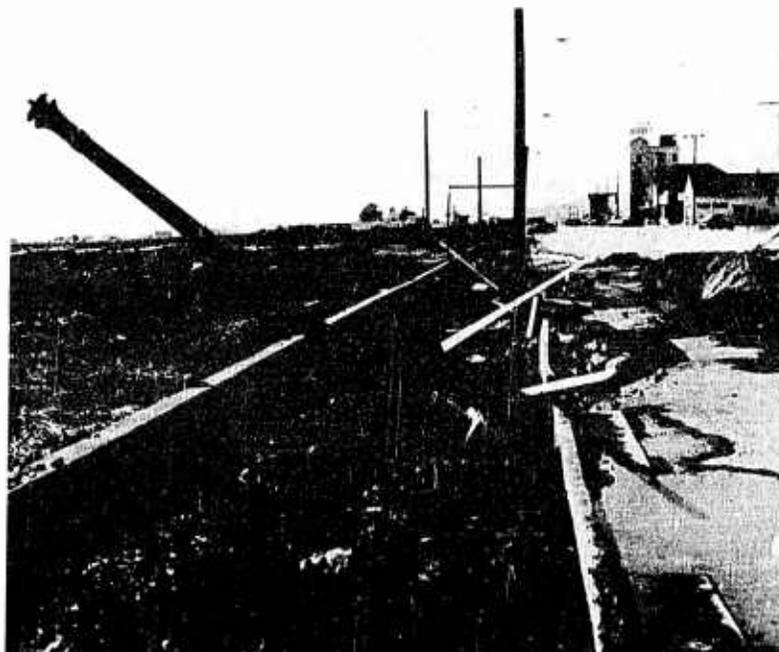
Figure 53. Erosion causes pole tippage, misalignment of curbing, fragmentation of black top road, and exposure of sea wall.

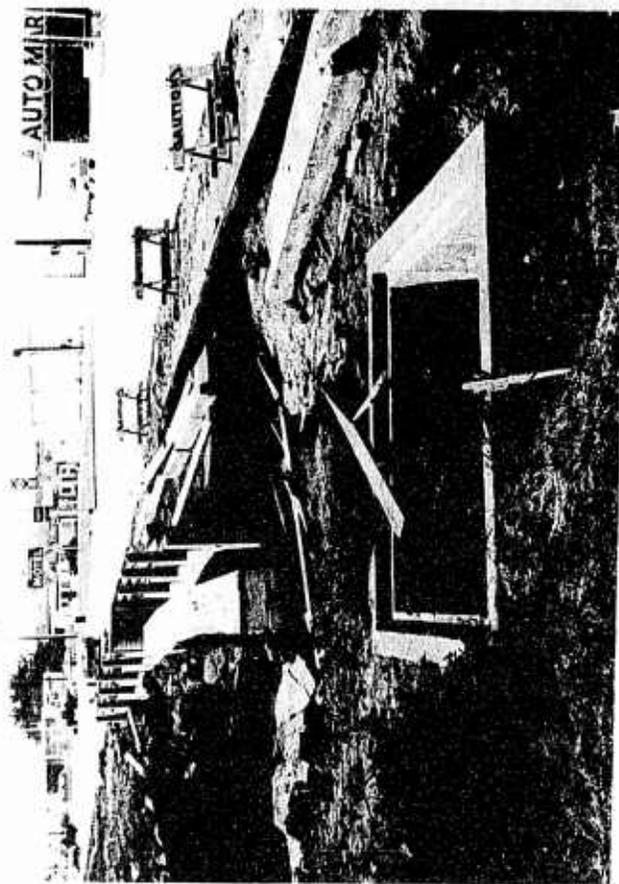
Figure 54. Erosion bares Elk River concrete box culvert and undercuts Highway 101. Steel beam tidal barrier on left normally protects bridge from logs.

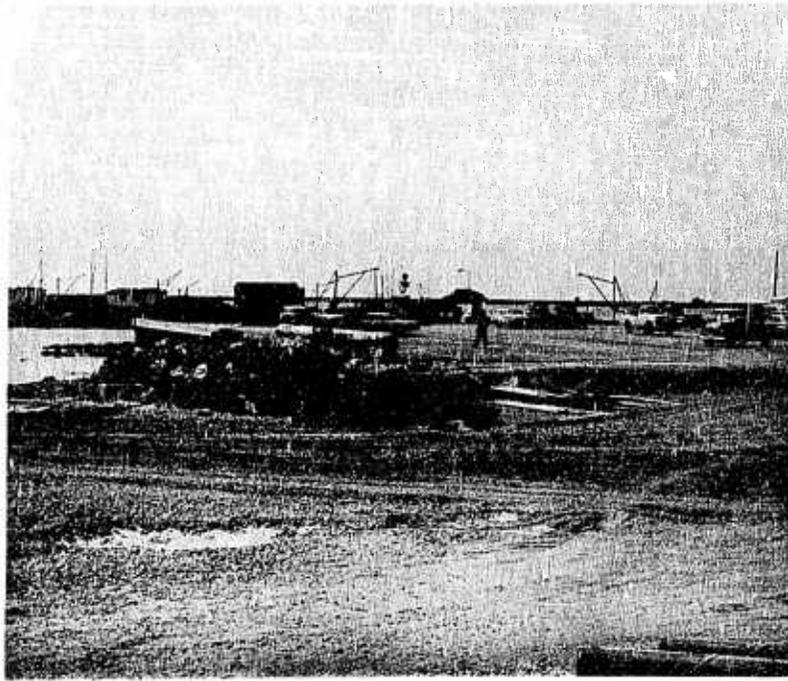
Figure 55 Scour at Citizens Dock Parking Lot

**Problem:** Find intensity of boundary shear pressure,  $\mathcal{T}$ , from recession of tsunami wave at Crescent City Citizens Dock parking lot.

$$\mathcal{T} = 64 \times 12 \times 14.5 / 1.5 \times 5280 = 1.4 \text{ psf}$$

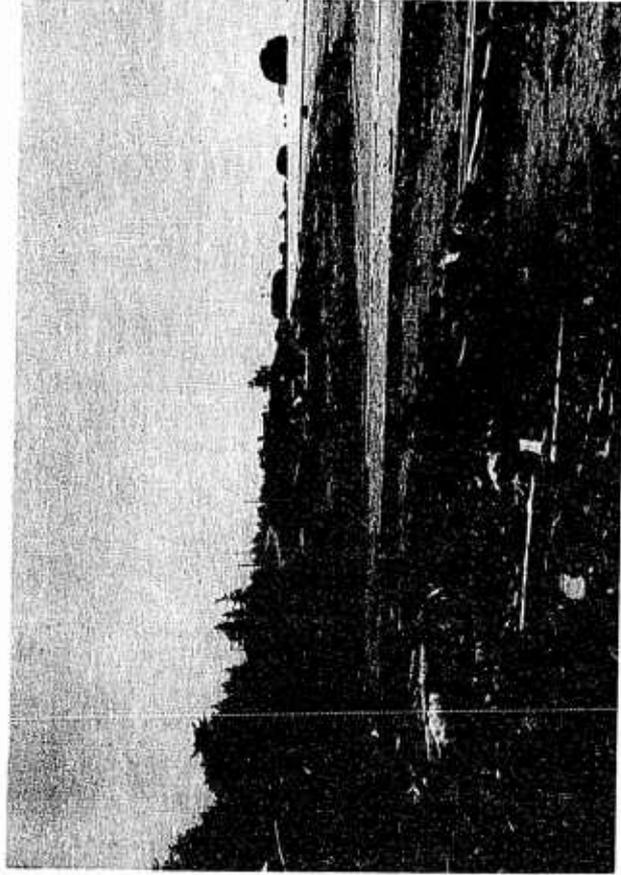
**Figure 56.** Waterfront logs were being driven into walls and glass windows with the force of a battering ram.

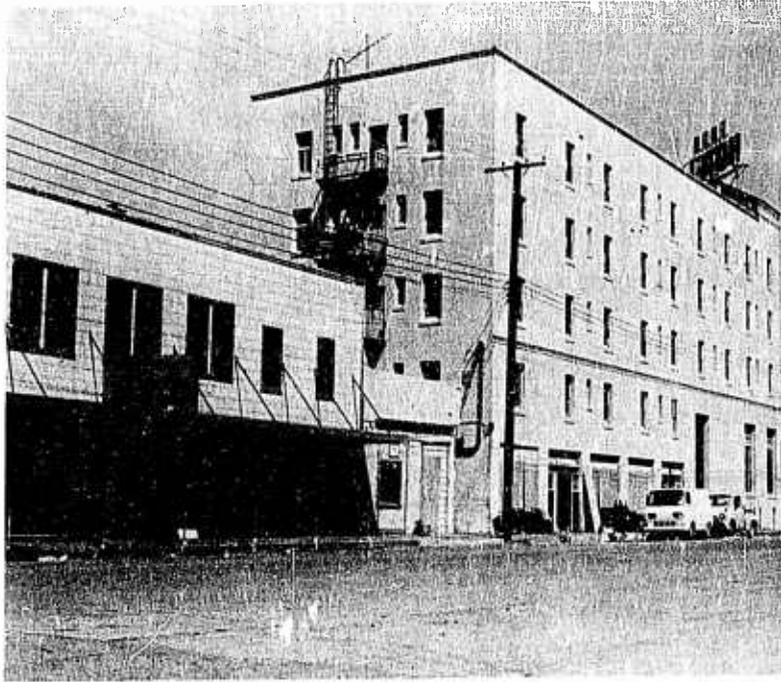
Figure 57. Plywood now boards windows along Front Street broken by floating debris carried on 4- to 6-foot inundation.

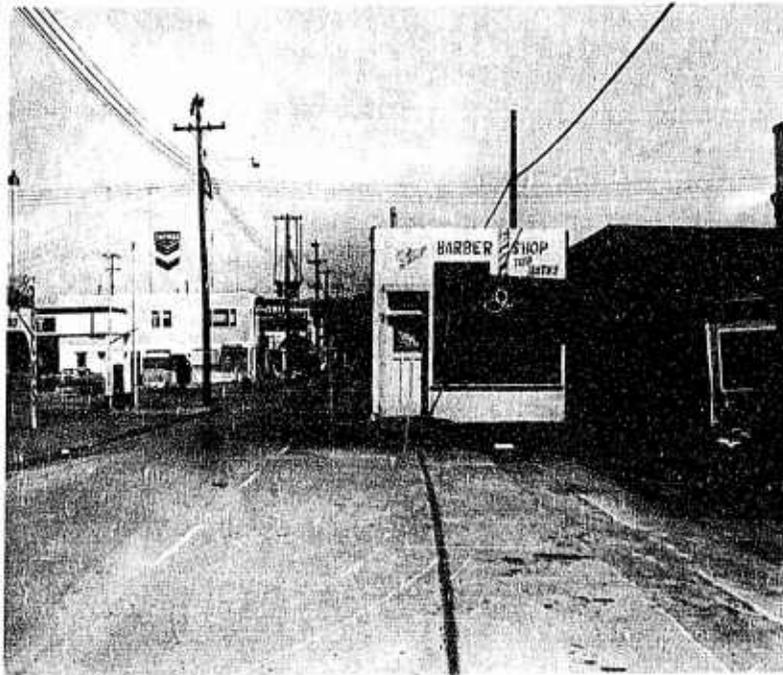
Figure 58. Barber shop was one of many buildings that blocked Second Street by floating across it.

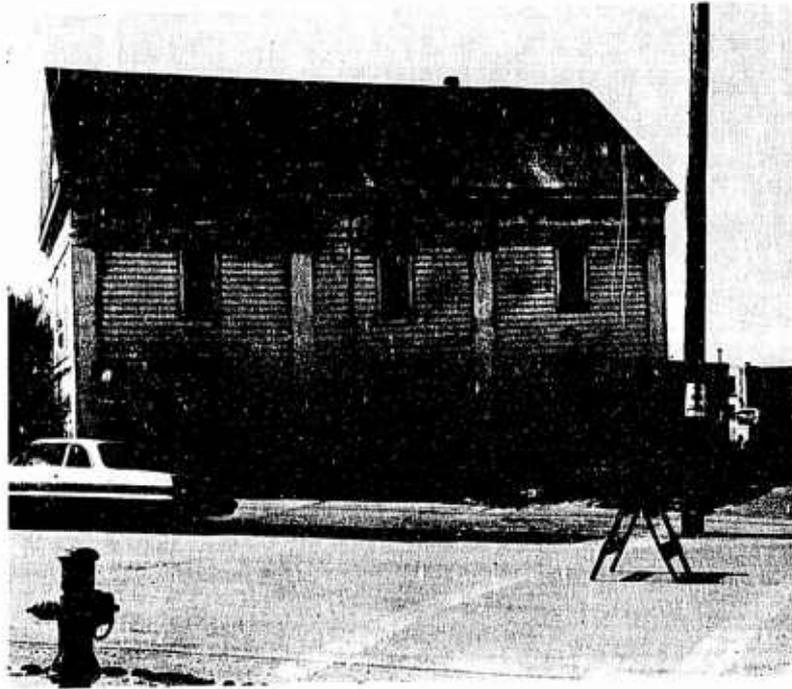
Figure 59. Turbulent waters (5 feet deep) moved two story Odd Fellows Hall 30 feet and rotated it  $45^{\circ}$ .

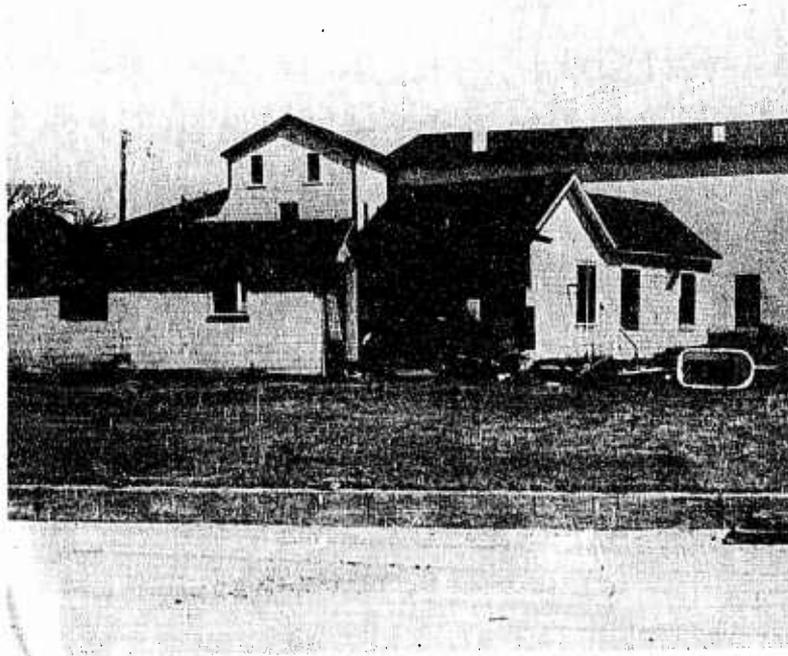
Figure 60. Home on Front Street left its foundation and broke in half. Bathtub still attached to plumbing.

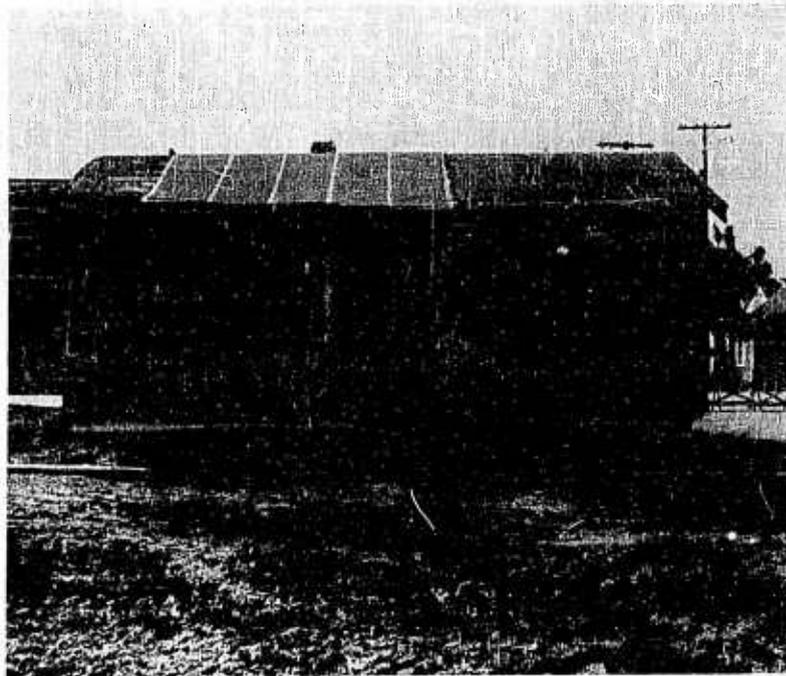
Figure 62. Forces from five feet of flowing water moved housing units up to one block from their foundation.

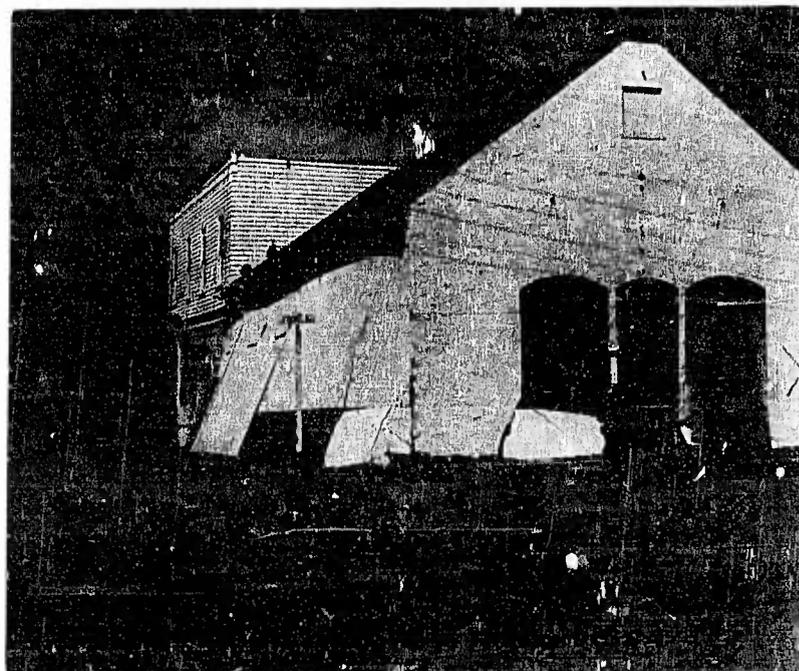
Figure 63. Side wall of Turf Club bulges outward - caused by rapid recession of tsunami waters.
