Technical Note N-622

TSUNAMI DAMAGE AT KODIAK, ALASKA, AND CRESCENT CITY,  
CALIFORNIA, FROM ALASKAN EARTHQUAKE OF 27 MARCH 1964

W. J. Tudor

November 1964

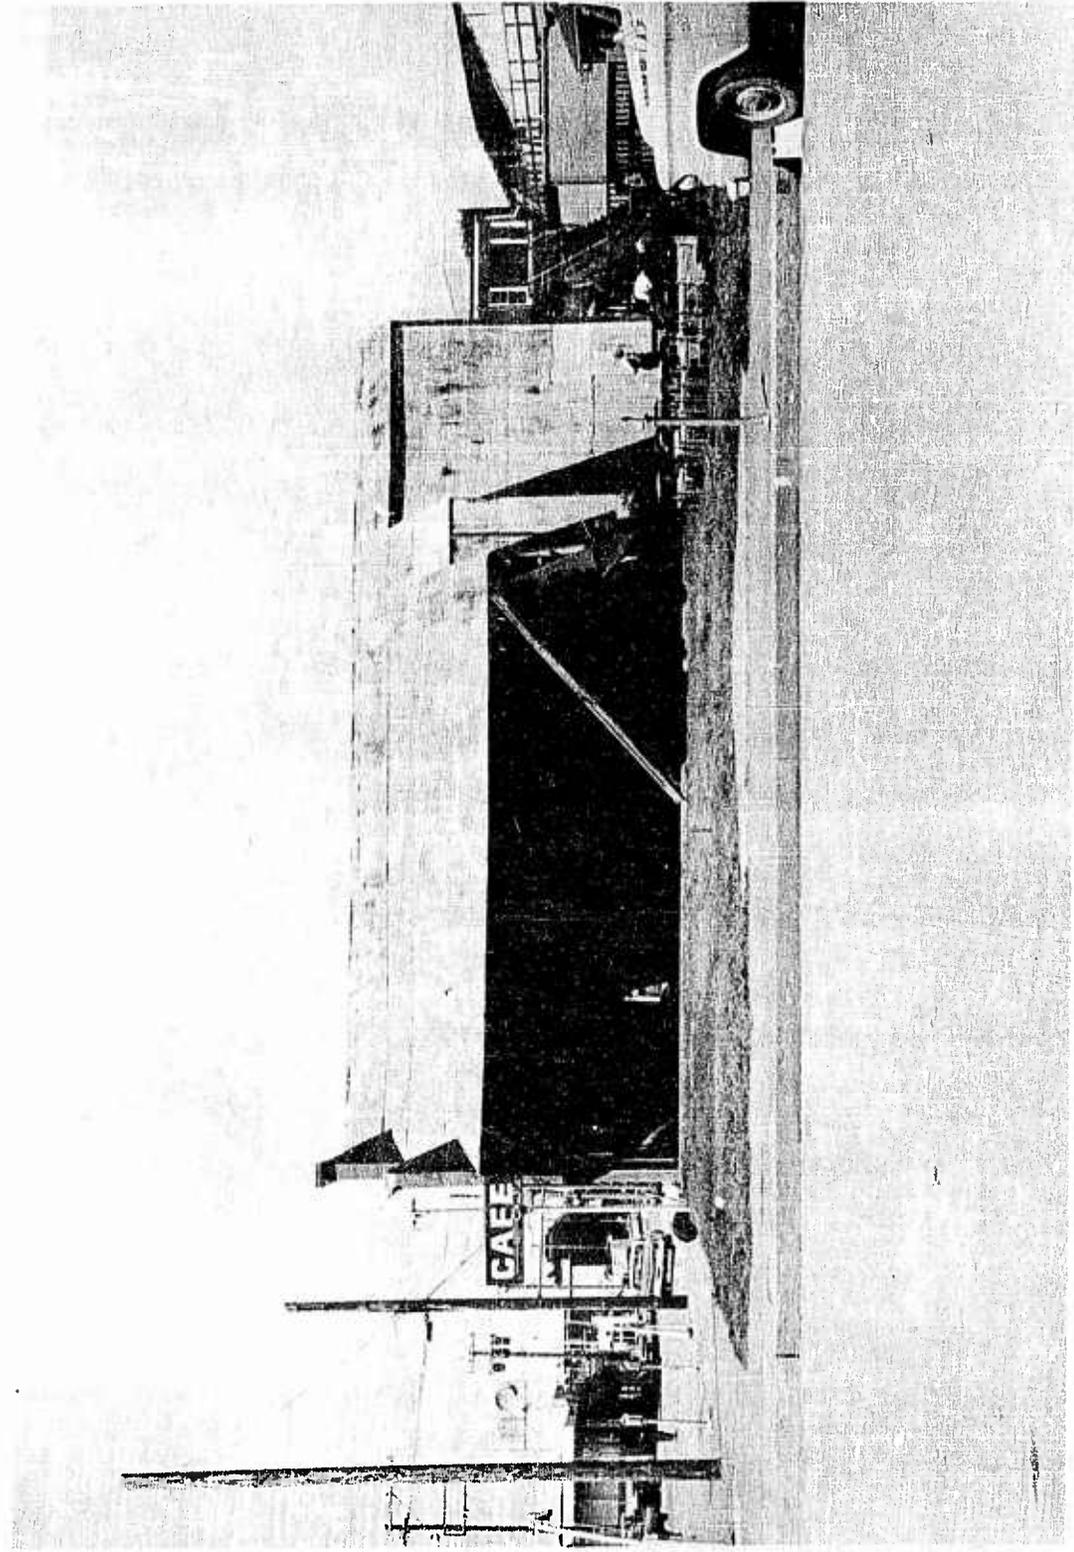
Figure 64. Entire side of corrugated steel transit shed type building along Front Street collapsed.

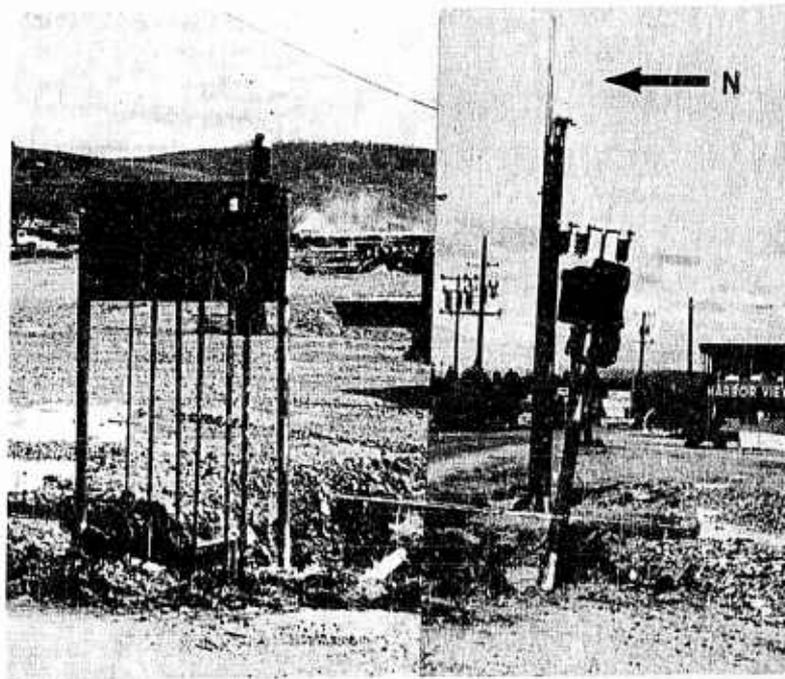
Figure 65 . Wave force and approximate velocity needed to produce yielding of light box at Crescent City Harbor. Bottom photo shows the front and side views of the light box .

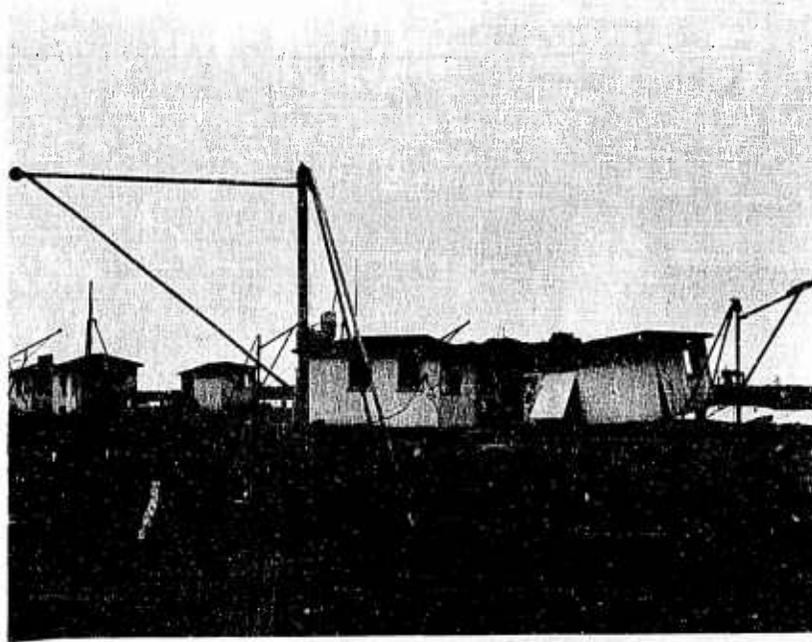
Figure 66A. Commercial fish shacks on Fish Pier arm of Citizens Dock were deflected as tsunami passed.

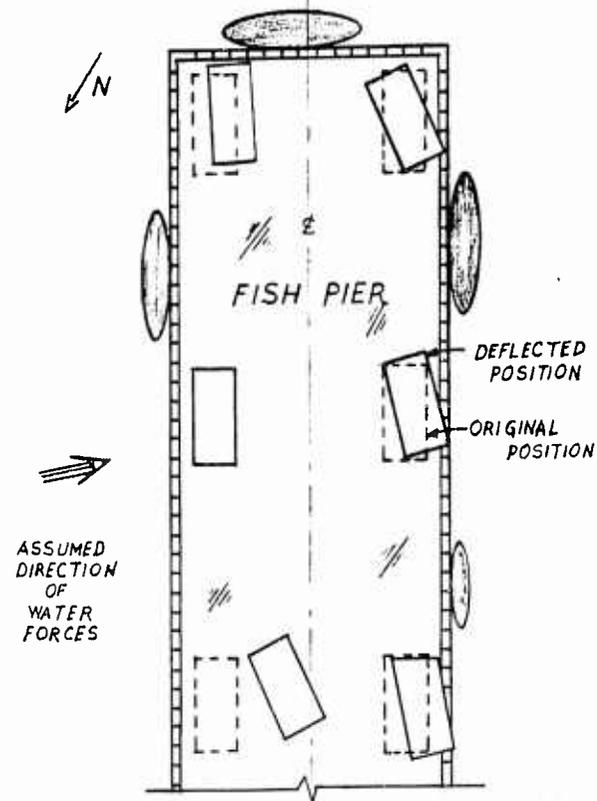
Figure 66B. Fish shacks nailed to decking by 2 X 4's deflected almost inversely proportional to pier corner. Shack that did not move was reinforced and had strong columns at corners.
