CRASH INJURY INVESTIGATION

U. S. ARMY HU-1A

BELL IROQUOIS HELICOPTER ACCIDENT

TREC Technical Report 60-71

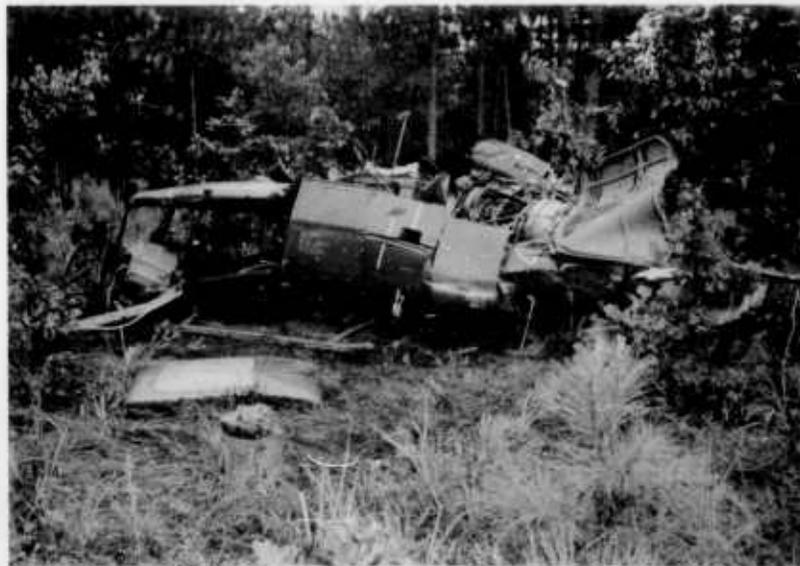
As the aircraft settled, in the nose high attitude, the main rotor blades struck near the top of a tall pine tree and were demolished. The aircraft then began to yaw and roll to the left; however, before any significant yaw or roll developed, the aircraft contacted the ground in a nose high attitude. As the tail boom contacted the ground and a tree stump simultaneously, it was torn free from the main fuselage. The main body of the aircraft fuselage then bounced approximately 20 feet. At this point (still in a slightly nose high attitude) it contacted a tree stump which was driven up through the under-belly and through the cabin floor near the right center of the cabin as the aircraft settled to the ground (principal impact). Upon contact with the stump, the forward end of the fuselage section was whipped downward with the entire section coming to an abrupt stop. Figure 3 illustrates the kinematics of the crash sequence. Figure 4 is a view of the aircraft after it came to rest.

Figure 4. View of left side of the aircraft

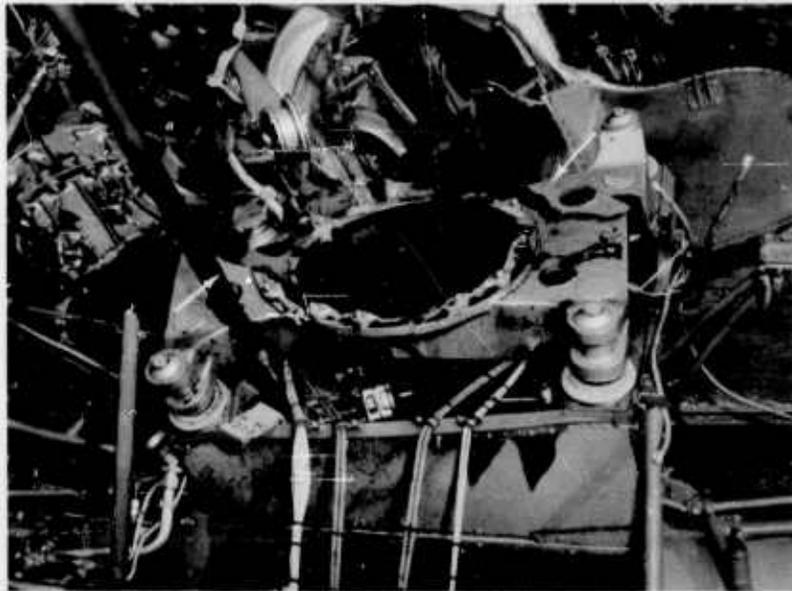
The transmission assembly failed in this accident in the same manner as experienced in previous HU-1A accidents. The significant failure point in all HU-1A accidents is the magnesium casting which serves as a cradle supporting the transmission assembly. In this instance, the transmission

Figure 5. Transmission torn free from its cradle support. Note the fractures in the magnesium casting (arrows).

failed rearward and to the right and was, therefore, not a contributing factor insofar as injuries are concerned in this accident. Had the direction of the crash forces been such that the failed transmission moved forward, it would have penetrated the rear bulkhead of the cabin area, as experienced in a previous HU-1A accident. This is a hazard which has been pointed out on several occasions. During a recent evaluation of the HU-1D helicopter, it was found that Bell Aircraft was providing for a fifth transmission mount to prevent the transmission from moving forward during a crash. It is questionable, however, whether this will resolve the problem because the failures have not occurred at the mounts, but rather in the magnesium casting which serves as a cradle for the transmission assembly. The failure experienced in this accident is shown in Figure 5.

2. Consideration be given to the utilization of a more ductile material to replace the brittle casting presently used to support the transmission;
3. The specifications for both crew and troop seats be revised to provide increased occupant protection under survivable crash force conditions;

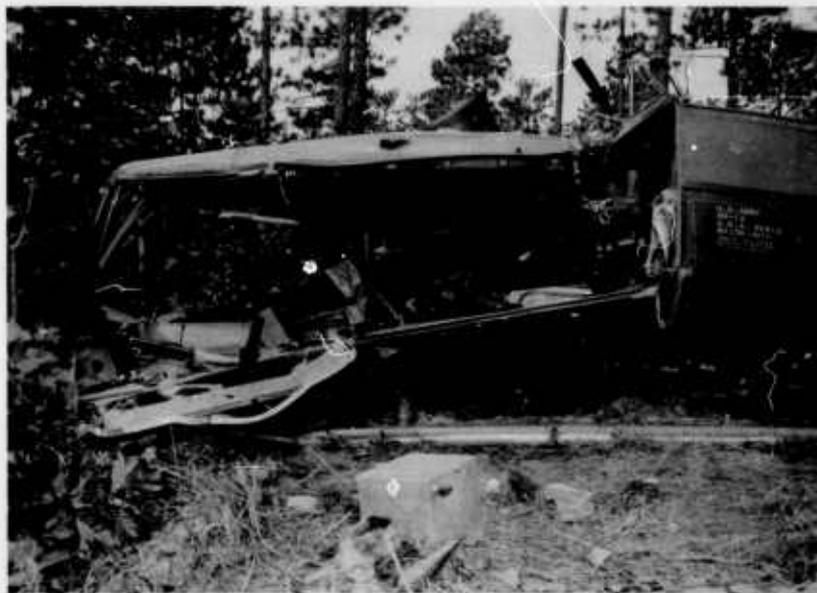
At principal impact, the side roof support members failed completely. This contributed to the failure of the aft roof support member permitting the roof to move forward and downward into the occupiable area of the cabin, reducing the occupiable height within the cabin from 4'8" to 2'8". The failure of these members is shown in Figures 6 through 9.

As the rear roof support member failed, it caused the rear bulkhead to tear and rip, with a jagged point striking the occupant of the rear troop seat at the base of the skull, injuring him critically.

Figure 6. Close-up view of left side of aircraft. The upper arrow depicts the rear bulkhead failure. The broken side supports can also be seen (lower arrows).

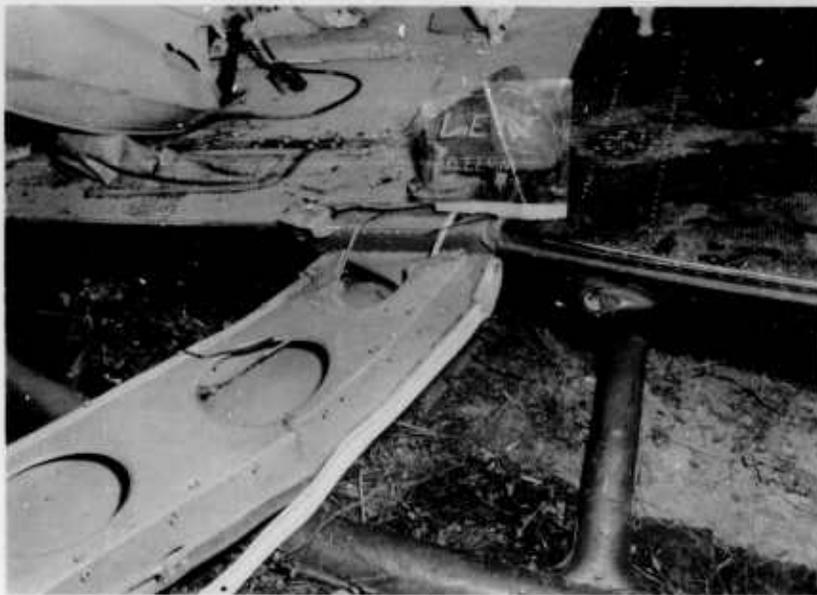
Figure 7. Failure of the left vertical side support at the floor. Cables are holding the support to the floor structure.

Failure of these support members has occurred in every HU-1A accident experienced to date, indicating an inherent weakness in the design of these members. This has been pointed out in previous accident reports and has resulted in "Request for Alteration" studies by the Army. As a result of the requests, Bell Helicopter has conducted the studies and submitted recommended solutions to this problem. The results of the Bell studies are set forth below:

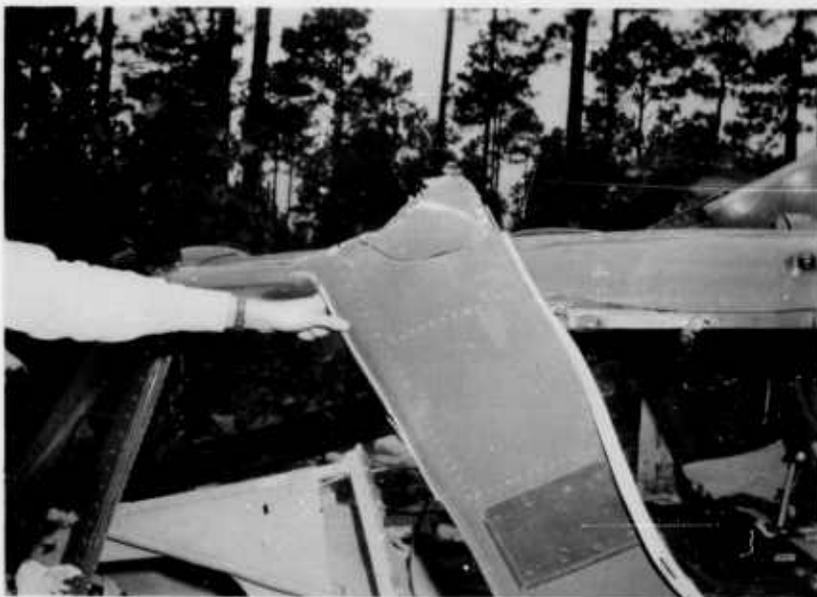
Figure 8. Side view showing failure of left vertical side support at the upper attachment to the roof structure.

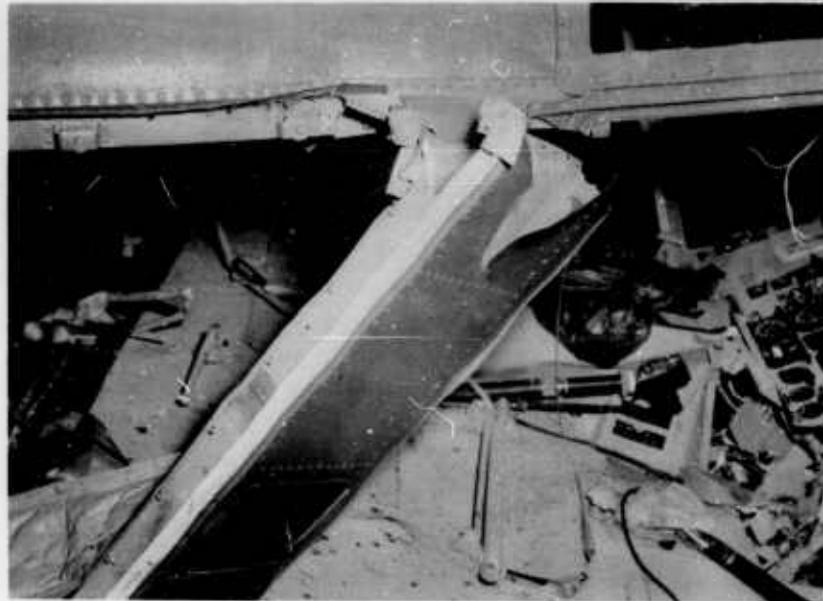
Figure 9. Side view showing failure of right vertical side support at the upper attachment to the roof structure.

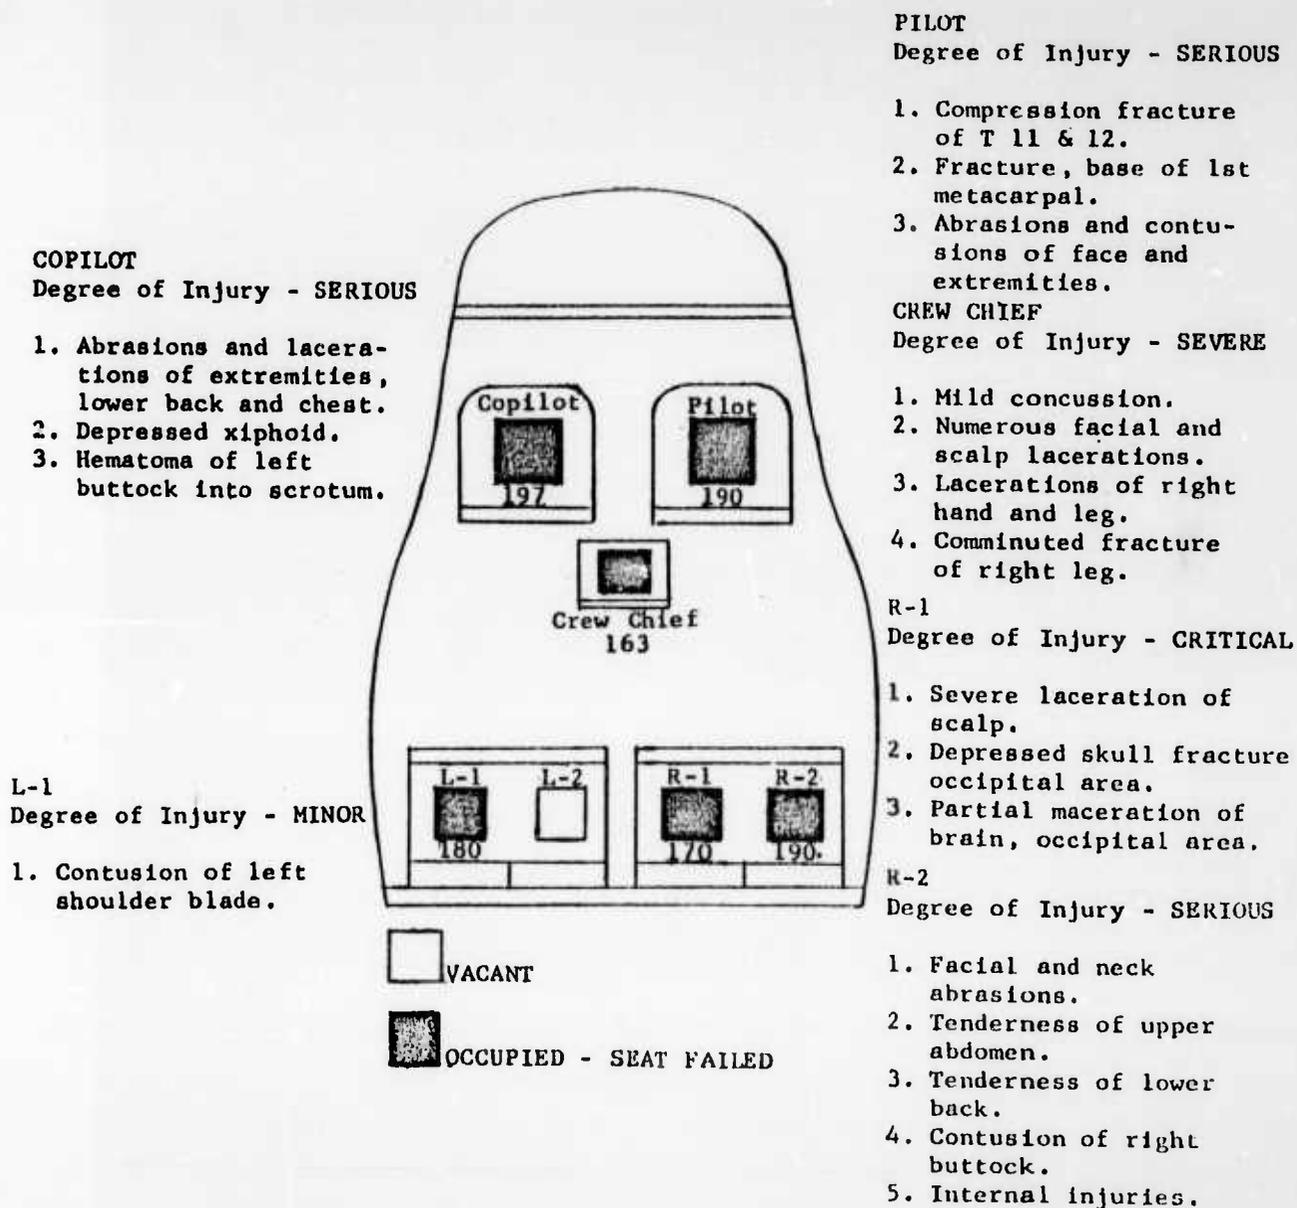
Figure 10. Seating Arrangement - Injury Chart - Seat Failure

of the aircraft at principal impact while still attached to their seats. All other occupied seats failed in place. Figure 10 illustrates the seating arrangement, injuries sustained by each occupant, and the seat failures.

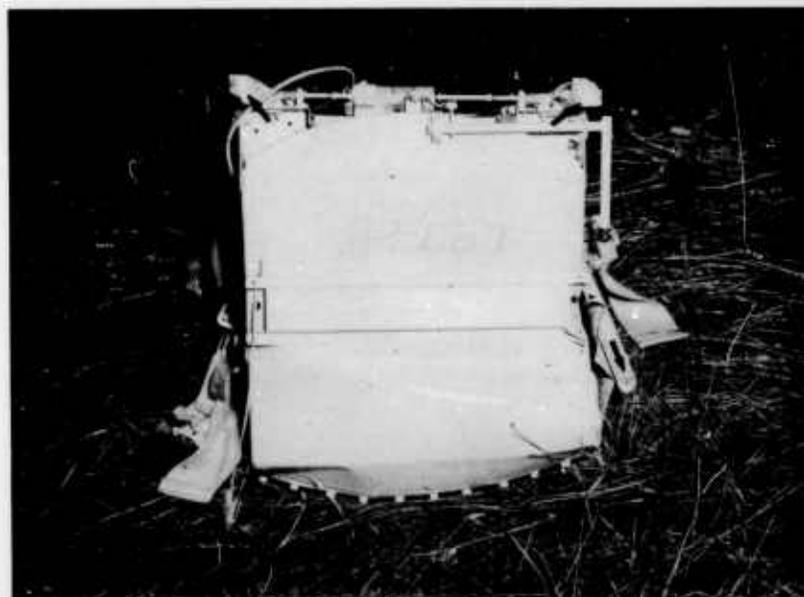
At principal impact the floor and lower seat frame were distorted due to high vertical forces and penetration of the floor by the tree stump. Because of the longitudinal velocity caused by the whipping action of the fuselage, the pilot apparently slid down and forward, deforming the forward lip of the seat pan as illustrated in Figure 11, and popping the rivets along the right side. As a result of the force applied to the seat by the pilot, and the distortion of the lower seat frame, the seat ripped free from the frame and was thrown forward and to the right out of the aircraft. Figure 12 is a view of the lower seat frame still attached to the floor.

Figure 11. Bottom view of seat pan - pilot. The dotted line indicates bent seat pan lip and popped rivets on the right seat. Arrows show locations of seat support failures.

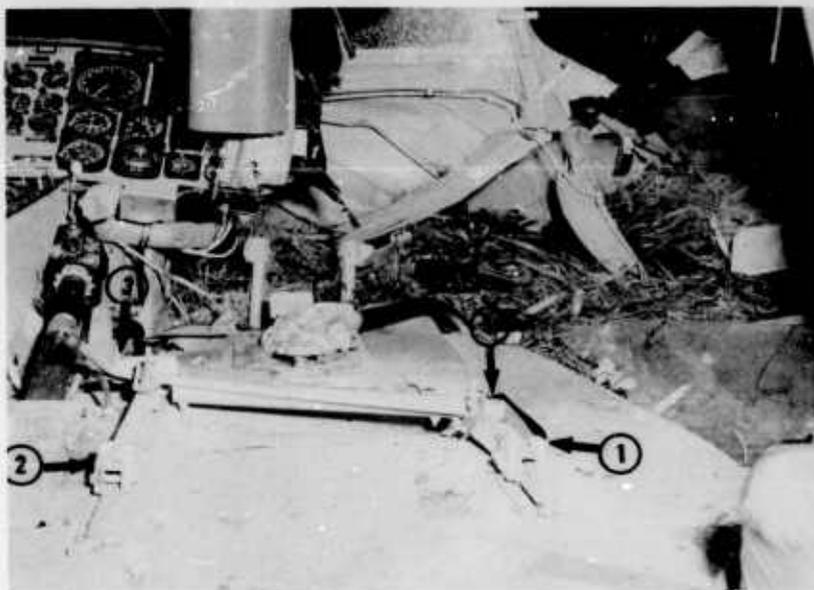
Figure 12. View depicting lower seat frame distortion and floor collapse. Arrows 1 through 4 indicate locations of vertical and diagonal seat frame failure.

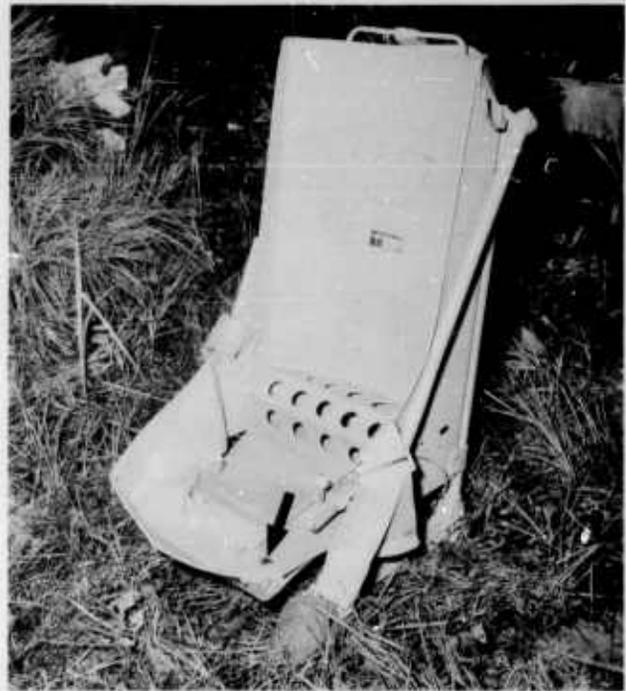
The occupant of the copilot seat apparently also slid downward and forward at principal impact, causing distortion of the forward seat pan lip in the same manner as the pilot's seat (Figure 13). The longitudinal force applied by the occupant of the copilot's seat at principal impact caused the rear seat support members to fail, permitting the seat to pivot forward and wedge the occupant head first in the torque pedal well. Figure 14 illustrates the portion of the copilot's seat frame remaining attached to the floor after removal of the occupant.

Figure 13. View of the broken seat pan - co-pilot. Note the forward and downward bending of the seat pan lip and the tension failure of the left corner of the seat pan (arrow). Also, note excessive width of shoulder harness guide.

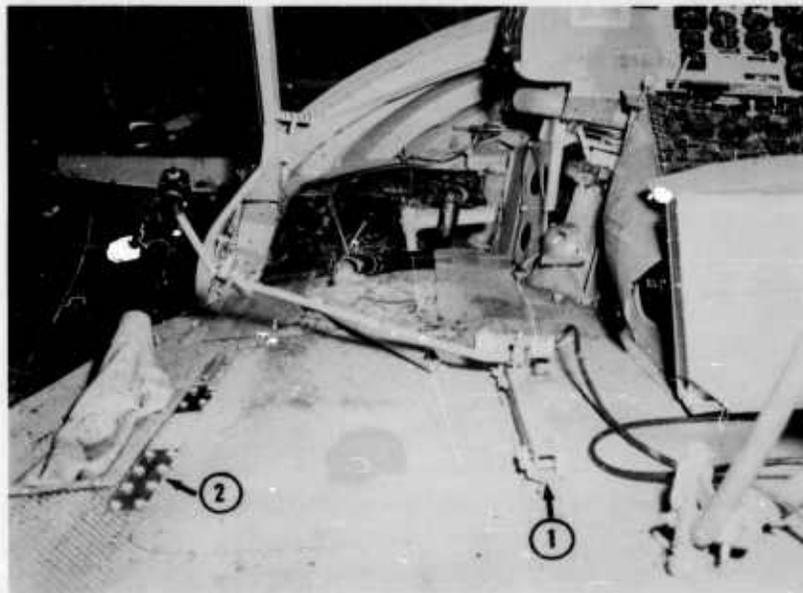
Figure 14. Copilot's seat failure. Removal of the left front occupant necessitated removal of the entire seat and, therefore, is not shown in this photograph. Arrow 1 depicts the manner in which the right rear anchorage failed and Arrow 2 shows how the rear portion of the left seat track pulled free from its floor anchorage.

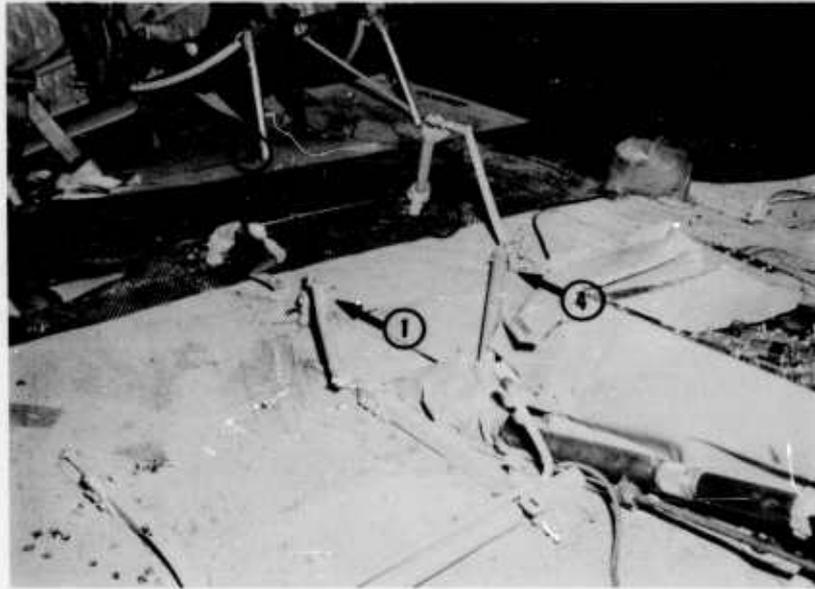
The longitudinal force exerted on the seat by the crew chief at principal impact caused the seat pan to tear free from the seat support. The seat supports apparently absorbed a considerable amount of energy by buckling and distortion before the seat pan tore free, as shown in Figure 15. Additional views of the medical attendant's seat are shown in Figures 16 and 17.

Figure 15. Buckling of the seat supports of the Medical Attendant's seat. (Arrows 1 through 4)

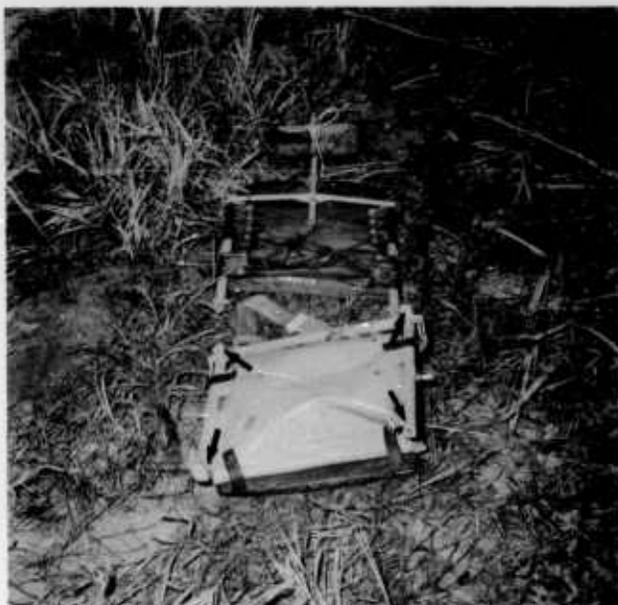
Figure 16. View of broken Medical Attendant's seat. Arrows denote points of support failure.

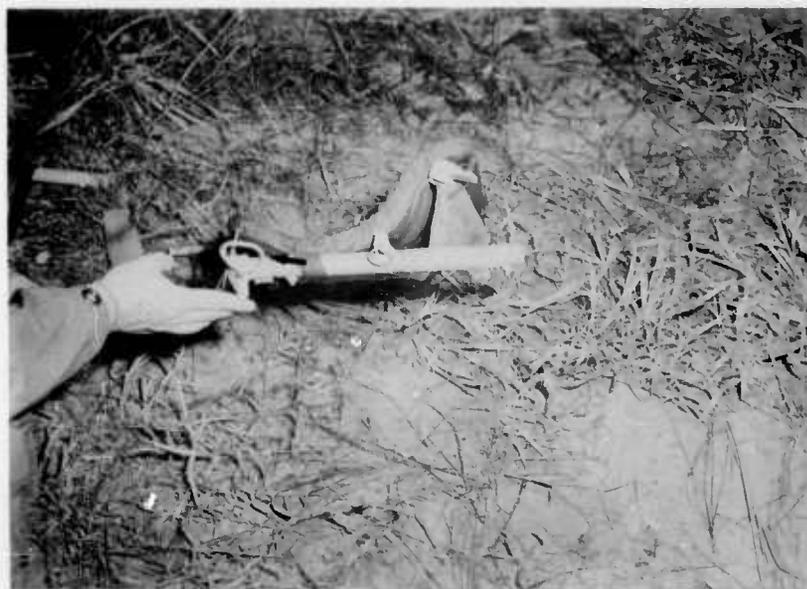
Figure 17. Seat belt attachment of Medical Attendant's seat (arrow). Notice how stress elongated the "O" ring, yet did not fail.

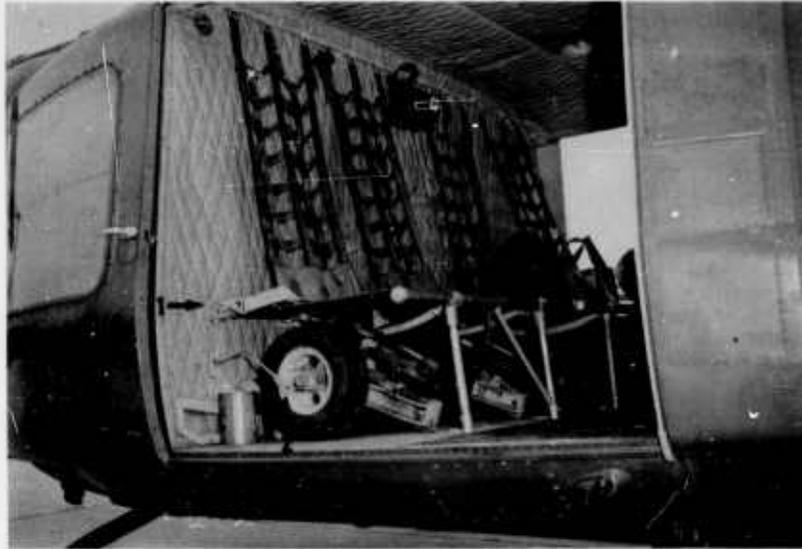
Standard military troop seats, designed to MIL-S-5804B, were installed in this aircraft as shown in Figure 18. The seat frame consists of upper, rear, and front support tubes to which is attached the nylon seat back and seat pan. The legs are attached to the front support tube. Curved spreaders maintain the distance between the front and rear support tubes.

Figure 18. Correct and incorrect belt installation. Over-all view of the cabin area depicting the troop seats and the loose equipment stowed beneath the seats. Arrow 1 denotes the incorrect method of attaching the safety belts. The belts should be attached to the cables which are provided (arrow 2).

With reference to the troop seats, it was noted that the seat belts were attached to clamps of the rear longitudinal seat support member, as shown by Arrow 1 of Figure 18. Attachment of the belts at this point overloads this member and frequently causes failure of the support member. Arrow 2 in Figure 18 shows the cable which is provided in this aircraft for seat belt attachment. These cables are tied directly to primary structure. Attachment of the belts to the cables provided would reduce the crash loads on the seat structure and would eliminate some of the failures experienced in the past. *

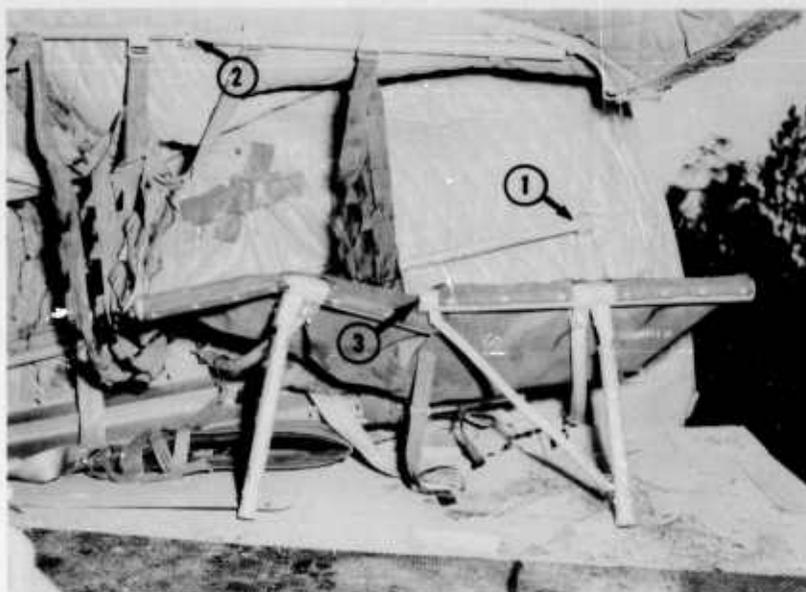
The left rear two-man seat shown in Figure 19 was occupied by one passenger on the outboard side. At impact the seat pan ripped from the rear lateral support tube. This support tube pulled out of the clamp on the left side of the bulkhead and moved two inches to the right, as shown by Arrow 1 of Figure 19. The hooks, which suspend the seat back from the upper support tube tore free from the upper support tube. The upper support tube failed at a drill hole where it is attached to the rear bulkhead, shown by Arrow 2, Figure 19. Failure of the seat pan and the downward force exerted by the occupant caused the front support member to break at a drill hole near the diagonal brace attachment. Failure is shown by

Arrow 3, Figure 19. Both front seat legs were also torn free from their floor attachments.

Figure 19. Failure of left rear troop seat. This seat was set up for photographic purposes. It was originally collapsed on the floor. Arrow 1 shows the clamp where the rear support tube was anchored. Arrow 2 shows the failure of the upper longitudinal tube where the seat backs are attached. Arrow 3 shows the failure of the front support tube at the drill hole.

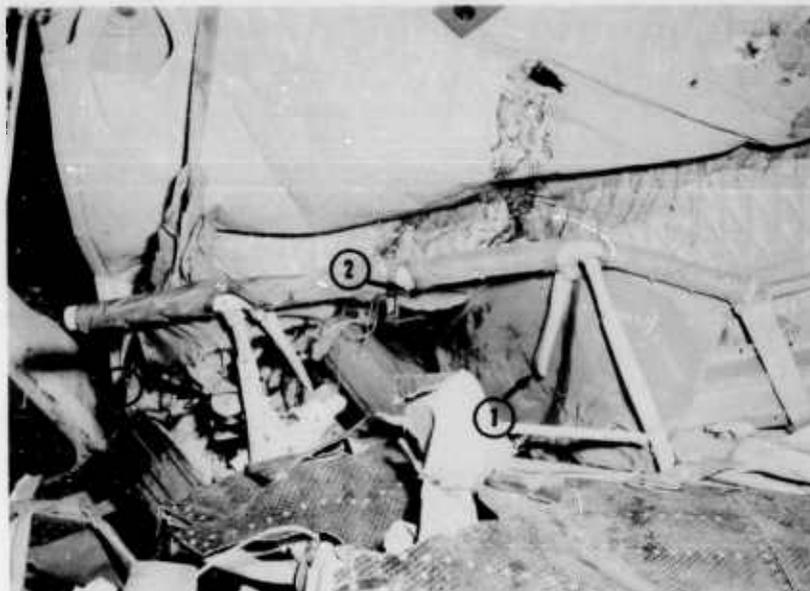
The right rear two-man seat shown in Figure 20 was occupied by two passengers. At impact the floor just ahead of this seat heaved upward as the aircraft impaled itself on the tree stump. The upheaval of the floor, plus the downward force exerted by the two passengers, caused distortion and failure of the vertical seat legs, permitting the seat pan to come into contact with the handle of the hydraulic pump on a set of ground handling wheels stowed under the seat, causing the seat pan to rip longitudinally. The seat spreader under the inboard occupant broke and the diagonal brace failed. The seat back support assembly also failed on this seat.

Figure 20. Failure of right rear troop seat. Note the ground handling wheels under the outboard seat. Arrow 1 indicates the broken seat spreader. Arrow 2 shows the failure of the diagonal brace. Arrow 3 indicates the position of the ground handling wheels.

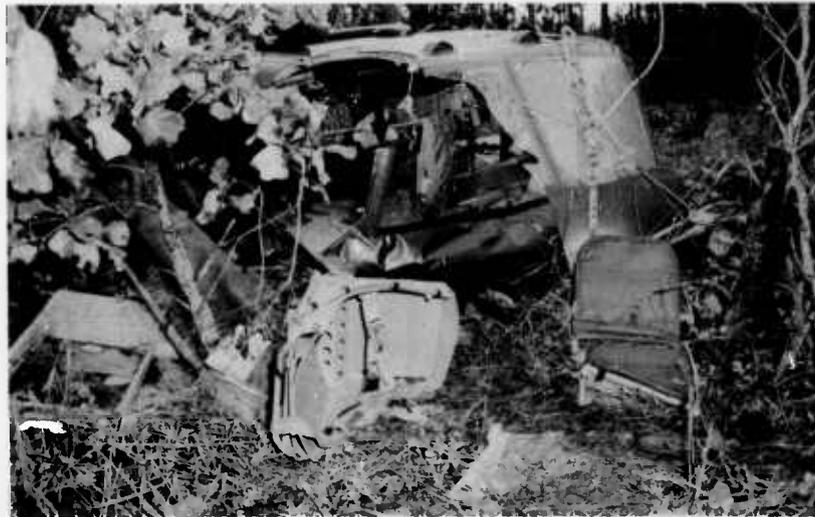
At impact, the pilot's seat failed, permitting the seat and its occupants to be thrown forcibly forward, down, and to the right. The pilot apparently struck the right front door post with his helmet and right side of his body and was then thrown clear of the aircraft (Figure 21).

Figure 21. Front right view of the aircraft showing the door post and the position where pilot and crew chief came to rest.

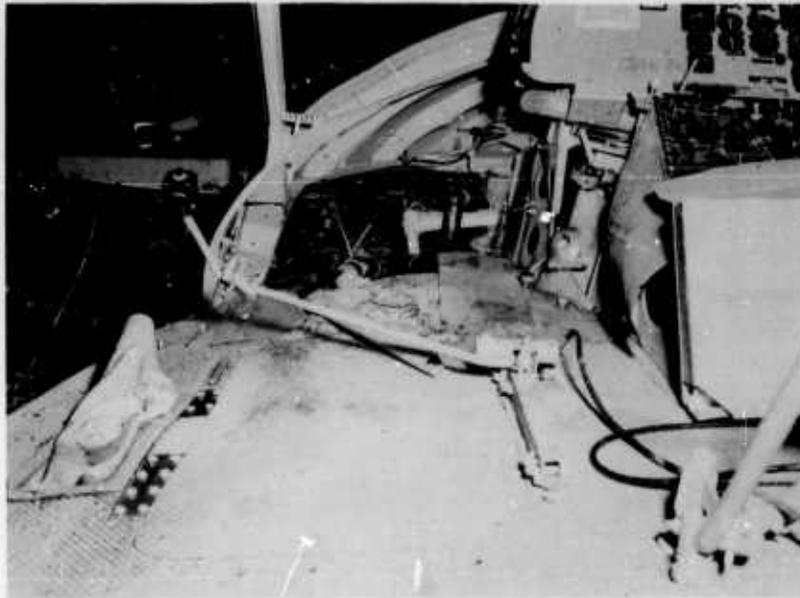
Figure 22. View of the left torque pedal-well after seat was removed. Note the broken cyclic stick.

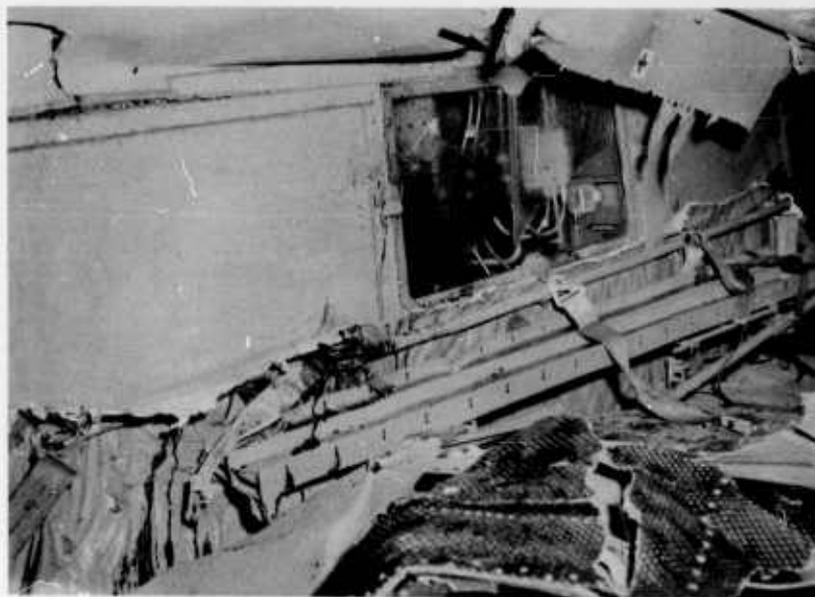
The occupant of this troop seat received critical head injuries when the top of the rear bulkhead failed and collapsed inward and down. At impact one of the structural members supporting the bulkhead broke and a sharp edge pierced the bulkhead and fabric, striking the head of this passenger while he was jackknifed in his partially collapsed seat. (See Figure 23.)

Figure 23. View of the aft bulkhead after it was stripped of the fabric. The arrow shows the sharp piece of metal that critically injured one of the occupants.

The jagged metal penetrated the skull, causing a serious laceration of the scalp, a depressed fracture at the base of the skull, and macerated brain tissue.

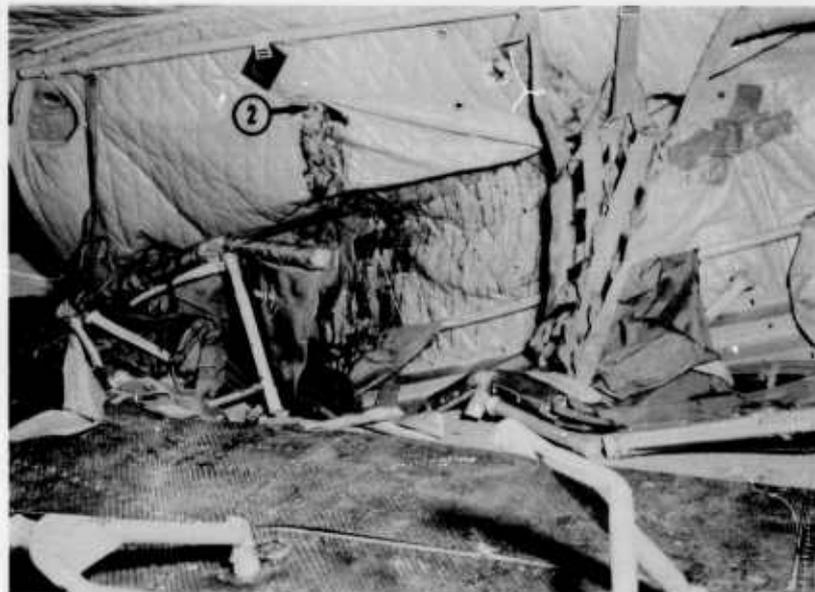
The occupant of this troop seat suffered serious injuries. At impact the nylon seat pan ripped longitudinally in the center. This was caused by the handle of the hydraulic pump equipment on a pair of ground handling wheels that were stowed under his seat (Figure 24, Arrow 1). The occupant received extensive contusions of the right buttock when he fell through the ripped seat pan and contacted these ground handling wheels.* His safety

Figure 24. View of the right rear troop seat. Arrow 1 shows where the seat pan tore across the ground handling wheels. Arrow 2 indicates the structural member that pierced the bulkhead, injuring the occupant of the inboard seat.
