OCTOBER 1964

# QUARTERLY TECHNICAL PROGRESS REPORT No.

XV-5A LIFT FAN  
FLIGHT RESEARCH AIRCRAFT.

5 GENERAL ELECTRIC COMPANY  
Cincinnati, Ohio.

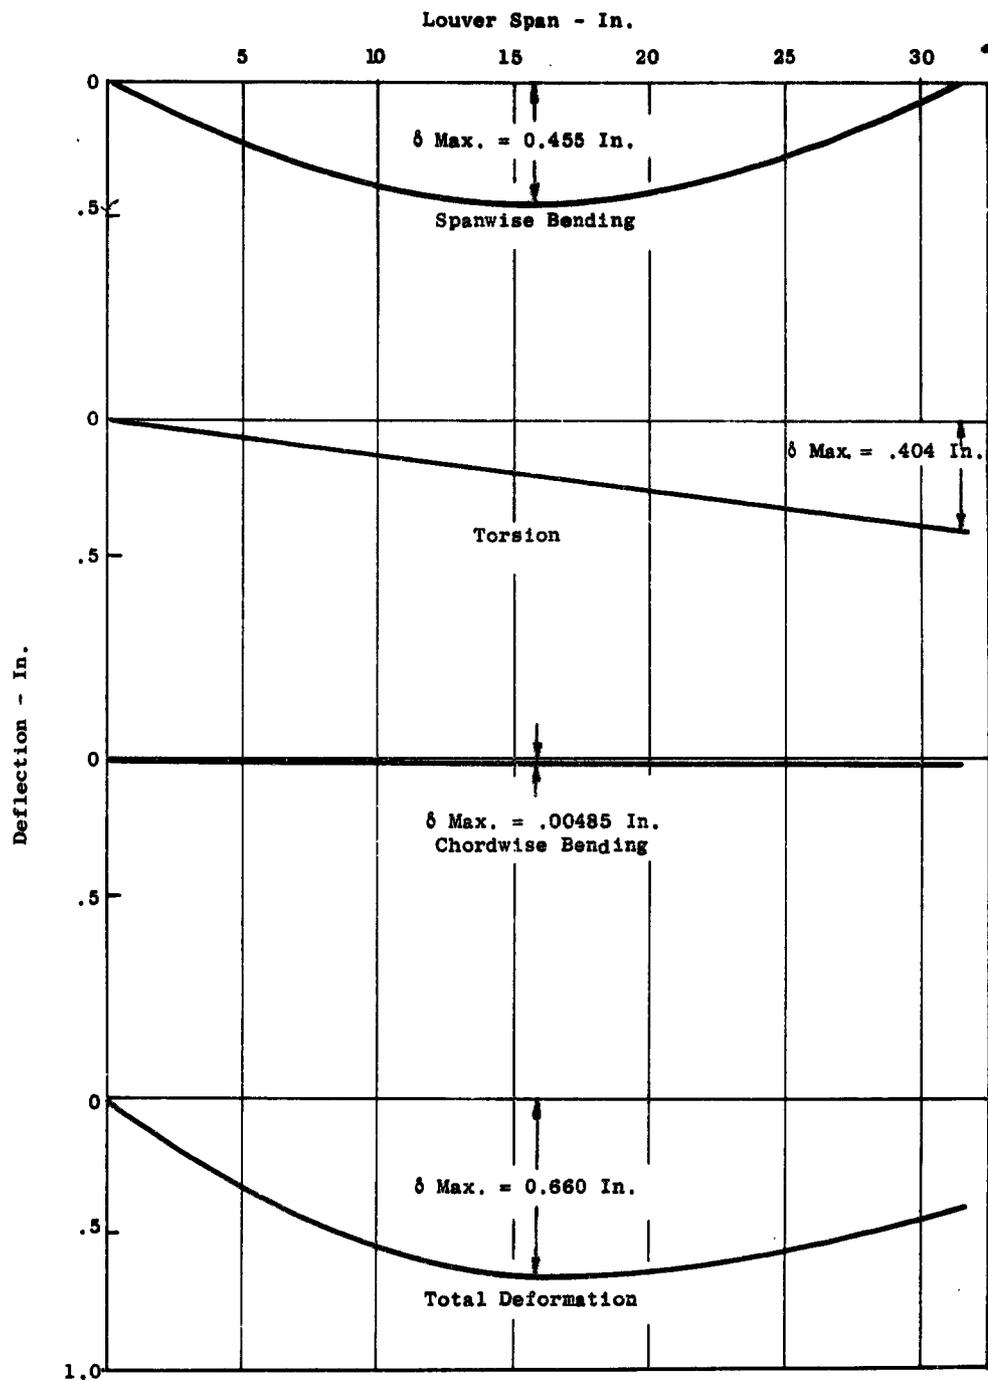
Figure 1. XV-5A Unmodified No. 20 Exit Louver Deformation at 20° Stagger Angle 100% Fan Speed.

During the portion of the ground testing when the push rods were firmly held by the load links, significant deflections were observed in the aluminum louvers. Tests to measure these deflections show that for a stagger angle of  $39^\circ$  and 100% fan speed, the angle of twist of the louver is  $5.3^\circ$  and at a vector angle of  $13^\circ$  the untwist is less than  $1^\circ$ . Although these deflections are not detrimental to the structural integrity of the louvers nor do they affect the roll acceleration obtained during flightworthiness testing, their reduction or elimination would increase thrust control effectiveness to either add a margin of control reserve or compensate for deficiencies elsewhere in the control system.

As a result of mechanical and aerodynamic analysis (results as per Figure 1), it was decided that the best way to modify the louvers would be to increase the effective skin thickness by putting another skin over the outside. Accordingly, the bow and twist would be reduced by more than half of the previous values. The method used was to take a formed outer skin of the same stock thickness and material as the louver and adhesively bond and rivet it to the louvers.

By using the same material and thickness, the existing louver skin dies could be utilized, saving both time and expense. Although an exact fit was not obtained between the contact surfaces of the louver and outer shell, it was sufficiently close to obtain a satisfactory bond. Both surfaces were chemically cleaned to remove any contaminants and pre-heated to 150°F prior to the application of resin.

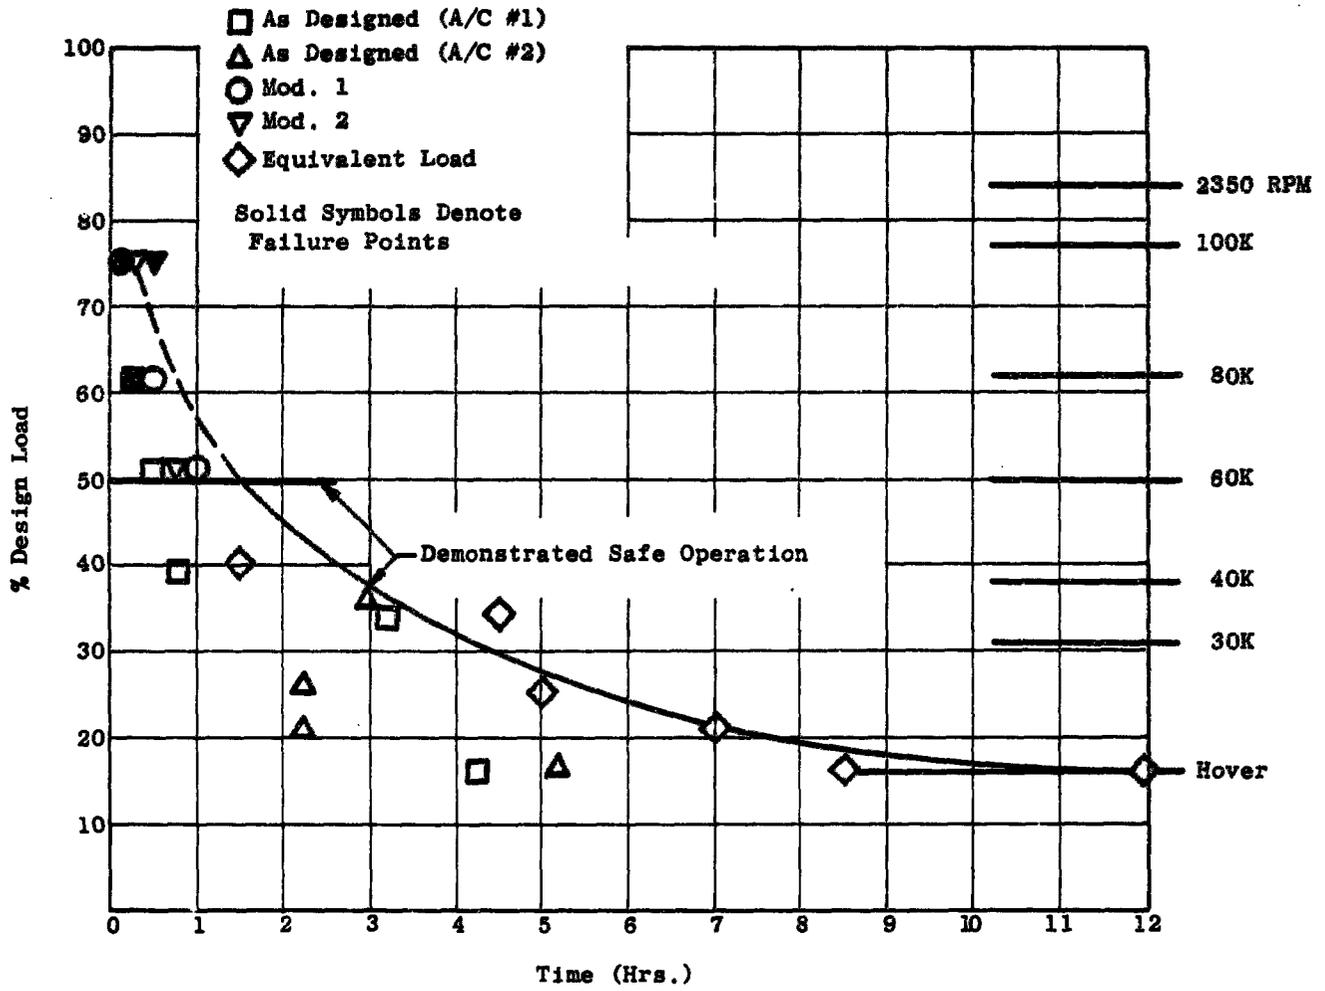
Figure 4. Safe Operational Limit - Inlet Vanes.

The vane operation performance in the wind tunnel was analyzed to establish a safe flight test limit (Figure 3). All the combinations of fan speed and tunnel velocity were analytically reduced to a per cent of design load basis and plotted against time of no failure operation (Figure 4). It was concluded that the aircraft could fly to 60 knots in the VTOL mode without the incidence of vane failure.

There was no attempt during the tunnel test program to conduct sustained continuous loading for significant times. Consequently, the load-life analysis is not a measure of maximum vane capacity as the data are based on conditions accumulated as a result of the wind tunnel test schedule. It can be noted that the only significant time accumulation occurred on the original, as-designed vanes, and the improvements realized as a result of Modifications I and II changes are used only as a safety factor to assure a safe flight test program with the 60 knots flight speed limit.

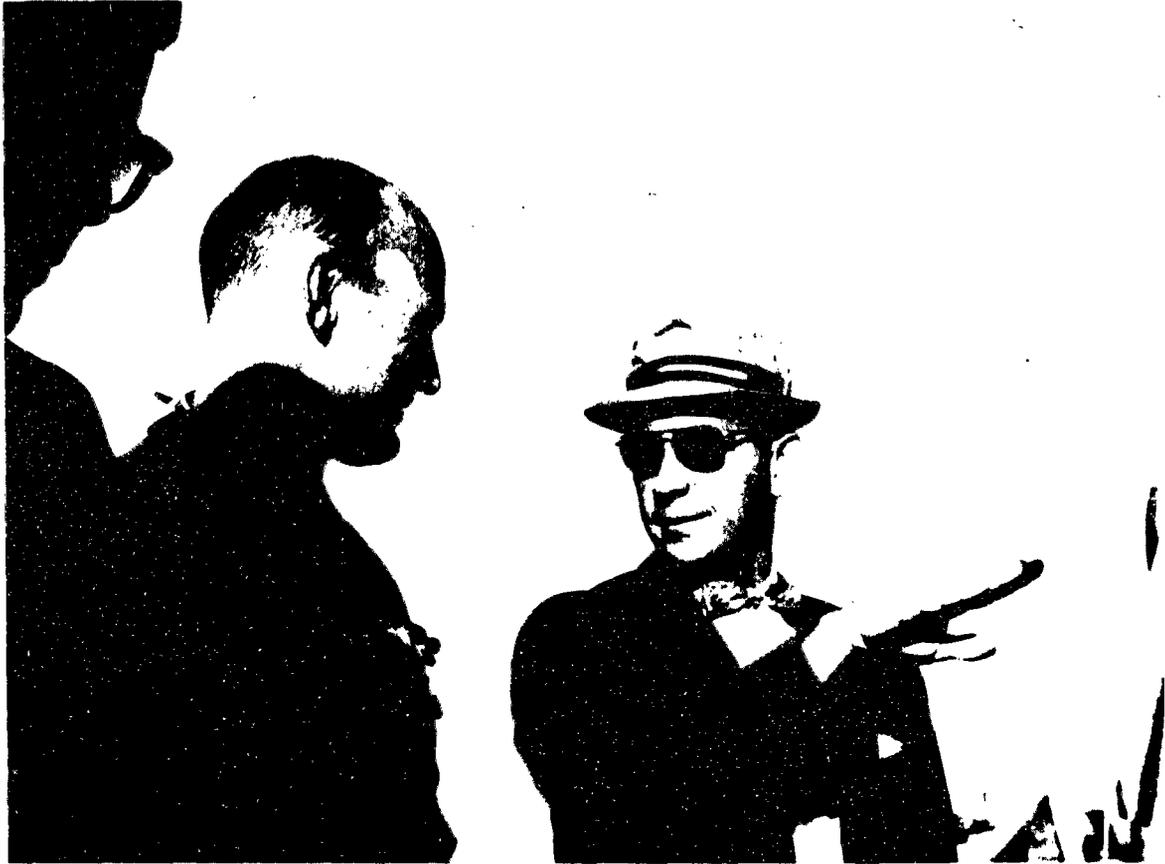
Figure 36. Post Flight Briefing.

After pilot and engineer discussions, see Figure 36, the flight operations were halted and further compressor stall investigation started. Details of the stall investigation and resulting aircraft configuration are described in Section V-B, page 113.
