FOAMGLAS INSULATION FOR
BURIED HOT PIPES

NAVAL FACILITIES ENGINEERING COMMAND

U. S. NAVAL CIVIL ENGINEERING LABORATORY

Technical Report R-451

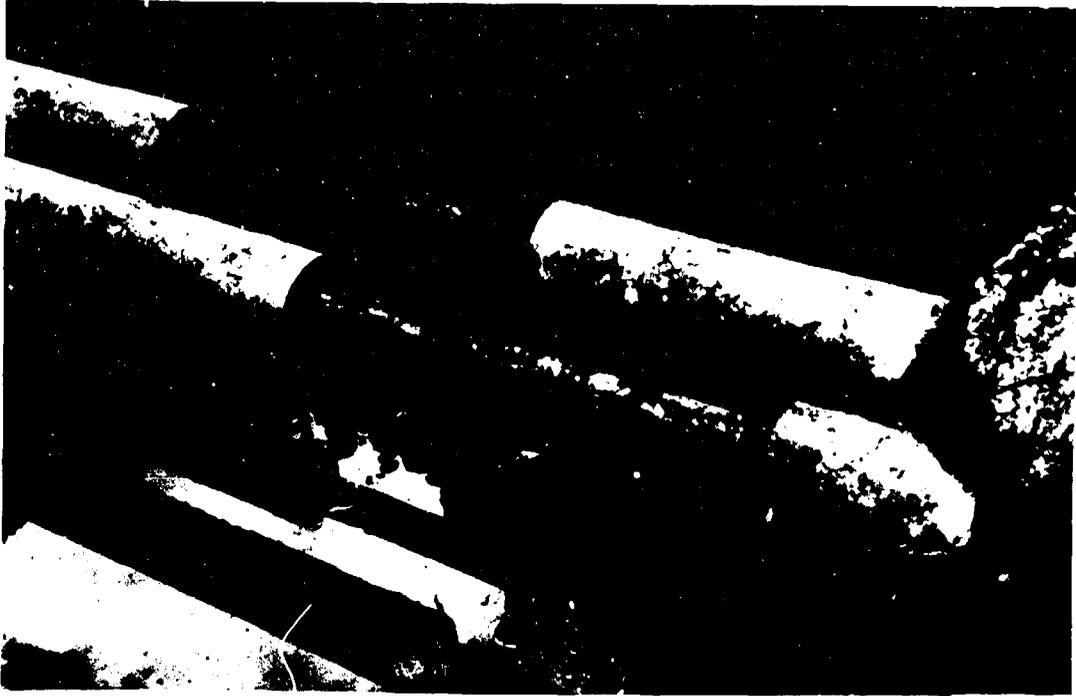
Figure E-1. Seattle. The insulation has been removed from the pipe revealing that both pipe and insulation are in good condition.

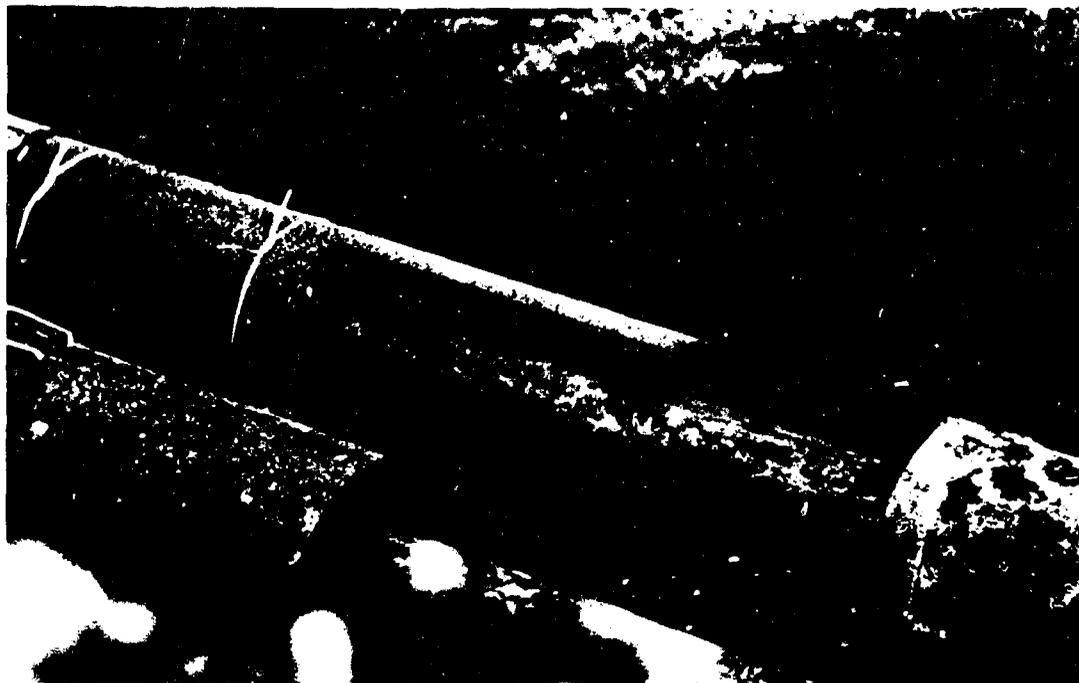
Figure E-3. Seattle. The pipe is being recovered with half sections of Foamglas which are being secured to the pipe with stainless steel wire.

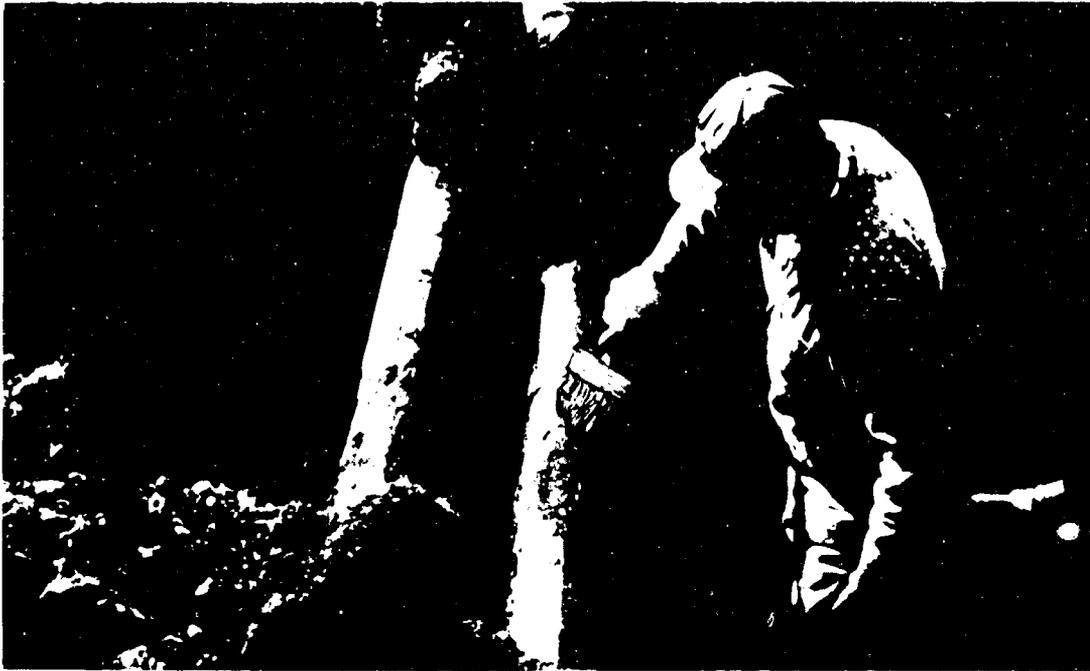
Figure E-5. St. Louis. Coating new Foamglas section with mastic; contractor thinned mastic with gasoline so that it could be applied with brush, thus ignoring Foamglas Manufacturer's recommendation that mastic be gloved on.

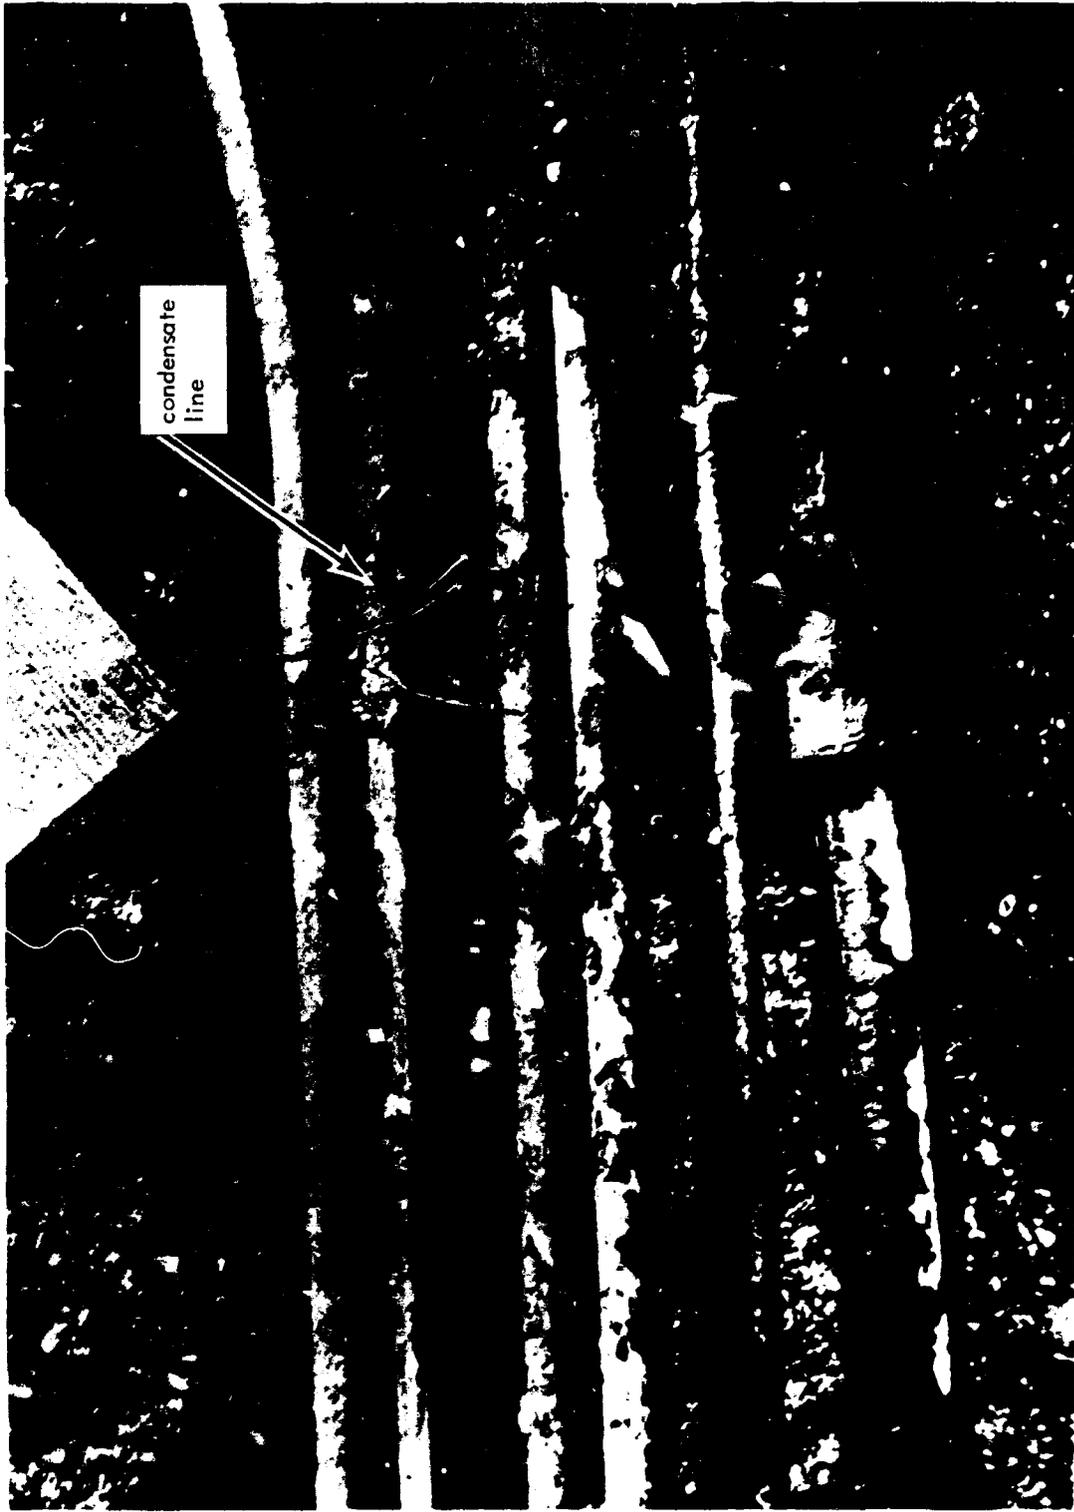
4. The failure at New Orleans was characterized by disintegration of the Foamglas; this did not occur at the other two sites. This disintegration probably resulted from pressures exerted by external steam which was generated when water intrusion reached the outer surface of the pipe. As mentioned previously, water intrusion could not be attributed to soil properties.

Figure E-9. New Orleans. Typical excavation after water was pumped from the hole. Note condition of Foamglas on condensate line.
