AM 66-18

Evaluation of Head and Face Injury Potential of Current Airline Seats During Crash Decelerations

June 1966

OFFICE OF AVIATION MEDICINE
FEDERAL AVIATION AGENCY

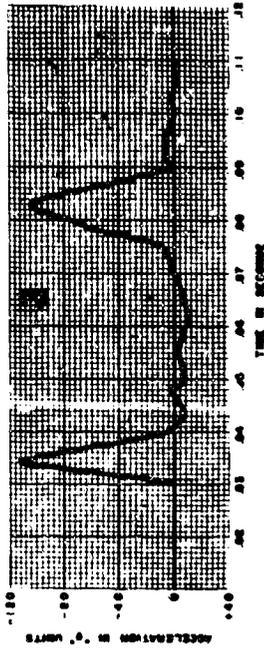
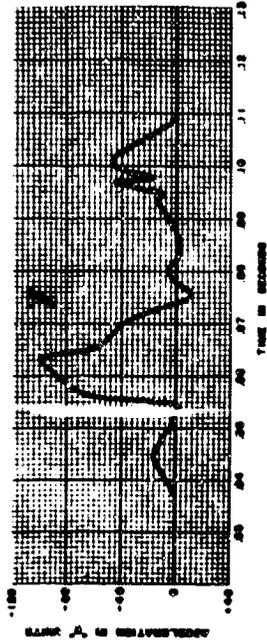
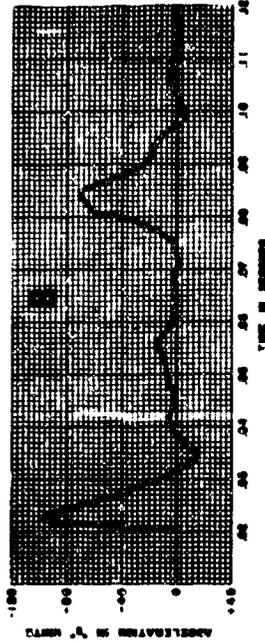
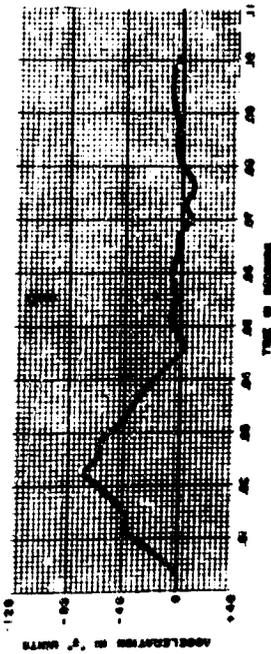
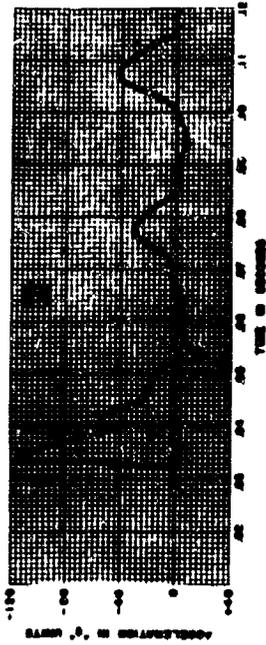
FIGURE A1. Seat A.

Five impacts of the dummy head were made against Seat A at the points shown in Figure A1

(Figures A1 through A10 are in the Appendix.) by numbers 1, 2, 3, 7, and 8. Corresponding "g" time-force curves are presented. Impact #1 (on the top of the middle seat) produced a sizeable deformation in the soft metal structure. The metal deformed readily and *contoured* to the head, distributing the force over a large area of the skull. The peak force was about 70g with a slow rise time (20 milliseconds). The deceleration extended over 40 milliseconds. Referring to Figure 1, we would expect this impact to produce no bony injury if struck by the forehead or teeth-maxilla areas, but it would be of sufficient force to fracture a single zygomatic (cheek bone), nose, or mandible (jaw bone). In all five instances, however, the passenger would be rendered unconscious.²

Impact #2 was between the left and middle seats with the seats in the upright position. Most of the force (120g peak) was used in forcing the seat backs to break forward. There was little deformation of the seat structure, causing the impact loads to be concentrated on a small area of the head. This would have produced fatal fractures. It is of interest that a steady pull of only 10 to 12 pounds is needed to force one of these seat backs forward.

Impact #3 against the center of the serving tray in the left seat back (with the seat upright) produced two peaks of over 100g: one when the seat back was forced forward and the other when the head subsequently struck the lower cross member of the seat back. There was no deformation of the serving tray. Estimates of injury potential presented in Table 1 are based on a previous report² and the area of contact of structure with the head. For injury estimates for the following figures, refer to Table 1.

Some seat-design engineers feel that under actual crash conditions the "break-away" type of seat back will fold forward from its own momentum out of the way of the head. If this is true, the head possibly will strike the lower portion of the seat back or a tubular cross member. Impact #7 simulates this condition. The right seat back was impacted in the forward position. In the graph for #7, the first small peak of about 15g was produced in bending the thin metal at the bottom of the seat before the head made contact with the heavy tubular cross member concealed beneath it. At that time a very lethal, long-duration (20 milliseconds) force of over 100g was applied to the head.

Impact #8 was against the top of the right seat back (seat upright) at the top edge of the serving tray. Note similarity of curves 3 and 8.

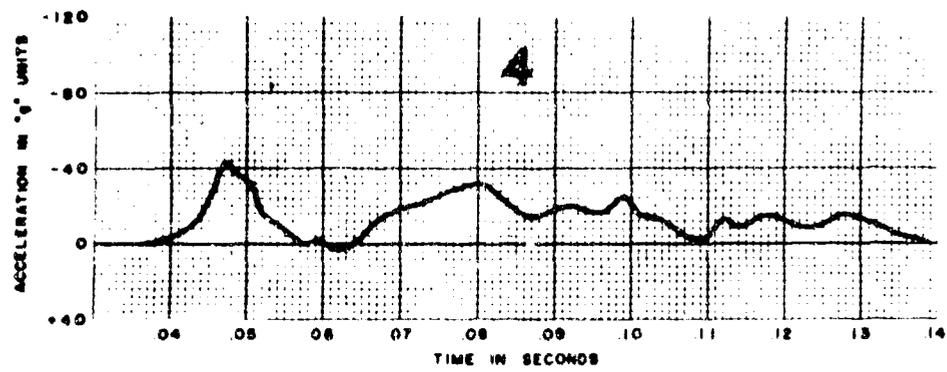
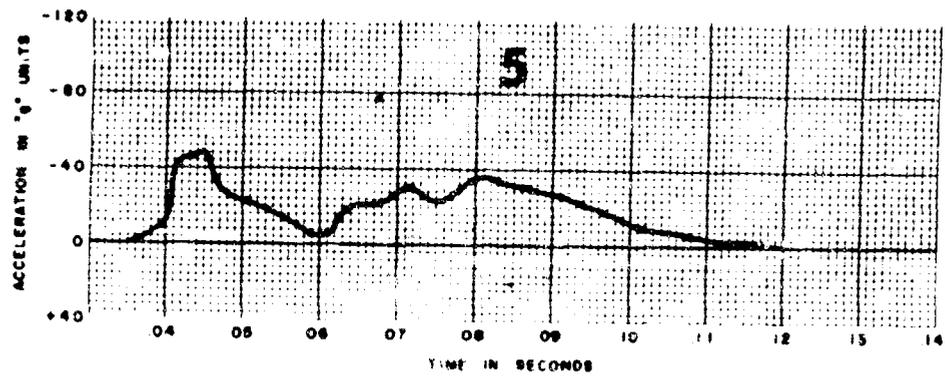
FIGURE 12 - Seat A.

Since the arms supporting the folding serving trays have broken off in some airline crashes and caused serious injury, two impacts were made on the unfolded trays of Seat A (Figure A2). Impact #4 was centered in an area between the left and center trays, whereas impact #5 was against the right edge of the left seat tray. The tray support arms in both cases bent several inches but did not fracture. The impacts produced long duration forces of about 40g or less.

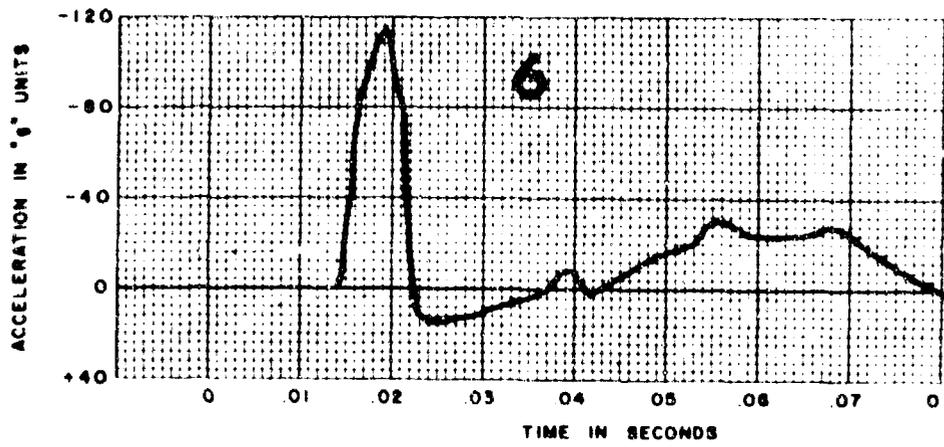
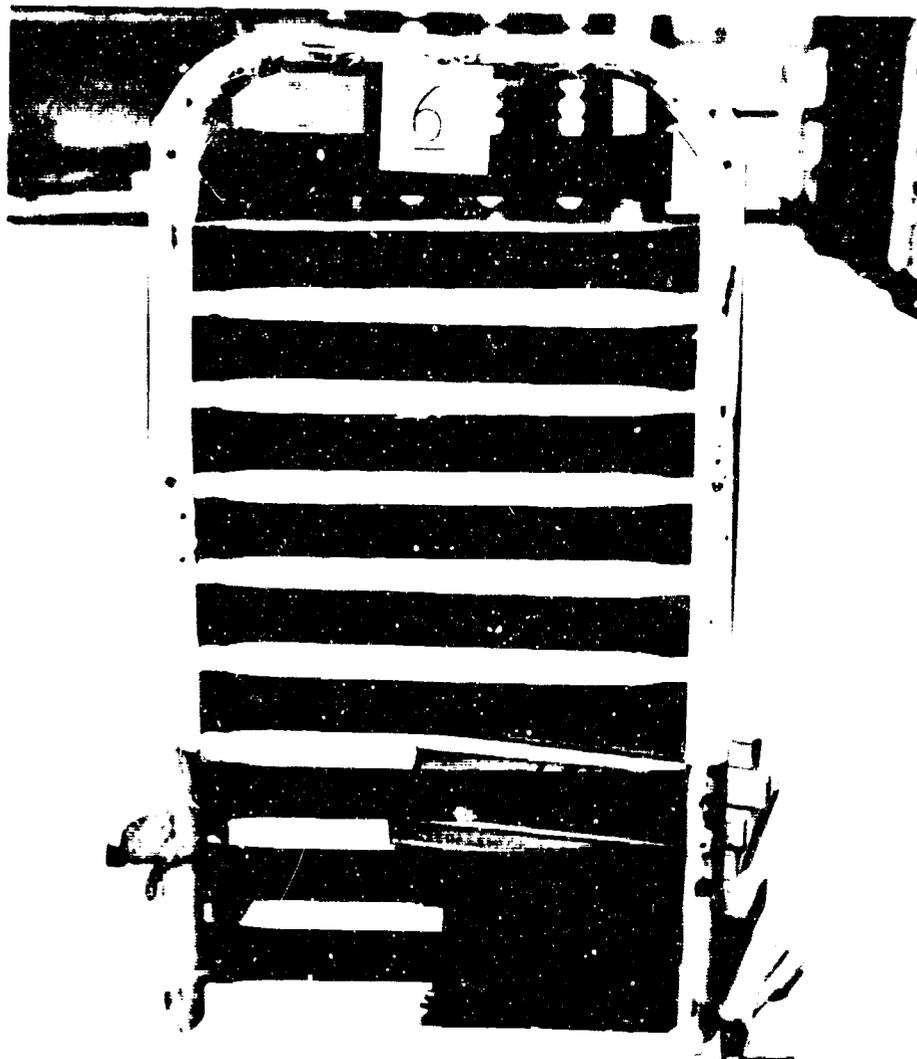
FIGURE A3. Seat B.

In Figure A3, the dent left by the head impact against the top tubular structure (Seat B) is barely visible in the photograph. The sharp

rising 120g peak force applied to an area of not more than 1 sq in. of the head would undoubtedly have caused fatal injuries.

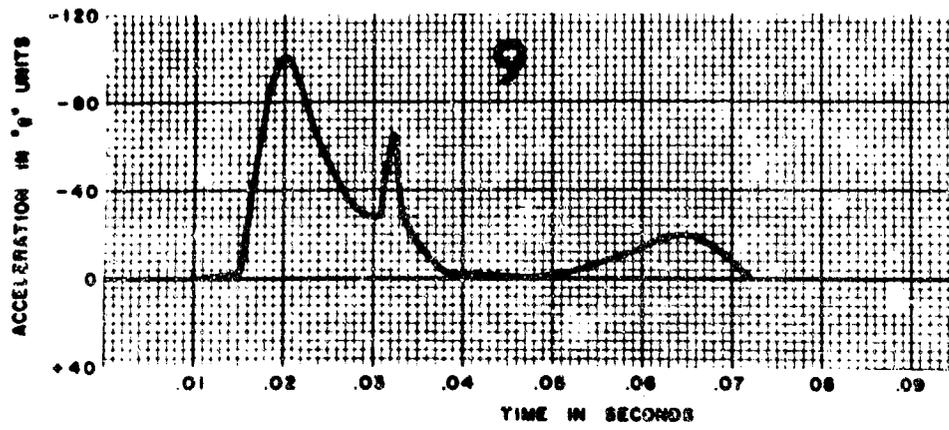
FIGURE A1 - SEAT C

Impact #9 against the top edge of Seat C produced a somewhat larger dent (Figure A4). The g-force curve looks almost as severe as the one in Figure A3; however, there is one important difference. Since the metal did deform and contour to the curvatures of the head, the pressure in pounds per square inch on the head would be much less than in the previous figure and the danger of injuries reduced accordingly.

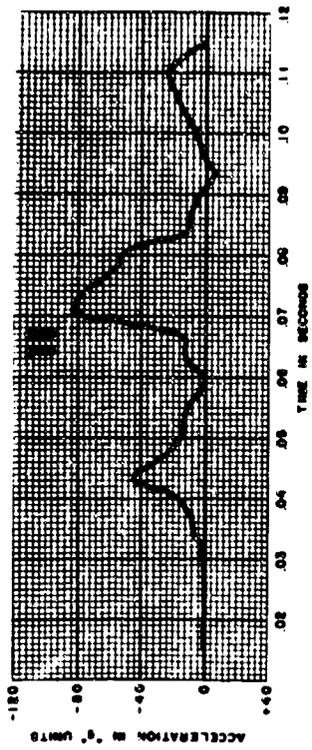
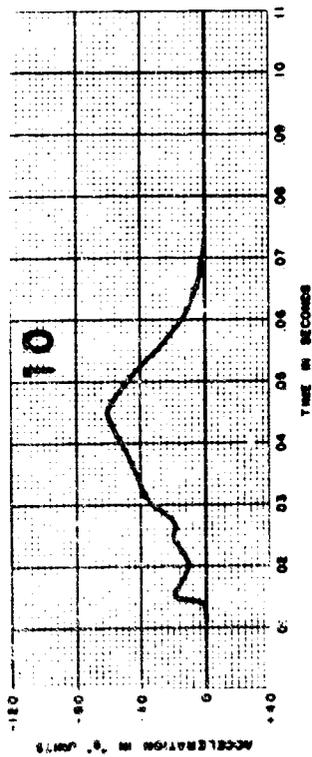
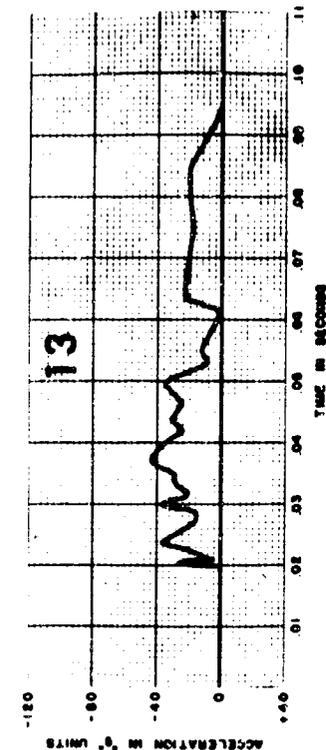
FIGURE A5. Seat D.

Three impacts against Seat D in Figure A5 show that it is a fairly safe seat for head impact. The top edge of the left seat back (test #10) deformed 11 inches and contoured perfectly to the head. Note that initial bending of the structure started at 20g and that the force is spread out with a slow rise time and a peak of not over 60g. Test #13 against the top rear surface of the right seat back shows a more desirable pattern. The head did not experience over 40g; however, test #11 against the tubular cross member at the bottom of the right seat back produced peak forces in excess of 80g. Throughout this report this type of tubular structure is shown to be very dangerous and undoubtedly causes a large number of head and leg fractures. This area of the seat requires additional safety-design consideration.

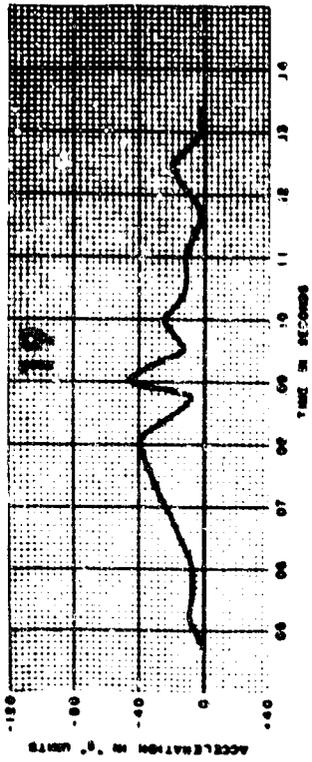
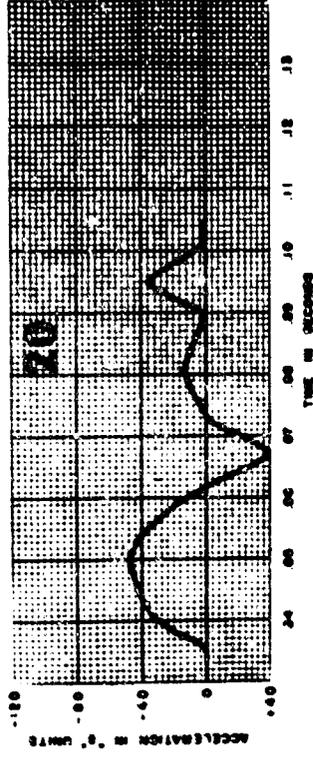
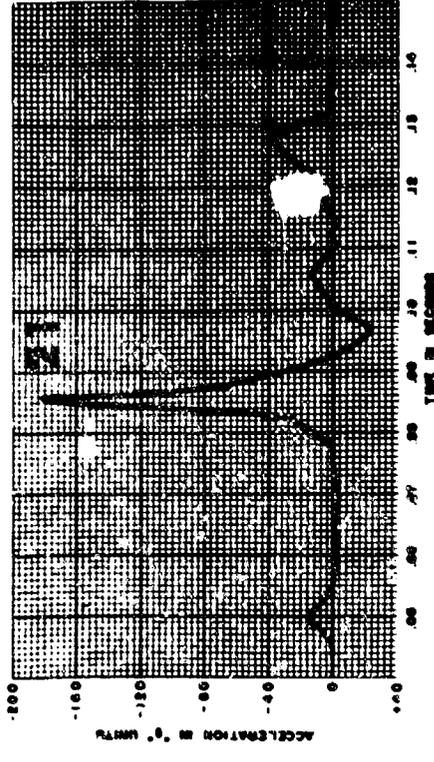
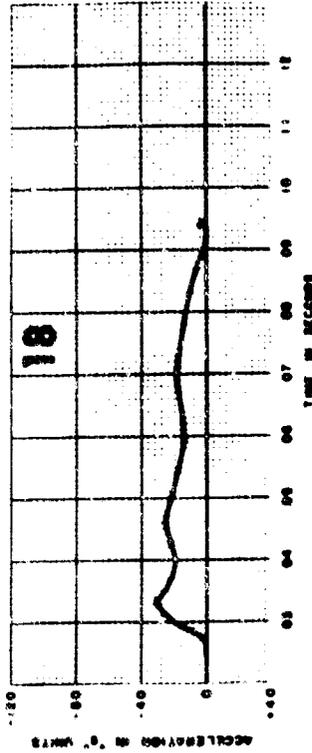
FIGURE A9. Seat E.

Seat E in Figure A6 (mostly fabricated of sheet aluminum) is shown by the force curves to have very good deforming characteristics with the exception of the lower tubular cross member, which produced fatal impact forces of 180g.

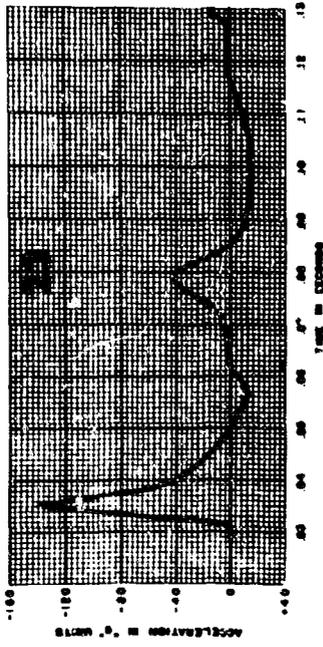
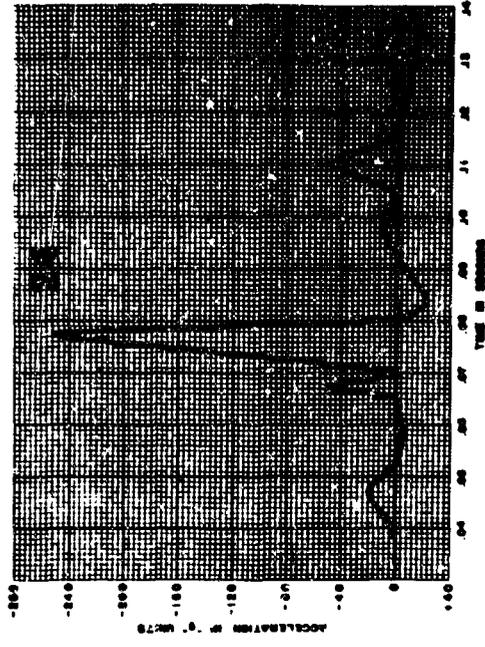
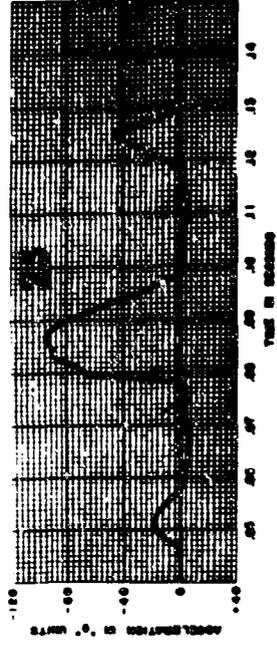
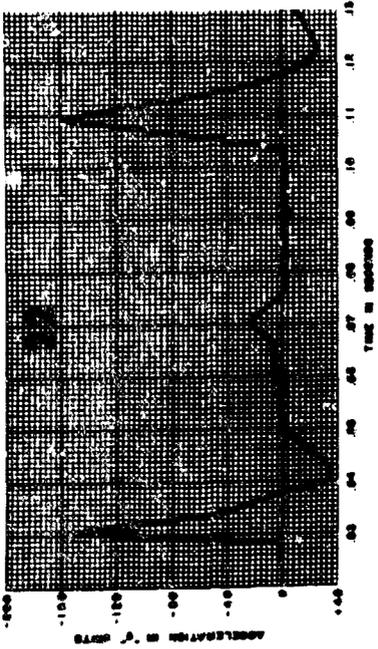
FIGURE A7. Seat F.

Seat F (Figure A7) is constructed of aluminum tubes and produced high forces during all impacts. The most dangerous part of the seat, however, is the aft end of the rigid seat arm protruding rearward between the seat backs. Test #24 against one of these arms produced a peak force of 250g.

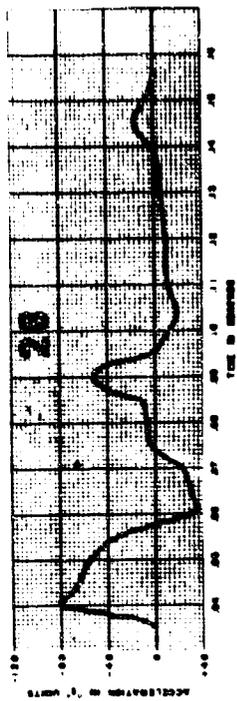
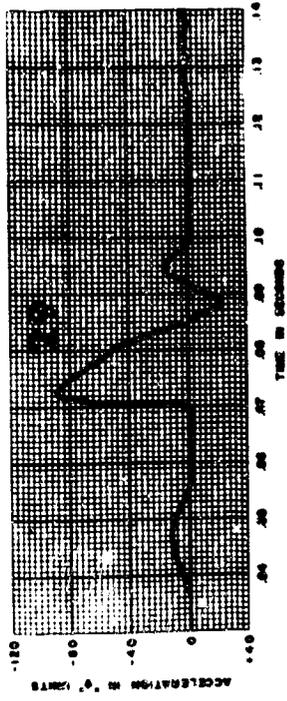
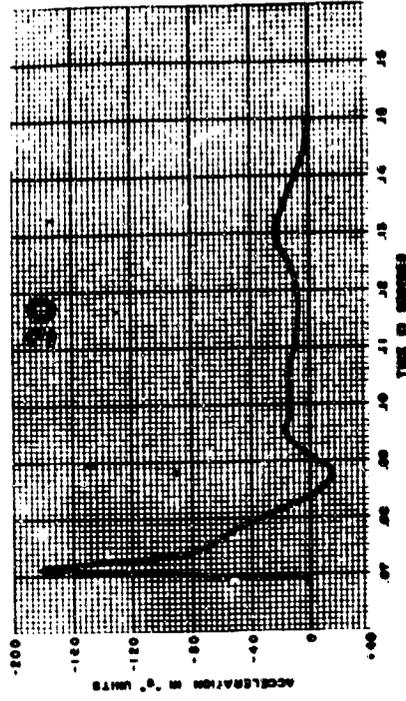
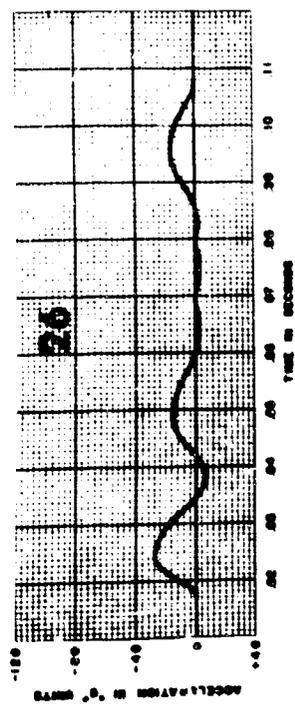
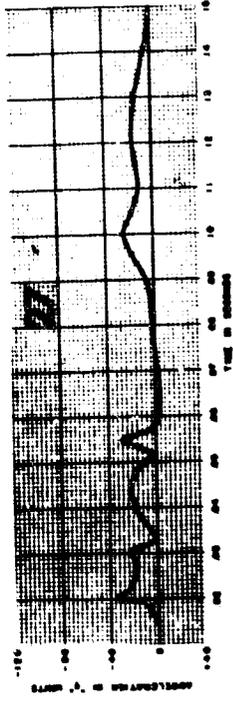
FIGURE A8. Seat G.

Seat G (Figure A8), similar in construction to that shown in Figure A4, produced low g-forces on the upper structure but again pointed out the danger of the rigid arm (test #30—180g).

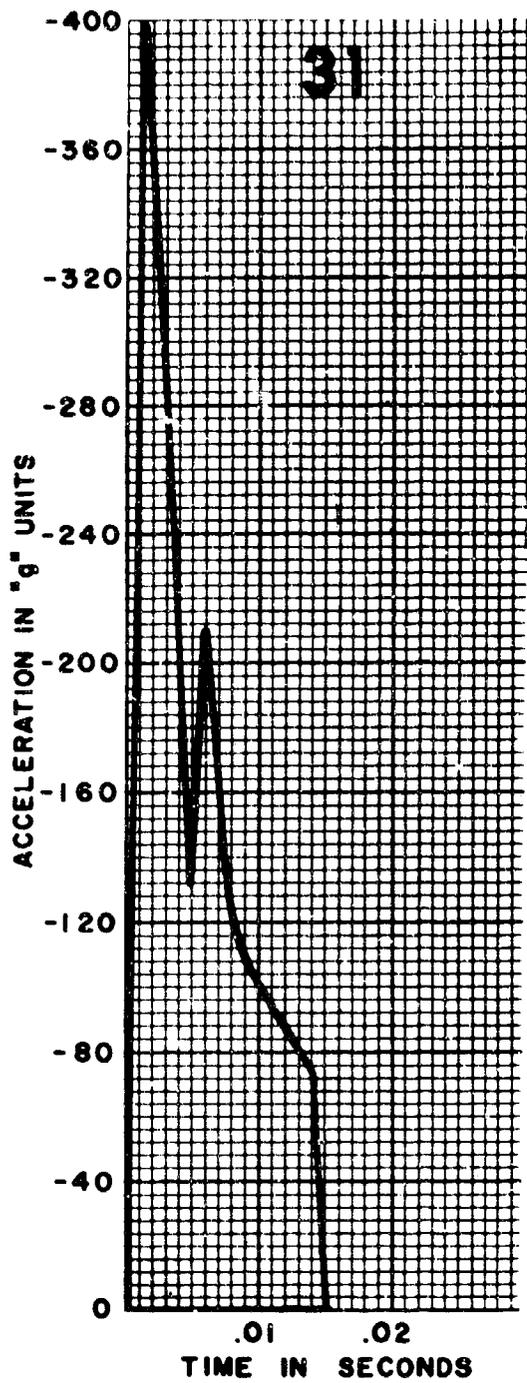
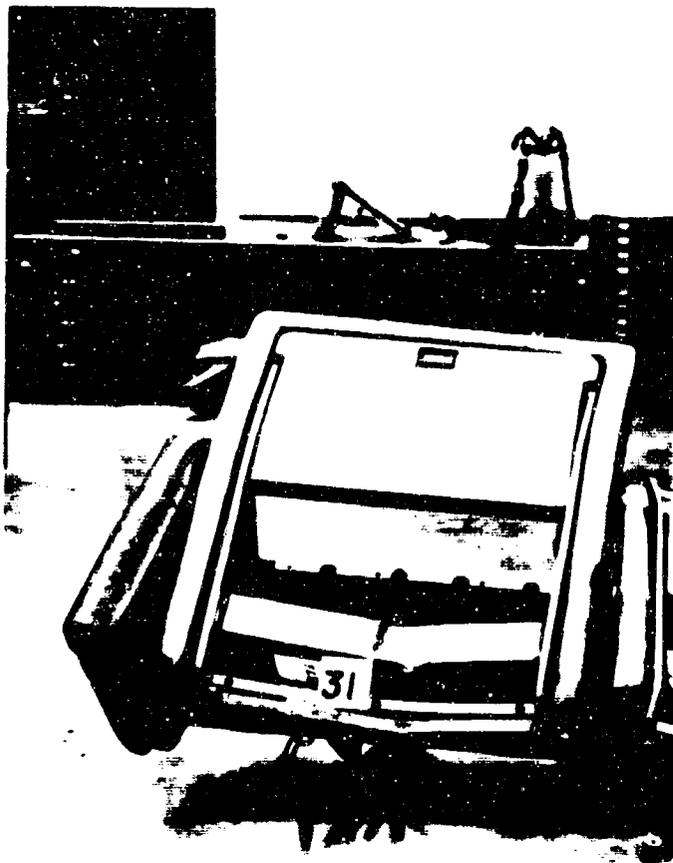
FIGURE A9. Seat H.

Seat H has two heavy, square-edged, tubular structures in the lower portion of the seat back. Tests #31 (Figure A9) and #32 (Figure A10) show unusually high g-forces when these rigid structures are impacted. The top of the seat back is also of square tubular construction and

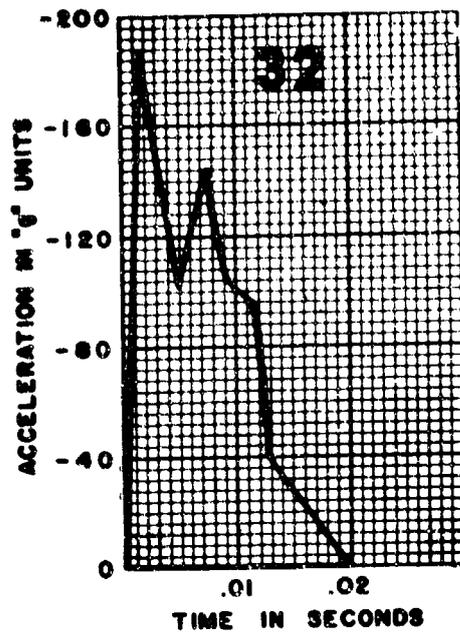
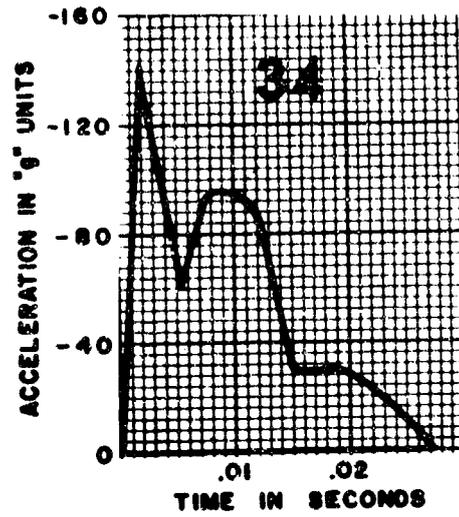
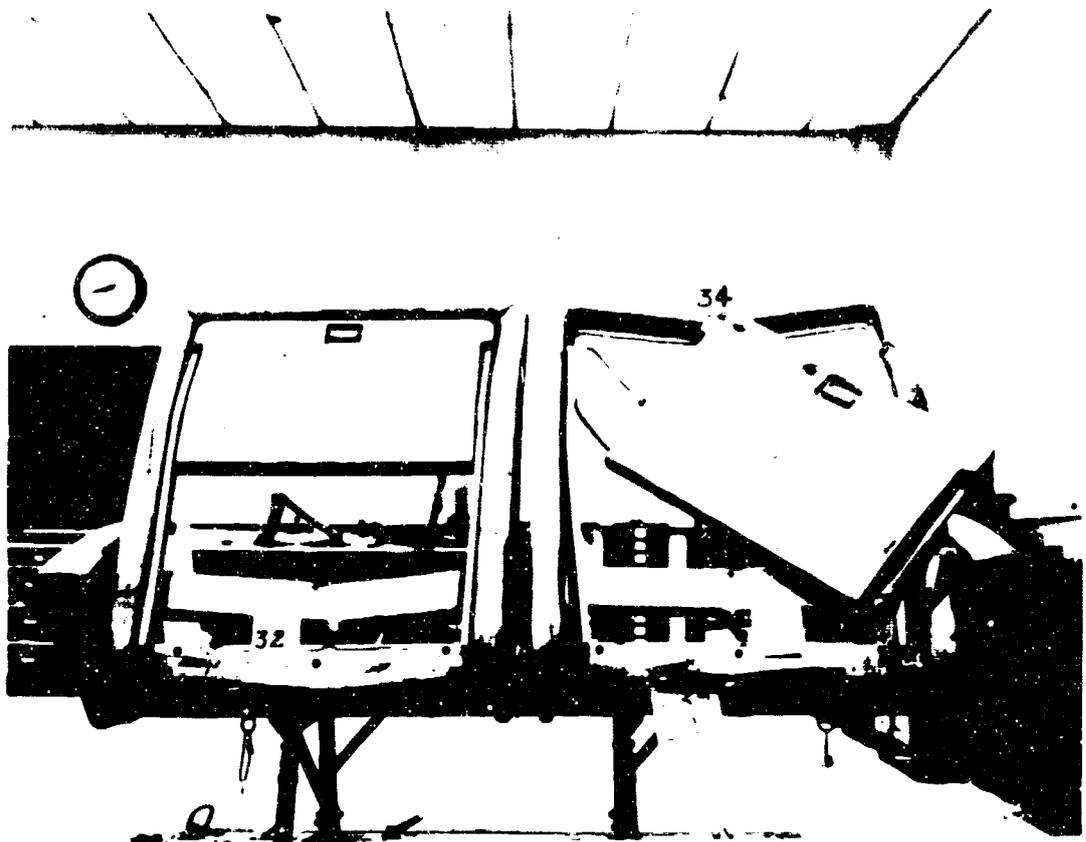
FIGURE A10. Seat II.

produced 140g when impacted (#34, Figure A10).
