**Final Report of the  
Pre- and Postshot  
Structural Survey**

D. M. Harvey/M. W. Jackson/F. A. Linville  
HOLMES AND NARVER, INC

FINAL REPORT OF THE  
PRE- AND PCSTSHOT STRUCTURAL SURVEY  
PROJECT DRIBBLE  
SALMON EVENT

UNITED STATES ATOMIC ENERGY COMMISSION  
NEVADA OPERATIONS OFFICE

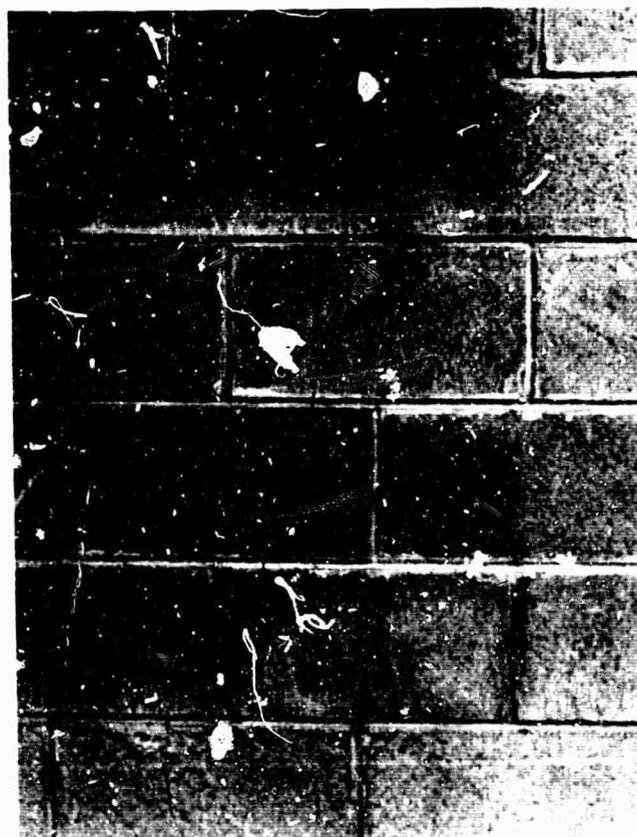
Photo No. 8 - Pre-Shot Shrinkage Cracks, H&N No. 83

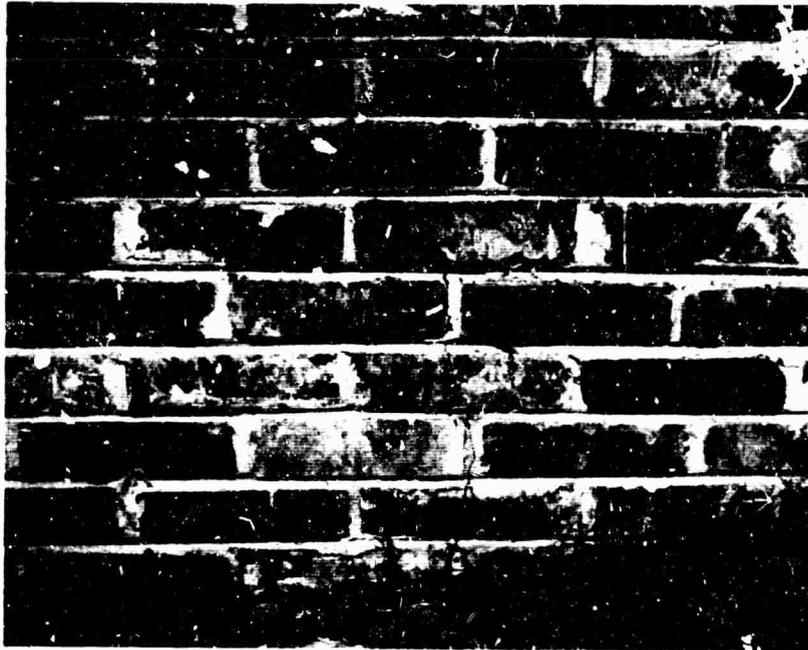
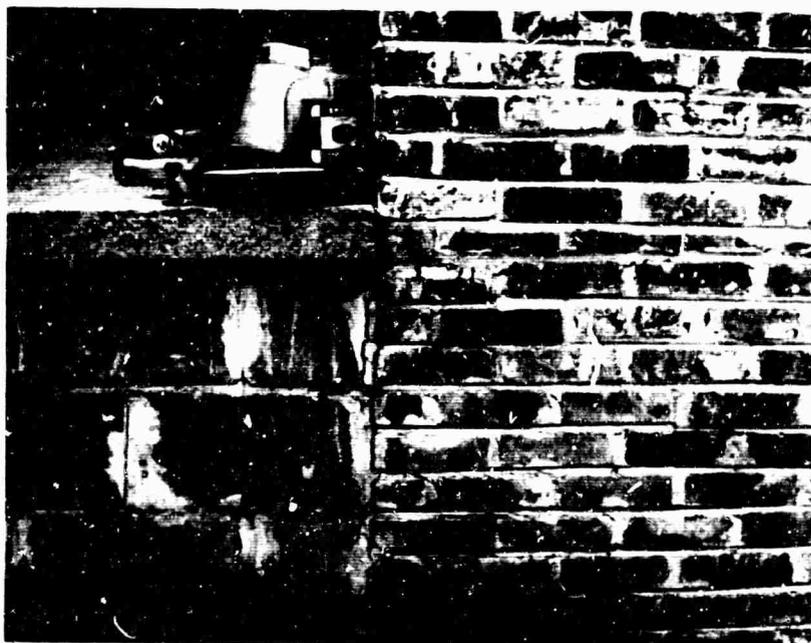
Photo No. 10 - Pre-Shot Cracks, H&N No. 190

Photo No. 11 - Pre-Shot Cracks, H&N No. 190

Photo No. 12 - Pre-Shot Cracks, H&N No. 190

Photo No. 13 - Pre-Shot Cracks, H&N No. 190

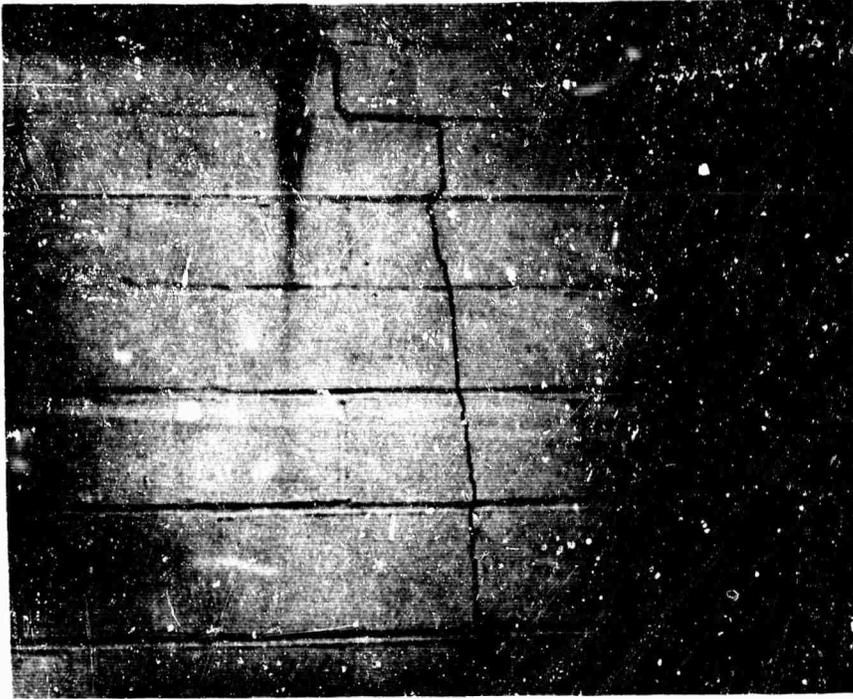
Photo No. 23 - Postshot of H&N No. 116 - Immediately After Event

A group of concrete block structures, the Baxterville School (H&N 116), were surveyed 6,950 meters from SZ. The ground motion was predicted to be 4 cm/sec. A large number of cracks were documented in the pre-shot survey (photos no. 19 to 22). The postshot survey indicated only possible minor aggravation. The engineer's report states, "It is remotely possible that some of the hairline cracks in the masonry have been aggravated". Photo no. 23 is a postshot picture of the crack illustrated in photo no. 22 taken immediately after the event. To determine the increase in the cracks with time, photo no. 24 was also taken of the same crack ten months after the event. It is apparent that there was only a small increase in the size of the crack.

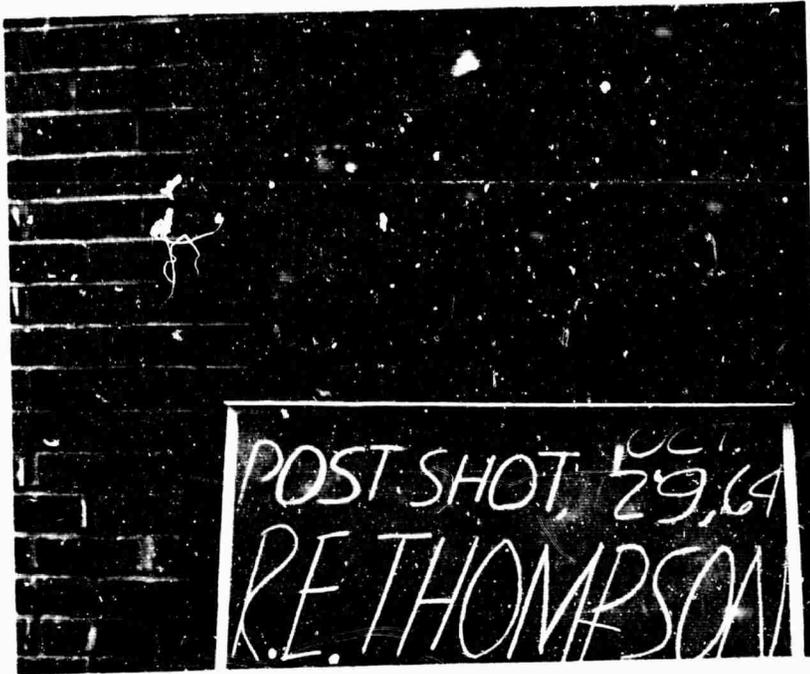
Photo No. 32 - Postshot Cracking in H&N No. 66 Chimney

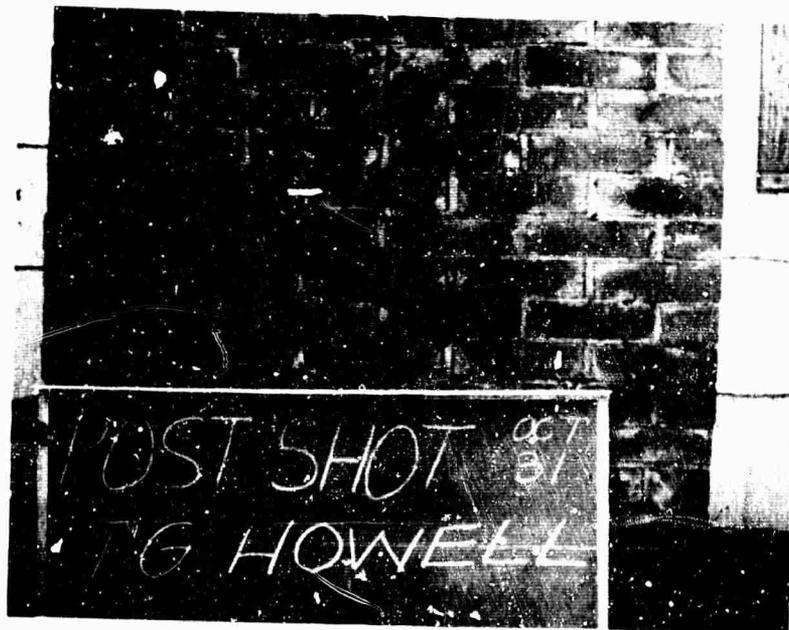
Photo No. 36 - Postshot Cracks in H&N No. 256 Chimney

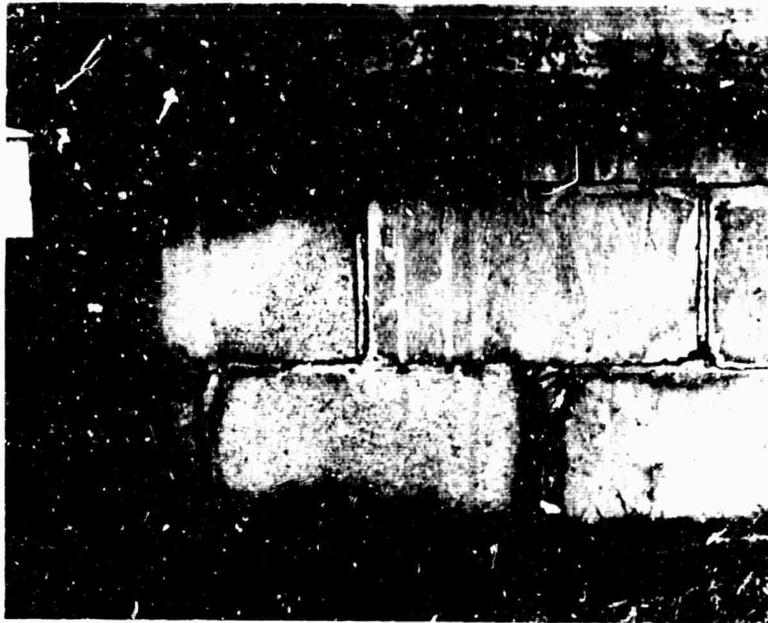
Photo No. 43 - Postshot Cracks in H&N No. 228 Porch Footing

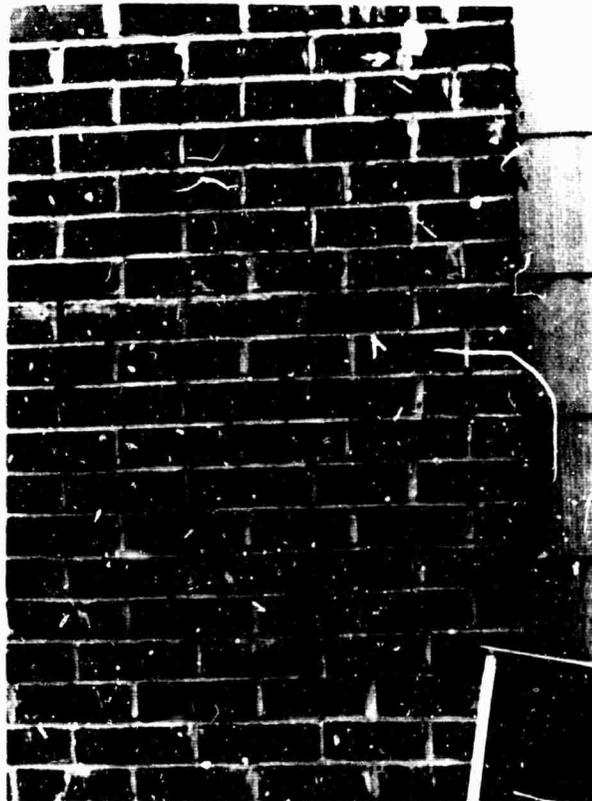
Photo No. 44 - Postshot Cracks in H&N No. 228 - Chimney

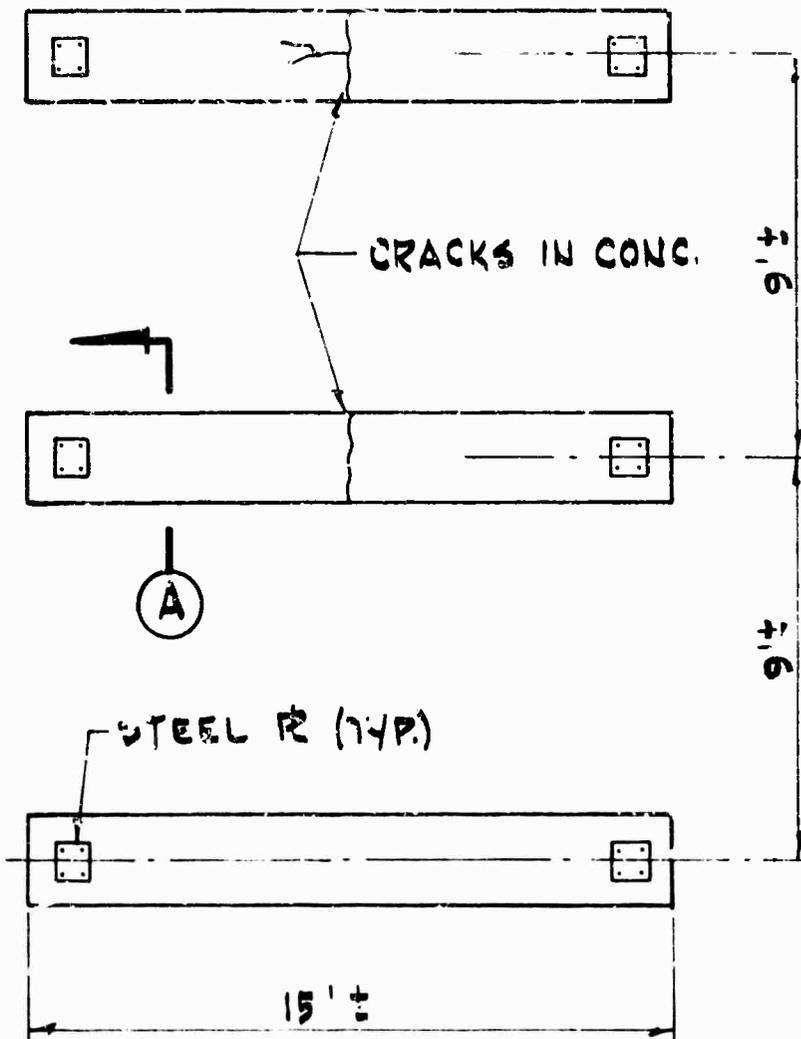
TOWER FOUNDATION PLAN

NOTE: NO DAMAGE TO THE STRUCTURAL STEEL WAS OBSERVED.

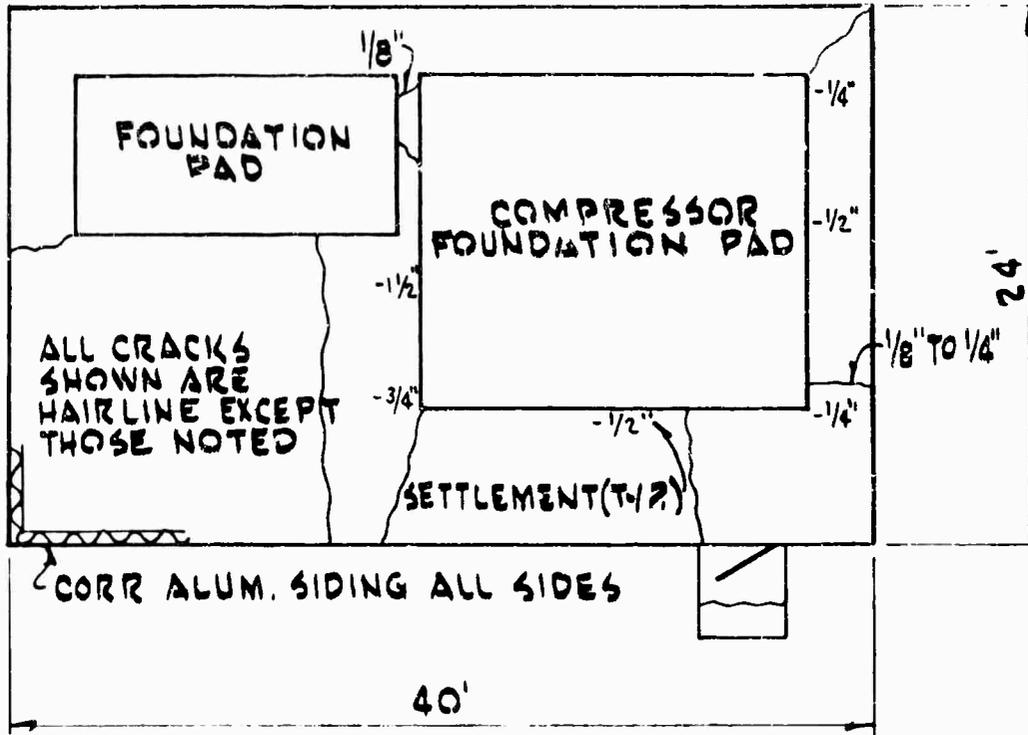
SKETCH No 5  
POST SHOT CRACKS OF  
COMPRESSOR HOUSE

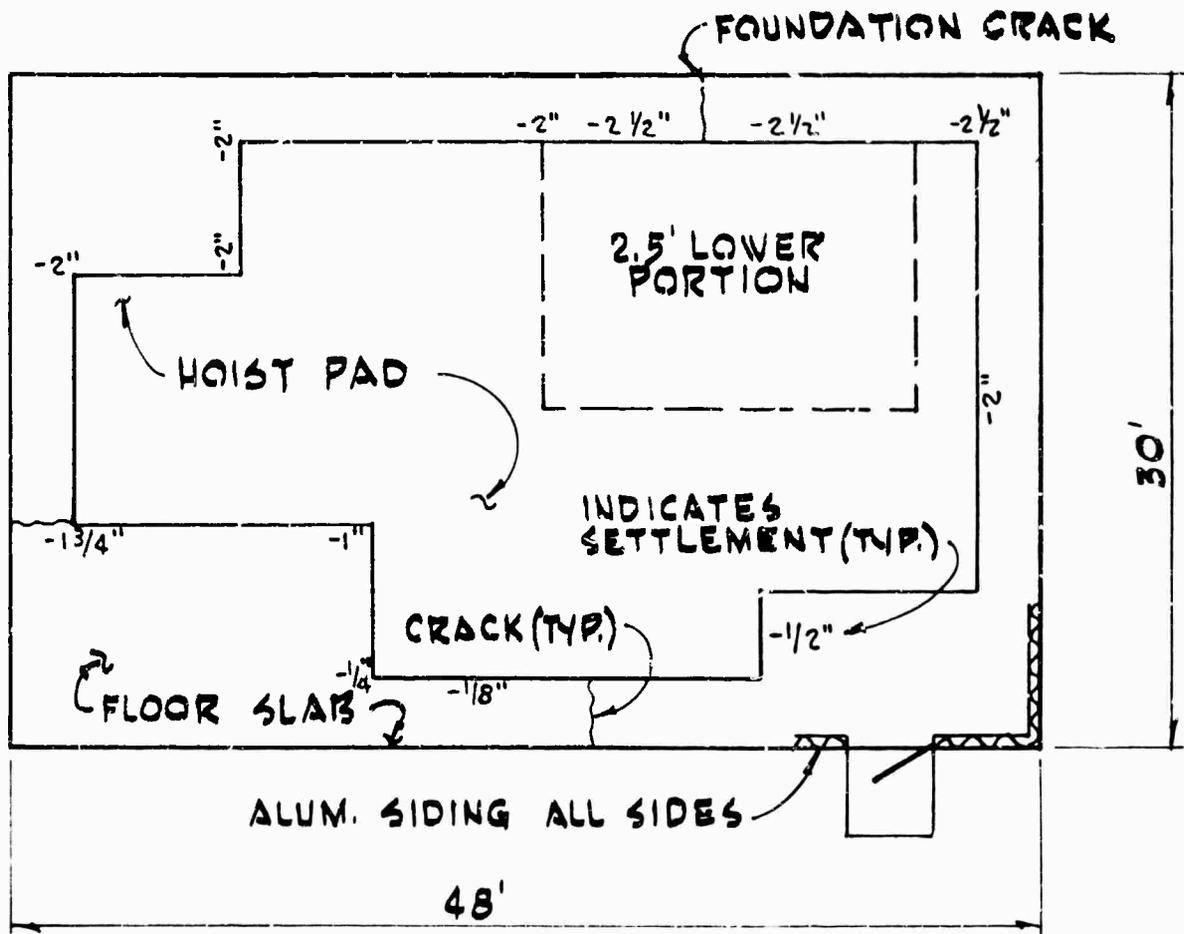
HOIST HOUSE NO 1 FLOOR PLAN  
NO SCALE

NOTE: THERE ARE VARIOUS MISC. CRACKS IN THE FLOOR IMPOSSIBLE TO TRACE BECAUSE BUILDING IS FILLED WITH BOXES AND CARTONS.

POSTSHOT CRACKS IN HOIST HOUSE  
NO 1 SLAB
