Technical Note N-1045

CATHODIC PROTECTION OF MOORING BUOYS AND CHAIN --  
PART V. CONTINUED STUDIES WITH CABLES PROVIDING  
CONTINUITY

August 1969

NAVAL CIVIL ENGINEERING LABORATORY  
Port Hueneme, California 93041

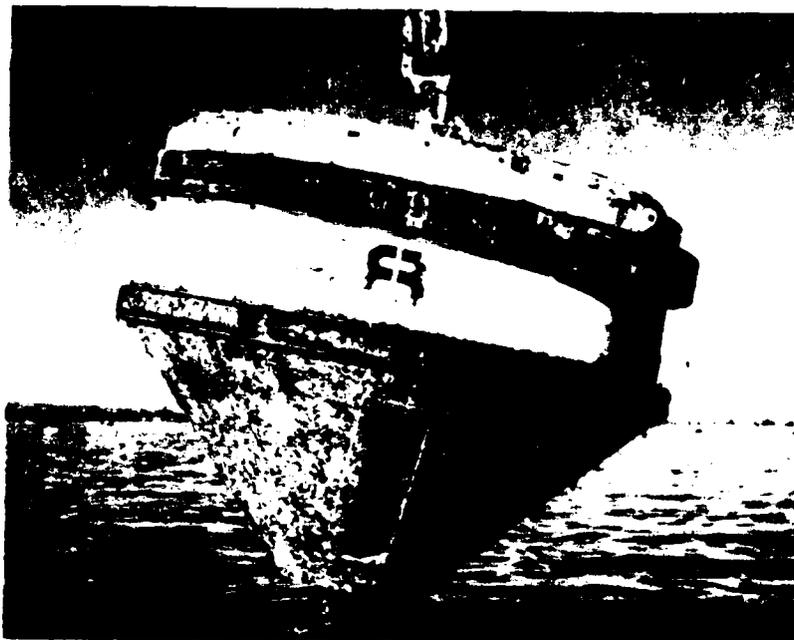
Eleven months after relocation of the cathodically protected mooring, the buoy was lifted from the water for the annual inspection specified in BUDOCKS Instruction 11153.4B. At that time the buoy was in excellent condition except for extensive marine borer damage to the lower wooden fender (Figure 4). There was very little corrosion above water (a few pinpoint rust spots) and none below. The riser chain showed no deterioration and the paint was still intact. A routine thickness measurement with a pair of calipers (Figure 5) revealed no reduction in chain thickness but a slight increase due to the thick paint. Both the buoy and the riser chain had medium to heavy marine fouling typical of other moorings in the area. Tunicates, barnacles, and green algae were the most typical organisms present. These were removed by high pressure hosing with seawater before the inspection.

Figure 4. Cathodically protected buoy after removal of fouling.
