**Corrosion Analysis of 304 Stainless Steel Wire Rope
and Fittings From a NOMAD Buoy Mooring System
After 34-Months Continuous Service
in the Gulf of Mexico**

T. J. LENNOX, JR.

September 1969

NAVAL RESEARCH LABORATORY
Washington, D.C.

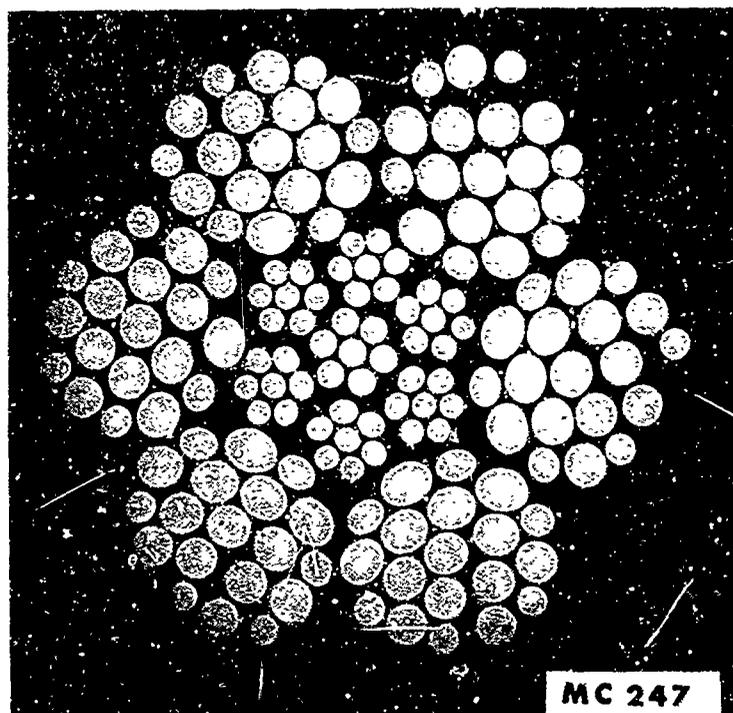
(a) Cross section (5X magnification)

(b) IWRC, center strand, outer wire
(15X magnification)

Fig. 1 - 304 stainless steel wire rope after 34-months continuous immersion as part of a Nomad buoy mooring system, showing the essential absence of corrosion at a distance of 11-13 ft from the top of the wire rope.

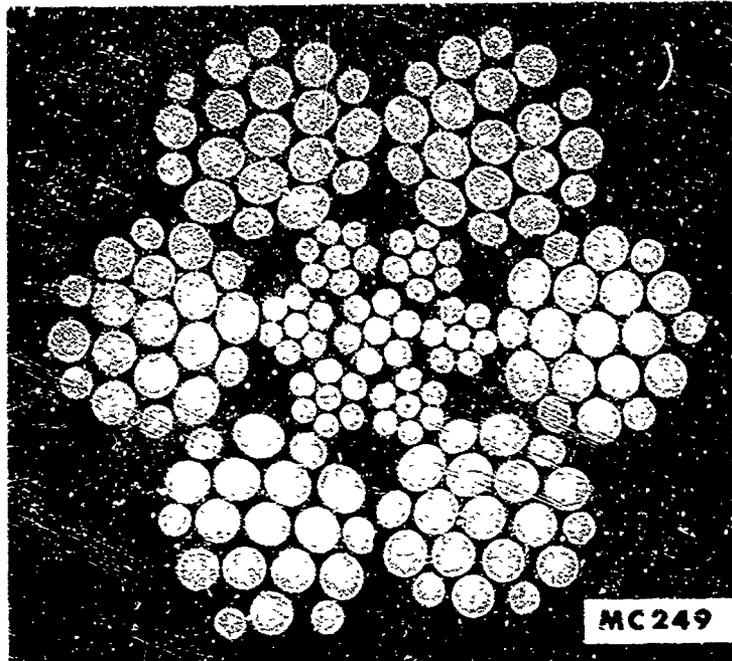
A definite transition was visually apparent between 1005 ft and 1009 ft. This transition was a change from a dark surface film to a heavily rusted condition beneath the neoprene jacket which covered the bottom 250 ft (approximately) of the wire rope. Only slight corrosion was observed just above and 4 in. outside the neoprene jacket. The condition of the wire rope at the rusted end of the transition area has been shown in Fig. 2.

(a) Cross section (5X magnification)

(b) Outer strand, inner wire
(15X magnification)

(c) IWRC, center strand, outer wire
(15X magnification)

Fig. 2 - 304 stainless steel wire rope after 34-months continuous immersion as part of a Nomad buoy mooring system, showing the moderate-to-severe corrosion at a distance of 1006 ft-7 in. to 1008 ft-7 in. from the top of the wire rope (rusted end of transition - under neoprene jacket).

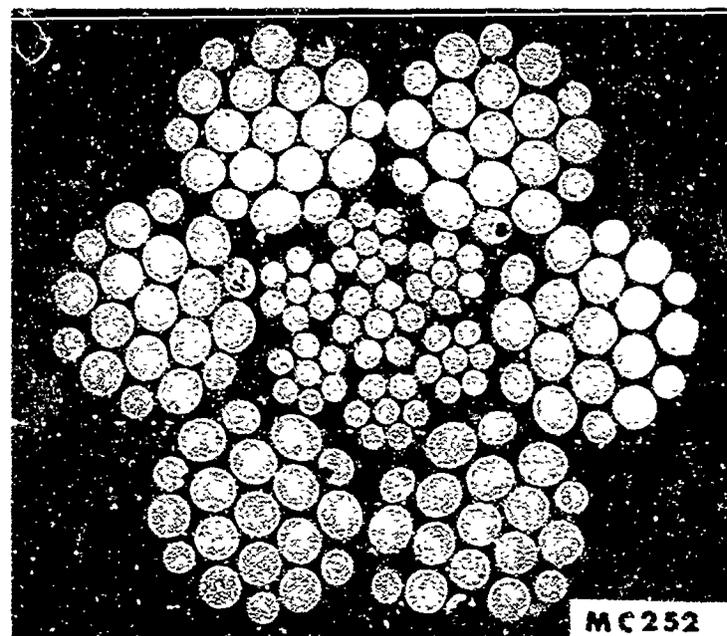
As would be expected when 304 stainless steel was shielded and not effectively cathodically protected, the corrosion under the neoprene jacket was quite severe. The tunnelling (black areas in cross-section photographs), deep pitting, and crevice corrosion that occurred on individual wires located between 1009 ft and 1233 ft from the top have been shown in Figs 3, 4, and 5. This tunnelling, deep pitting, and crevice corrosion was typical for 304 stainless steel corrosion in quiescent seawater.

(a) Cross section (5X magnification)

(b) Outer strand, inner wire
(15X magnification)

(c) IWRC, center strand, outer wire
(15X magnification)

Fig. 3 - 304 stainless steel wire rope after 34-months continuous immersion as part of a Nomad buoy mooring system, showing (a) tunnelling and (b) and (c) severe corrosion at a distance of 1008 ft-7 in. to 1010 ft-7 in. from the top of the wire rope (under neoprene jacket).

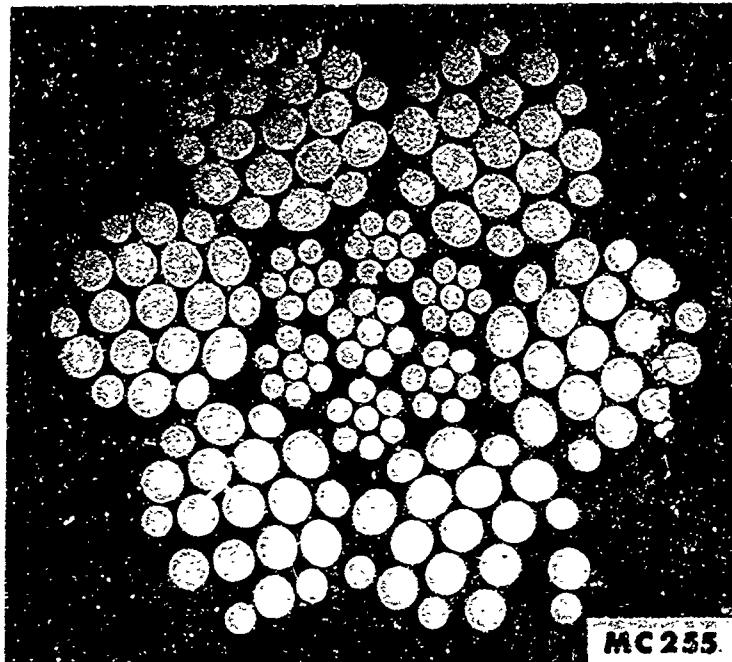
(a) Cross section (5X magnification)

(b) Outer strand, large outer wire
(15X magnification)

(c) IWRC, center strand, outer wire
(15X magnification)

Fig. 4 - 304 stainless steel wire rope after 34-months continuous immersion as part of a Nomad buoy mooring system, showing (a) limited tunnelling, but (b) and (c) deep pitting on individual wires at a distance of 1088 ft-8 in. to 1090 ft-8 in. from the top of the wire rope (bright appearance under jacket).

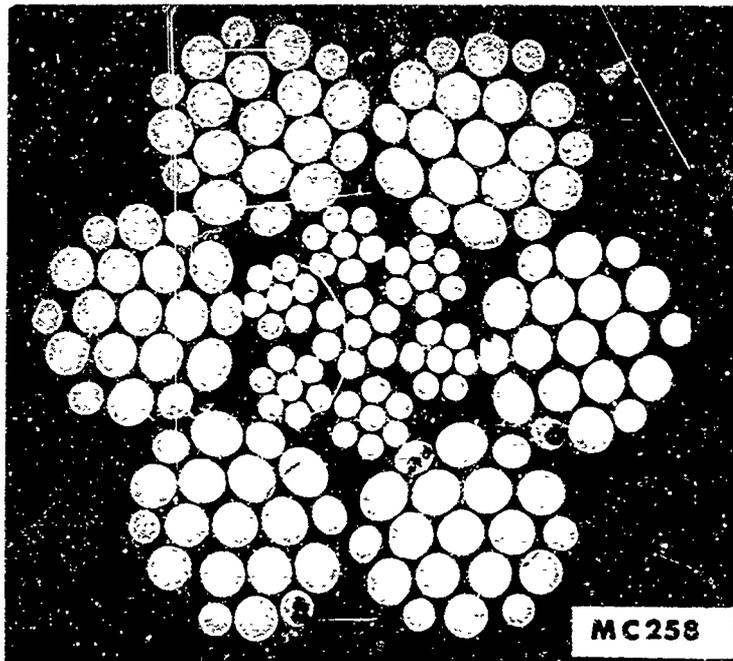
(a) Cross section (5X magnification)

(b) Outer strand, outer small wire
(15X magnification)

(c) IWRC, center strand, outer wire
(15X magnification)

Fig. 5 - 304 stainless steel wire rope after 34-months continuous immersion as part of a Nomad buoy mooring system, showing (a) severe tunnelling, (b) pitting and crevice corrosion, and (c) cracked area of a wire at a distance of 1231 ft-5 in. to 1233 ft-5 in. from the top of the wire rope.

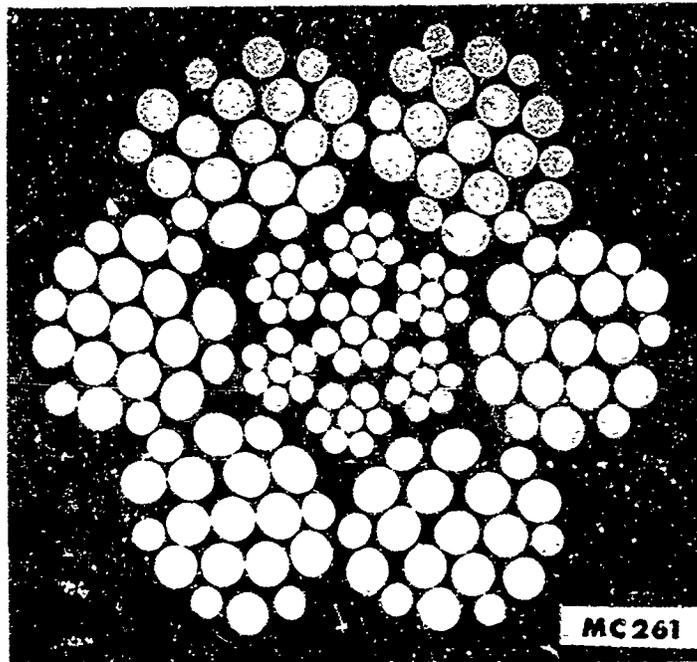
Fig. 6 - 304 stainless steel wire rope after 34-months continuous immersion as part of a Nomad buoy mooring system, showing the good condition of the wire rope under a cable clamp at the top of the wire rope (5X magnification).

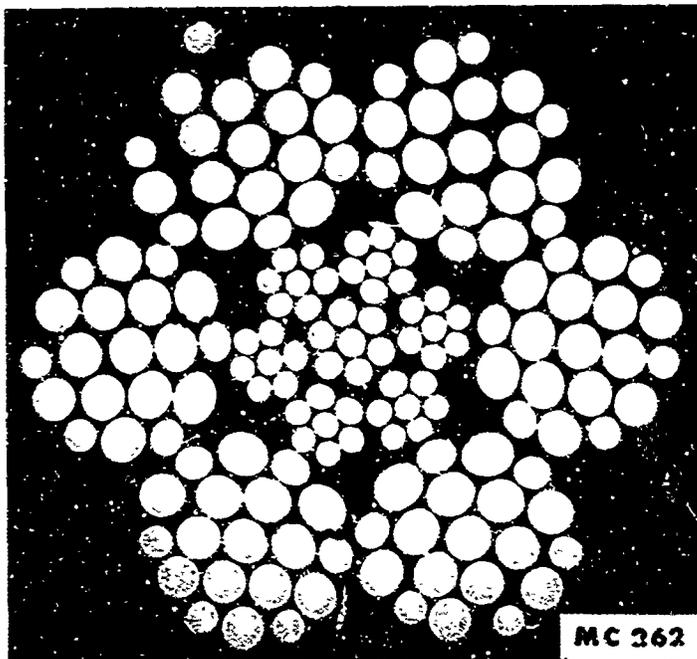
Fig. 7 - 304 stainless steel wire rope after 34-months continuous immersion as part of a Nomad buoy mooring system, showing corrosion at periphery of some wires under a cable clamp near the bottom of the wire rope (clamp and wire rope shielded with tape) (5 magnification).

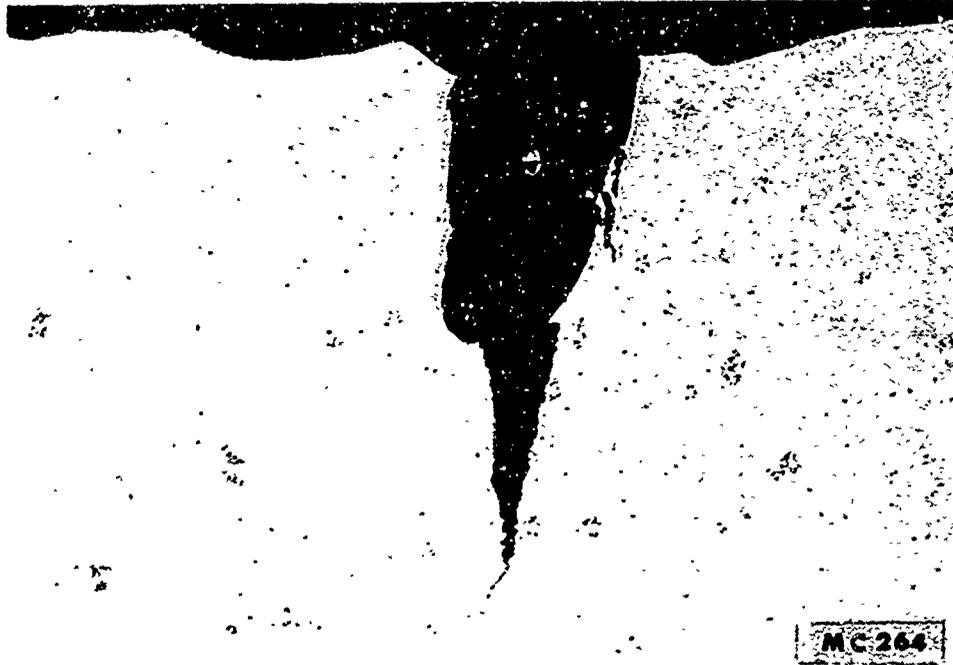
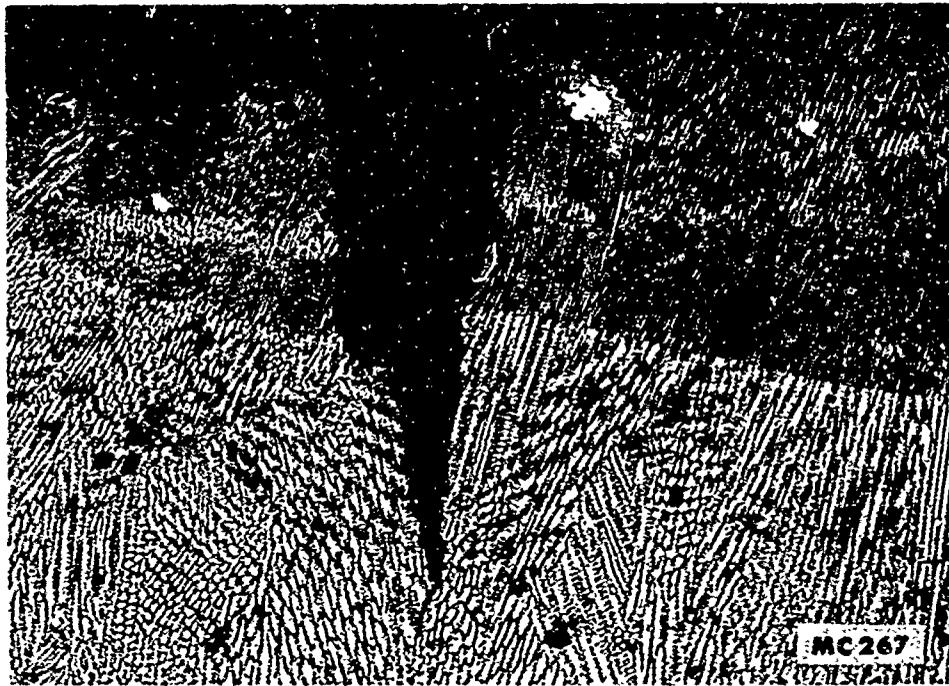
The overall condition of the upper and lower 304 stainless steel fittings, i.e., cable clamps, clamp nuts, and tube thimbles was generally excellent. Some shallow pitting had occurred, however, on the base metal of the tube thimble in the heat-affected zone caused by the welding of a wear plate to the tube thimble. A crack was also evident at the junction of the weld and the tube thimble located at the top of the stainless steel wire rope. This crack may have been caused by a cold weld or by uncutting during welding. The cracked area before and after electrolytic etching in 10 percent oxalic acid is shown in Fig. 9.

(a) Unetched (100X magnification)

(b) Electrolytic etch - 10% oxalic acid
(100X magnification)

Fig. 9 - Section of 304 stainless steel wire rope tube thimble showing crack which may have been caused by a cold weld or by undercutting during welding.
