INVESTIGATION OF TWO METHODS FOR IMPROVING THE CRASHWORTHINESS OF INTEGRAL FUEL TANKS

FINAL REPORT

1. Report No. FAA-RD-70-56		2. Government Accession No.		3. Recipient's Catalog No.	
4. Title and Subtitle INVESTIGATION OF TWO METHODS FOR IMPROVING THE CRASHWORTHINESS OF INTEGRAL FUEL TANKS				5. Report Date November 1970

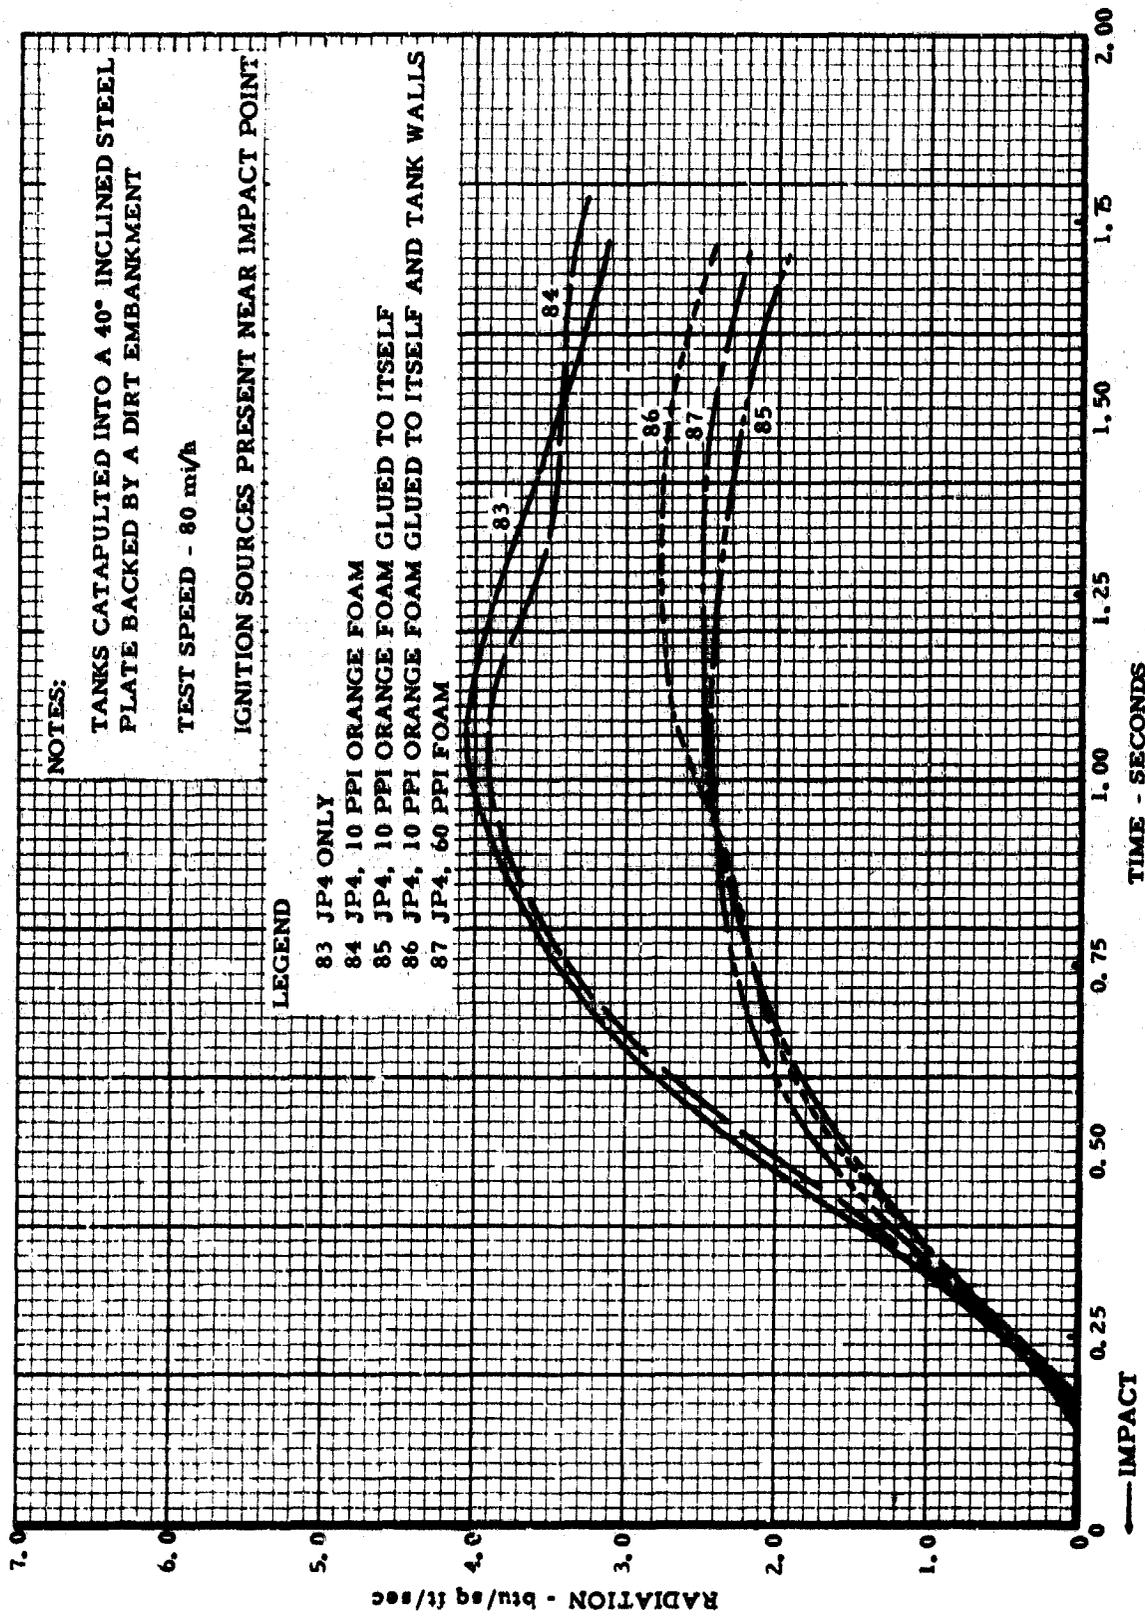
At impact the tanks broke open and the escaping fuel was ignited by burning smudge pots placed around the impact area. All of the fuel burned in the immediate vicinity of the impact area when the control tank containing JP-4 only was tested. On the other tests the fuel-soaked foam carried some of the burning fuel away from the impact area which accounts for the lower radiation readings for these tests as shown in Figure 6. Assessment of the high-speed photographs of these tests was made to determine if there was any substantial decrease in time for ignition of the fuel following impact. In all configurations tested, the fuel spray ignited within a time interval ranging from 40 milliseconds to 60 milliseconds after impact. This difference was considered to be quite insignificant.

FIGURE 6 RADIOMETER RESULTS OF F-86 FUEL TANK CATAPULT TESTS

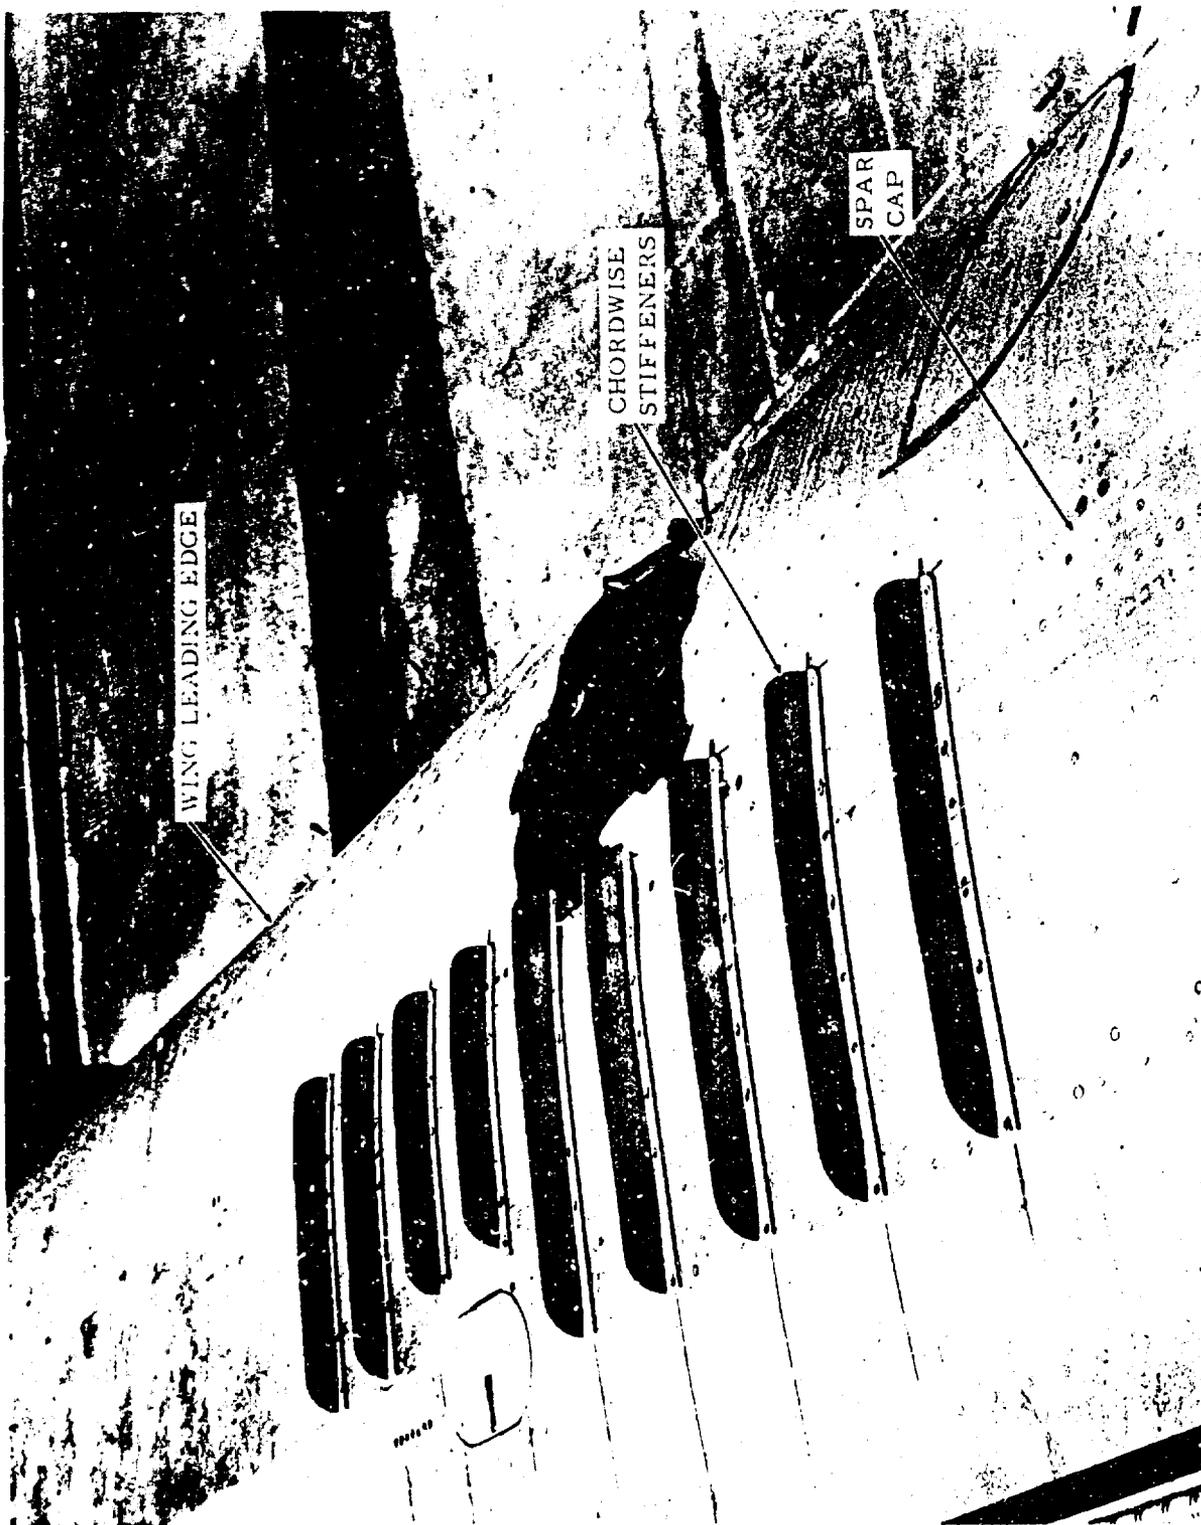
As shown in Figure 7, the tee sections were attached to the test specimen only in the immediate vicinity of the impact area. The actual weight of the tee was 8.24 pounds for this test, but extrapolation of this modification to the entire span of the outer wing panel would result in a total weight of tee sections of 45.5 pounds. The 0.020-inch-thick aluminum doubler weighed 15.5 pounds making the combined weight of structural reinforcement 61.0 pounds for the entire outer wing panel. Since the DC-7 outer panels weighed approximately 1000 pounds empty, this modification resulted in a 6 percent increase in weight. However, the 0.020-inch-thick doubler added no significant chordwise strength, and if retrofitted internal to the panel, the tees would be reduced in overall length by approximately the width of each stringer less its flange; thus decreasing the overall weight an additional increment so that at most the overall weight might be 40 pounds or only a 4 percent increase in dry wing weight.

The wing modified with the 0.040-inch-thick aluminum doubler ruptured almost as much as the unmodified control wing panel after impact, but the wing with the 0.020-inch-thick aluminum doubler and the 1 1/2-inch tee sections did not rupture upon impact.

FIGURE 7 CHORDWISE STIFFENERS ON DC-7 INTEGRAL WING TANK

2. The addition of 0.040-inch-thick aluminum alloy doubler strips aft of the upper and lower front spar caps did not appreciably increase the resistance of the integral tank structure to damage by impact. However, reinforcement of the front spar caps and internal chordwise structure between ribs such as simulated in these tests, can reduce damage to the point of preventing fuel leakage after impact.
