# TARGET RESPONSE TO EXPLOSIVE BLAST

Final Report  
By  
George H. Custard  
John R. Thayer  
Falcon Research and Development Company  
Denver, Colorado

September 1970

ARMED SERVICES EXPLOSIVE SAFETY BOARD  
FORRESTAL BUILDING  
WASHINGTON, D. C.  
Contract No. DAHC04-69-C-0095

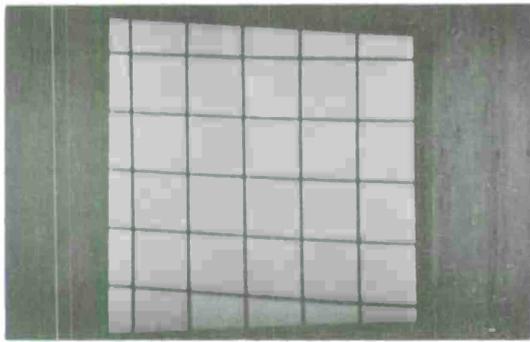
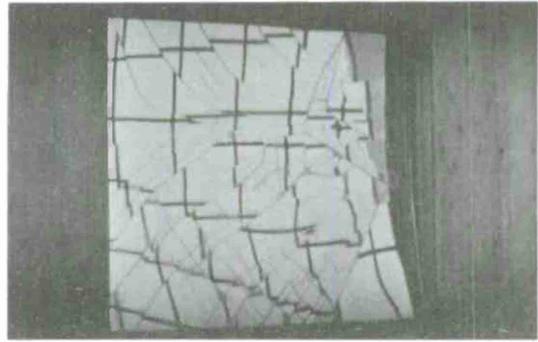
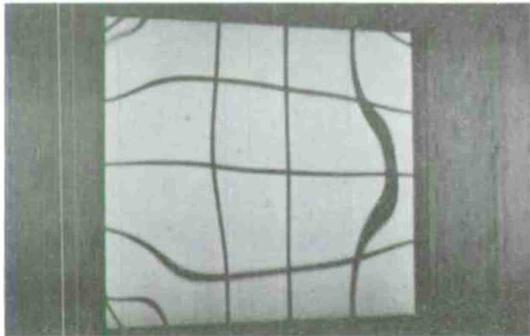
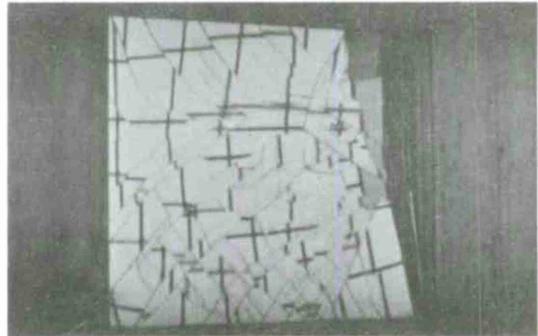
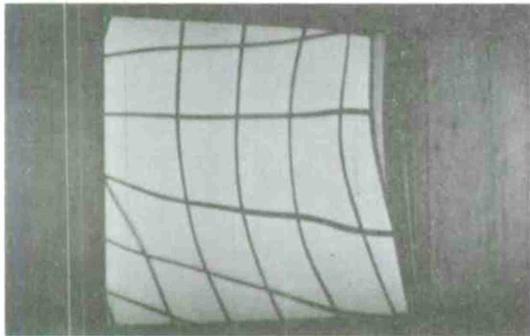
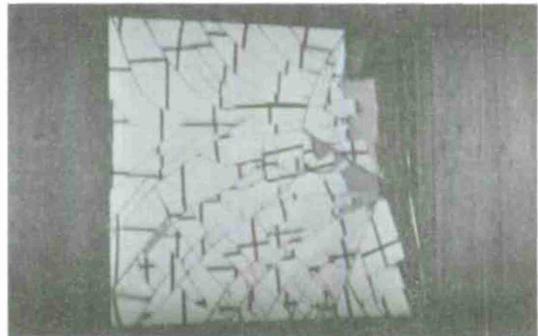
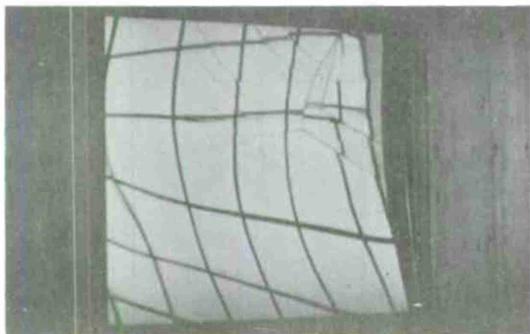
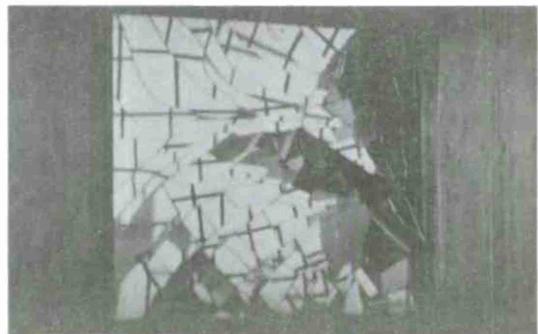
Figure 11. Selected Frames from the Film Record of Window Breakage Taken at 1,000 Frames/Second.

All cameras operated properly on this test and good quality 16-mm photographs of the loading and breakage process were secured. Figures 11 and 12 show series of frames taken from the two film records of the 530-foot window test. These photographs were taken at 1000 and 400 frames per second for Figures 11 and 12 respectively. An analysis of the film records shows that the first cracking of the window took place 35 milliseconds after shock arrival and that the breaking process continued for an additional 10 milliseconds.

The deflection of this window was somewhat more complex than a simple oscillation prior to breakage. The center portion of the window appears to complete a full cycle at about 12 milliseconds after shock arrival; however, the surrounding glass has, at times, moved in different directions than the center of the window. At about +23 milliseconds the left side of the window appears to be well forward of its original position and starting to move in a rearward direction while the right side of the window is beginning to move back from the original position. The total deflection at this point in time is sufficient to allow the right side of the window to escape from the supporting moulding. This would have required a radial deflection of about 3 inches if simple window curvature were assumed. The window continues to be held at the top, bottom and left edges even after the right side escapes from its support. It is interesting that breakage did not occur until twelve more milliseconds elapsed and substantially more window motion had taken place. At breakage, or at least soon thereafter the left side of the window can be seen to be moving forward while the right side is moving backward or into the building.

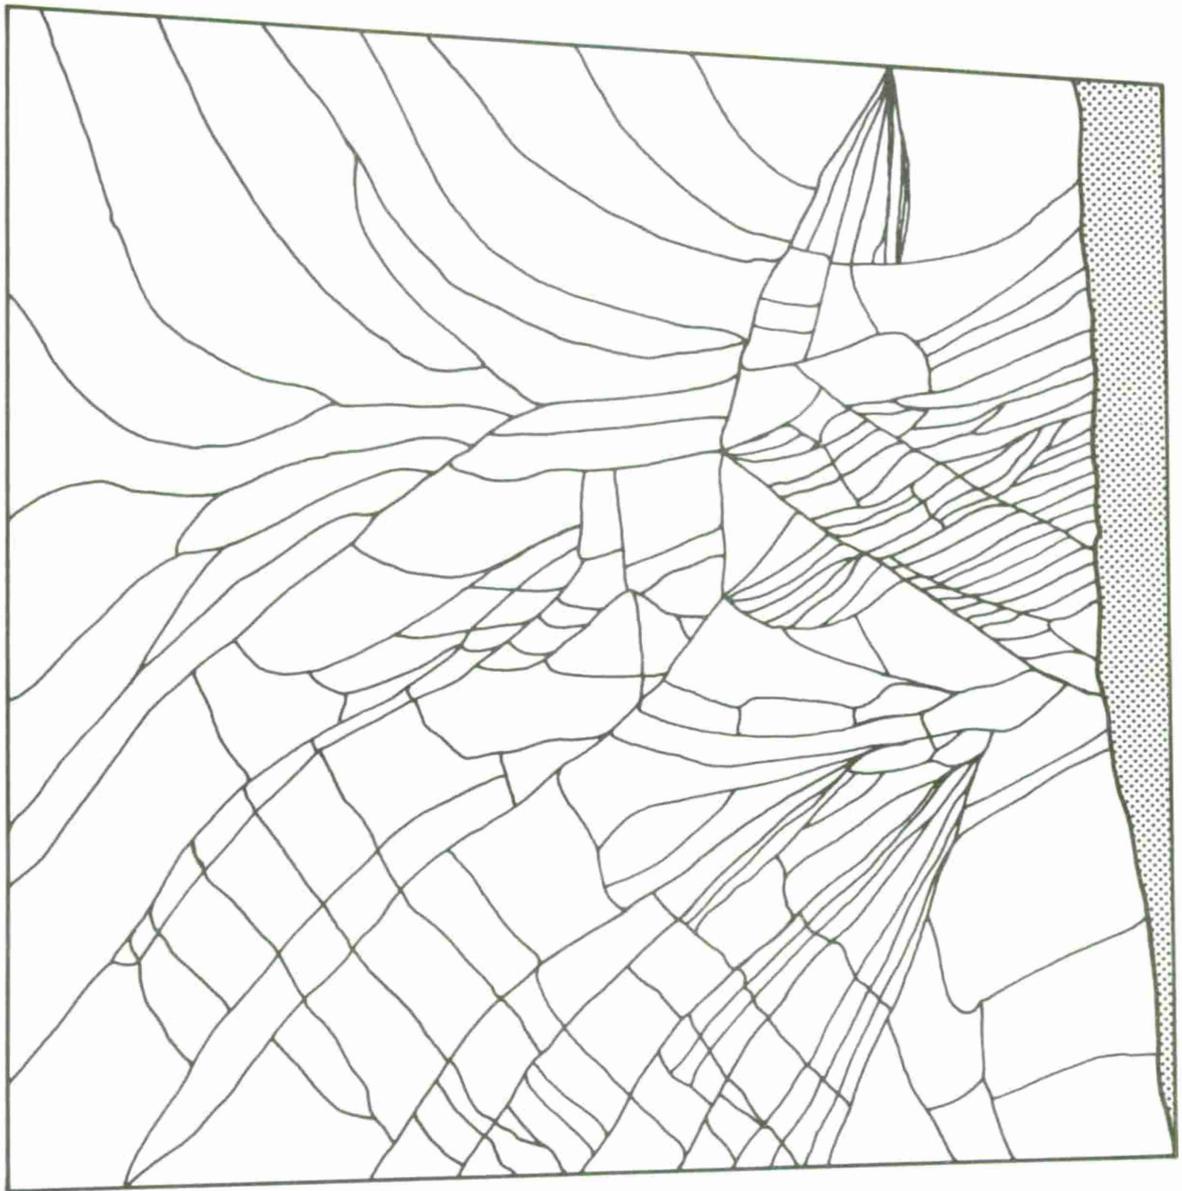
Figure 13. Fragments Produced by the Blast Loading of 4 Ft. by 6 Ft. Plate Glass Window.

in this test of blast interaction with the window. Figure 13 provides a diagram of these fragments. At least for the larger fragments the shape and size of the fragments is clear and can be accurately drawn. The smaller fragments cannot be defined with as much accuracy since they cannot be seen as clearly and since each crack did not always produce a separate fragment. A number of fragments were found on the ground which had cracks within them but which had not been sufficiently fractured to separate. Figure 13 thus represents a best estimate of the discrete fragments into which the window was broken.

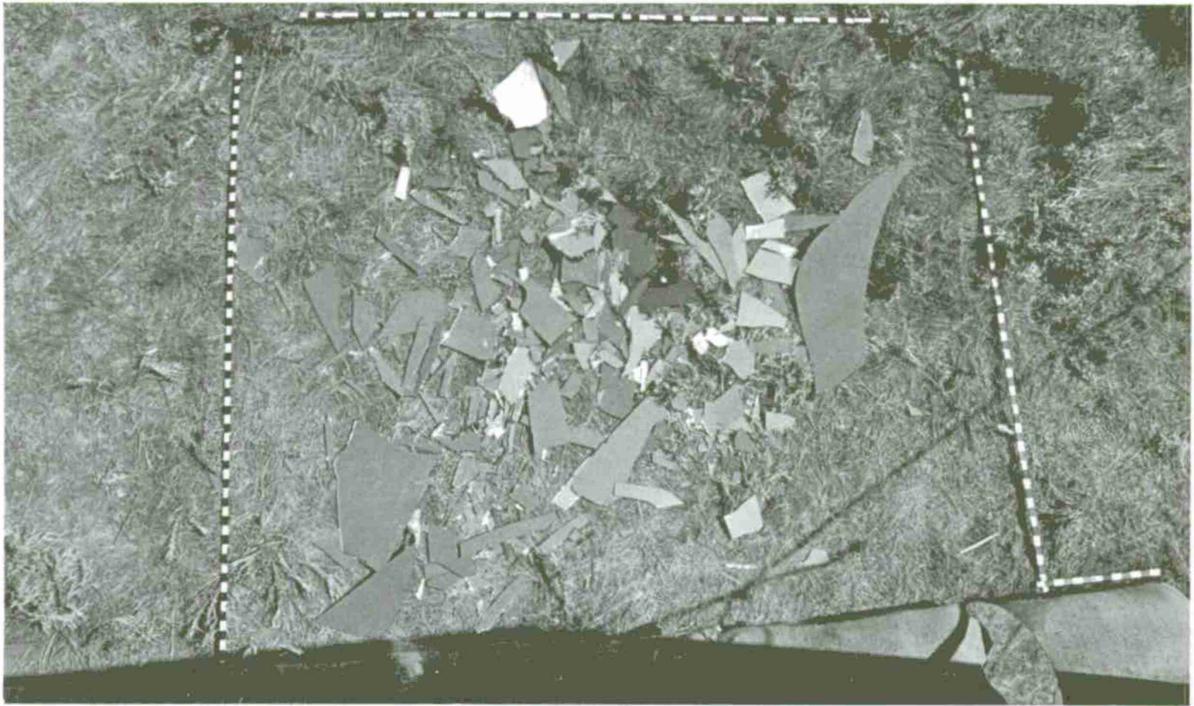
Figure 14. Glass Fragment Distribution Outside the Structure.

The larger fragments which were found on the ground following the test were also examined. Figure 14 shows the pile of fragments which landed outside the building and Figure 15 shows the fragments which went into the building. Very few fragments moved more than six feet forward of the building as they fell outside. Inside the building most fragments were within three feet of the front wall and none reached the back wall, only eight feet away. Approximately 60 percent of the fragment weight fell outside the building and 35 percent inside with 5 percent remaining in or on the window frame.

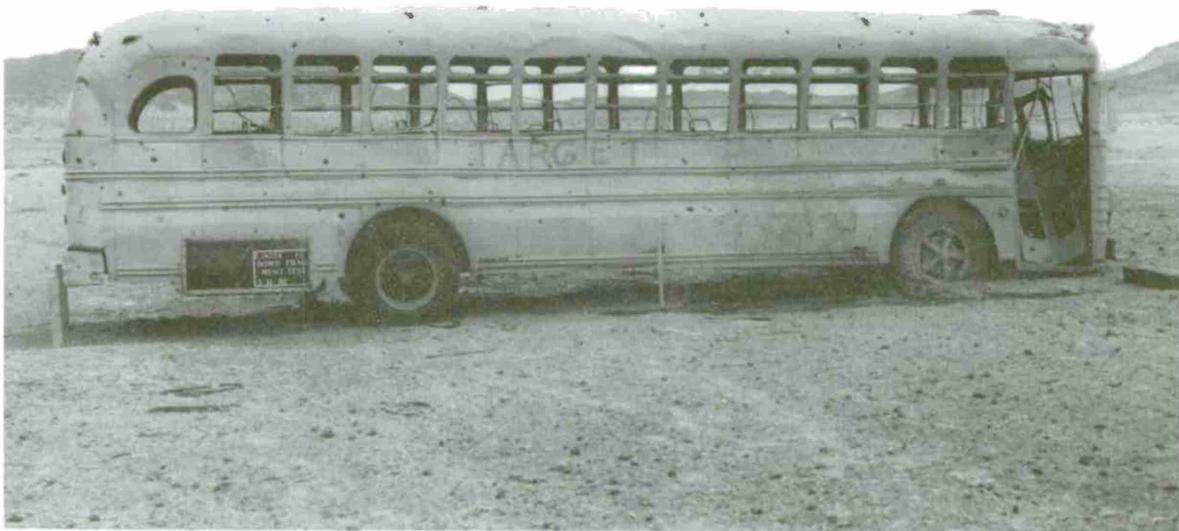
Figure 17. Damaged Bus Following the Test at China Lake.

Both the bus and the pickup were moved laterally by the blast wave. The bus was moved 3 to 4 inches at the front and 7 to 8 inches at the rear. The pickup was moved 5 inches at the front and 4 inches at the rear.

An examination of the earth surface in the vicinity of the tires showed that the tires which were on the far side of the blast had slid along the surface and had dug into the soil at the far edge to a significant extent. Tires on the near side of the vehicle left no marks at all and may have actually been above the surface as the lateral motion took place. This would indicate that the vehicles may have approached an overturning condition but then fell back to their original posi-

The sheet metal of the bus was steel, about 0.030 inch thick. Surface bending of this steel is evident in Figure 17. The sheet metal of the truck was heavier, except for the homemade cab, and was damaged less extensively. Maximum deformation of the bus sidewall was 7 to 8 inches on the near side. The far side of the bus was bulged outward only slightly between the vertical stiffeners. The sheet metal below the floor line was bent outward as much as 3 to 4 inches in some locations on the far side of the bus. The bus door was torn loose at the hinge attachment.

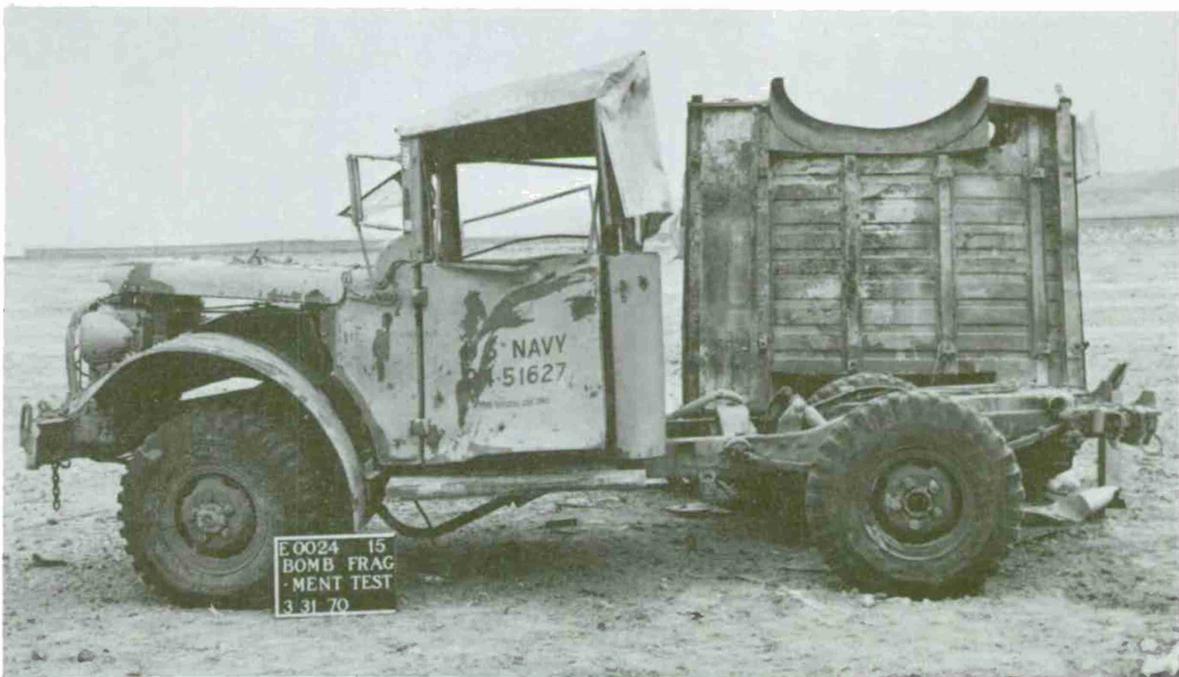
Figure 18. Damaged Pickup-Camper Following the Test at China Lake.

Post test examination indicated that the truck bed had not been securely bolted to the truck frame. An analysis of the potential for overturning the camper body as a separate unit indicates that the observed action would have been predicted. The weight of this unit has been estimated at 700 pounds with a center of gravity 17.3 inches above the frame members and 30 inches laterally from the overturning axis. The computed net impulse required to overturn such a unit is 50 psi-ms, while the actual impulse, from this test at 180 feet, on the camper body was approximately 150 psi-ms. The observed overturning action for this unit would have been much more severe had it not been for the binding, bending, and general restraint provided by the attachment bolts even though they were without nuts. A number of these bolts were seriously bent following the test. Other factors tending to reduce the overturning action for the camper included a 5- to 10-knot wind and poor blast coupling due to deformation and destruction of the near side of the camper by the blast wave.

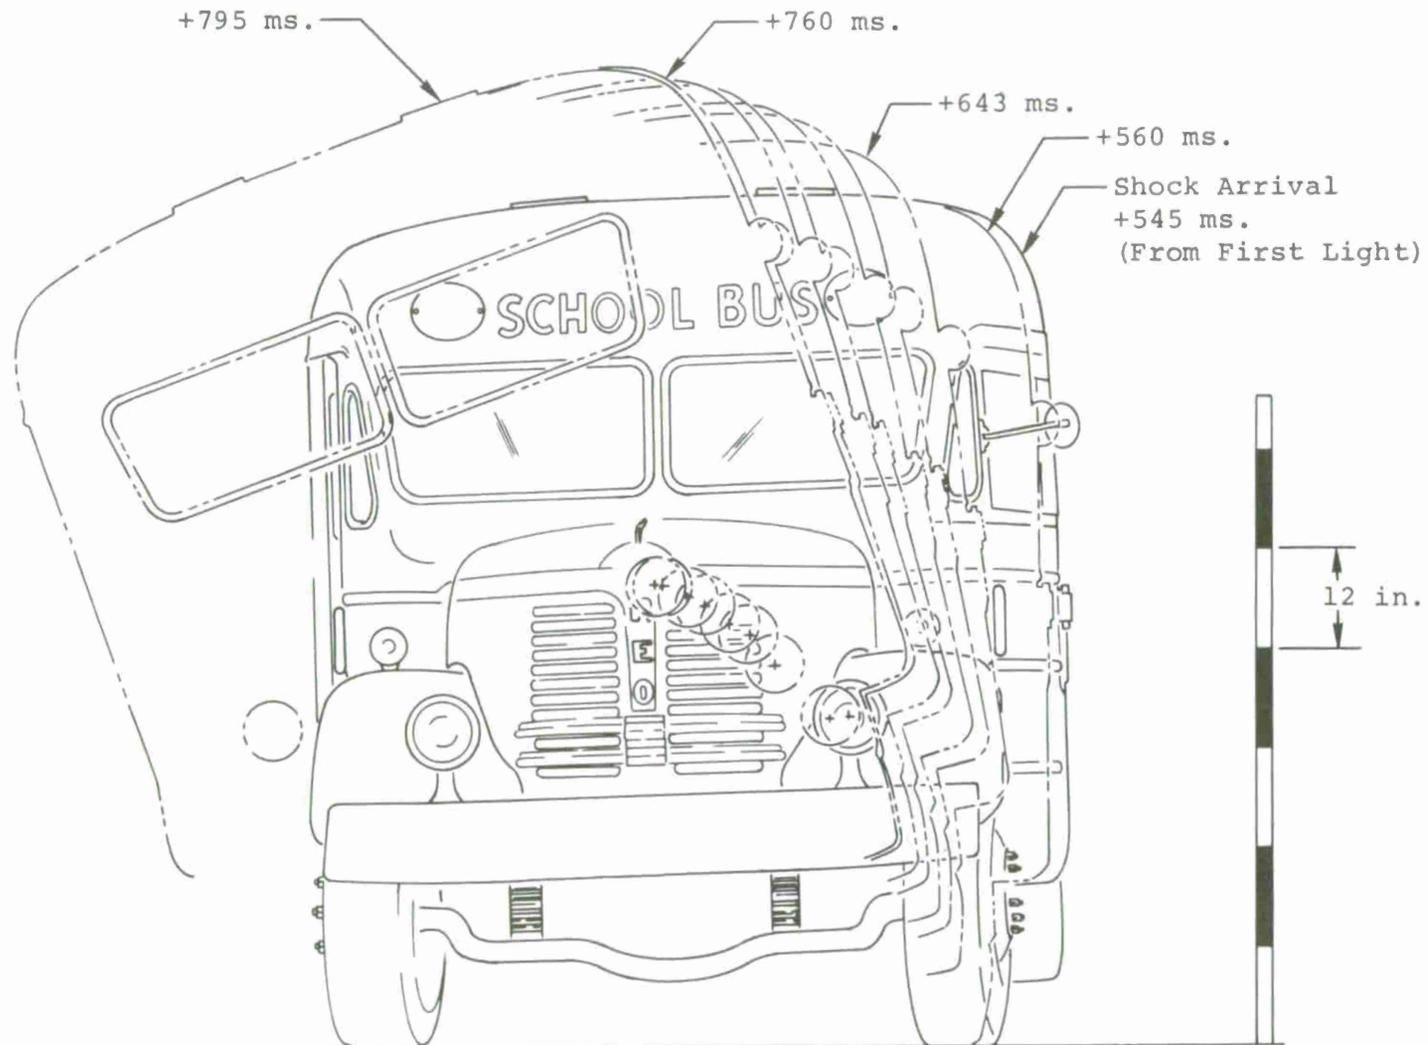
Figure 19. Bus Overturning Motion as Derived From the Analysis of High Speed Photographs.

An examination of the rotation of the bus as shown in the high speed films (summarized in Figure 19) indicates that 60 to 30 percent of the work needed to overturn the bus was completed. The center of gravity was lifted approximately two thirds of the total rise needed for overturning. Thus one conclusion which might be drawn from these data would be that the suspension system of this bus absorbed about one third of the impulse delivered to it and consequently the estimate of impulse needed for overturning should have been proportionately higher. While these data may not be sufficient to accurately determine such a factor, they do clearly indicate that more impulse was needed to complete the overturning. The needed additional impulse must have been at least an additional 80 psi-ms since no more than 80 percent of the required work has been done at a time near the end of the loading curve when the maximum delivered impulse was 315 psi-ms. Similarly the additional impulse needed must be no more than 200 psi-ms since at least 60 percent of the required work was accomplished. The total required impulse for this vehicle is thus bracketed between approximately 400 and 500 psi-ms.

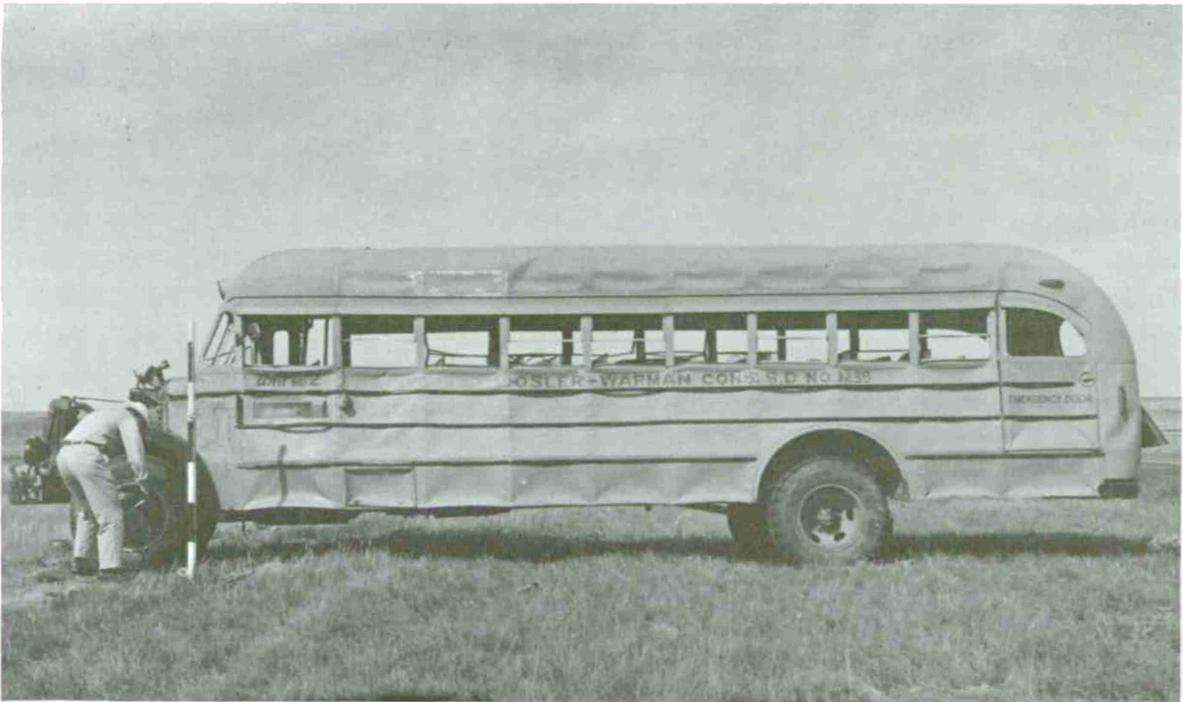
Figure 22. Damage to the Large Bus Following the Dial Pack Test - Side View.

The rear wheels of the bus were displaced sideways 11 inches; all windows were broken out of the vehicle except for one small one on the right front by the door which was not even cracked. The three small windows in the door itself were only cracked and not removed. The fourth window in the door was blown out.

One of the seats inside the bus was torn loose from the floor; however, this one appeared to have been seriously rusted prior to the test, the other seat frames remained attached and in place. About half of the seat cushions were still in their original location, the others had been tossed about. The luggage rack on the far side of the bus was torn loose, but on the near side (the side toward the blast) the rack was in place with the exception of one brace or hanger.
