Technical Note N-1130

IMPROVED TECHNIQUES FOR THE NON-DESTRUCTIVE TESTING
OF DIESEL ENGINE PISTONS

October 1970

NAVAL CIVIL ENGINEERING LABORATORY
Port Hueneme, California 93041

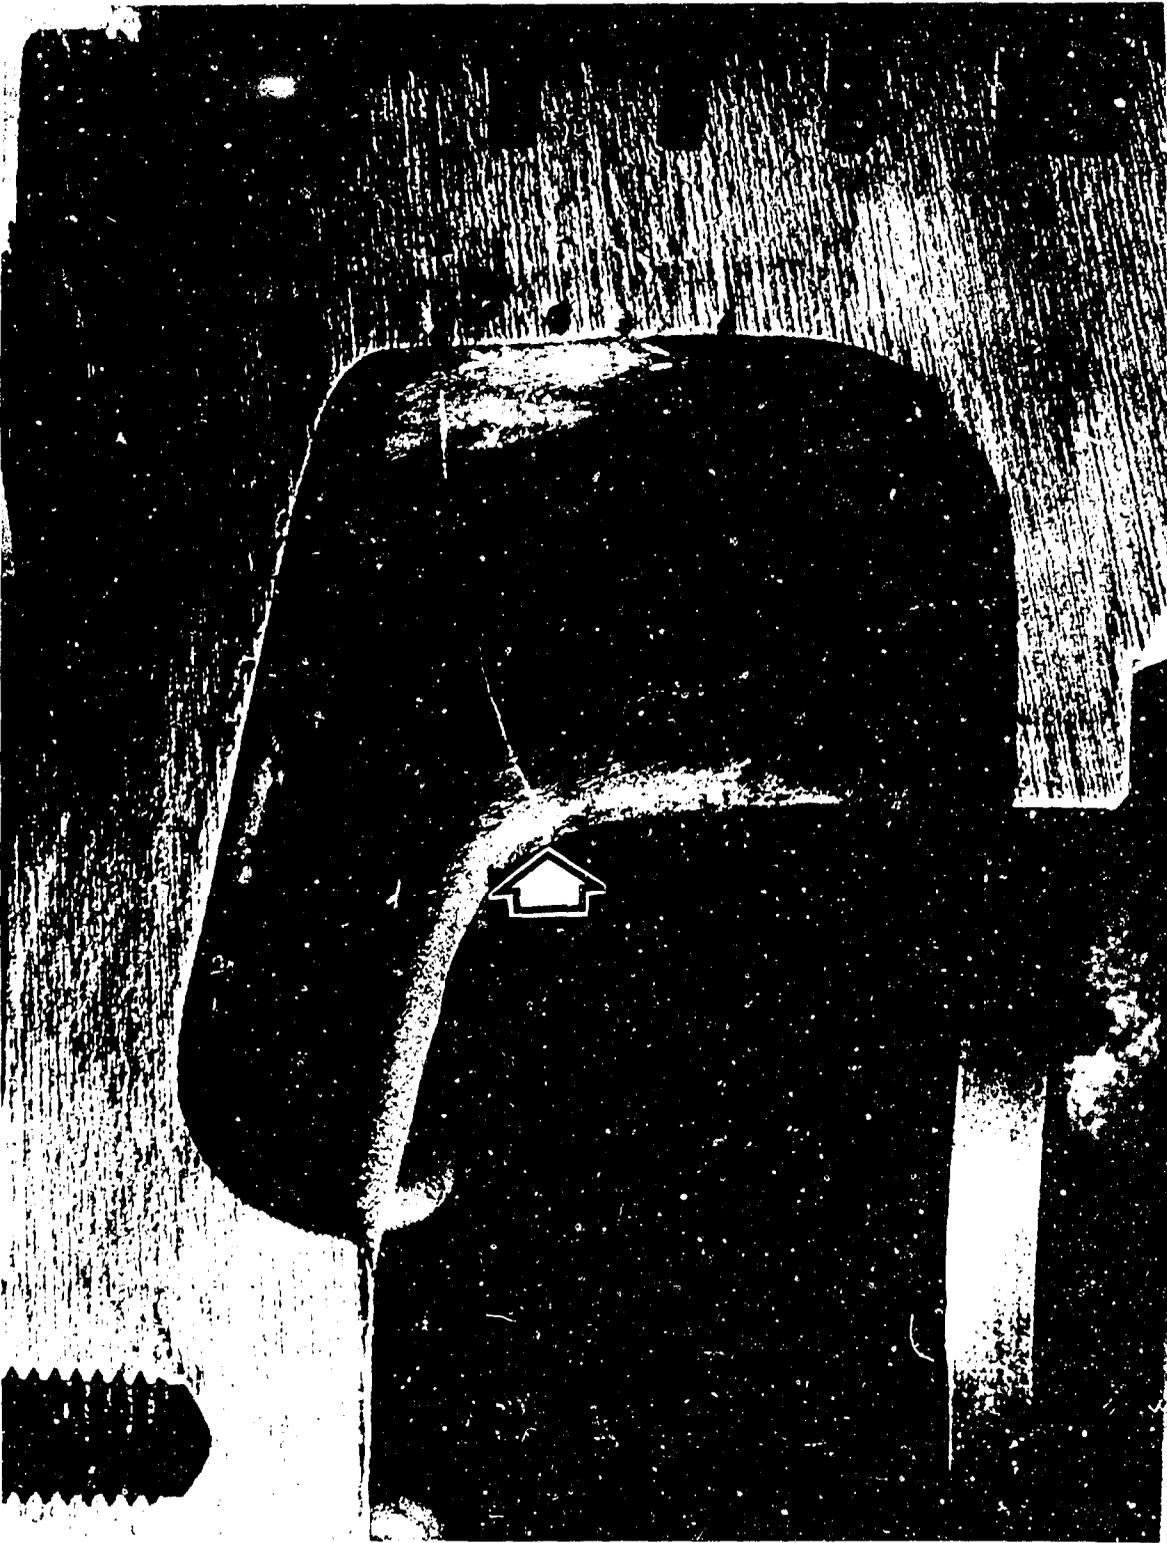
Initially two new, unused pistons were supplied for examination, and for use as a basis of comparison. Subsequent examination of all available defective and suspected pistons indicated that the cracking, and ultimate failure, originated along the inner major radius profile of any of the four major webs inside the piston, and propagated radially outward toward either of the two upper ring grooves (as illustrated in Figure 2). As the engine continues to operate, this cracking continues to develop circumferentially around the piston, until finally the top portion, or crown, separates from the piston body with disastrous results to the engine.

Figure 3. Fatigue crack in Enterprise piston. (1.5X)

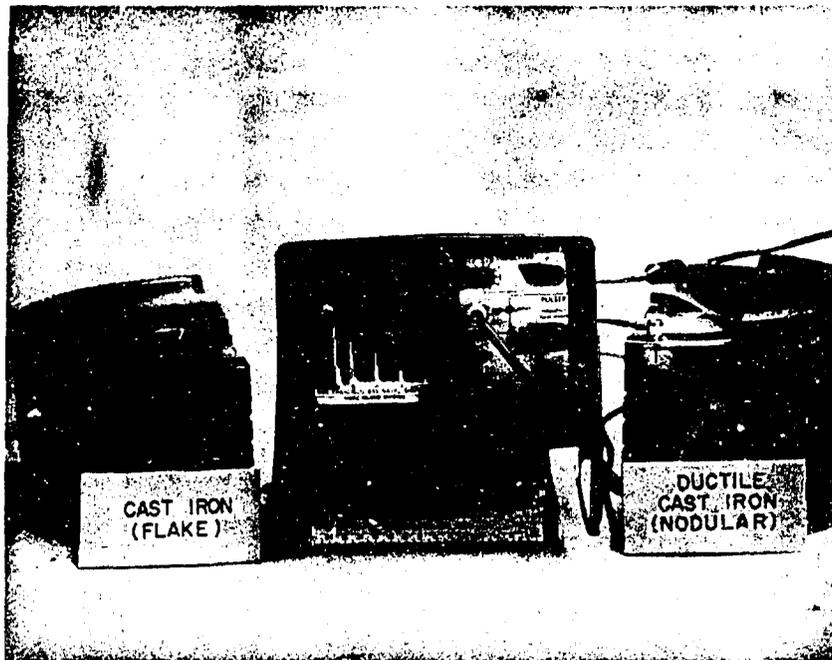
Figure 9-A. Satisfactory oscilloscope display - nodular cast iron.

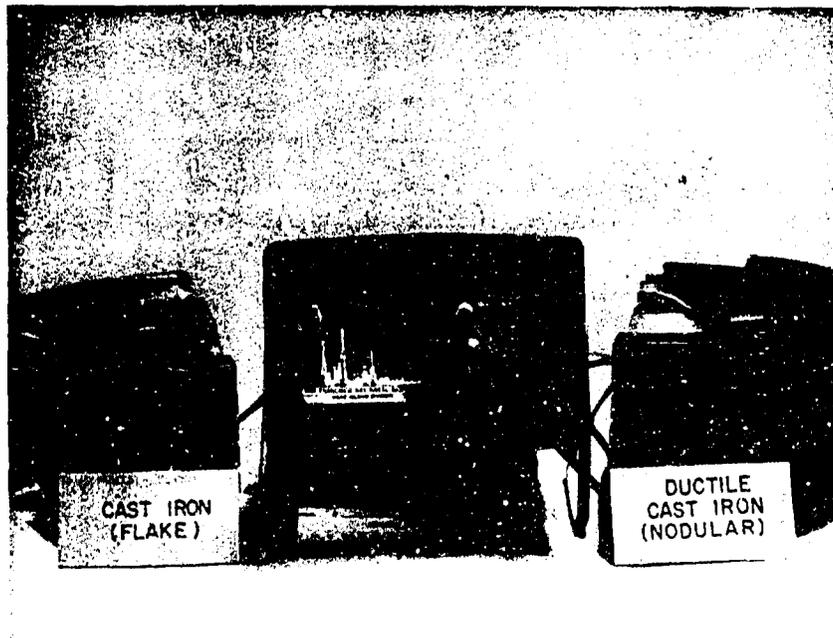
Figure 9-B. Unsatisfactory oscilloscope display - flake cast iron.

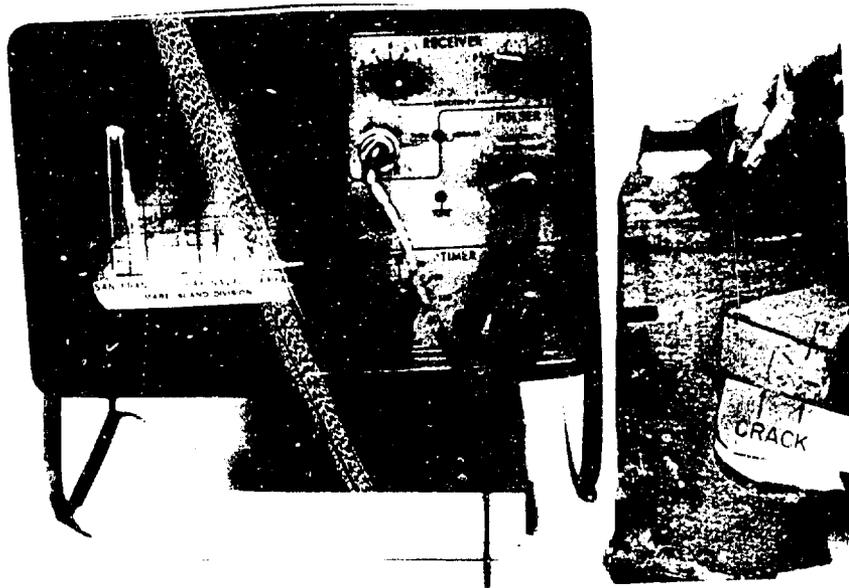
As the scan progresses, the 1-7/8 inch depth signal will gradually diminish to zero level. This results from the sound waves being directed at the internal radius of the major web and reflected away from, rather than back to, the transducer. (Note position "1" of Figure 7.) This area of the piston has been found to be a very vulnerable point with regard to crack susceptibility. It is therefore essential that the inspector be especially alert in this area for any signal indication in the 1 to 2 inch depth range, which may be indicative of an incipient failure in the piston structure. (See Figure 10 for typical oscilloscope response to a cracked web.)

Figure 10. Oscilloscope display of cracked web.

The entire search procedure, as outlined above, is now repeated over each of the remaining three major webs of the piston. Any piston which displays indications of a discontinuity in any portion of a major web, must be considered as defective, and that piston should be scheduled for immediate removal from the engine.

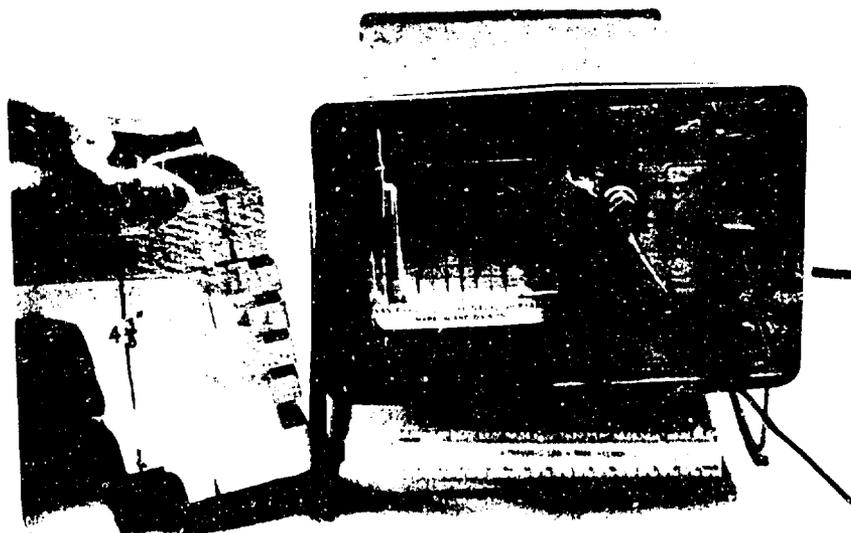
In continuing the scan outward from this point, if the web is sound, an indication will soon appear on the viewing screen at an approximate depth of 4-3/8 inches. (See position "2" in Figure 7 and Figure 11.) This is a reflection from the inner flange of the piston, and is evidence of satisfactory sound wave penetration through the major web profile. It should be noted that a continuation of the scanning from here on into the concave portion of the piston top surface will require a liberal "puddling" of couplant in order to adequately conduct the sound waves into the piston.

Figure 11. Acceptable major web at $4 \frac{3}{8}$ " thickness.
