FINAL REPORT  
ON  
SCANNING ELECTRON MICROSCOPY STUDY OF  
6309 SIZE BEARINGS

JANUARY 31, 1971

RESEARCH LABORATORY  
**SKF INDUSTRIES, INC.**  
ENGINEERING AND RESEARCH CENTER  
KING OF PRUSSIA, PA.

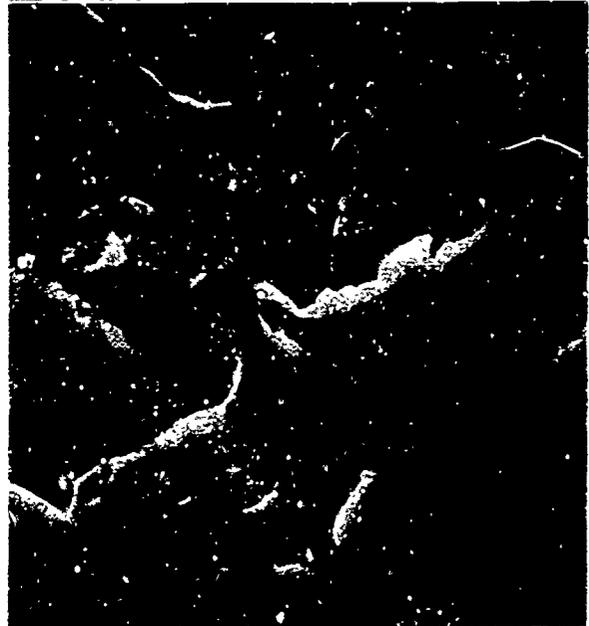
D. Higher magnification of lower right hand region of C.

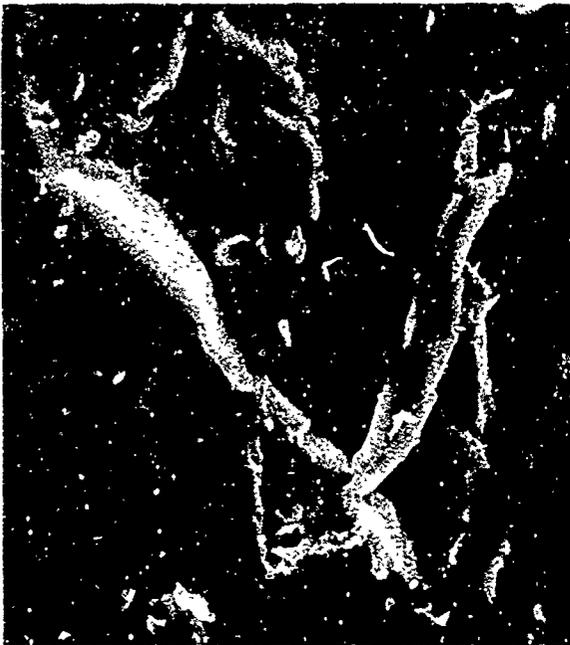
E. Higher magnification of lower left hand region of defect grouping in C.

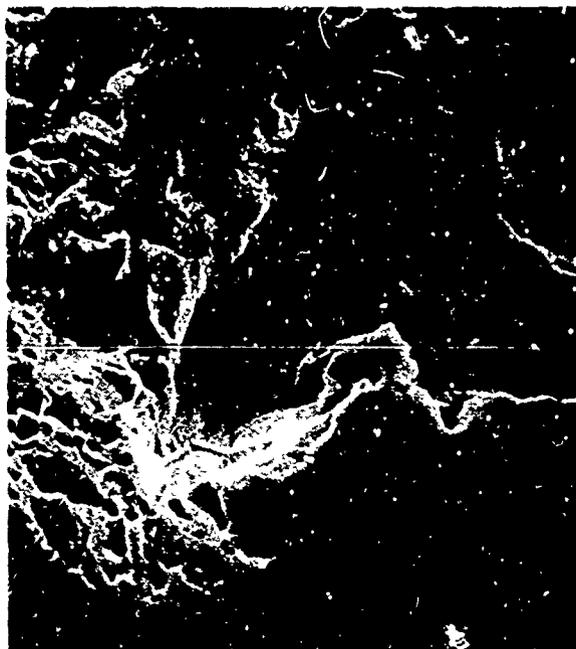
A. 300X B. 1000X  
Defect between Heathcote band and edge of contact in  
T. U. (49.9 M.R.) carburized steel - low speed - grease.

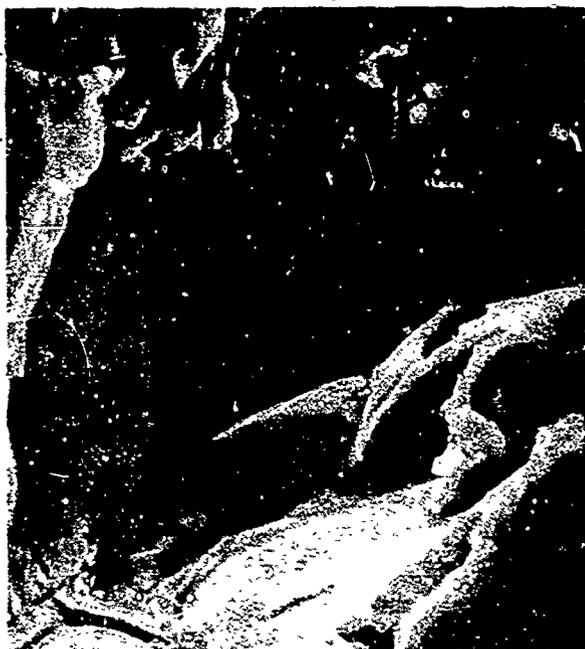
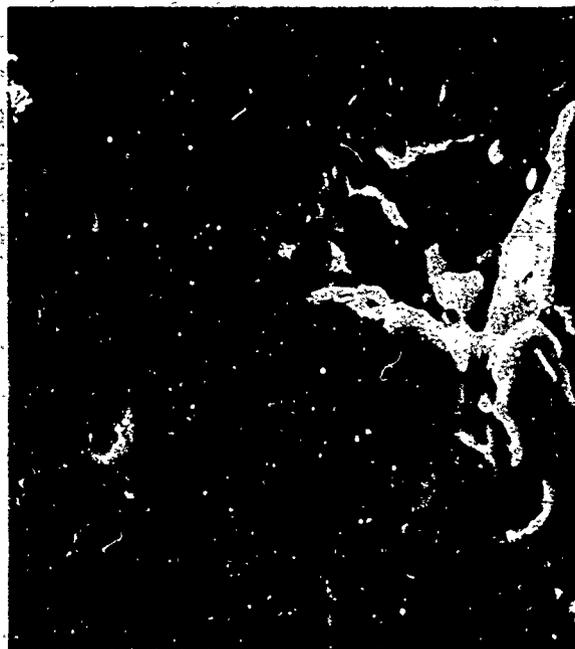
C. 3000X D. 1800X  
Higher magnification of B. Defect near edge of contact area  
in T.U. (400 M.R.) carburized  
steel - high speed - heavy oil.

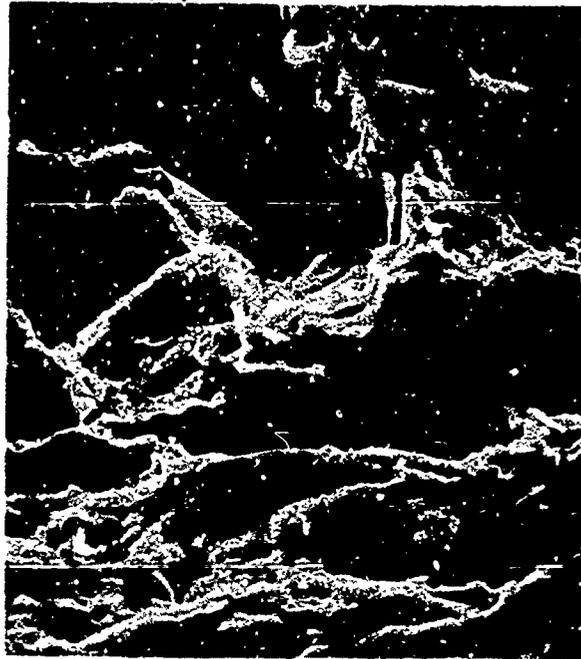
E. Higher magnification of defect  
in Enclosure 14, Figure A.

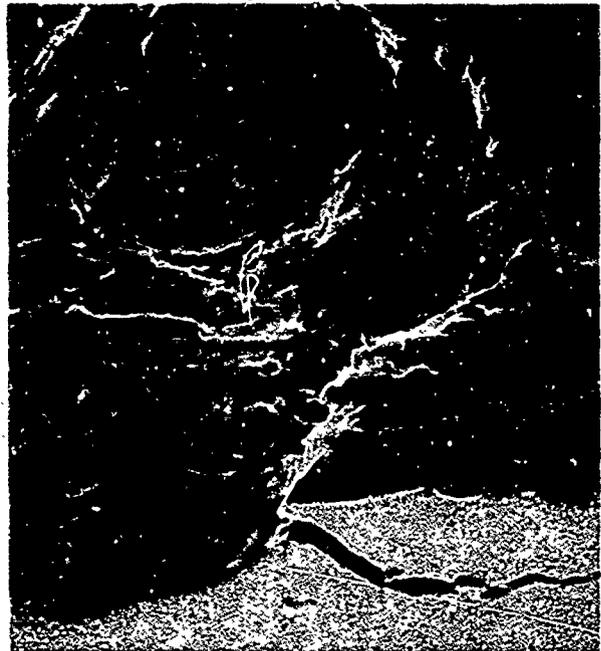
B. Cracking at entrance end of spall. Crack is growing opposite to the direction of rolling.
