FIRE TESTING OF INDEPENDENT FIBERGLASS  
FUEL TANKS WITH AND WITHOUT PROTECTIVE  
COATING OF FIRE RETARDANT PAINT

UNITED STATES COAST GUARD  
OFFICE OF RESEARCH AND DEVELOPMENT  
APPLIED TECHNOLOGY DIVISION

LTJG J. D. RICHART, USCG  
MERCHANT MARINE TECHNICAL DIVISION  
OFFICE OF MERCHANT MARINE SAFETY

Date: 2 July 1971

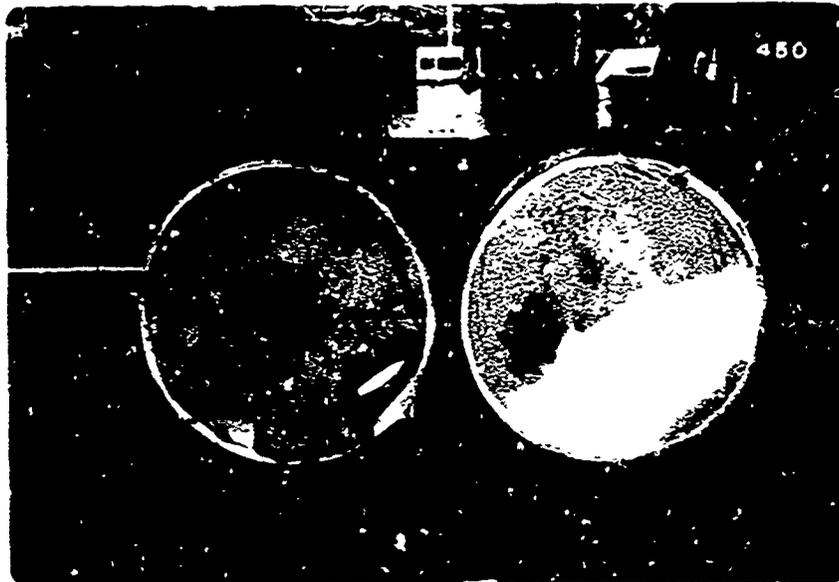
Results of tests conducted on the eight independent fiberglass fuel tanks are summarized in Table I. Tests #1 and #2 were both for 2m30s and the time-temperature data were close to the YSB criteria for the 2m30s gasoline fire test (see FIG. 1, reference (1)). Photographs (3) and (4) show the internal appearance to be very good for both tanks. The unpainted tank has charred somewhat, causing some degradation of wall soundness, but both tanks could withstand several minutes more fire exposure before failure.

PHOTOGRAPH # 4: Test #2, tank  $\frac{1}{4}$  full of diesel fuel, painted, 2m30s of fire exposure. Note soundness of tank wall.

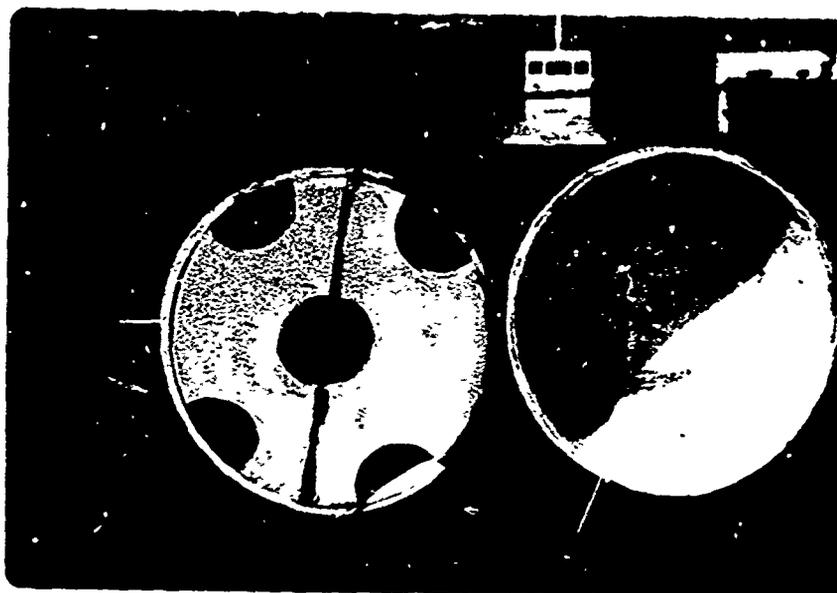
PHOTOGRAPH # 11: Test #4, painted tank after opening, showing excellent internal appearance of baffle and tank wall.

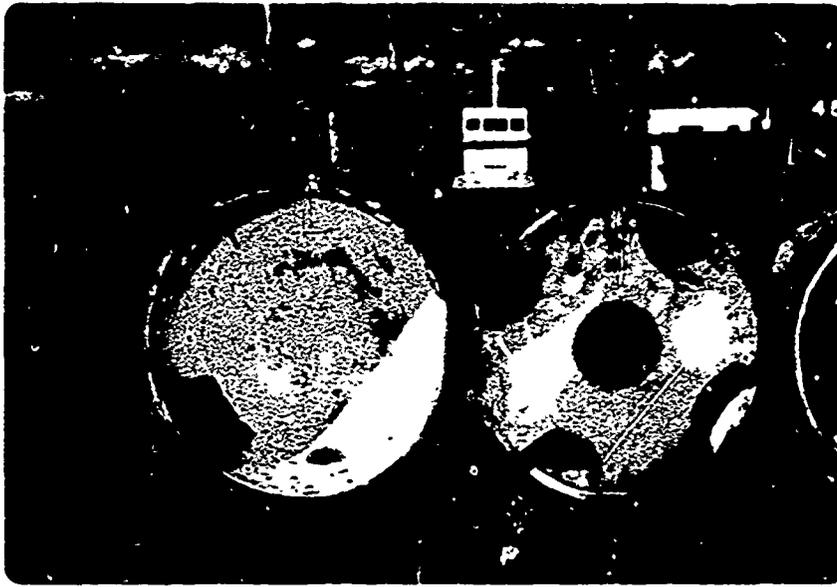
PHOTOGRAPH # 19: Test #6, unpainted tank's internal appearance after fire. Note delamination in right half of tank.

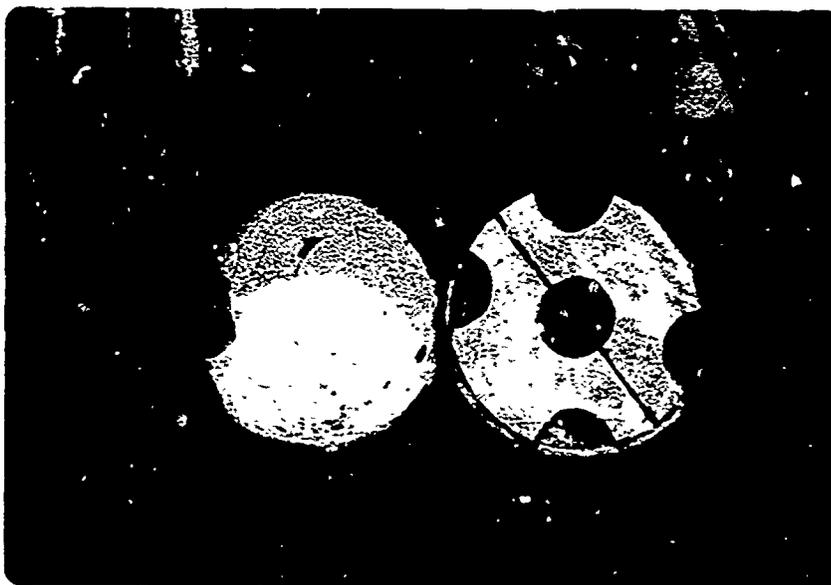
Test #8, painted and full of fuel, showed the tank to withstand severe fire exposure. As in the previous test the tank was engulfed in flames the entire time (see photographs (25) and (26)). At the eight minute mark flames were four feet high and vapors were burning at the top of the vent spud at a controlled rate. The final two photographs show the tank to be in better condition after an 11 minute fire than the unpainted counterpart was after less than 8 minutes of exposure to similar intensities (see FIG. 6).

PHOTOGRAPH # 28: Test #8, painted tank after 11m00s fire. Delamination took place along outside  $\frac{1}{4}$  inch of wall. Otherwise, the interior was in good condition. Compare the baffle to its counterpart in Test #7.
