Report No. FAA-RD-72-25

# SONIC BOOM AND NATURAL DETERIORATION EFFECTS ON BUILDINGS: WHITE SANDS, N.M. STRUCTURE RESURVEY

FEBRUARY 1972  
FINAL REPORT

(A SUPPLEMENT REPORT TO REPORTS SST 65-15 (VOLS. 1 AND 2) AND SST 65-18)

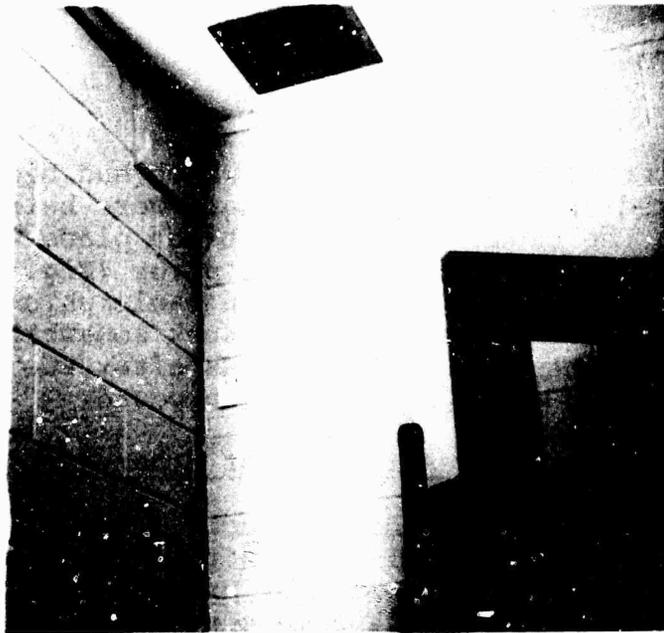
Mr. Bradley noted to me that the ORC Station had been completely redecorated, painted and all cracks caulked about 6 months prior to Feb. 24, 1972. Yet this concrete block building showed new cracks which had been photographed in the chief's office (Fig. 1) and new cracks in the power room (Fig. 2) and bathroom facilities. No booms of any significance had taken place since the time of redecoration.

Fig. 1 An old crack has opened up in the Station Chief's office at the ORC Station 6 months after redecoration.

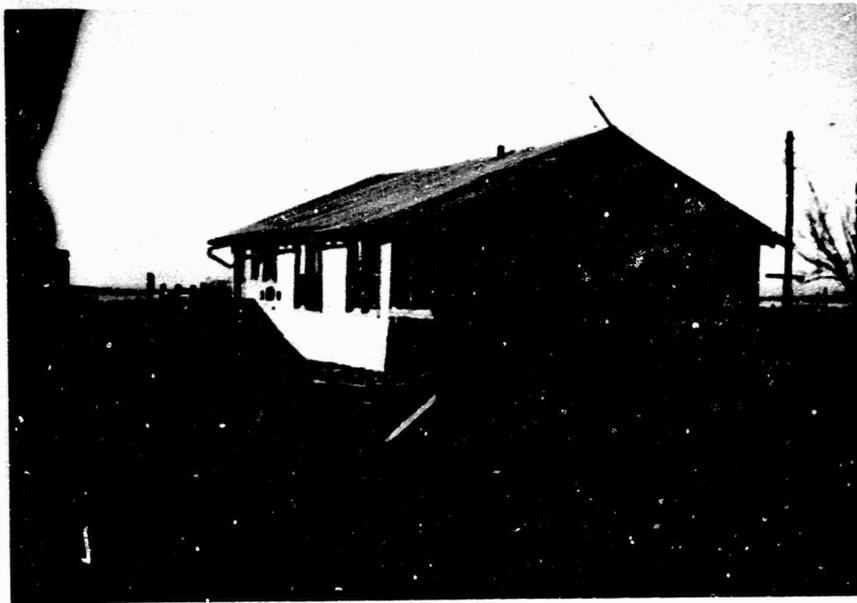
I visited the "Abandoned Ranch" shown in Figs. 3 and 4. Its condition is still bad with the additional glass damage. It was reported by Mr. Withers that the glass was broken by vandals some time earlier.

Fig. 3 "Abandoned Ranch" is still in bad condition. The windows were broken by vandals, as reported by Mr. Withers. All were new and unbroken at the beginning and end of the program.

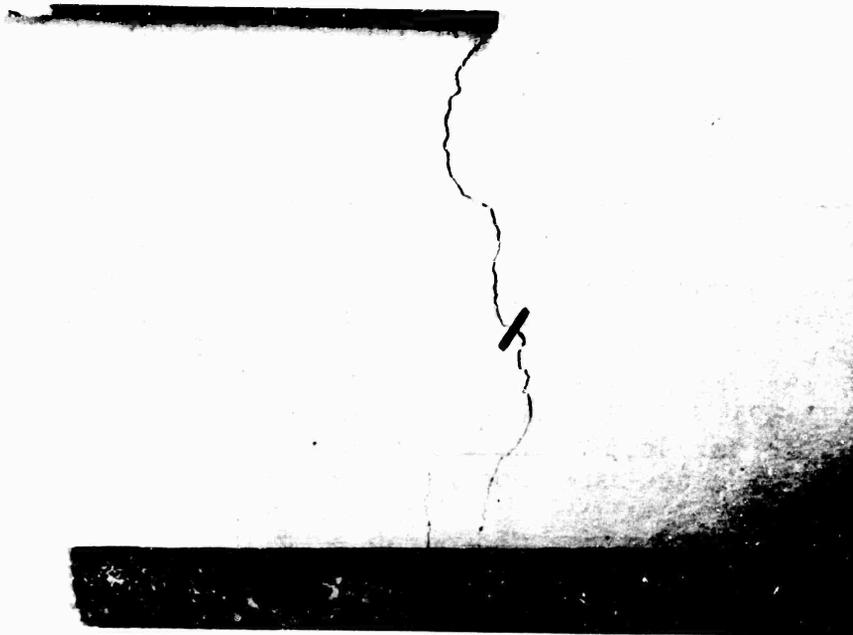
On the exterior of the ranch house a crack was found which Mr. Paul Freund monitored throughout the program which flew 10 psf. and larger boom intensities over the property. No movement was noted during the program beyond the mark in Fig. 7. In the last seven years, however, settlement has caused the crack to extend.

Fig. 7 Crack extension over the last seven years at Wither's ranch.

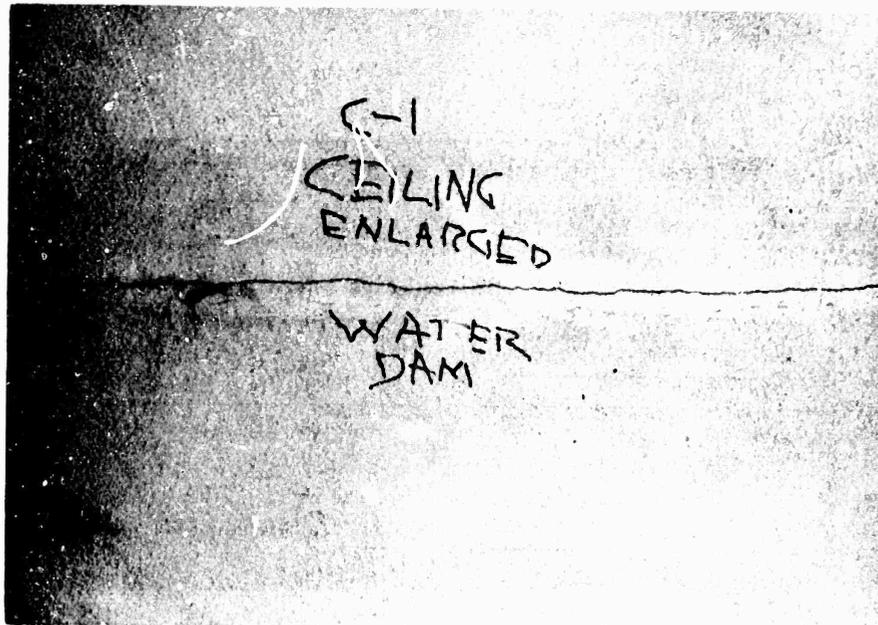
Fig. 13 Typical enlarged crack in C-1

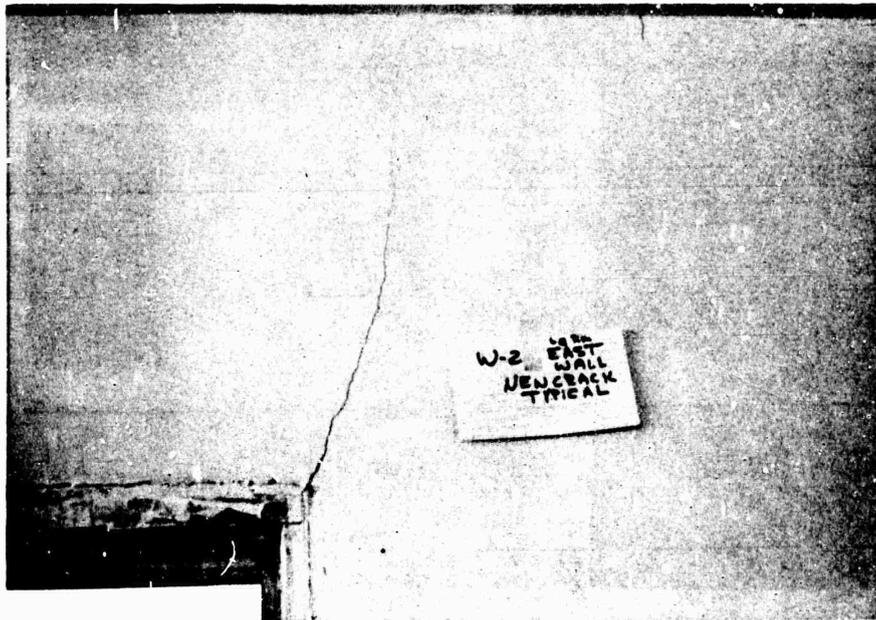
Fig. 20 W-2, Typical new crack

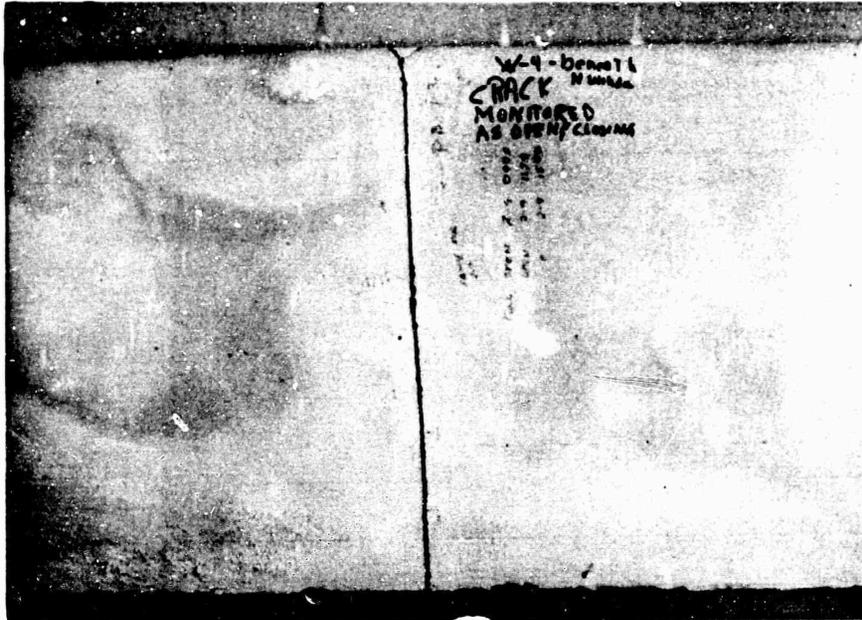
Fig. 33 W-4, Crack Monitored as Opening and Closing During Program is Now Greatly Enlarged

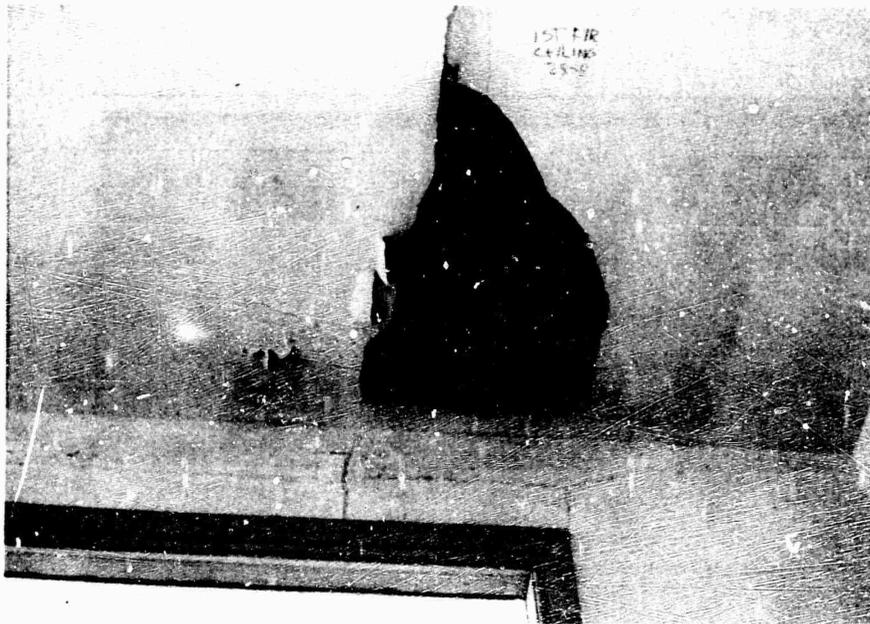
Fig. 39 2S-5, Ceiling in 1st Floor. Note Extreme Contraction of Wood Lath Giving Low Bond Strength to Plaster Keys.

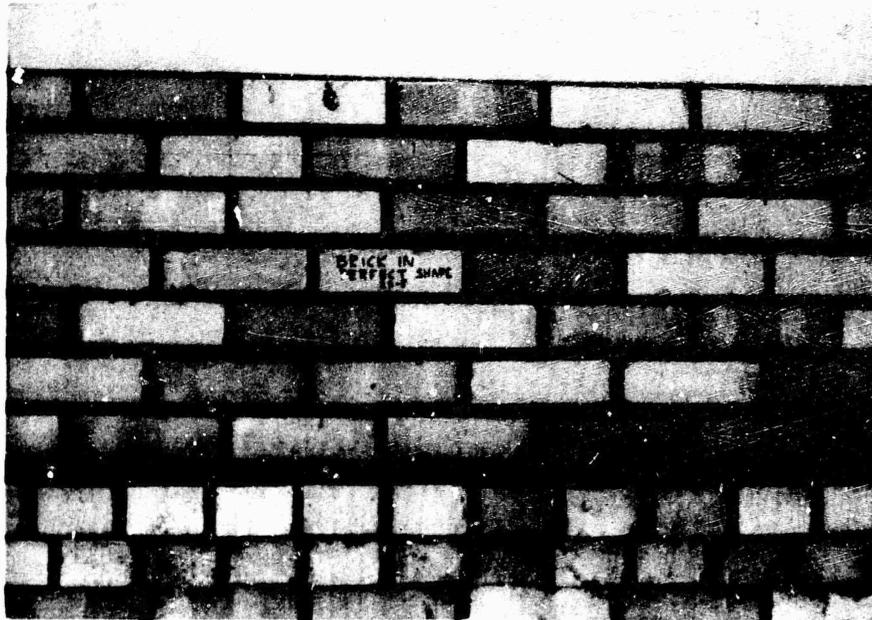
Fig. 40 2S-5, Fireplace Masonry in Perfect Condition

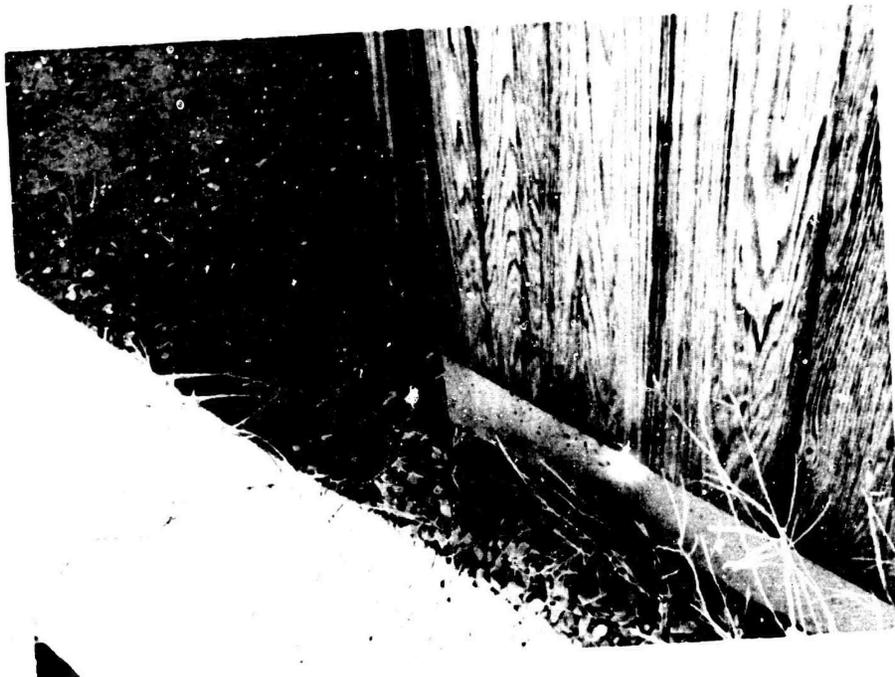
Fig. 45 PF-6, Closeup of Northwest Corner Damage

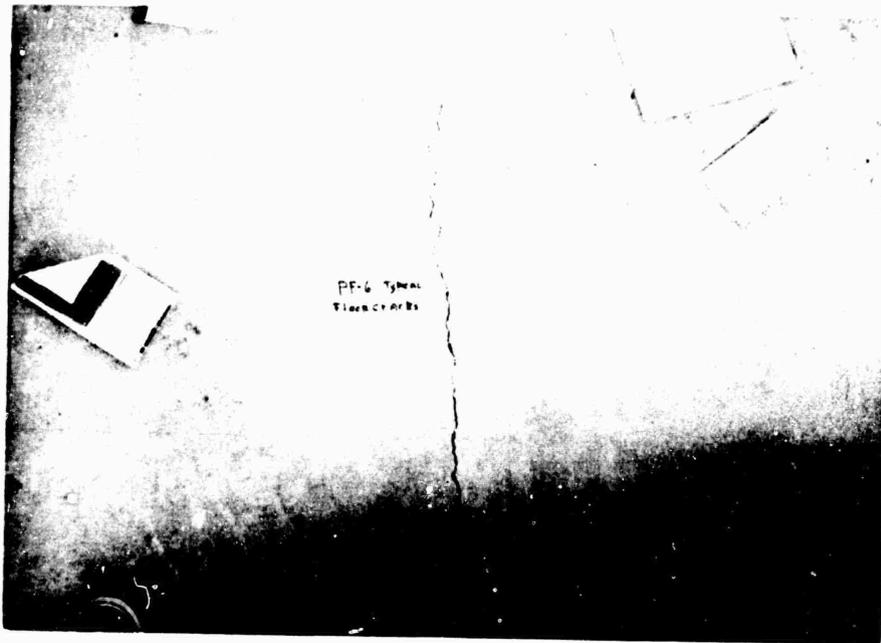
Fig. 47 PF-6, Floor Cracks in Building Not Found in C-1, W-2 due to Different Slab Design (See SST 65-15 (Vol. 2) Dwg B-3 and B-9).

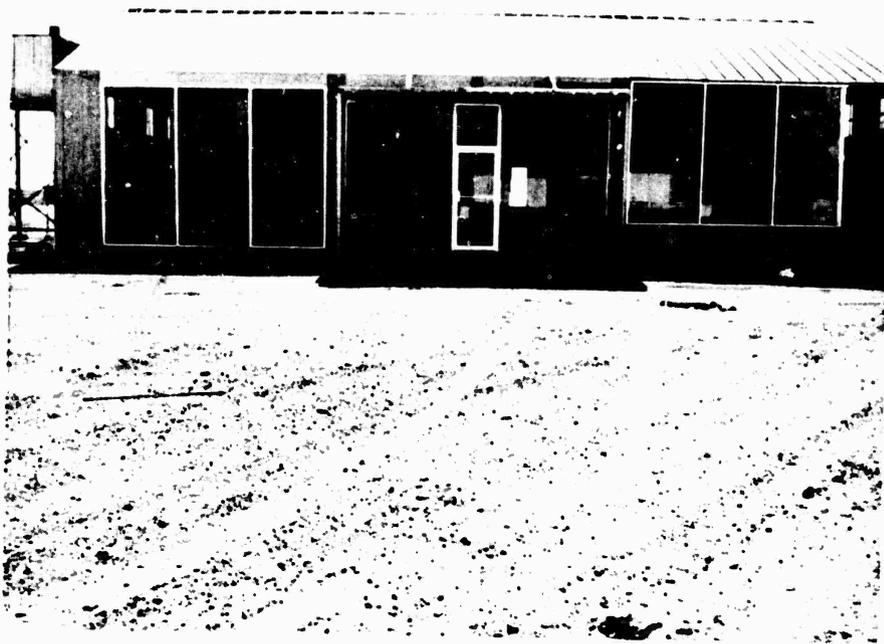
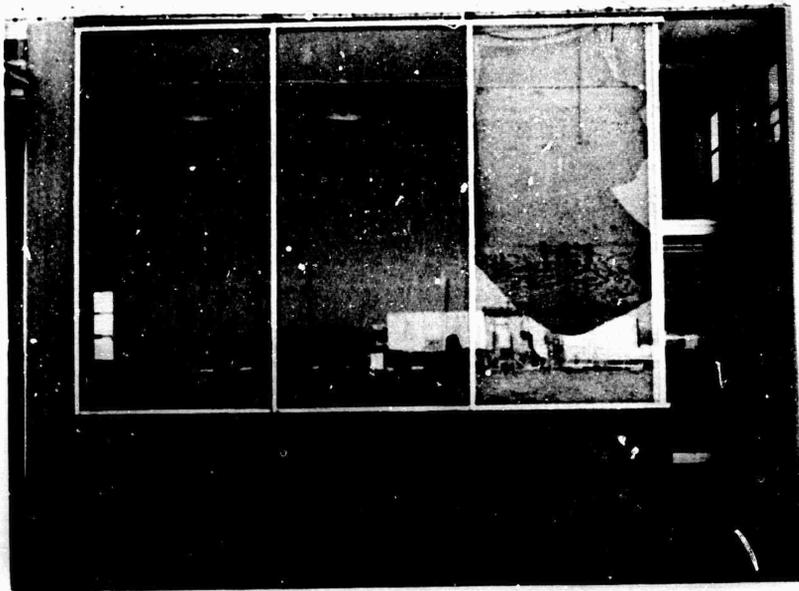
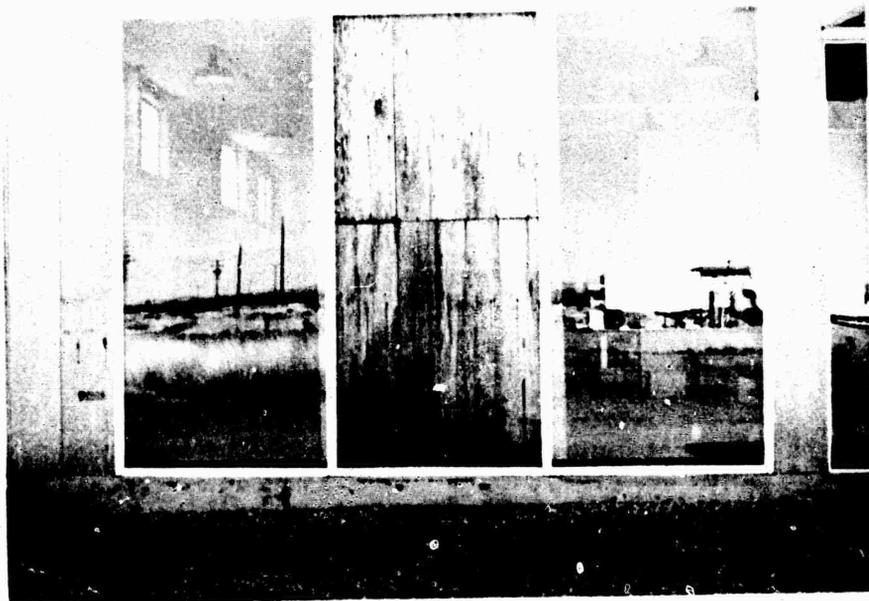
The Store-Front had two windows broken. The center solar gray glass (panel b) in the left three panels had broken. The mechanism of damage to the large window on the right

Fig. 48 Store Front, Window on Right and Solar pane on left are Broken

Fig. 49 Store Front, 5' 0" x 9' 6" x 13/64"  
(actual thickness) Broken Pane

Fig. 50 Store Front, 5' 3" x 10' 8" x 13/64"  
(actual thickness) Broken Pane

side of the Store-Front building did not look like sonic boom damage since it was highly localized in the top center portion of the frame. Using the techniques described by Wiggins\* the probabilities computed for these two windows to be broken by sonic boom and not panels d and e leaves doubts as to sonic boom being the cause of damage.

The approximate probabilities that panes b and h would be broken by sonic boom and not panes d and e (which are weaker as shown by the Dec. 2, 1964 incident reported on page 192 of SST 65-18) are shown in Table 1 using linear and non linear theory.

These probabilities suggest that booms did not break the panes of glass. Further, since the broken panes were boarded up, panes d and e are considered to be the original panes used on the program and have not been replaced since 5-20-65.

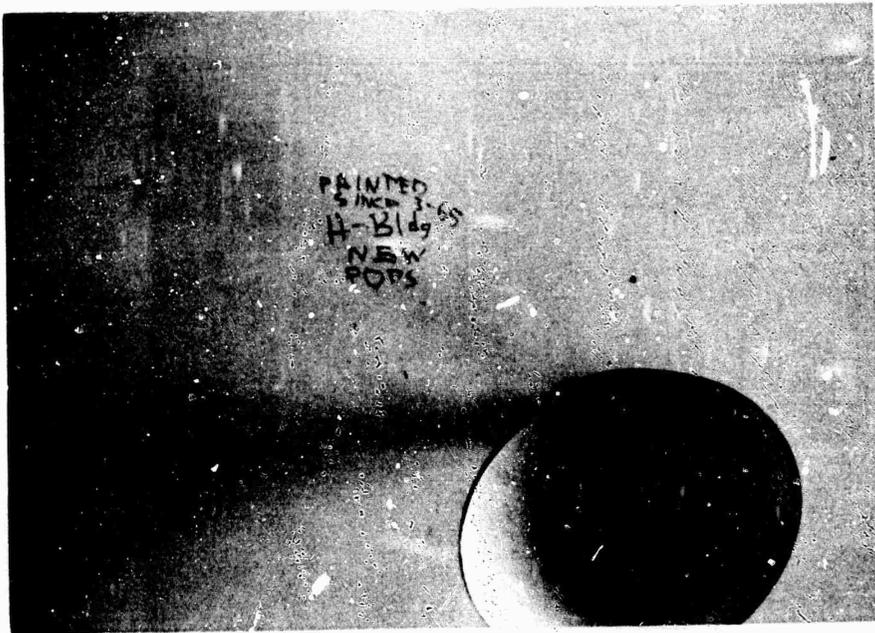
Fig. 51 H-Building, New Nail Pops after Redecoration Between Inspection Periods.

Fig. 52 H-Building, Replaced Ceiling Since Program and Since Redecoration.

Part of the H building had been repainted and nail-pops and ceiling damage sufficient to warrant replacing part of the ceiling had occurred since the boom program. Even so nail-pops have reappeared in the ceiling and walls.
