MISCELLANEOUS PAPER S-72-22

CONDITION SURVEY, FORNEY ARMY AIRFIELD FORT LEONARD WOOD, MISSOURI

June 1972

Conducted by U. S. Army Engineer Waterways Experiment Station

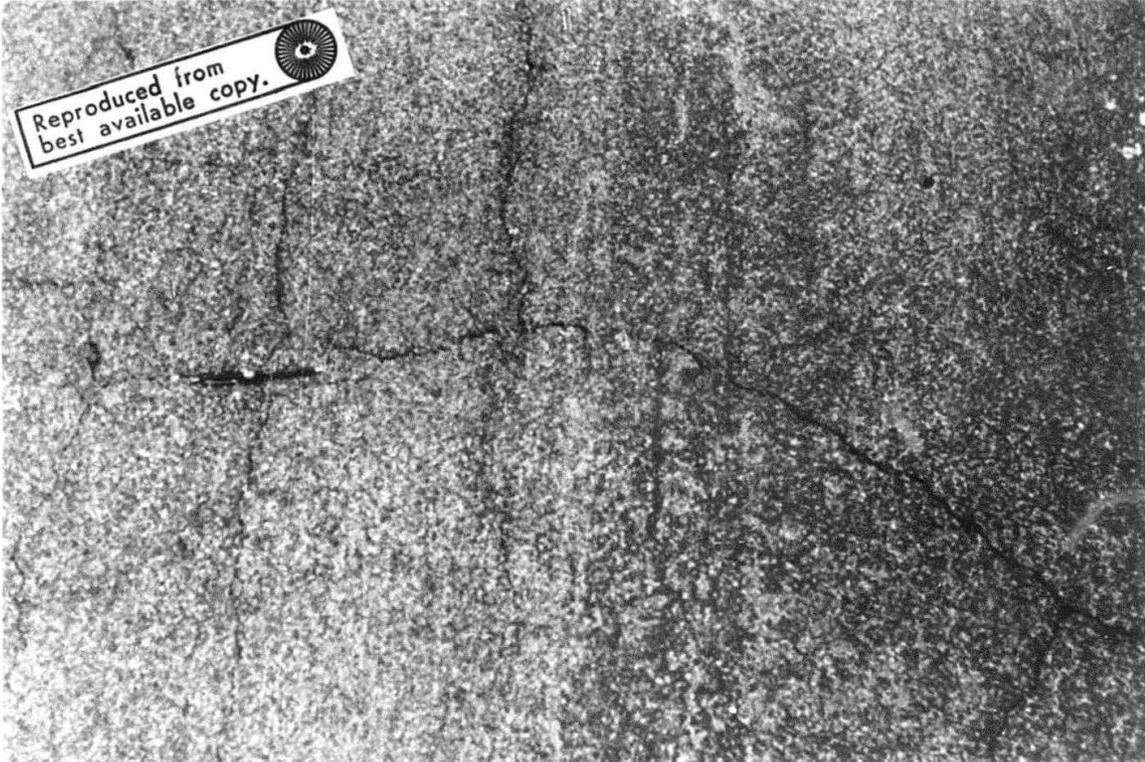
8. A visual inspection of the pavements in April 1971 indicated the airfield pavement to be generally in fair condition. The runway contained numerous cracks; however, the major portion appeared to be adequately supporting the aircraft using the pavement. The typical condition of the major portion of the runway pavement is shown in photograph 1. Photograph 2 shows the condition of an area about 25 ft wide, located east of the center line and extending from the vicinity of runway sta 34+60 to 40+60; this area is showing considerable distress. Another area, approximately 25 by 100 ft and located near runway sta 65+00, showed some distress

Photograph 1. Typical condition of runway pavement

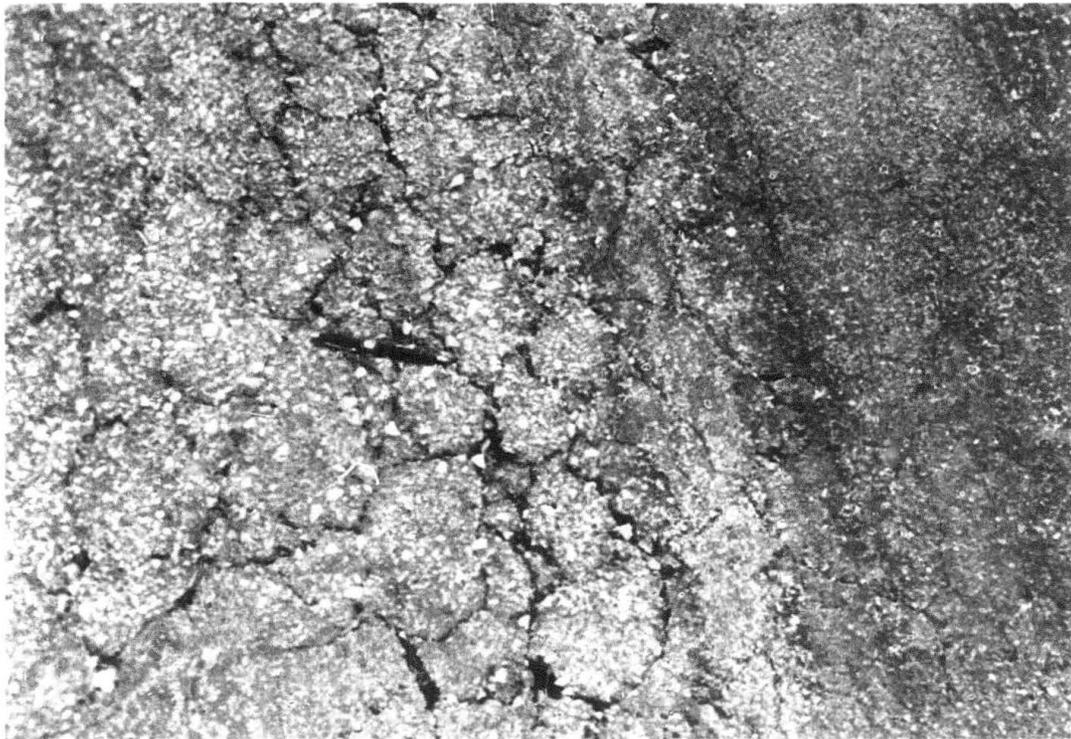
11. An evaluation of the pavements based on this visual inspection cannot be made without supporting field tests. The Facilities Engineer has requested the Omaha District, Corps of Engineers, to prepare an estimate for the performance of field testing and for an evaluation of the pavement facilities. Due to the fact that one area of the runway is showing considerable distress and another area shows distress to a lesser degree, it must be assumed that the load-carrying capacity of the runway pavement structure has been or is being exceeded.

Photograph 2. Distressed area near middle of runway

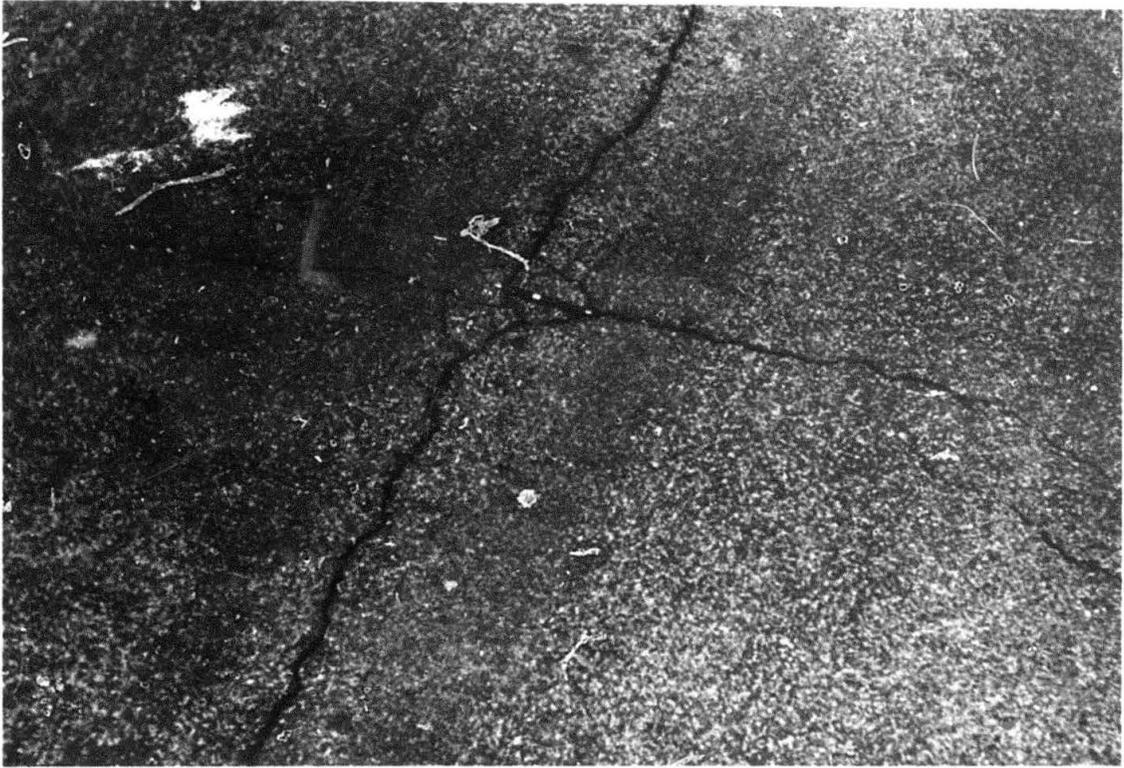
9. The taxiway and apron contained numerous cracks. Views of typical pavements of the taxiway and apron are shown in photographs 4 and 5, respectively. The cracks in the taxiway were approximately 25 ft apart in each direction and appeared to be contraction cracks. Neither the taxiway nor the apron showed any structural distress.

Photograph 4. Typical condition of taxiway pavement

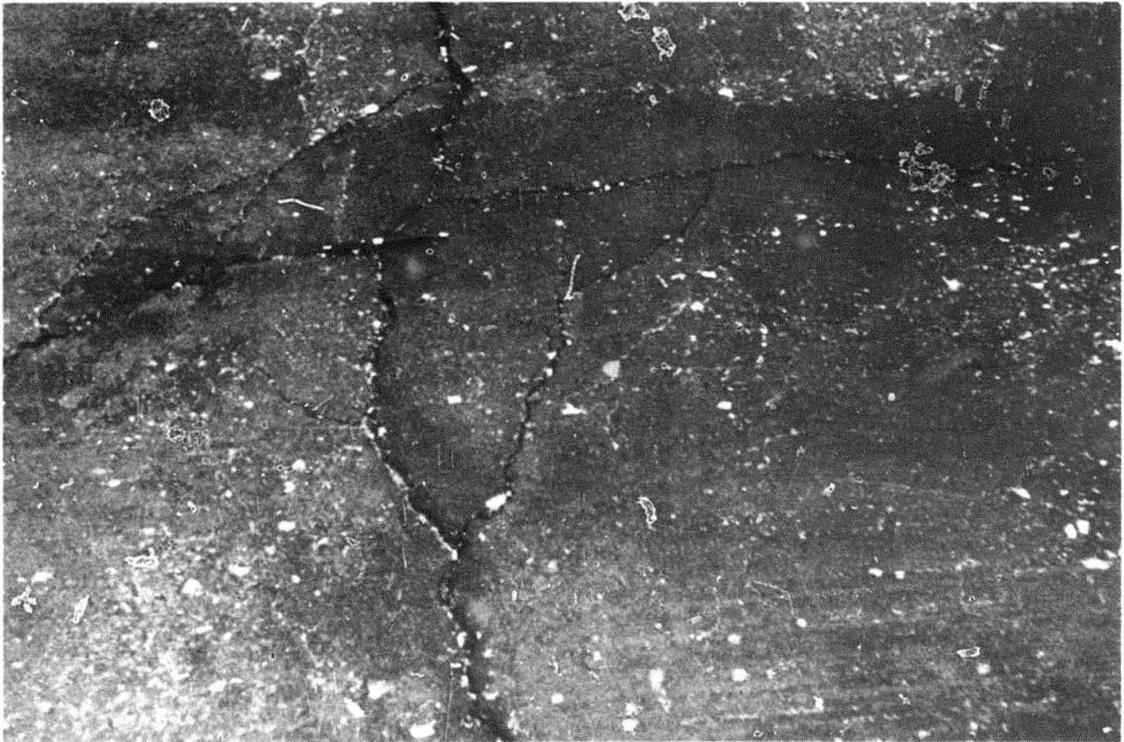
Photograph 5. Typical condition of apron area
