Marine Corrosion Studies

The Effects of Dissimilar Metal Couples and Toxicants from Antifouling Paints on the Corrosion of 5086 and 6061 Aluminum Alloys and Their Response to Cathodic Protection

(Fourteenth Interim Report of Progress)

NAVAL RESEARCH LABORATORY
Washington, D.C.

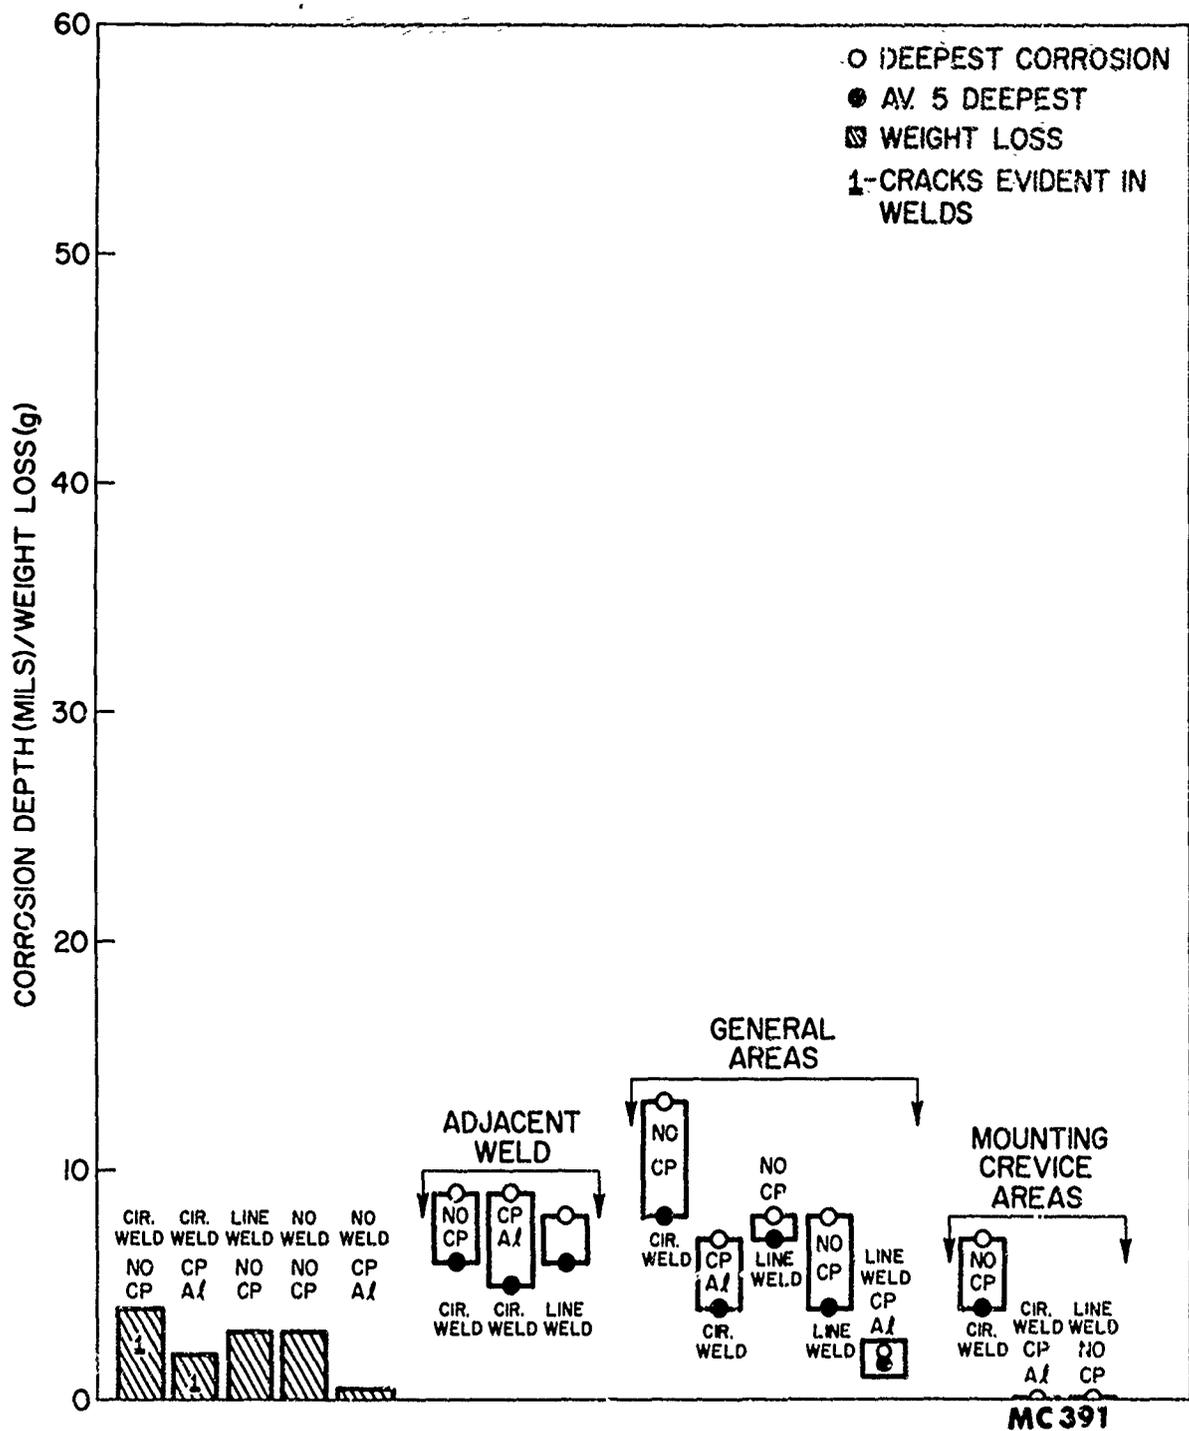
The depth of corrosion and the response to cathodic protection for various areas on the welded specimens of 5086-H32 aluminum are shown in Fig. 2. These data showed that the deepest corrosion on any of the welded specimens in seawater was 13 mils and that cathodic protection effectively reduced the depth of corrosion except at the area immediately adjacent to the weld on the circular welded specimen. There was evidence of cracks in the welds, notably on the circular welded specimen. The weld cracks were evident after exposure whether or not the specimen was cathodically protected by an aluminum anode, but it was not certain whether these cracks were present prior to the exposure. The weld area and areas adjacent to the weld on

Fig. 2 - Welded 5086-H32 aluminum; with and without cathodic protection (CP), 809 days in seawater at Key West, Florida.

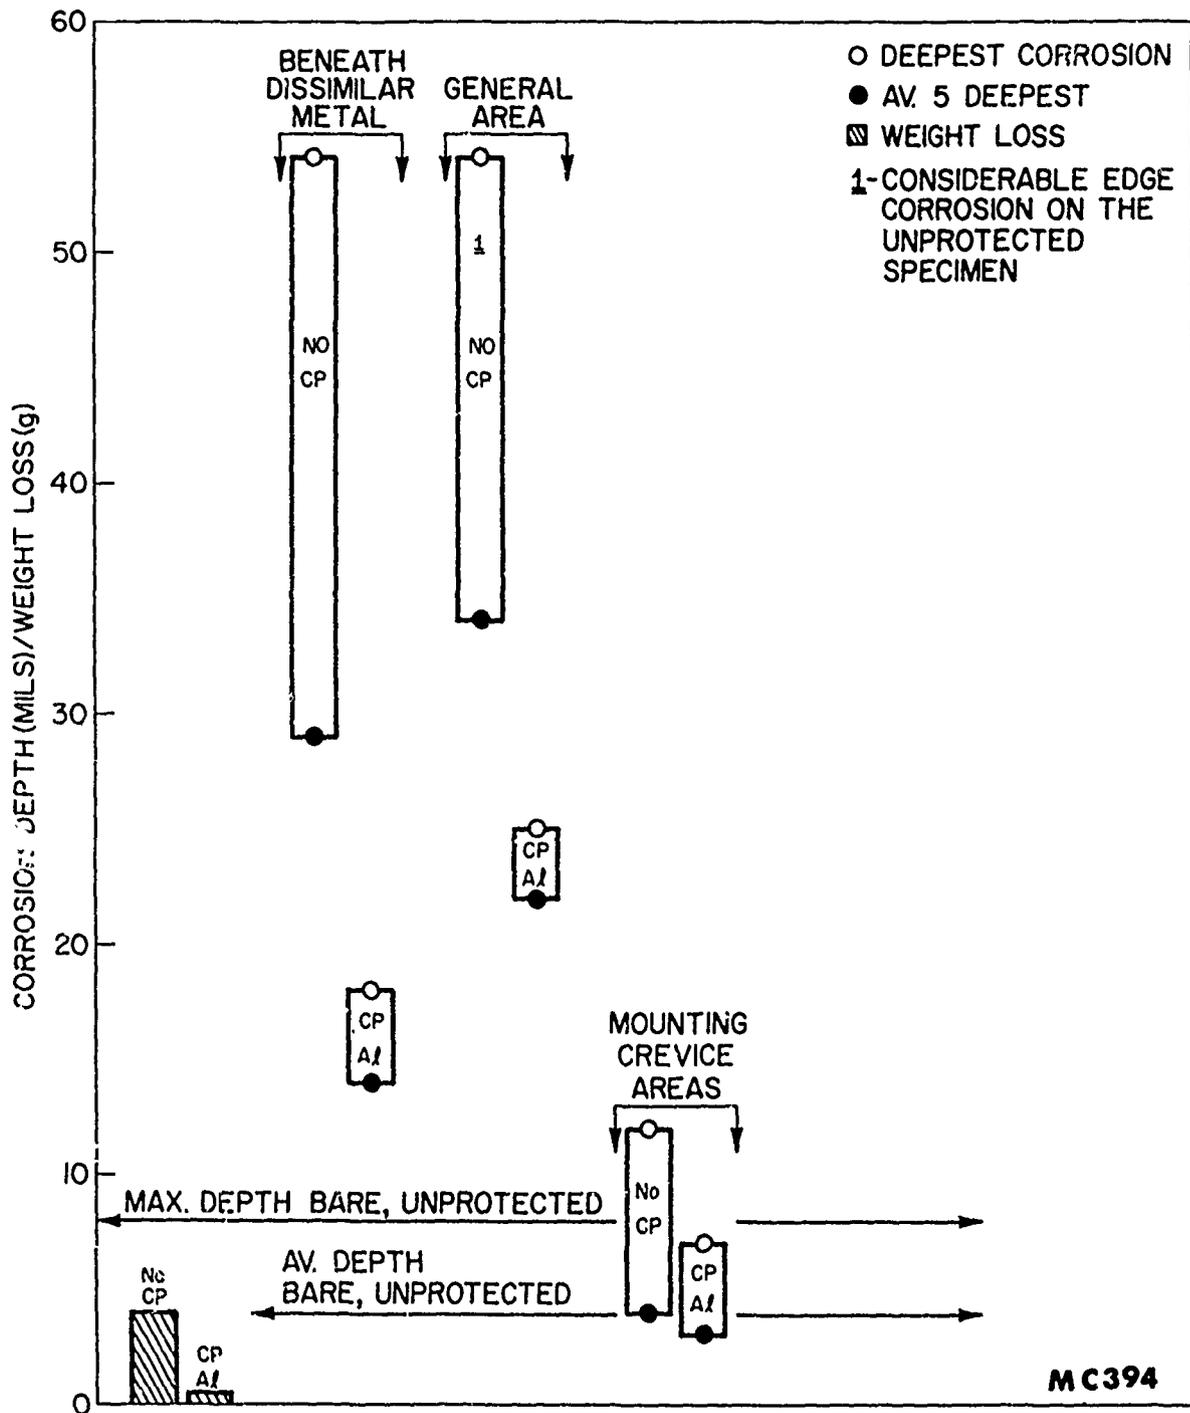
Each of the following dissimilar metals: copper nickel, 10%; yellow brass; 304 stainless steel; and mild steel caused accelerated corrosion at some location on the 5086-H32 aluminum. Of all the dissimilar metals studied the copper nickel caused the deepest corrosion beneath the dissimilar metal and on the general areas of the specimen. The 304 stainless steel accelerated the corrosion of the aluminum the most at the crevice formed by the phenolic mounting spacers. Edge corrosion of the aluminum was also caused by each of the dissimilar metals.

Fig. 5 - 5086-H32 aluminum coupled to copper nickel, 10%; with and without cathodic protection (CP), 809 days in seawater at Key West, Florida.

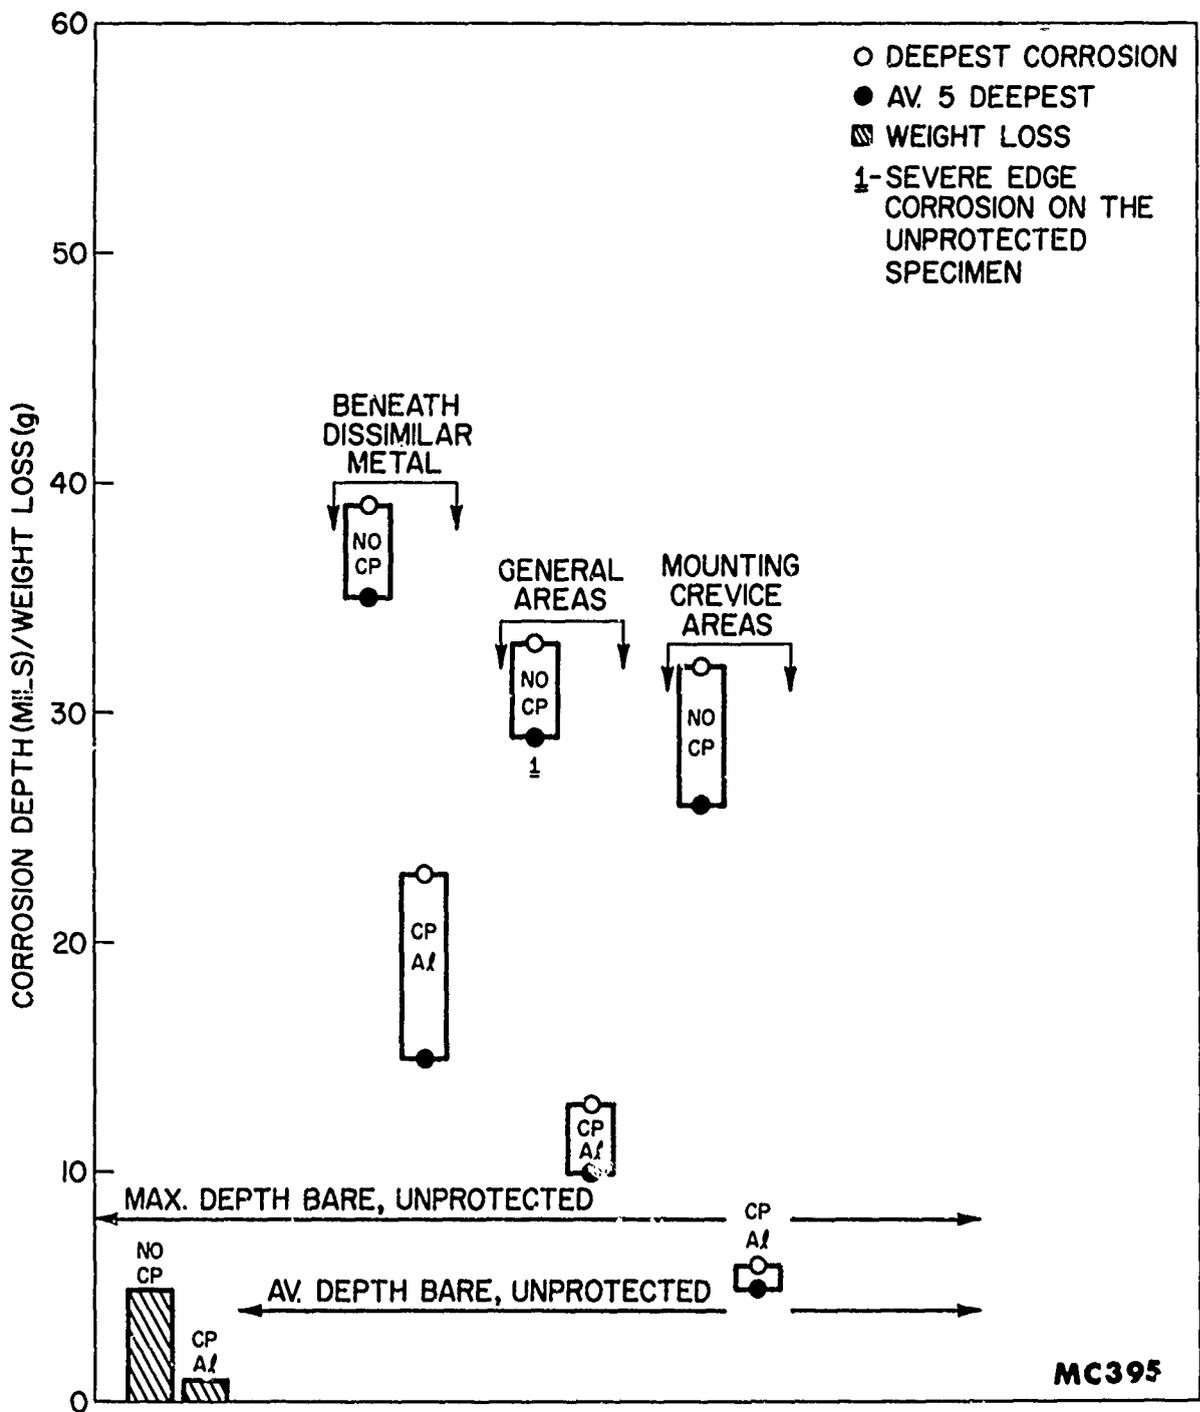
Fig. 6 - 5086-H32 aluminum coupled to yellow brass; with and without cathodic protection (CP), 809 days in seawater at Key West, Florida.

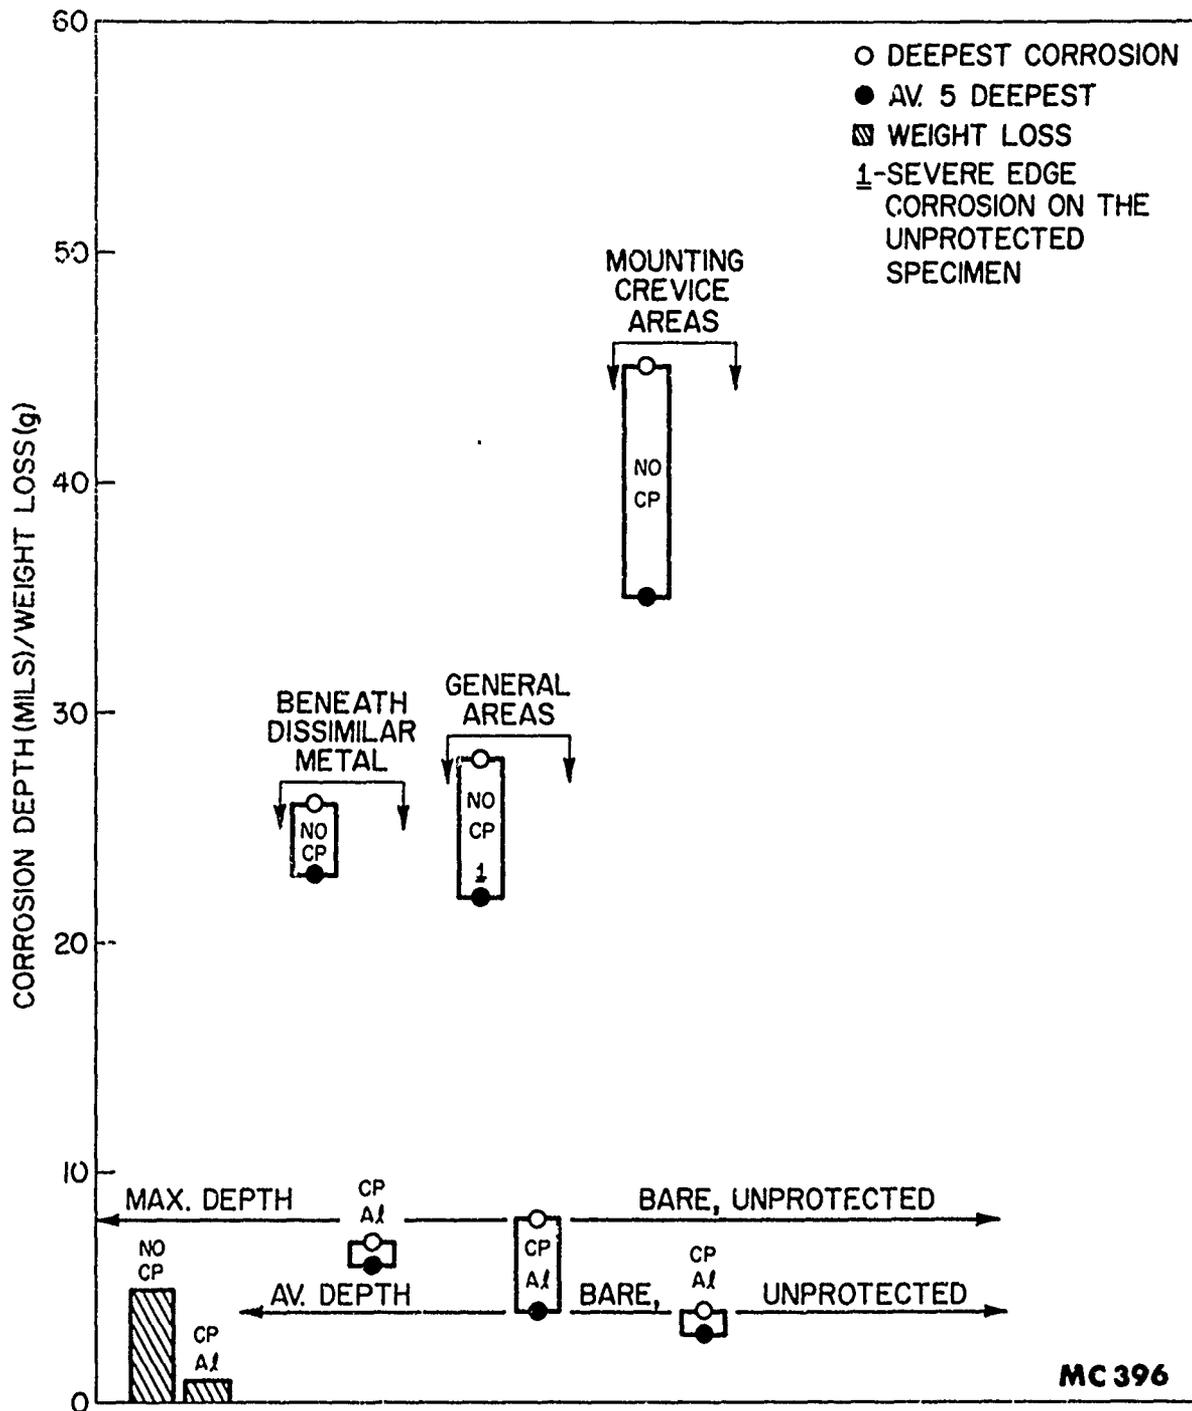
Cathodic protection from the aluminum anodes reduced the depth of corrosion on the 5086-H32 aluminum caused by the dissimilar metals, but only in the case of the 304 stainless steel couple (Fig. 7) was the depth of corrosion reduced to that observed on the bare, uncoupled and unprotected 5086-H32 aluminum. The depth of corrosion on bare 5086-H32 aluminum (with and without cathodic protection) and not coupled to a dissimilar metal has been shown on Fig. 9. The data for the maximum corrosion depth for bare and unprotected 5086-H32 aluminum have been shown on the appropriate graphs for comparative purposes.

Fig. 7 - 5086-H32 aluminum coupled to 304 stainless steel; with and without cathodic protection (CP), 809 days in seawater at Key West, Florida.

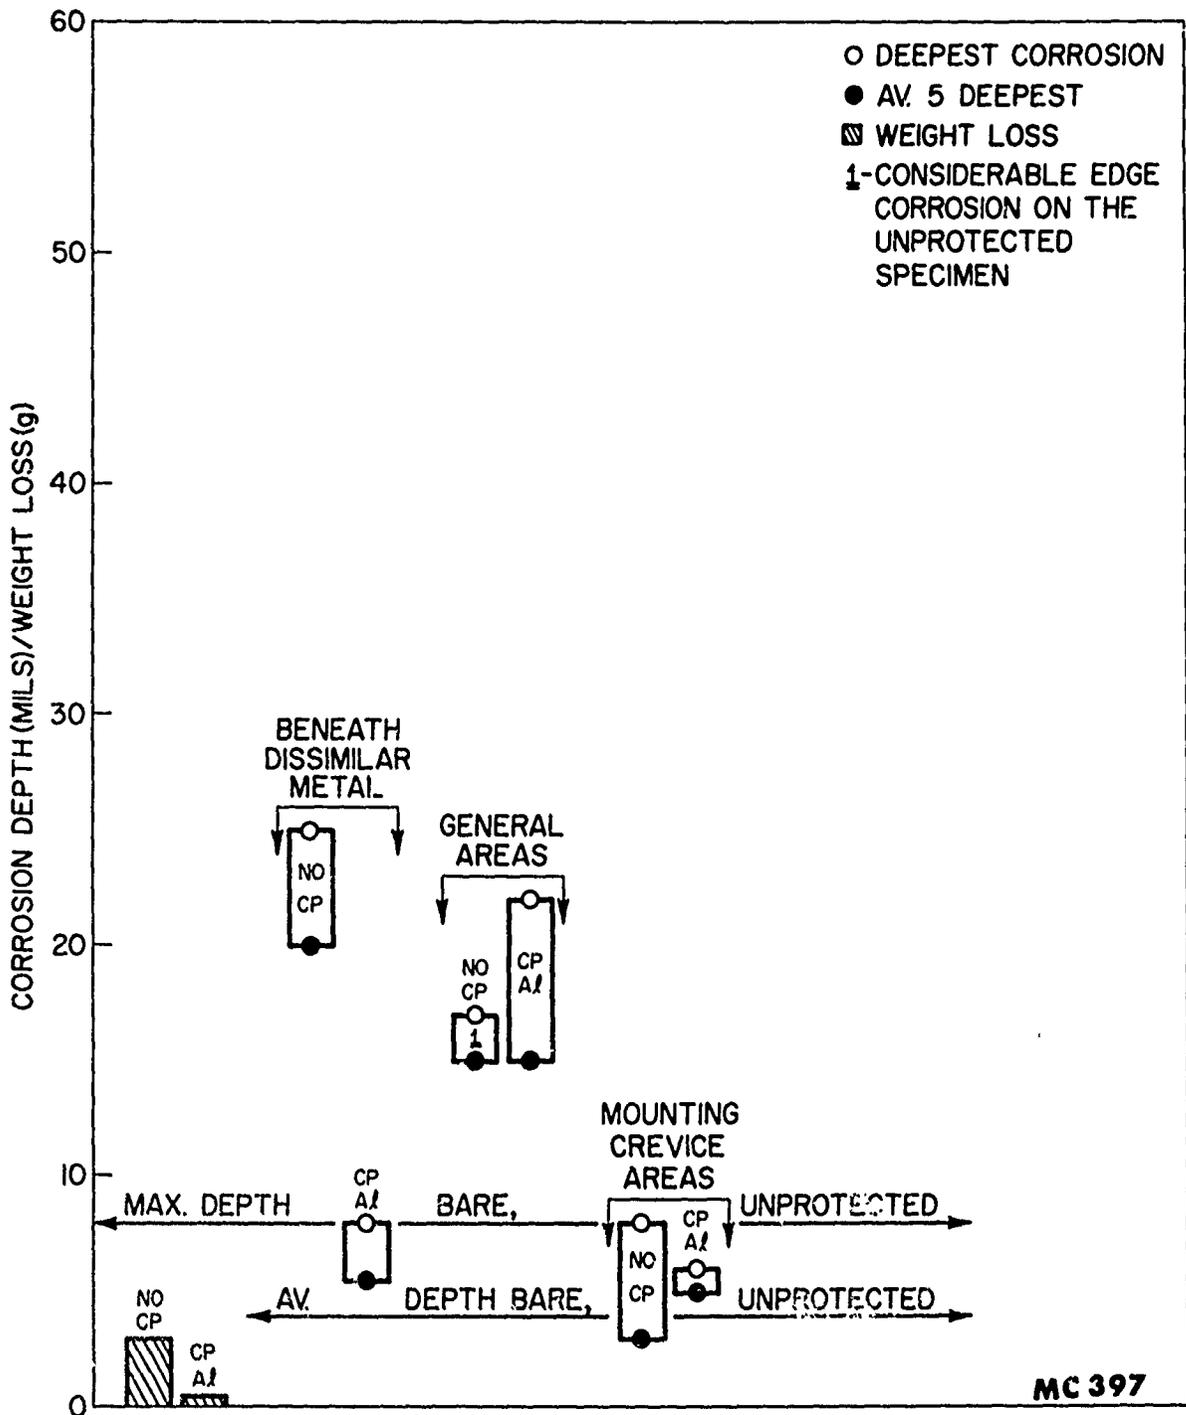
Fig. 8 - 5086-H32 aluminum coupled to mild steel; with and without cathodic protection (CP), 809 days in seawater at Key West, Florida.

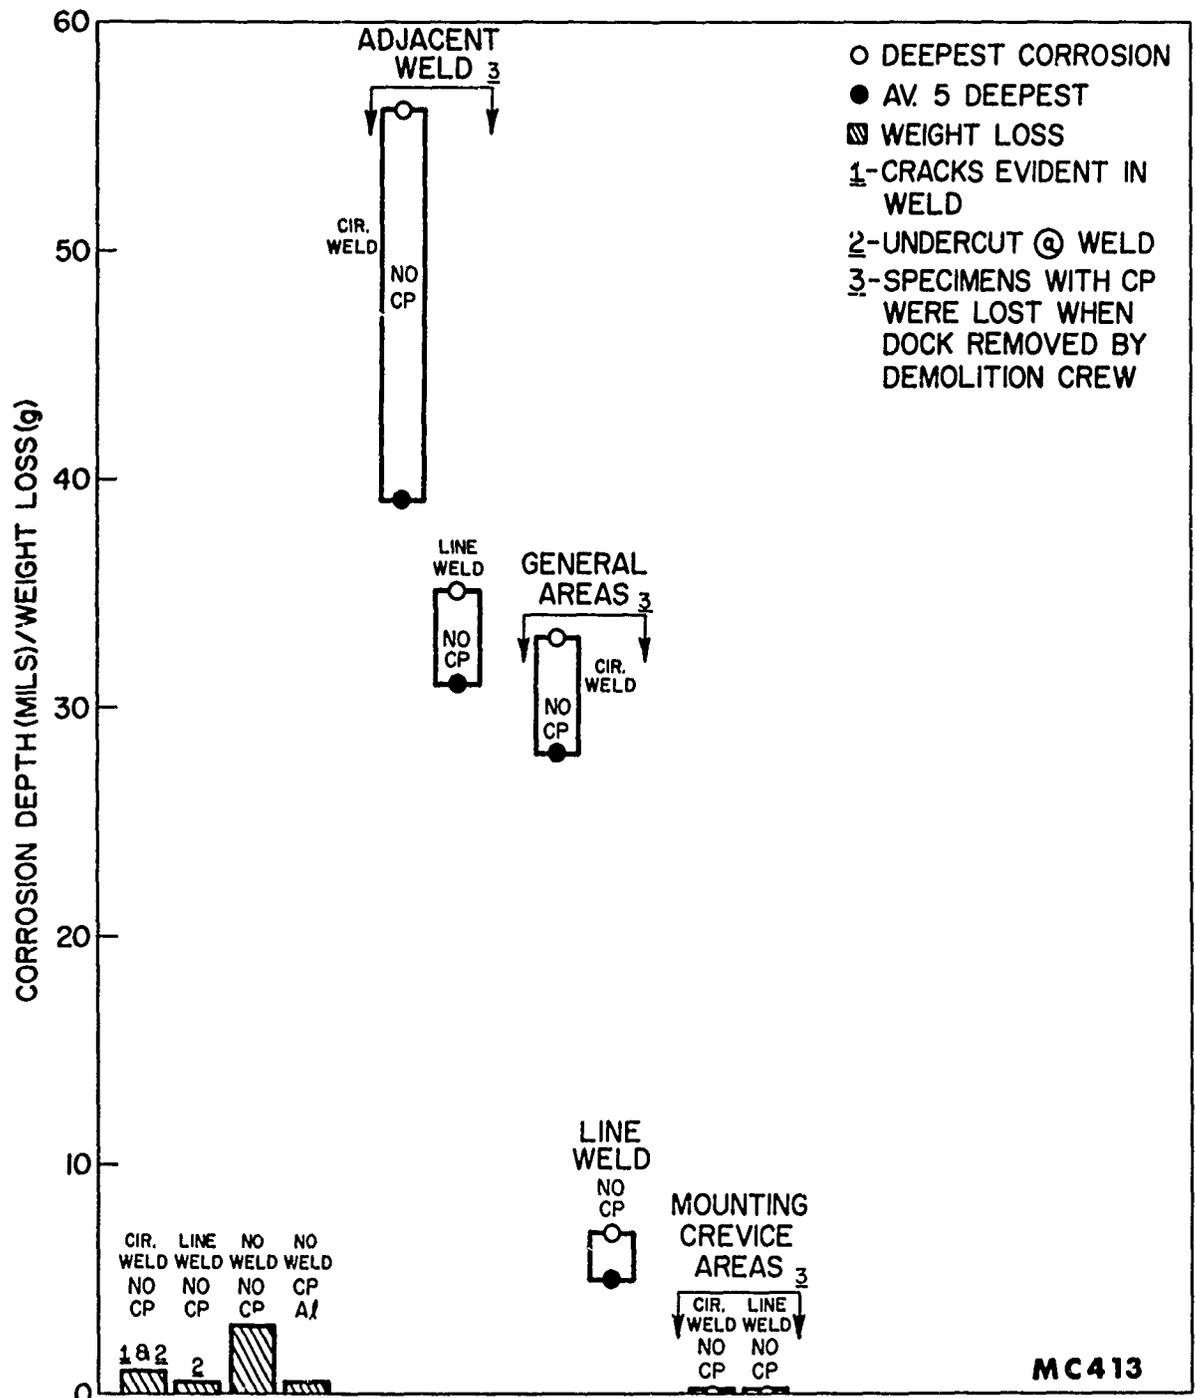
The data for the depth of corrosion on the welded specimens of 5086-H32 aluminum exposed for 675 days in the Potomac River are summarized in Fig. 24. The 5086-H32 aluminum corroded to a depth of 56 mils adjacent to the weld and to 33 mils on general areas of the specimen. The deepest corrosion occurred on the circular welded specimen which also showed slight cracks in the weld, but it was not certain whether these cracks were present prior to exposure. The weld and adjacent areas on this specimen are shown in Fig. 25.

Fig. 24 - Welded 5086-H32 aluminum after 675 days in the Potomac River.

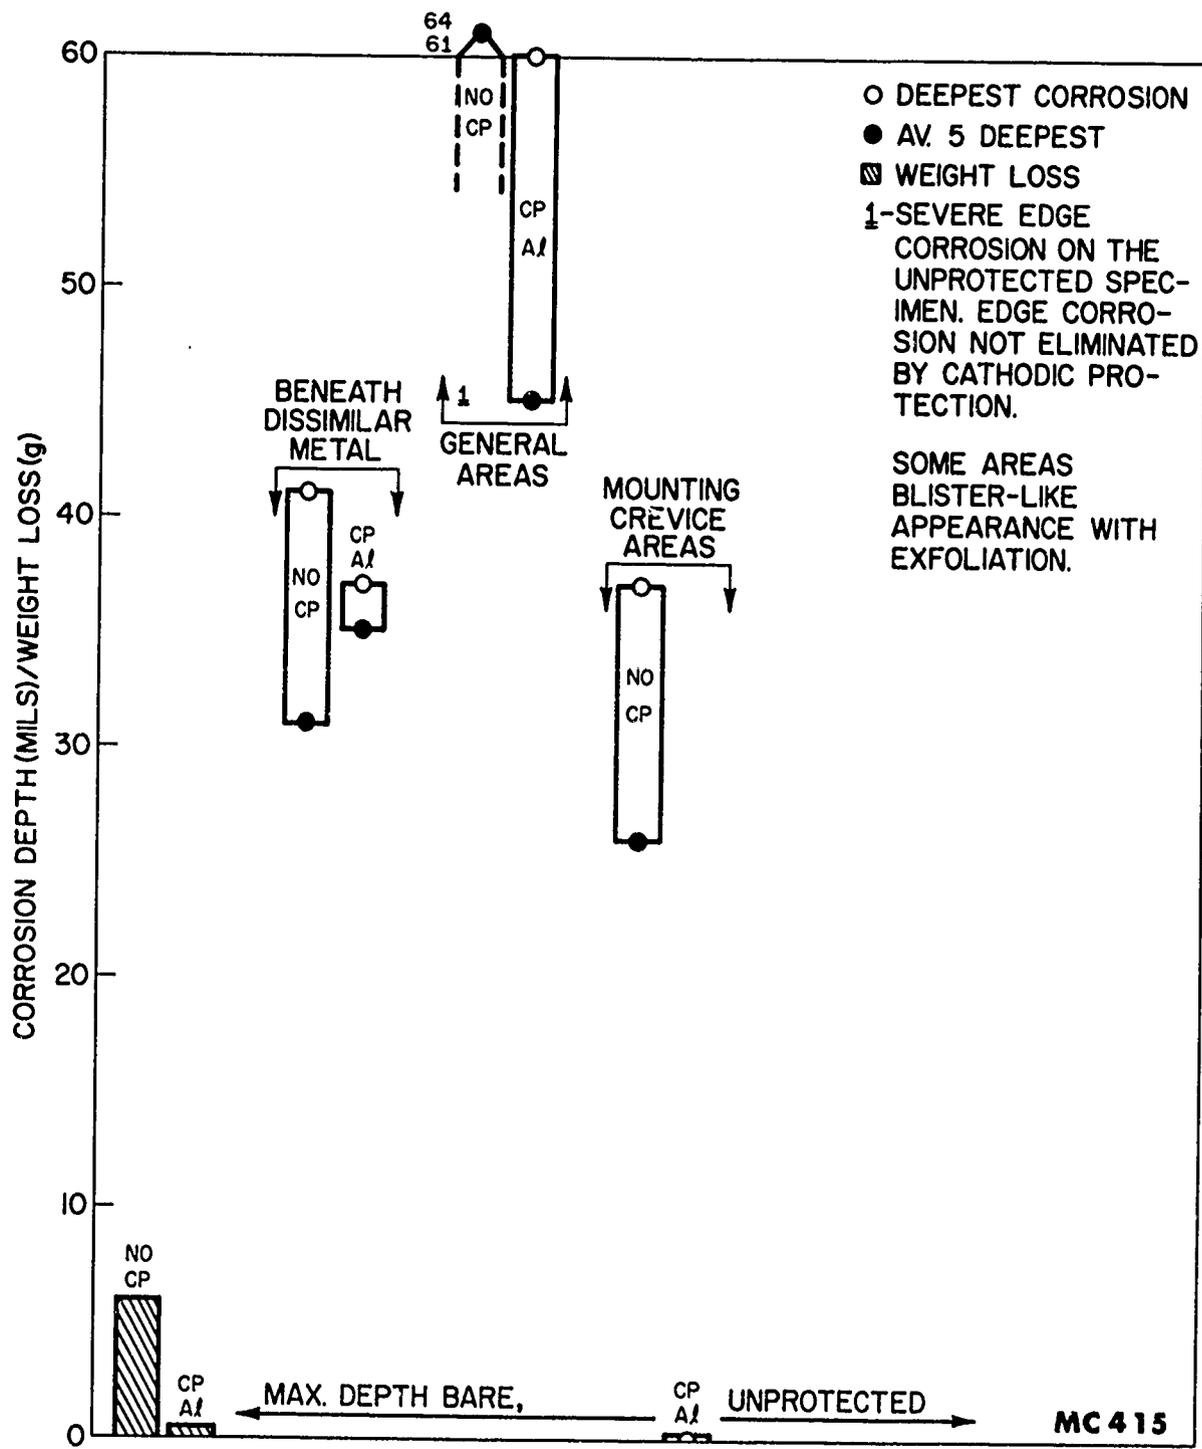
Fig. 26 - 5086-H32 aluminum coupled to copper nickel, 10%; with and without cathodic protection (CP), 675 days in the Potomac River.

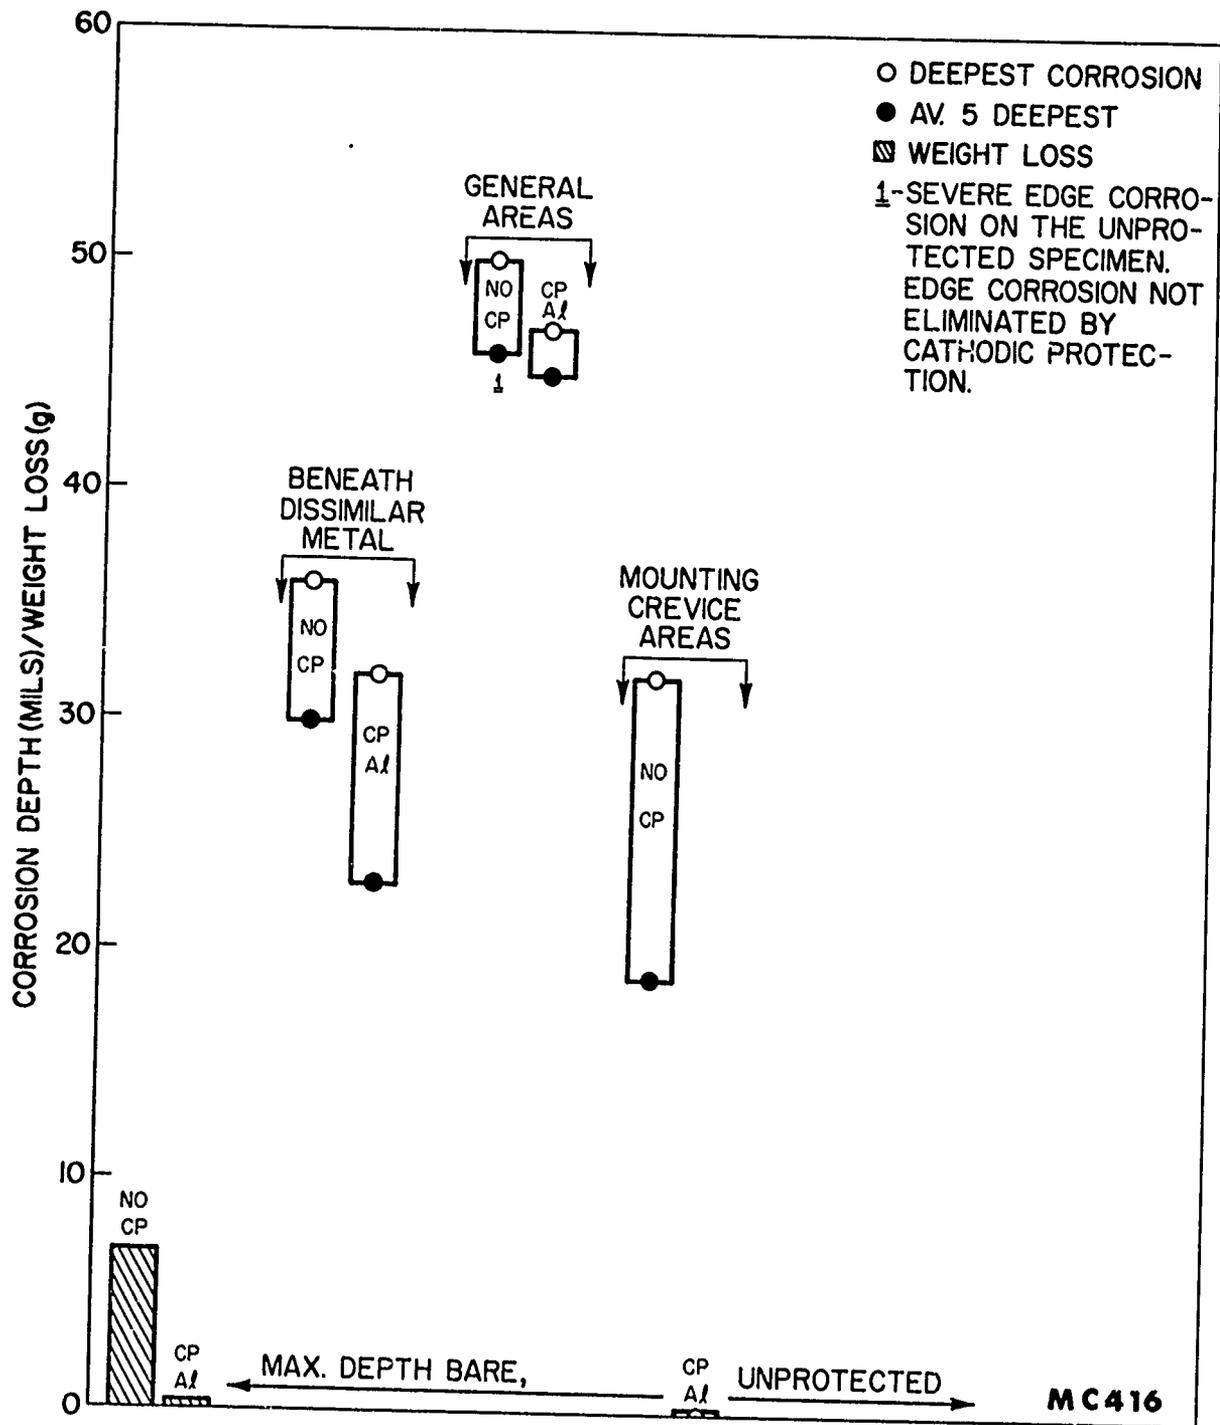
Fig. 27 - 5086-H23 aluminum coupled to yellow brass; with and without cathodic protection (CP), 675 days in the Potomac River.

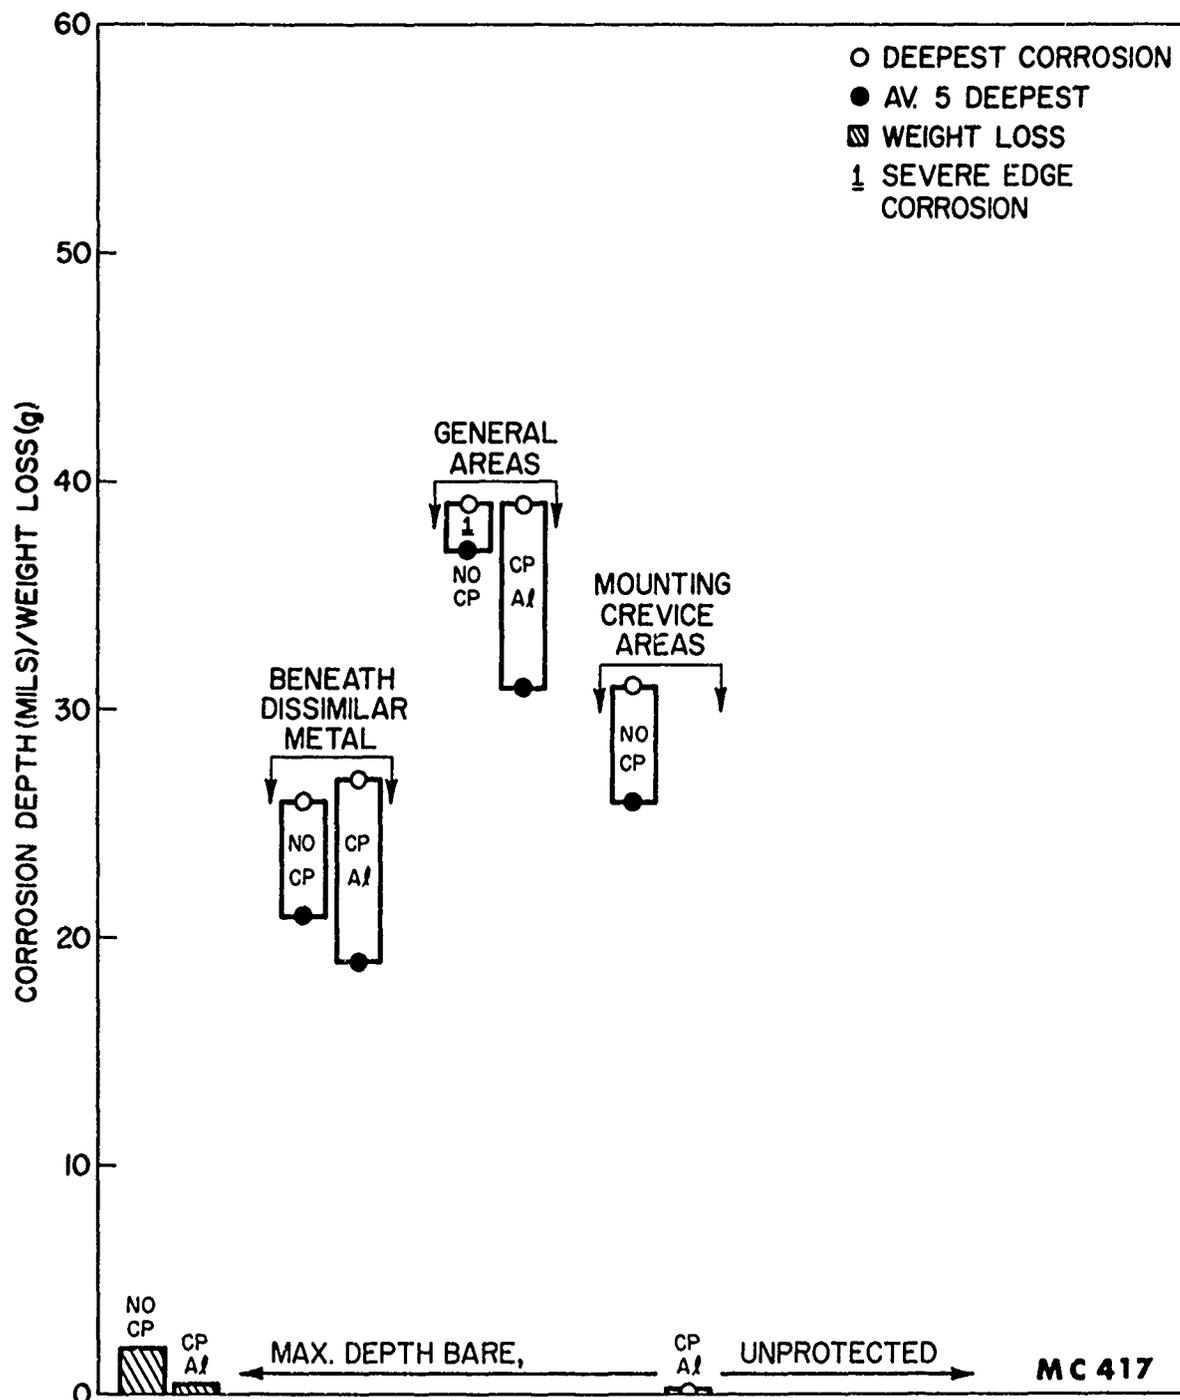
Fig. 28 - 5086-H32 aluminum coupled to 304 stainless steel; with and without cathodic protection (CP), 675 days in the Potomac River.

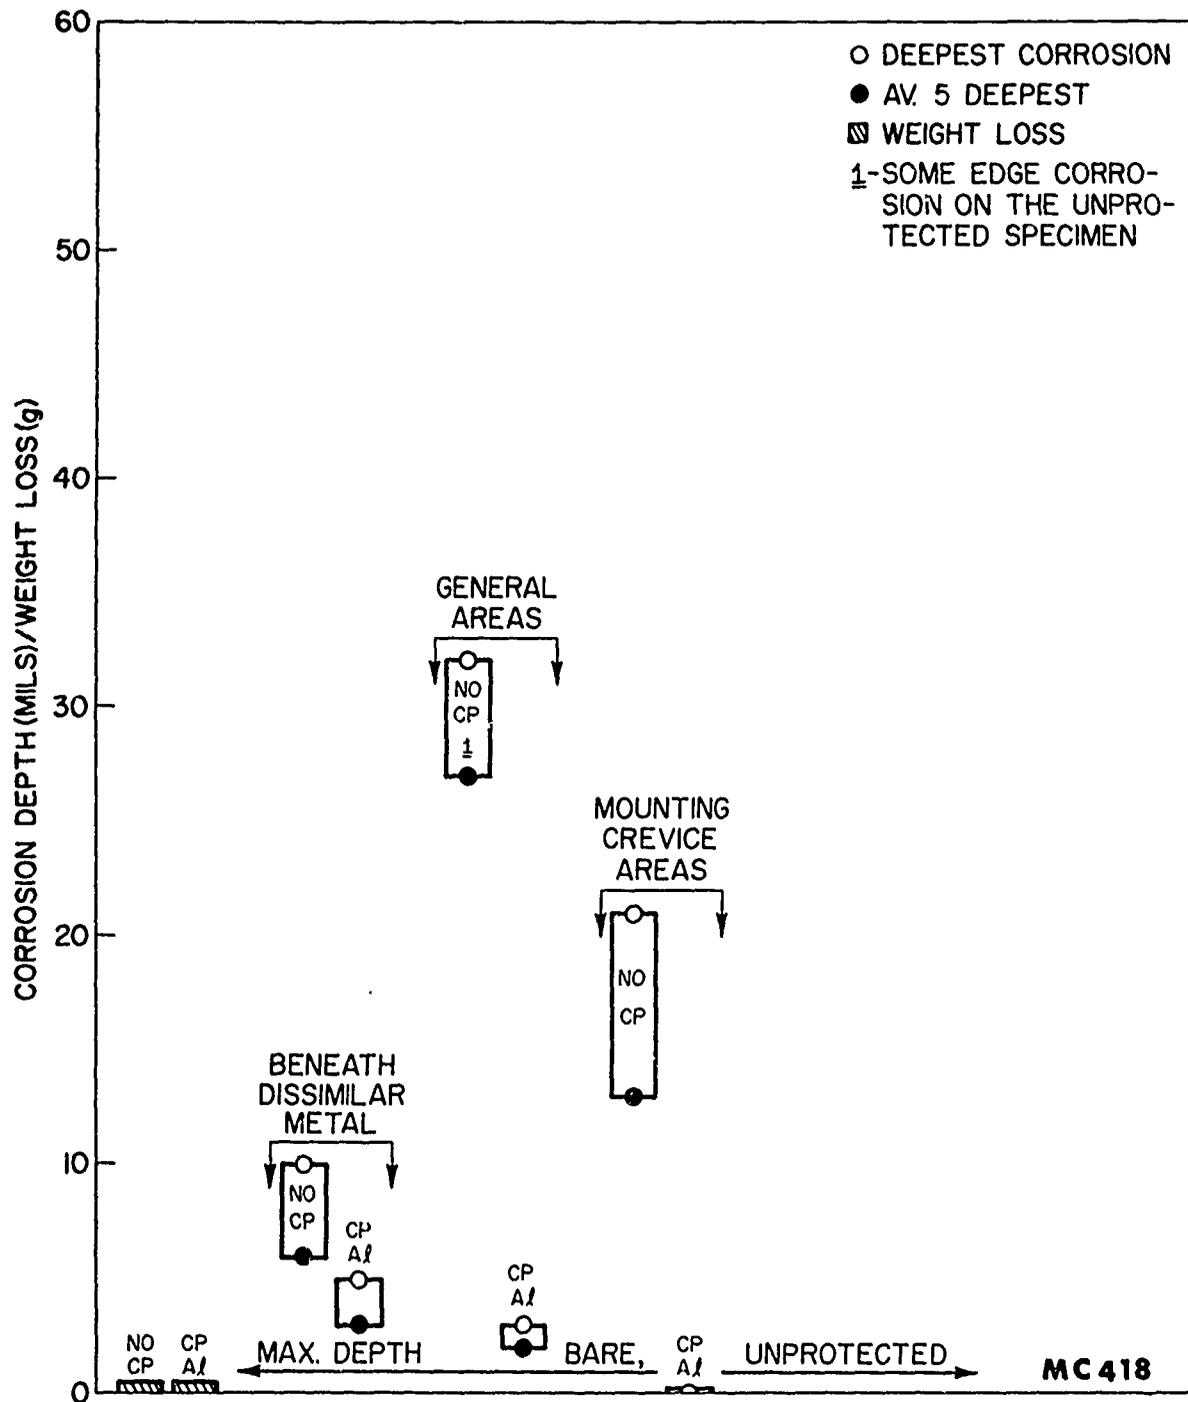
In the case of the mild steel couple in the Potomac River cathodic protection was effective and significantly reduced the depth of corrosion at all locations on the 5086-H32 aluminum, Fig. 29.

Fig. 29 - 5086-H32 aluminum coupled to mild steel; with and without cathodic protection (CP), 675 days in the Potomac River.

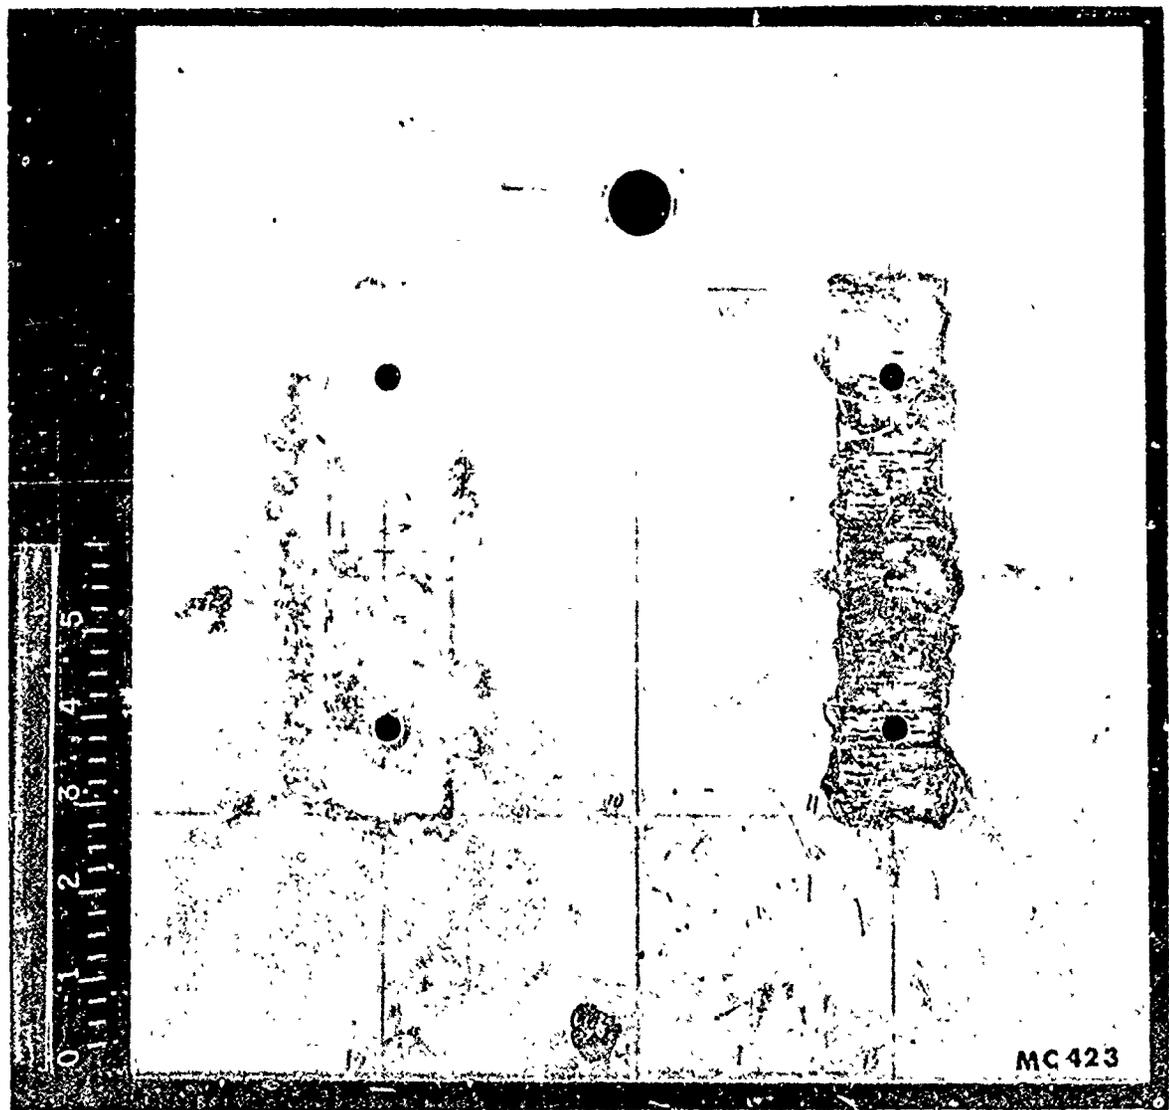
Fig. 34 - 5086-II32 aluminum coupled to yellow brass; with cathodic protection, 675 days in the Potomac River. Original magnification 0.5 X

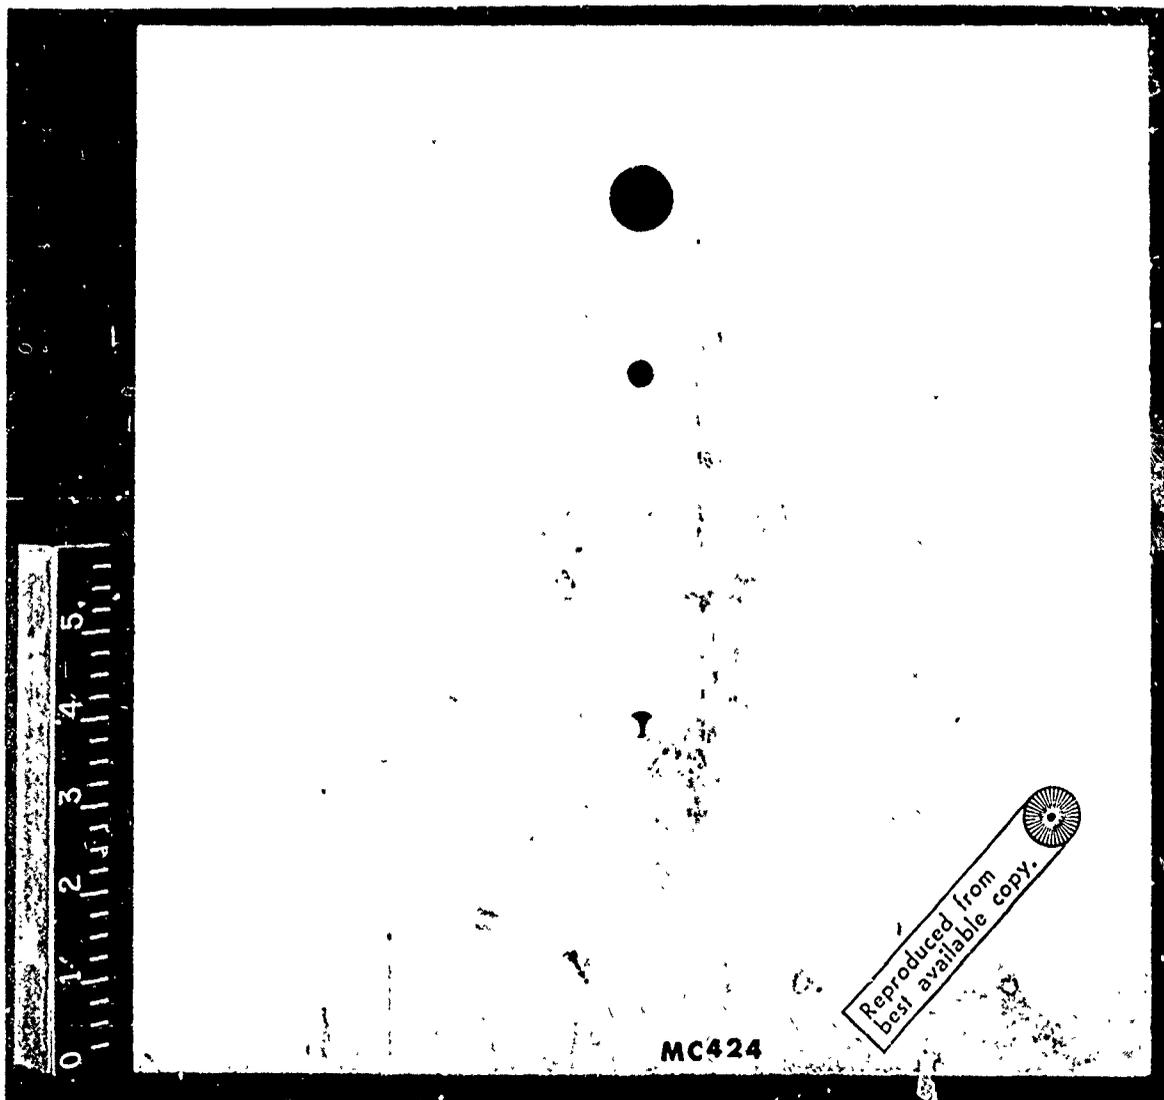
Fig. 35 - 5086-H32 aluminum coupled to 304 stainless steel; without cathodic protection, 675 days in the Potomac River. Original magnification 0.5 X

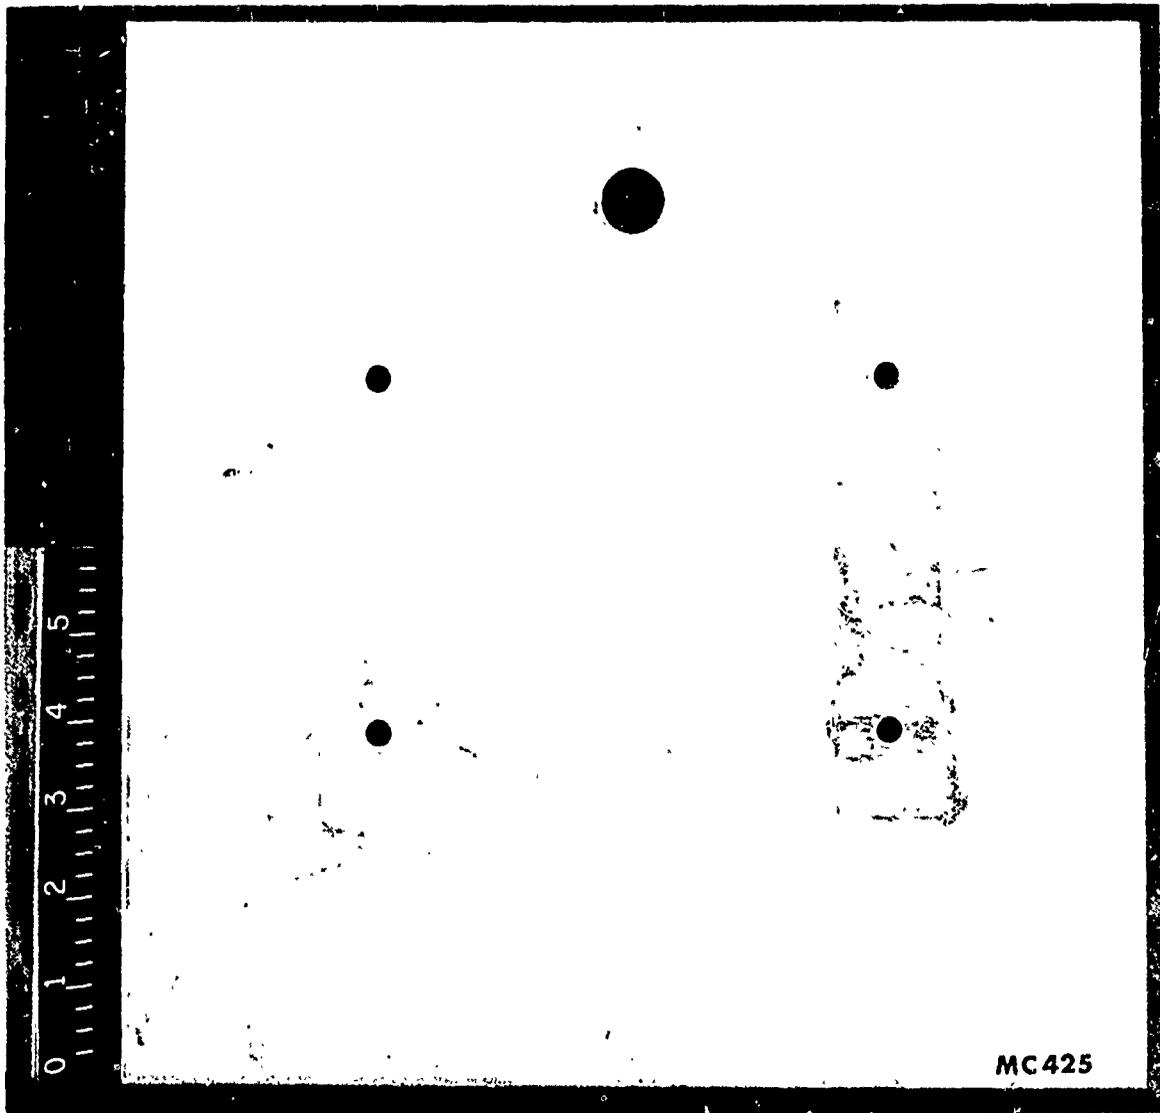
Fig. 36 - 5086-H32 aluminum coupled to 304 stainless steel;
with cathodic protection, 675 days in the Potomac River .
Original magnification 0.5 X
