Marine Corrosion Studies

The Effects of Dissimilar Metal Couples and Toxicants from Antifouling Paints on the Corrosion of 5086 and 6061 Aluminum Alloys and Their Response to Cathodic Protection

(Fourteenth Interim Report of Progress)

NAVAL RESEARCH LABORATORY
Washington, D.C.

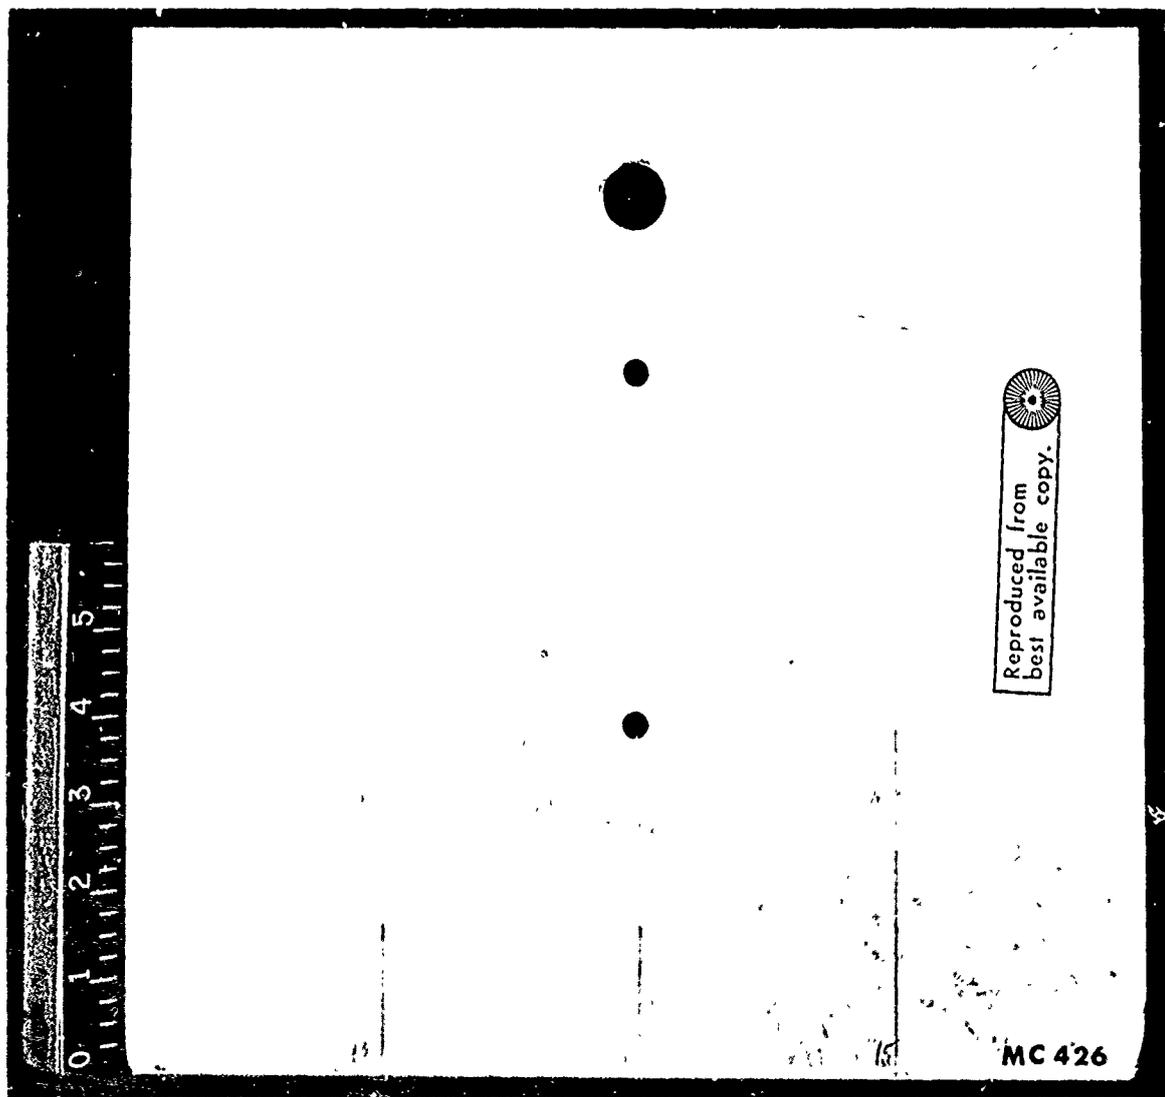
Fig. 37 - 5086-H32 aluminum coupled to mild steel; without cathodic protection, 675 days in the Potomac River. Original magnification 0.5 X

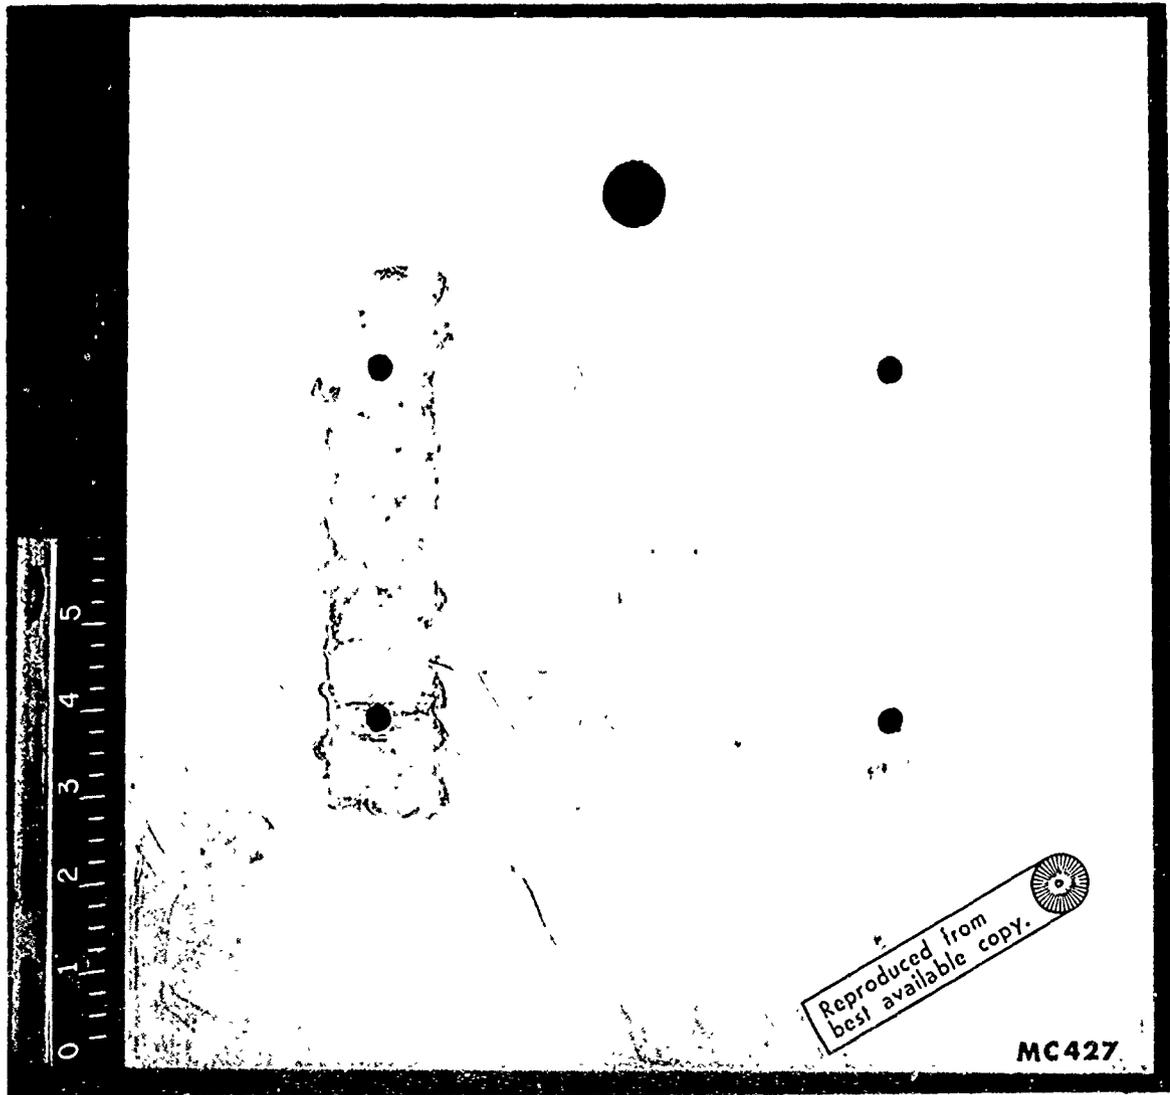
Fig. 38 - 5086-H32 aluminum coupled to mild steel; with cathodic protection, 675 days in the Potomac River. Original magnification 0.5X

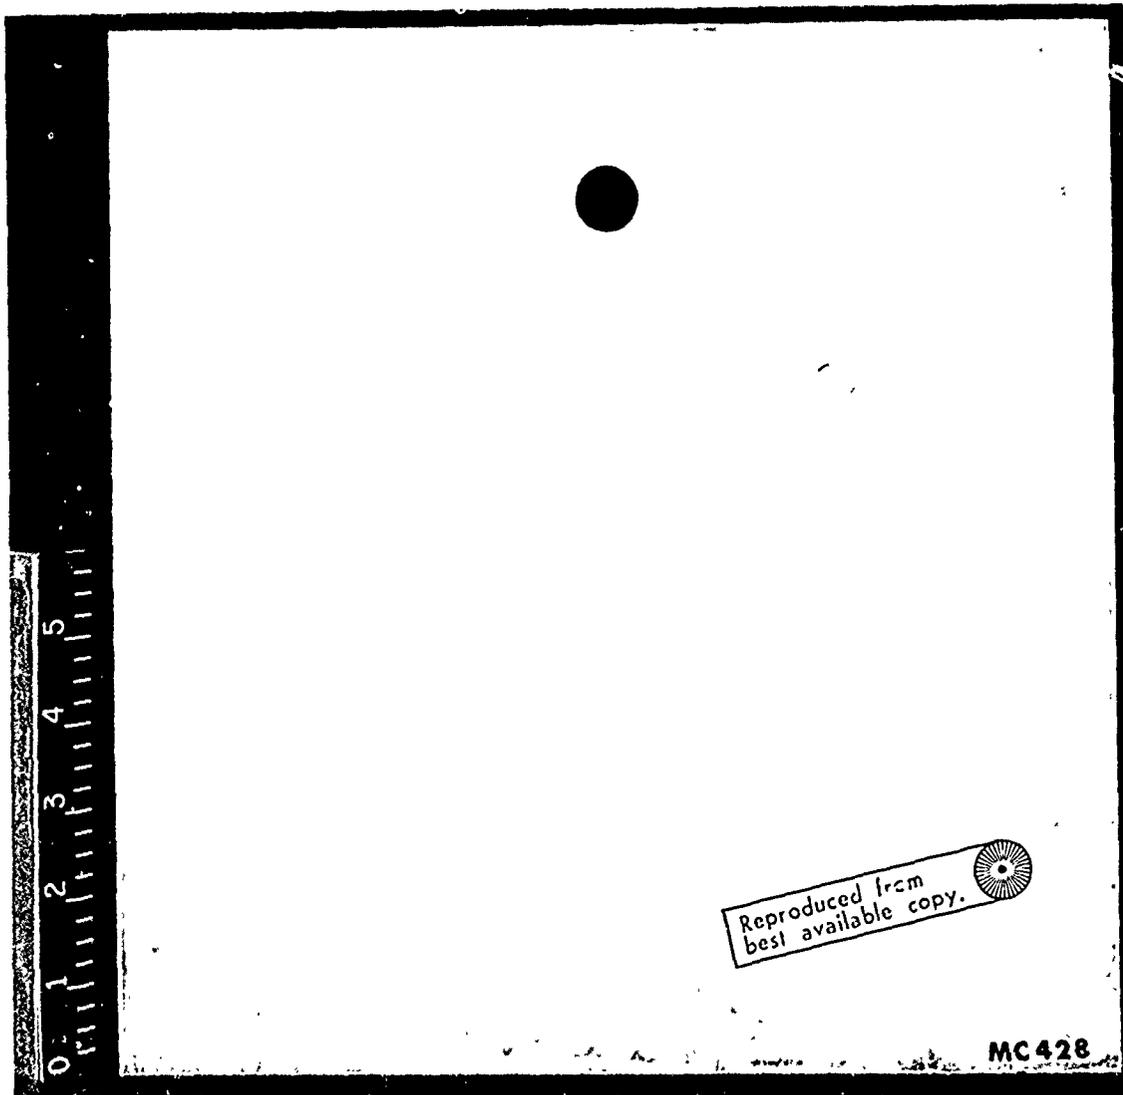
Fig. 39 - 5086-H32 aluminum; without cathodic protection, 675 days in the Potomac River. Original magnification 0.5 X

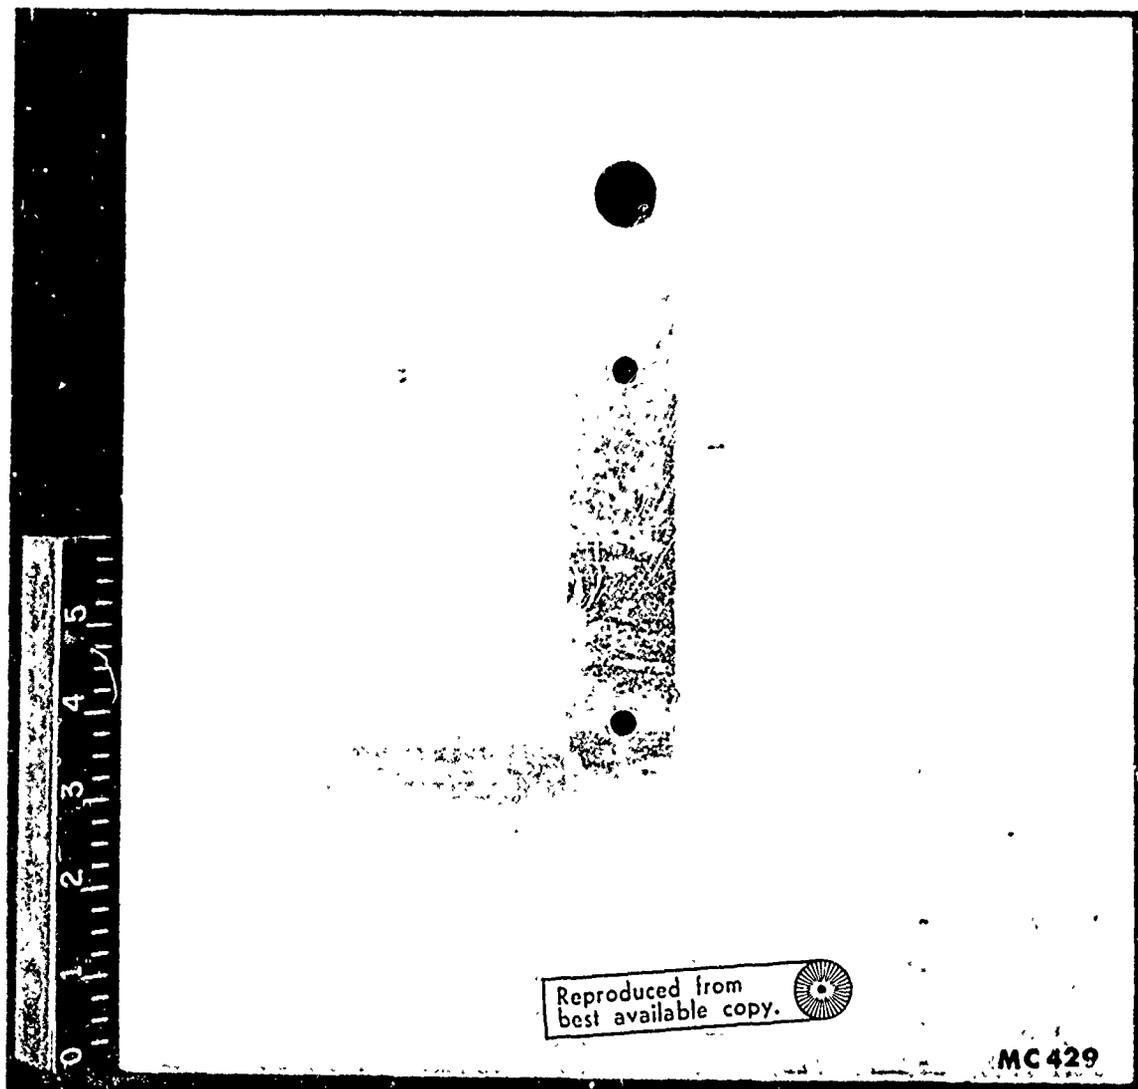
Fig. 40 - 5086-H32 aluminum; with cathodic protection, 675 days in the Potomac River. Original magnification 0.5 X
