FIELD STUDY OF FENCING MATERIALS IN A MARINE-ATMOSPHERIC ENVIRONMENT -
RESULTS OF UP TO THREE YEARS OF ATMOSPHERIC EXPOSURE AND CORROSION RATE
DETERMINATION

Technical Note N-123

Eddy S. Matsui

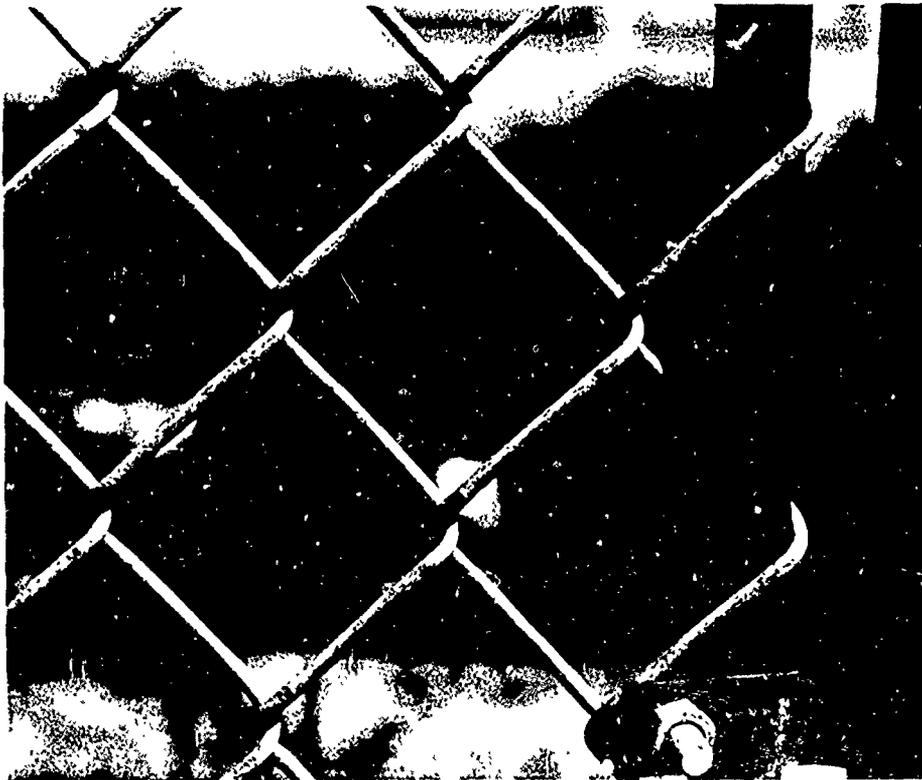
Systems 1 and 2 - Light and Heavy Zinc-coated Fabrics: The surface of the zinc-coated fabrics exhibited a bright metallic appearance when inspected at the time of installation (Figure 3). At the time of the fifth inspection (2 years after installation), the surface of both fabrics were nearly completely covered with a white corrosion product, a blend of fine air-borne sand and dirt that formed a rough surface on the fence wire. Very faint speckles of rust stains, in the form of pin-hole rust, appeared on the surfaces of the wire. Some of the rust stains were superficial and were probably caused by iron contaminated air-borne sand and dirt. The air-borne sand and dirt accumulated on the windward side more than the leeward side of the wire.

Figure 3. System 1. Newly installed zinc coated steel.

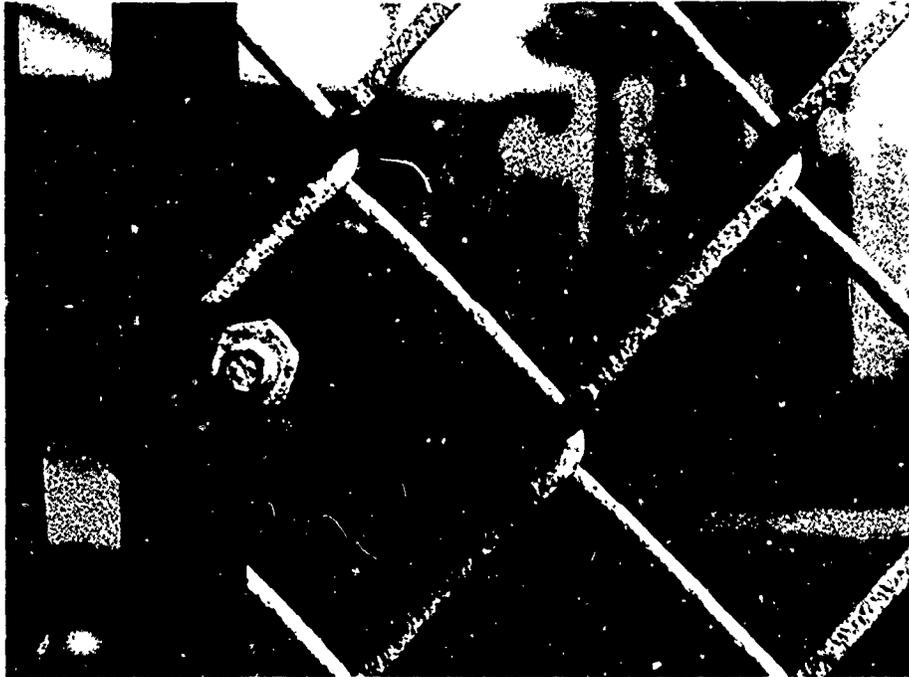
At the sixth inspection (3 years after installation), the zinc coating on the wire seemed to have disappeared, and only a dark gray zinc-iron alloy remained under the white corrosion product. Speckled rust stains were more apparent compared to the previous inspection and were distributed uniformly over about 5% of the zinc-coated surface (Figure 4). A little more of the rust stains were observed on wires located near the water than on those located away from water. The zinc-coated wires tarnished and corroded much faster than they normally would in a non-maritime environment. This was readily evident when comparing the test fence against a similar fence at a public school which was located 10 miles inland from the shore. After five years of atmospheric exposure, the school yard fence had tarnished to only a gray color and there was no accumulation of the white coarse corrosion product (Figure 5).

Although the corrosion products had accumulated and covered the entire wire surface of both systems, the performance of the zinc-coated wire for the first 3 years was rated fair because there was no significant amount of red rust formed on the base metal. Overall ratings are summarized in Table 3.

Figure 4. System 1. Zinc-coated steel - after 3 years of exposure.

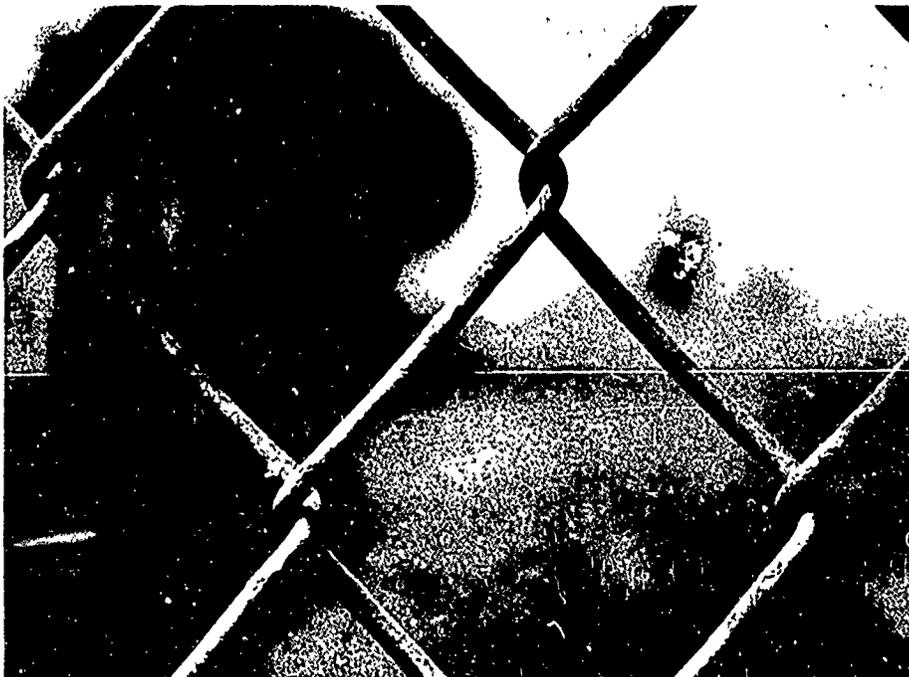
Figure 5. Zinc-coated steel - after 5 years - located 10 miles inland from shore.

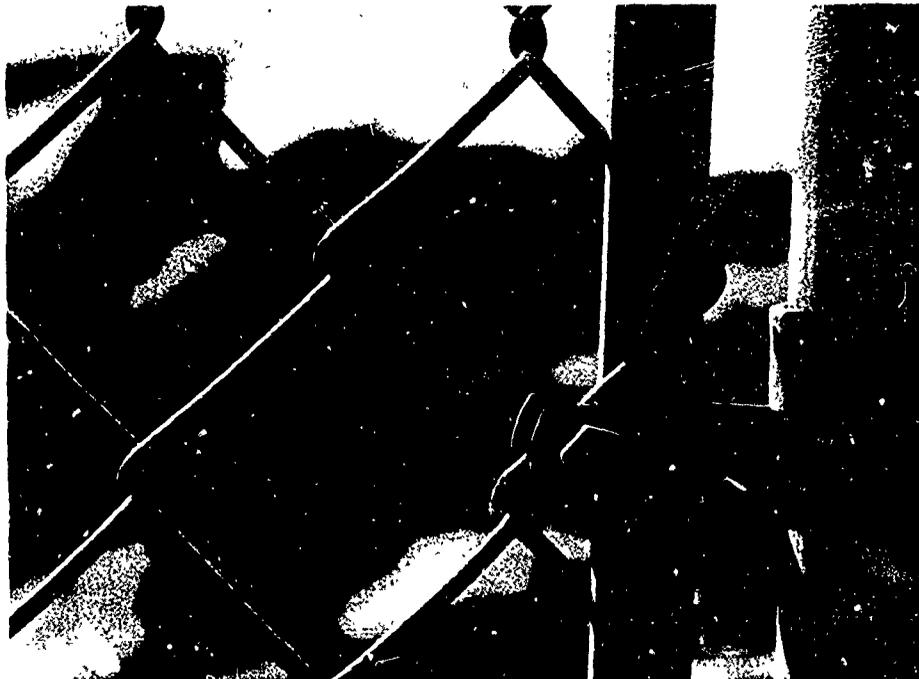
Systems 3 and 4 - Light and Heavy Aluminum-coated Fabrics: The bright metallic appearance of the aluminum-coated wires (Figure 6) diminished rapidly as the exposure test continued, and the surface of the wire was rapidly covered with white corrosion products. The corrosion products were coarse and consisted of white loosely-adhering crystals, which crumbled easily when rubbed between the fingers.

Figure 6. System 3. Newly installed aluminum-coated steel.

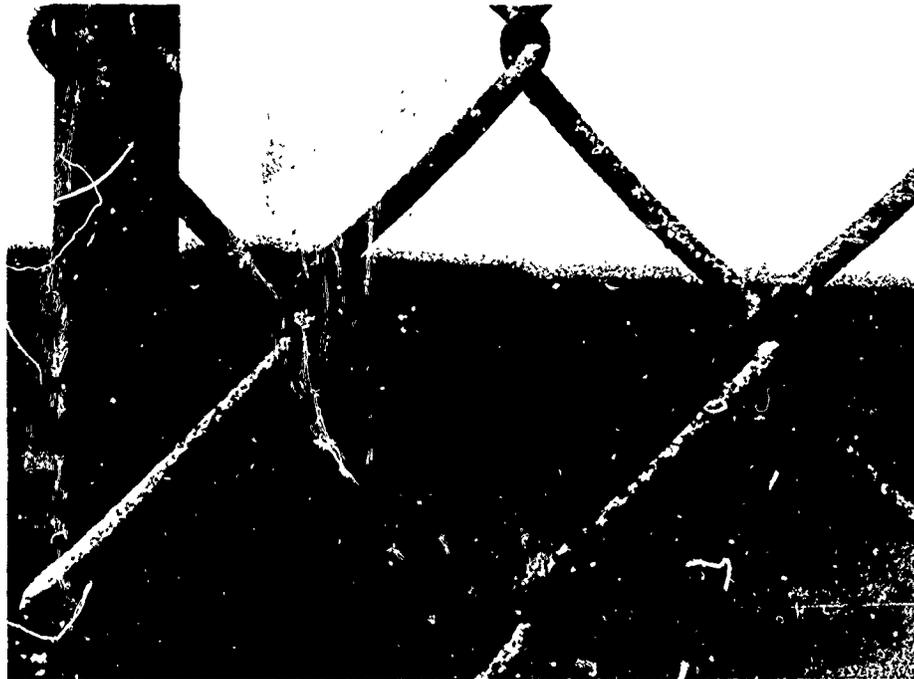
System 8 - Aluminum Alloy Fabric: During the three years of exposure, the bright metallic appearance of the aluminum alloy wire (Figure 11) was gradually lost by the accumulation of white corrosion product (Figure 12). The accumulation rate of the whitish corrosion product was slightly slower than that of the aluminum-coated wires, Systems 3 and 4.

Figure 12. System 8. Aluminum alloy after 3 years of exposure.

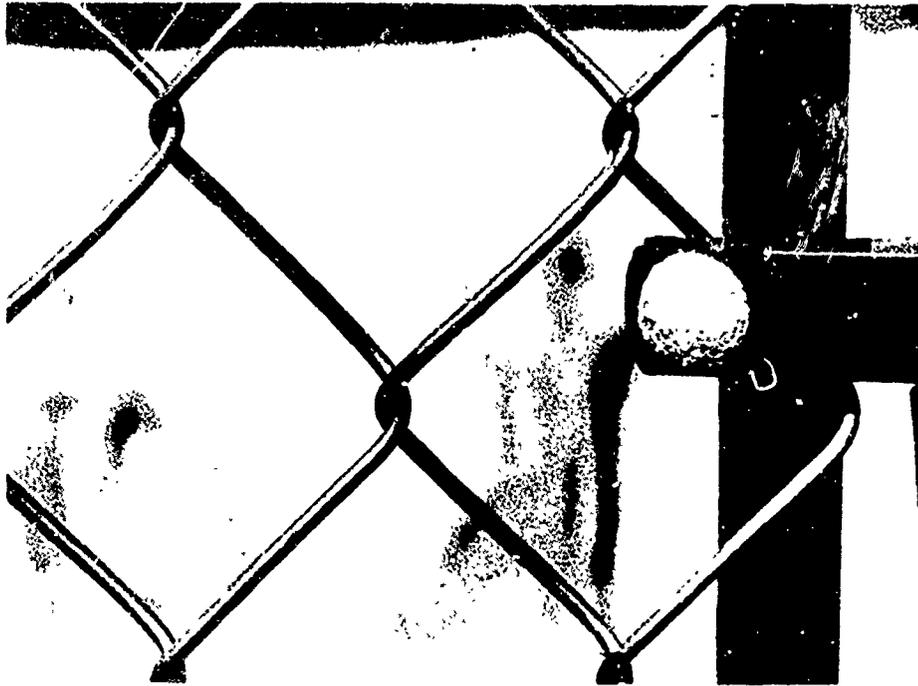
System 9 - Stainless Steel Fabric: The stainless steel fabric maintained its bright metallic appearance (Figures 13 & 14) throughout the three years of exposure. However, some of the accumulated sand and dust on the fabrics were not washed away easily following each rainfall and gave a rusty appearance.

The overall performance of the stainless steel fabrics was rated excellent.

Figure 14. System 9. Stainless steel after 3 years of exposure.

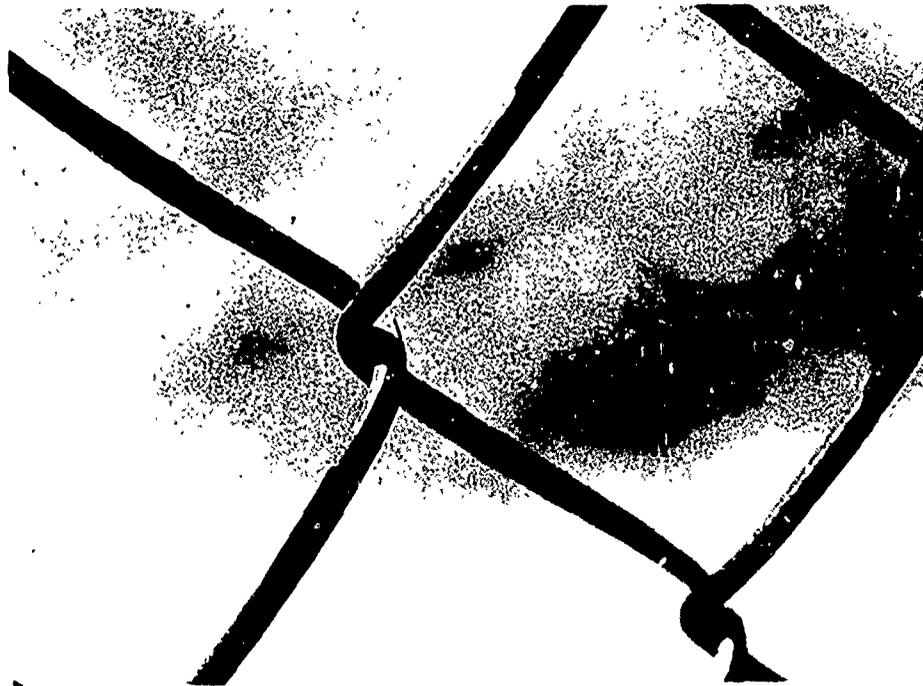
During the 12 months of atmospheric exposure, the fabric showed no evidence of cracking, color fading, or any other form of visible deterioration in the vinyl-coating (Figure 22). However, rust and blisters appeared in the areas where the fabric was damaged by an external mechanical force.

Except for the damaged areas, the performance of the vinyl-coated fabrics were rated excellent during the first 12 months of exposure.

Figure 22. System 14. Blister formation around damaged area - after 12 months of exposure.

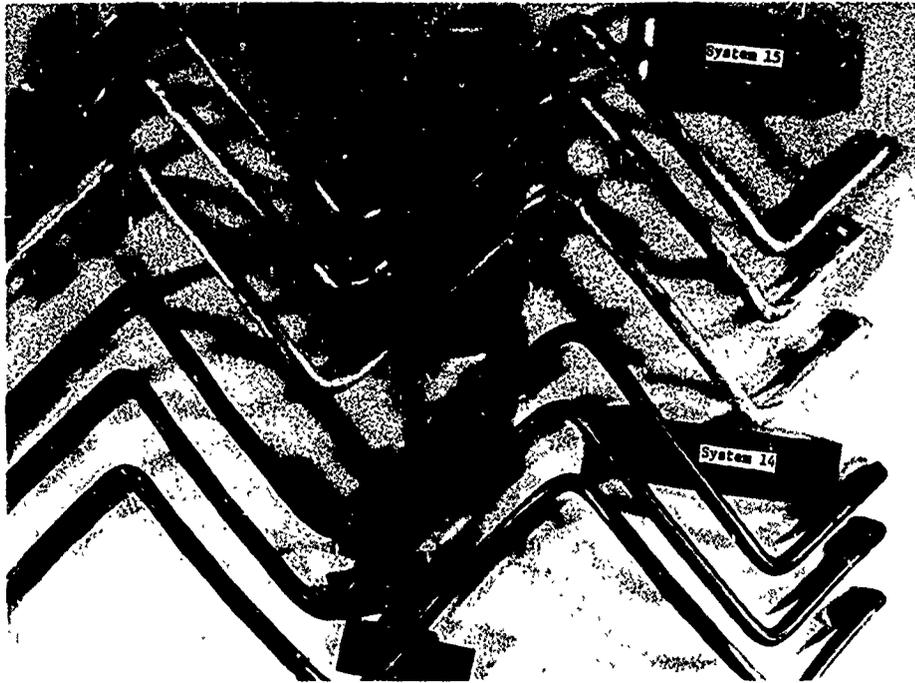
However, after 12 months of exposure, only 45% of the surface of System 15 was covered with a white corrosion product. System 15 lost 0.2 mils or 1.4% of the aluminum coating; this was far less than the loss of coating in Systems 3 and 4 with a comparable length of exposure (Figure 28).

Figure 28. Systems 14 & 15. Remaining aluminum coat and condition of core wire after 12 months of exposure.

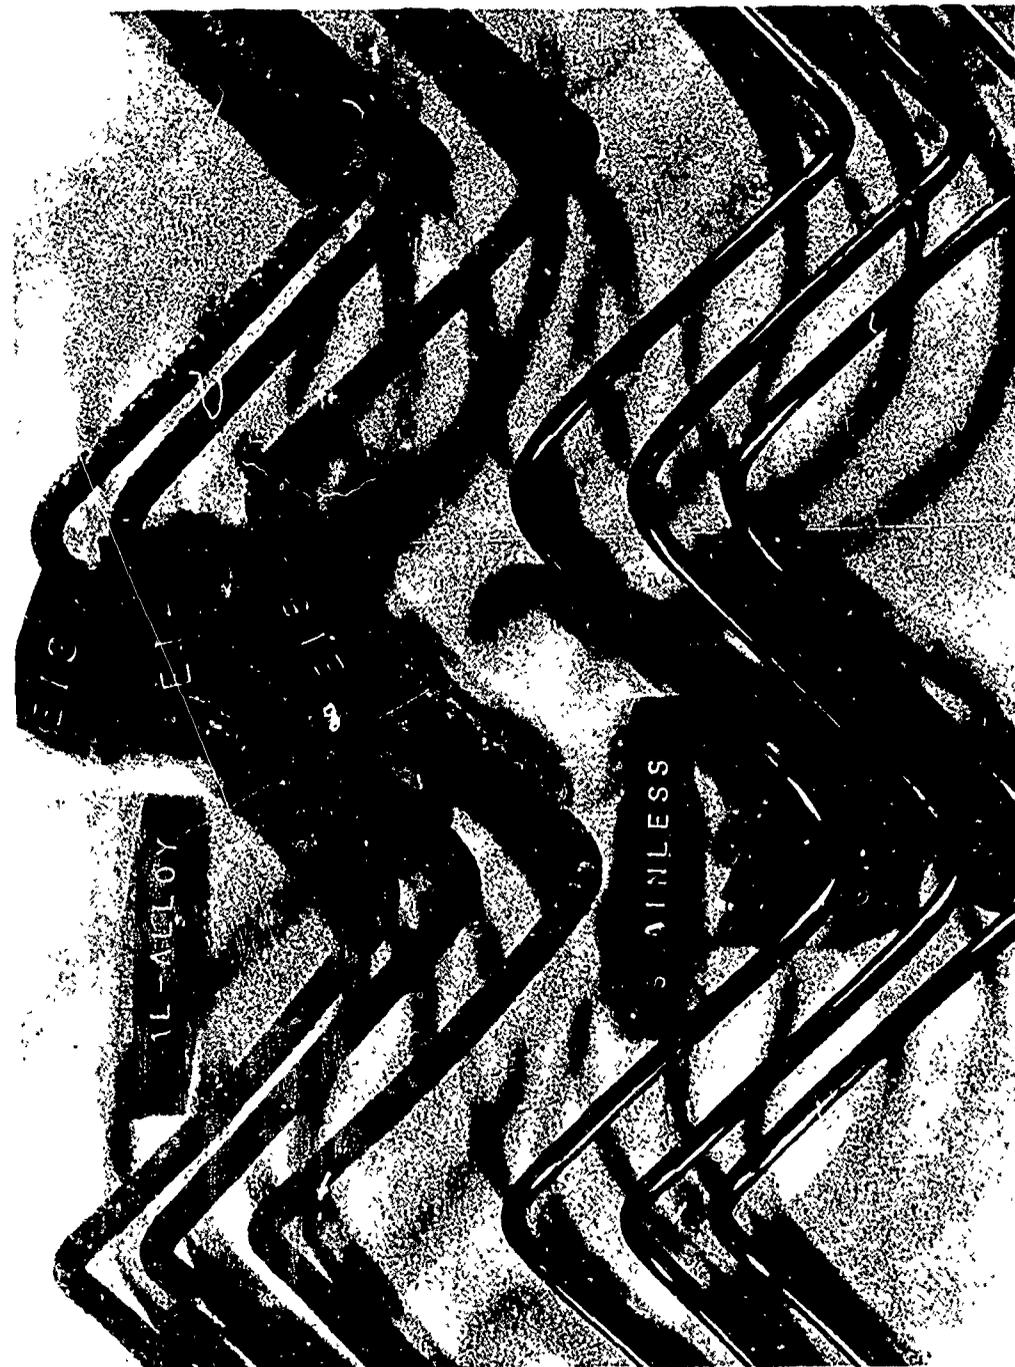
Aluminum Alloy Wire, System 8: After 24 months of exposure, the surface was completely covered with a white corrosion product and air-borne sand and dirt (Figure 32). Aluminum alloy wires lost an average of 0.5% and 1.2% of its weight after 12 and 24 months of atmospheric exposure, respectively.

Most of the corrosion of the aluminum alloy wires was in the form of pin-hole pitting. Thus, depth of penetration was deep, although the amount of metal lost was very light. The corrosion rate obtained by the amount of weight loss in metals as shown in Table 4 is therefore misleading because the corrosion rate so obtained will be much less than the actual penetration of pin-hole pitting. Although the amount of metal weight lost was small, the penetration of some of the pin-hole pittings were as deep as 2 mils or more when examined under a microscope.

Figure 32. Systems 6 & 9. Aluminum alloy and stainless steel wires - after 24 months of exposure.

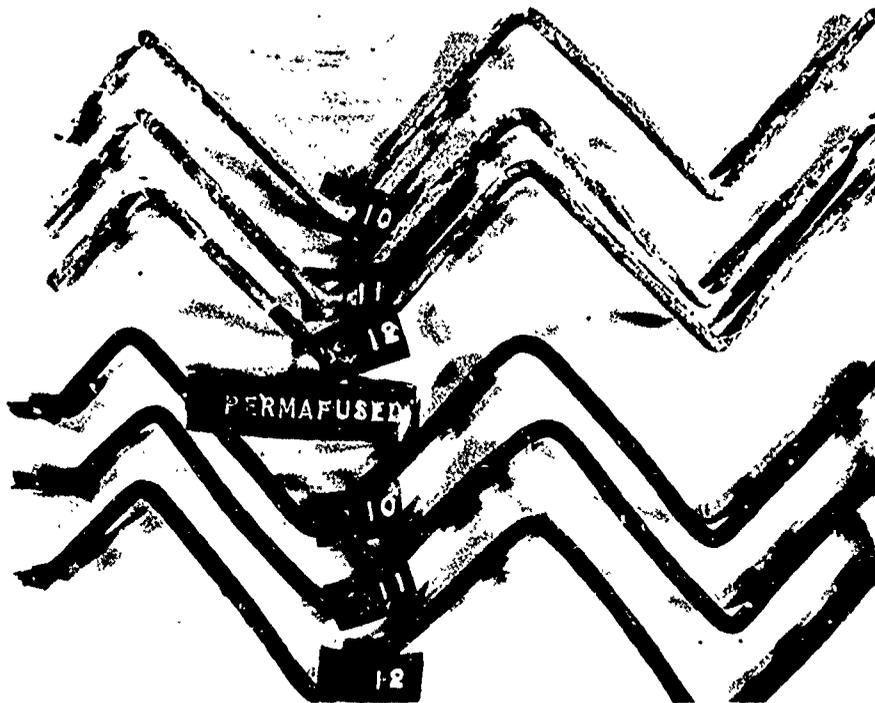
Aluminum-welded wire, System 15: After 4 months of salt-spray exposure, approximately 25% of the surface was covered with a white corrosion product (Figure 35). Except for a small amount of red rust at the cut ends and scribed areas, there was no other red rust on the wires. System 15 was very corrosion-resistant and lost very little of the aluminum coating in comparison with the aluminum-coated wire (System 4) which received extensive pitting corrosion during the comparable length of salt-spray test (Figure 36 vs 37).

Figure 35. Systems 14 & 15 - after 4 months of salt-spray test.

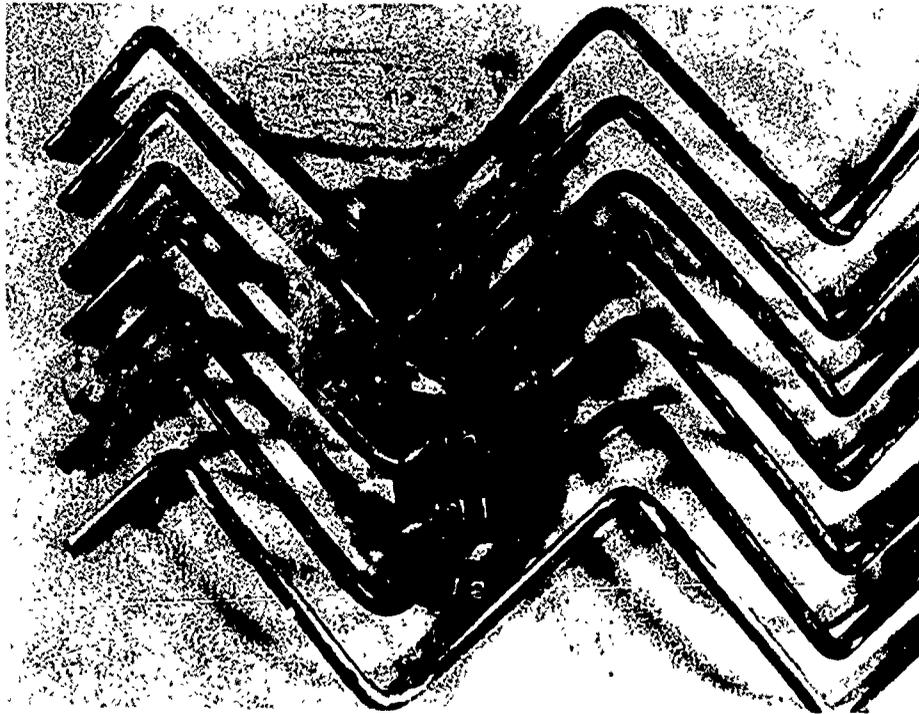
Figure 36. System 15. Corrosion product removed after 2 to 4 months of salt-spray test.

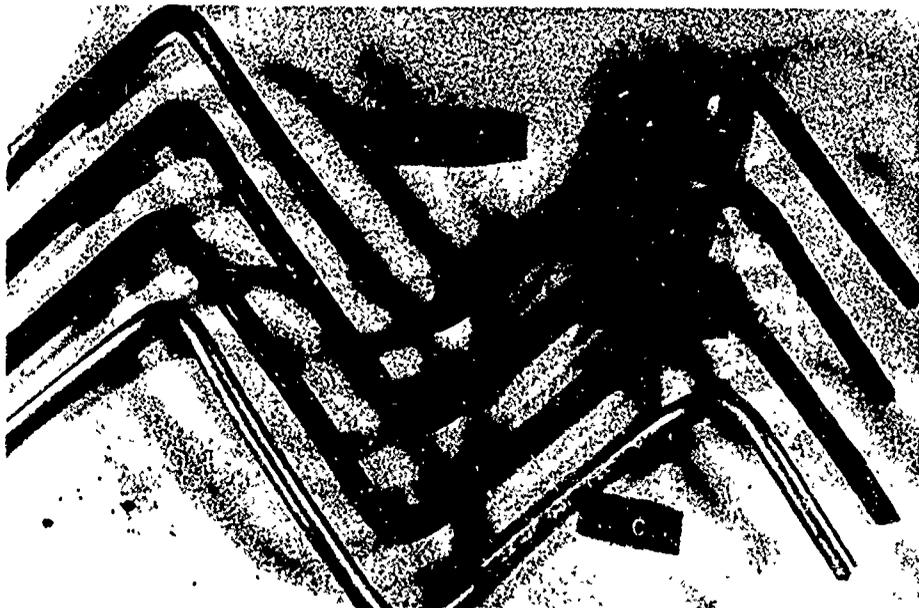
Figure 37. System 4. Corrosion product removed after 4 months of salt-spray test.
