RADC-TR-72-148
Technical Report
July 1972

ELECTRICAL OVERSTRESS FAILURES IN SILICON DEVICES

Rome Air Development Center
Air Force Systems Command
Griffiss Air Force Base, New York

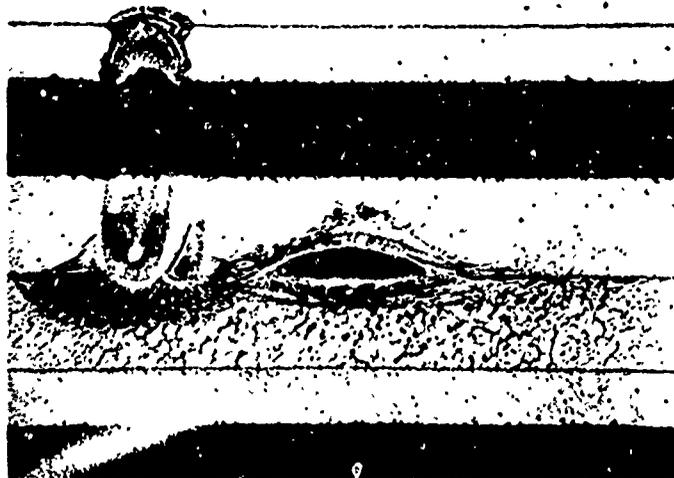
Figure 9
After Three Pulses, Severe Aluminum
Degradation and a Flash Over,
But No Short

conspicuous grain growth. After the third pulse, Figure 9, the aluminum has completely pulled away from the contact step, there is considerable damage in the contact area and a flashover has occurred adjacent to the initial damage. The flashover did not short the device.

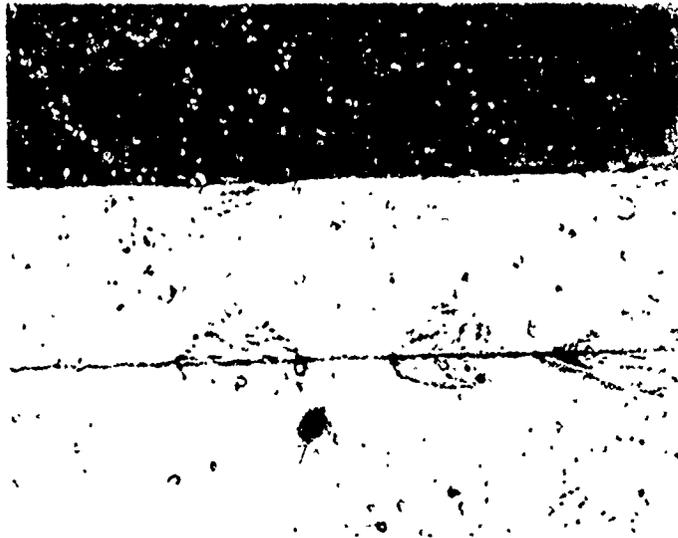
Figure 10
Evidence of Conduction Filaments
Beneath the SiO_2 , Negative Side

In second breakdown it is known that filaments form which conduct high currents. Evidence for such conduction filaments, in addition to the flashover was seen at both positive and negative electrodes. Figure 10 is a photograph showing traces of conduction filaments. These traces were produced by the high temperature generated by the conduction filament beneath the oxide, which caused aluminum on top of the oxide to melt and recrystallize along the path. There are two paths in this photograph. In spite of the feeling that the zap should initiate where all the damage is being done, ample evidence exists to prove that the zap actually does go from the positive to the negative side regardless of the silicon type. In Figure 11, for example, while extensive damage is seen at the negative side, it is obvious that aluminum has moved from the positive electrode. First, it is wider on that side, and second, the highest temperature for the longest time was experienced above the zap on the positive side as evidenced by the greater aluminum melting (black area) and flow.
