MIGRATION OF SILVER THROUGH GOLD PLATING
ON ELECTRICAL CONTACTS

Army Missile Command
Redstone Arsenal, Alabama

19 December 1972

TECHNICAL REPORT
RL-72-19

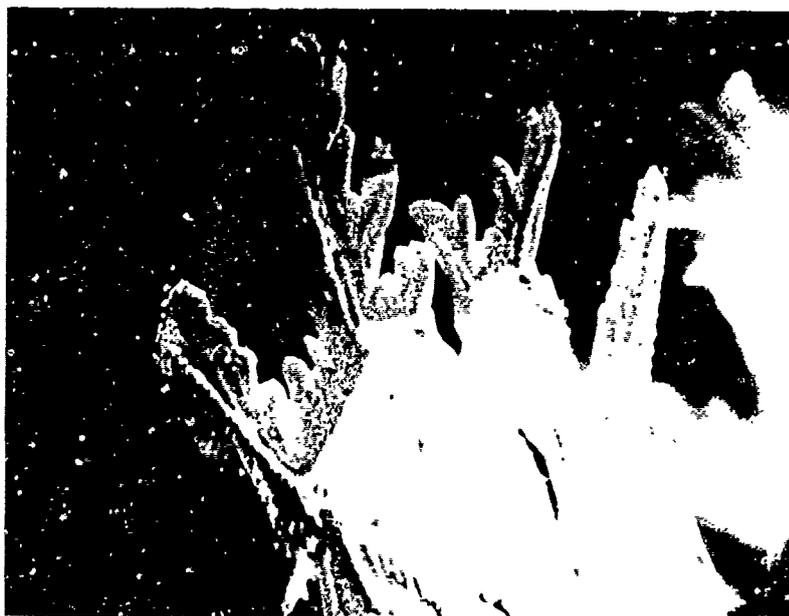
FIGURE 20. ELECTRON MICROGRAPH. EXHIBITS A CORAL-LIKE STRUCTURE OF SILVER/SILVER SALT CRYSTALS. MAGNIFICATION 1300X.

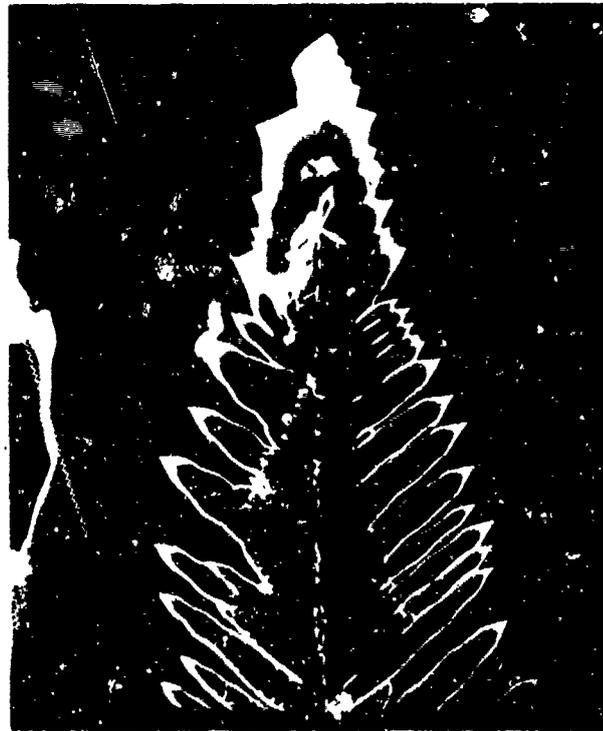
FIGURE 26. ELECTRON MICROGRAPH. SHOWS THE TOP OF THE CHRISTMAS TREE (FIG. 25) WITH BEAD DECORATION AND FLOWER JUST BELOW THE TIP. MAGNIFICATION 500X.

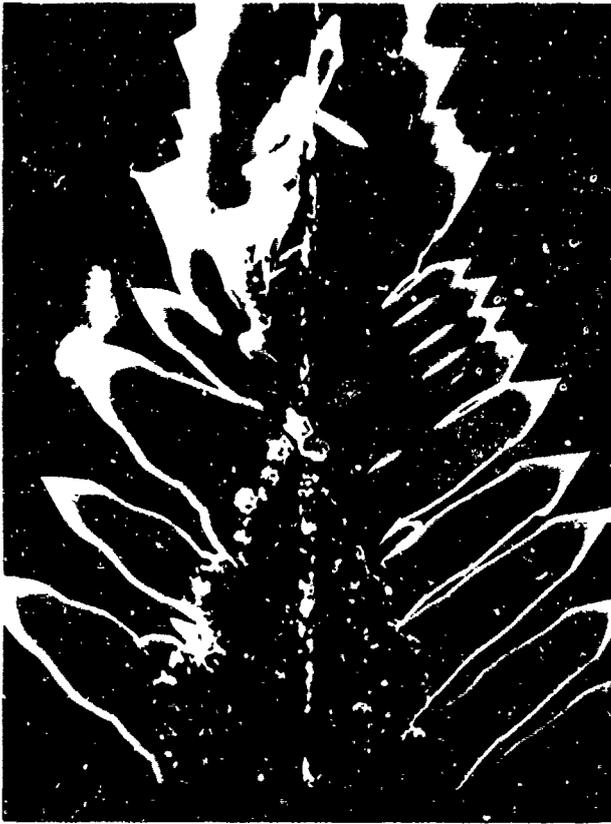
FIGURE 27. ELECTRON MICROGRAPH.
THE CHRISTMAS TREE (FIG. 25)
EXHIBITS THE BEADED AREA
LOOKING MORE LIKE ROUGH
DIAMONDS WITH THE FLOWER
AT THE TOP AN ORCHID.
MAGNIFICATION 1000X.

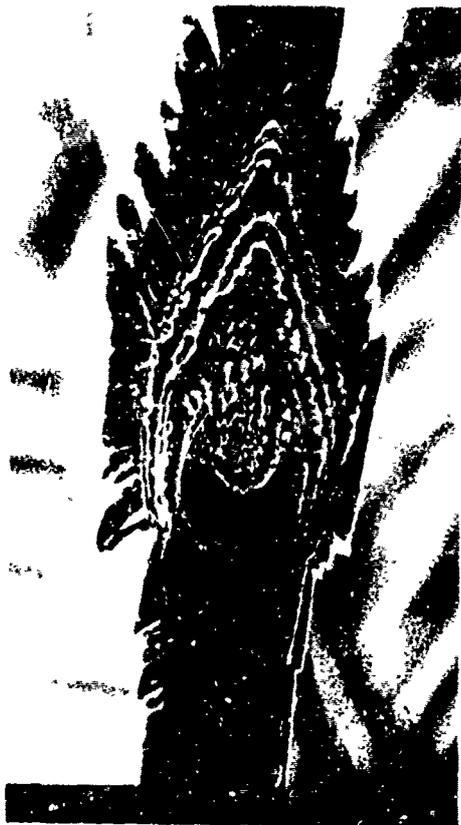
FIGURE 29. ELECTRON MICROGRAPH. DELINEATES THE CENTER OF THE SPIRE FROM FIGURE 25, SHOWING THE UNIQUE COMPLEXITY OF CRYSTALS MAKING UP THE CRYSTALLINE PROTRUSION. MAGNIFICATION 1000X.

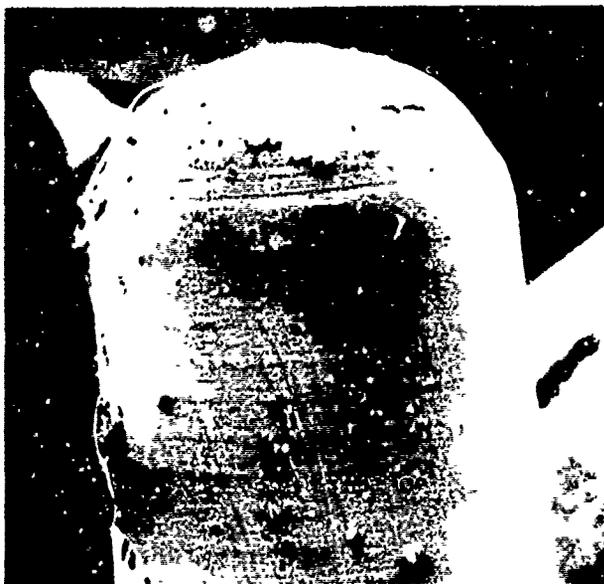
FIGURE 32. ELECTRON MICROGRAPH.
DEPICTS THE TIP OF A NEW
CONNECTOR PIN WITH TRASH
CLINGING TO IT.
MAGNIFICATION 62X.

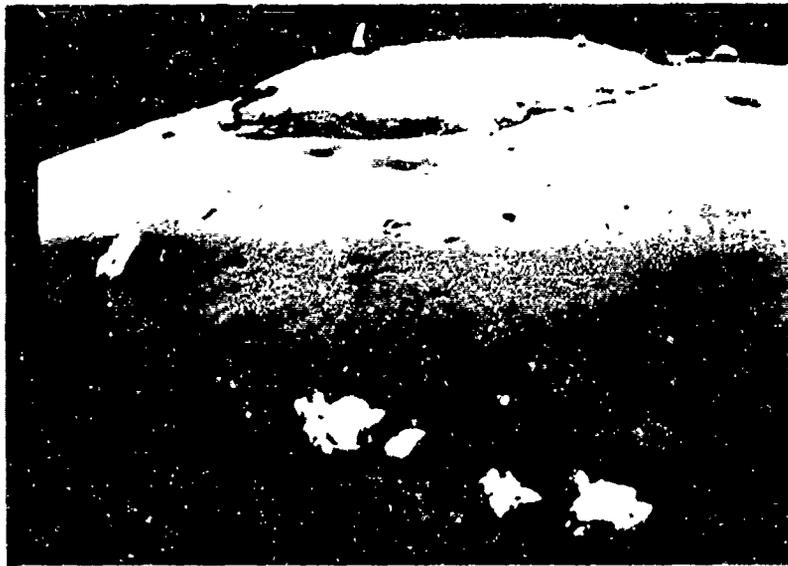
A higher magnification (250X) gives a closer look at the knot, Figure 33. It also shows a small projection on this bump and what seems to be a crack in the plating down the middle of the photograph.

FIGURE 33. ELECTRON MICROGRAPH. DISPLAYS THE TOP OF A NEW PIN SHOWING THE SMALL KNOT ON THE TIP AND A SMALL PROTRUSION ON THE KNOT, AS WELL AS A CRACK DOWN FROM IT. MAGNIFICATION 250X.

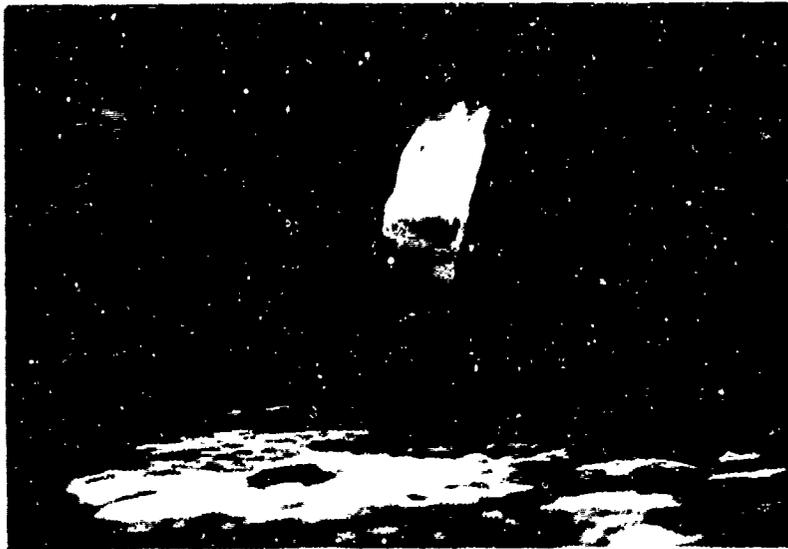
The protrusion on the top of the knot is enlarged also, and could be a bit of trash. However, higher magnification at 2400X, Figure 35, makes it appear to be an intimate part of the pin. Figure 36, from a different angle at 6000X apparently verifies it. However, focusing on the base of the protrusion at 6000X, Figure 37, confirms definitely that it is indeed firmly adhered to the pin.

FIGURE 35. ELECTRON MICROGRAPH. AT HIGHER MAGNIFICATION THE POSSIBLE PIECE OF TRASH LOOKS MORE LIKE AN INTEGRAL PART OF THE PIN. MAGNIFICATION 2400X.

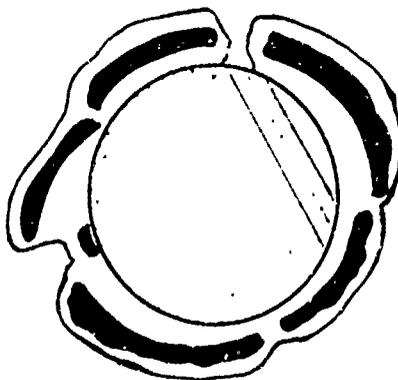
FIGURE 41. PHOTOGRAPHED SKETCH. AN ILLUSTRATION OF A BADLY SILVER MIGRATED PIN ELECTROLESS NICKEL PLATED TO CAPTURE THE LOOSELY ADHERED GOLD PLATING. CENTER: PIN, DARK PARTICLES: GOLD PLATE; OUTLINED SURROUNDING LIGHT AREA: ELECTROLESS NICKEL PLATE.
