CONDITION SURVEYS OF PAVEMENTS SUBJECTED
TO CHANNELIZED TRAFFIC, DAVIS-MONTHAN
AIR FORCE BASE, TUCSON, ARIZONA

Army Engineer Waterways Experiment Station
Vicksburg, Mississippi

April 1957

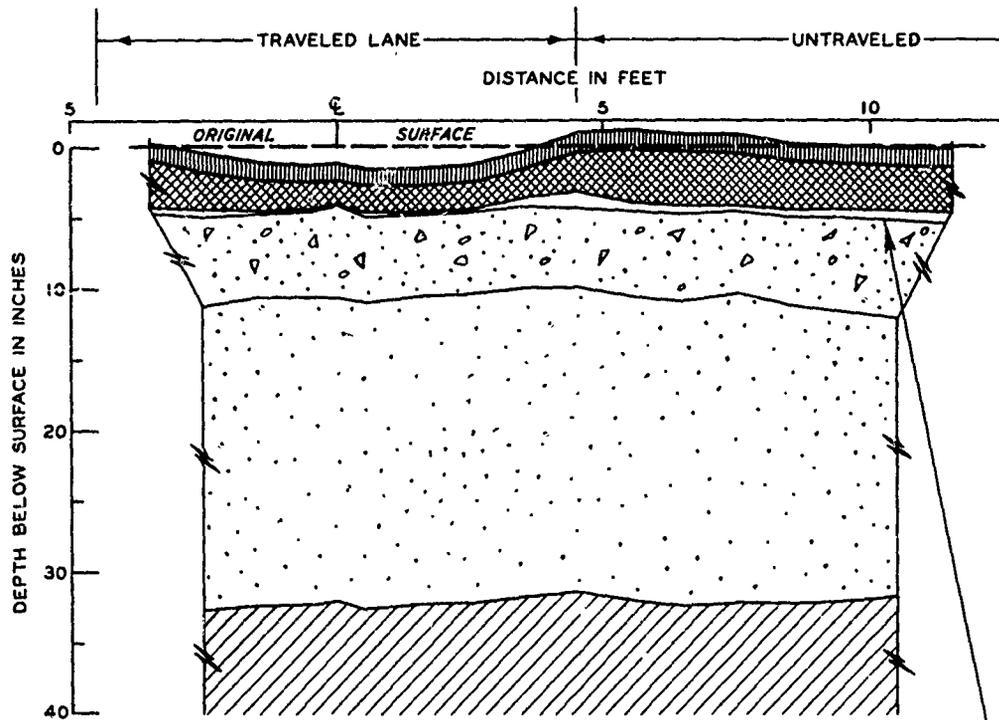
PROFILE OF TEST TRENCH
TAXIWAY 14

9. Pavement. The pavement at all test locations consisted of a wearing course and a binder course. The pavement was approximately 4 in. thick at all locations tested except test trench 5, where the pavement was about 3-1/4 in. thick in the traveled lane and about 5-1/4 in. thick outside the traveled lane (plate 2). The cored specimens were

Analysis of the above data indicates that conditions are generally the same in the wearing course in both the traveled (pits 1, 4, and 5T) and untraveled (pits 2, 3, and 5U) areas. The data for the binder course showed about the same conditions in traveled and untraveled areas except for voids in the total mix and voids filled with asphalt. In the traveled areas voids averaged about 1.3% and voids filled averaged 91.2%; in the untraveled areas voids averaged 2.2% and voids filled 84.7%. Laboratory tests performed on the cored specimens indicated that at all locations tested, except the binder course in the traveled area of trench 5, the stability of the asphaltic concrete was above the 1000 lb required for high-pressure tires at the time of the design of these pavements. Flow values for the wearing course were all below the maximum allowable of 16 except for the traveled area of test trench 5; those for the binder course were higher than 16 except at test pit 3. Voids in the total mix were well below the minimum allowable of 3% for wearing courses and 5% for binder courses in both traveled and untraveled areas. Conversely, the voids filled with asphalt were well above the maximum allowable in all cases. Observation of the sawed face of the asphaltic concrete at test trench 5 indicated that the major part of the loss in grade at that location was due to movement in the binder course (plate 2). The movement in the binder course is believed to be partially due to low shear

resistance between the binder course and the base course. About 1/8 in. of fine material had cemented together forming a hard, slick surface on the base course. Engineers at the field stated that this probably resulted from slush rolling. The prime did not penetrate this hard surface and, therefore, provided little bond to the base course. The stability of the rich binder course was not sufficient to resist movement when the temperature of the pavement became high during the summer months. No plastic flow was apparent in the wearing course.

FINE MATERIAL CEMENTED TOGETHER FORMING A SLICK SURFACE ON TOP OF THE BASE COURSE.
