THERMAL AGING OF SILVER-PLATED COPPER AIRCRAFT
ELECTRICAL WIRE

AIR FORCE MATERIALS LABORATORY

MAY 1973

AFML-TR-73-113

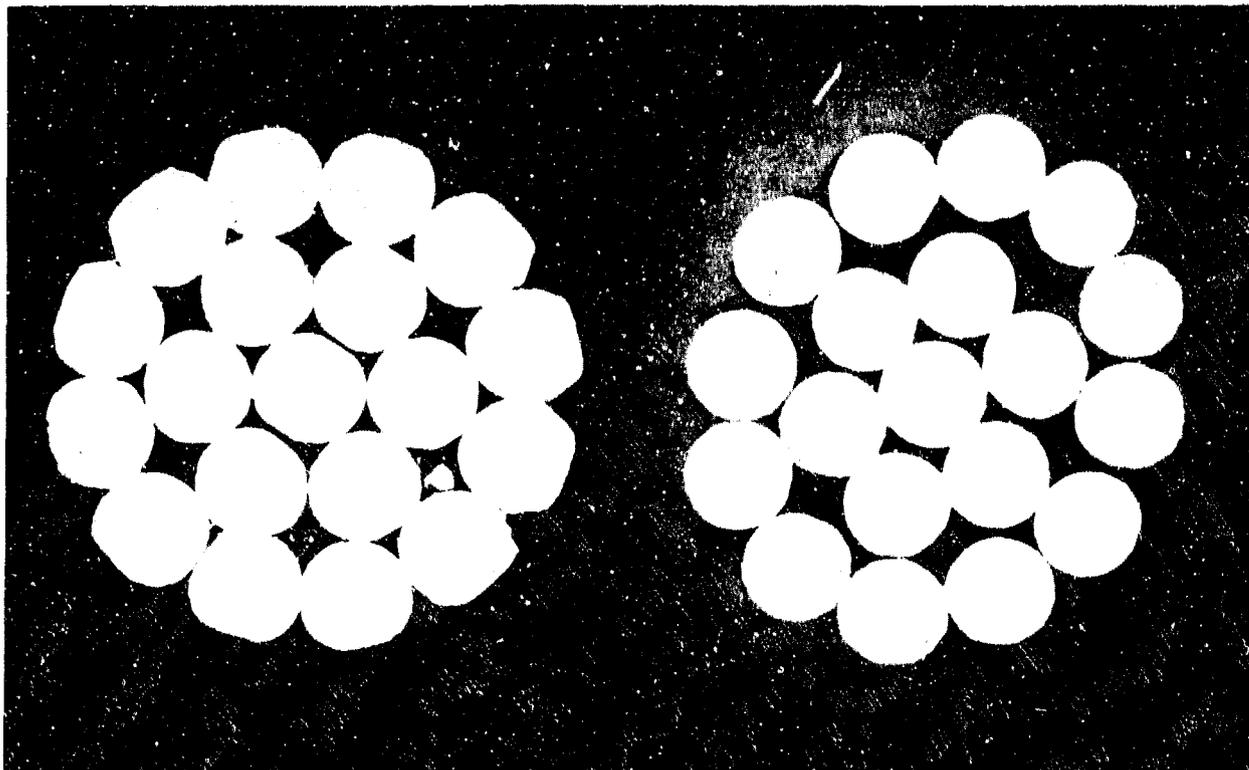
Figure 1 shows full cross-sectional views of unaged unilay and concentric stranded wire. The results of drawing the wire through a die in order to achieve diameter tolerances are clearly evident in Fig. 1a. The individual strands have been deformed considerably and the radial interstrand contact area, particularly in the outer strands, has been markedly increased. What would normally be a simple longitudinal line contact of adjacent strands is now, in effect, a longitudinal contact surface of significant width. Conditions are thus made ideal for strand blocking at elevated temperatures through the interdiffusion of silver between adjacent strands.

Most of the exposed wire strand edges, seen in Fig. 1a for example, are too rounded or smeared for the above effect to occur. However, at many of the V-shaped regions, where two individual strands come into contact, the edge is relatively sharp. Regions of this type are shown in Figs. 2-4, particularly in Fig. 4c. In many instances when the electron beam was positioned over one of these edges, sulfur could be detected. When the beam was withdrawn from the edge, but still positioned over the silver layer, no sulfur could be detected. Thus the sulfur observed was surely associated with the vertical (outside) surface. The frequency with which sulfur detection occurred was much greater than could be explained by a chance cross-sectioning through the isolated sulfur-bearing areas noted earlier.

Figure 1. Cross-sectional views of unaged wire. (a) No. 20 (19/32) Kapton insulated unilay wire, X65. (b) No. 18 (19/30) Teflon insulated concentrically stranded wire, X50.

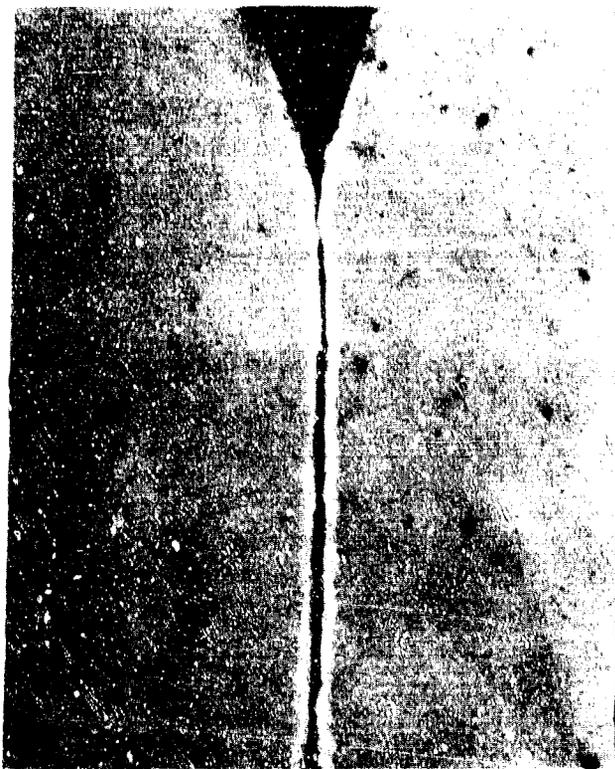
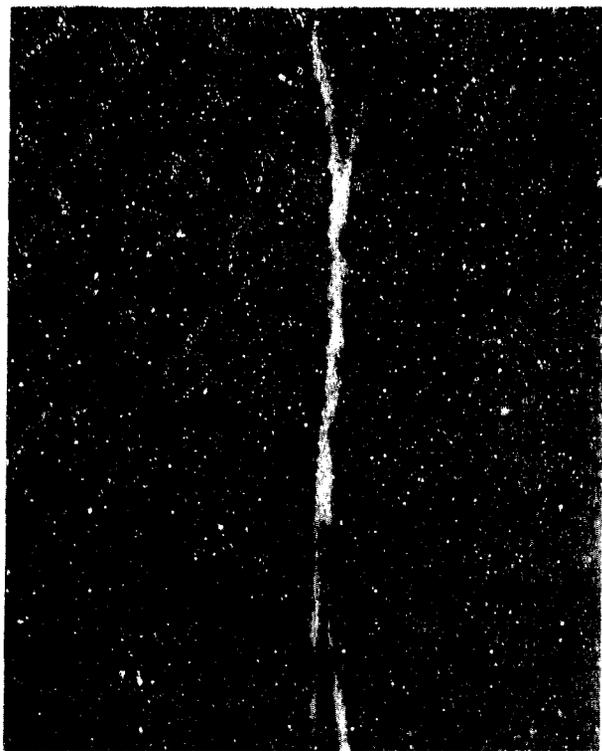
The most striking features seen in Figs. 2-4 are the obvious formation of a reaction product at the copper/silver interface and an equally obvious degradation of the silver plating. The extent to which the latter has occurred can be seen more clearly in the SEM photographs of the longitudinal wire surface shown in Figs. 5-7. The beaded or globular appearance of the surface material gives the impression that a process similar to incipient melting has taken place.

Figure 2. Cross sections of No. 20 (19/32) Kapton insulated unilay wire unaged and aged at 150°C, X1200. (a) Unaged. (b) 500 hrs. (c) 1000 hrs.

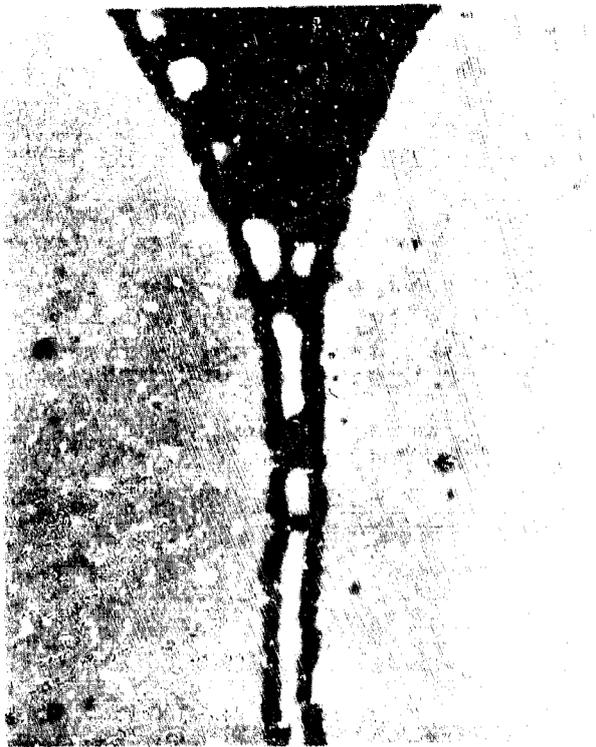
Figure 4. Cross-sections of No. 20 (19/32) Kapton insulated unilay wire aged at 230°C, X1200. (a) 125 hrs. (b) 264 hrs. (c) 500 hrs.

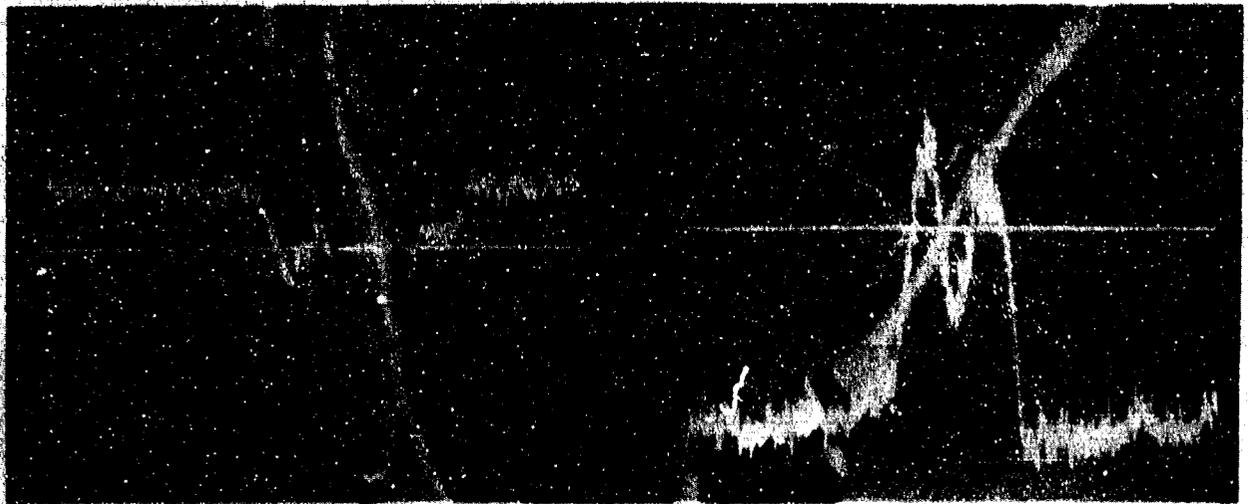
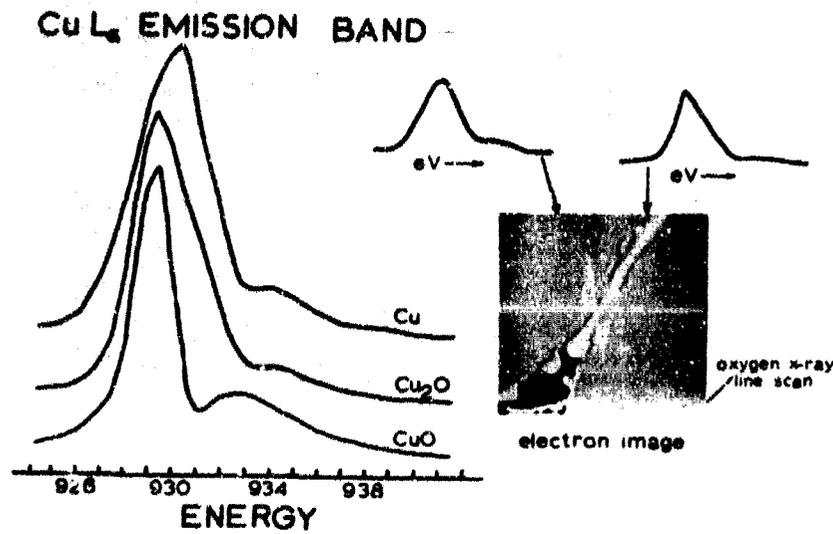
the copper/silver interface is a simple compound of copper and oxygen. Figures 9a and b show the changes in the intensity of the characteristic copper and oxygen X-rays emitted from various points along a scan through an interstrand boundary. The location of the scan trace is nominally represented by the heavy white line superimposed on the reversed-polarity back-scattered electron image of the sample. Numerous cursory scans failed to reveal the presence of any additional elements of significance other than the silver plate between the copper oxide layers and a number of iron-base impurities that occurred well within the copper strands. The oxygen X-ray intensity originating from the silver layer is quite low, indicating that this material is primarily silver metal and not silver oxide (Ag_2O).

Figure 9. Electron microprobe scans of No. 20 (10/32) Kapton insulated unilay wire aged 500 hrs at 230°C. (a) Reverse electron image with Cu K_α X-ray emission scan, X2880. (b) RE image with O₂ K_α X-ray emission scan, X1440. (c) Cu L_α X-ray emission band profile for Cu, Cu₂O, CuO.

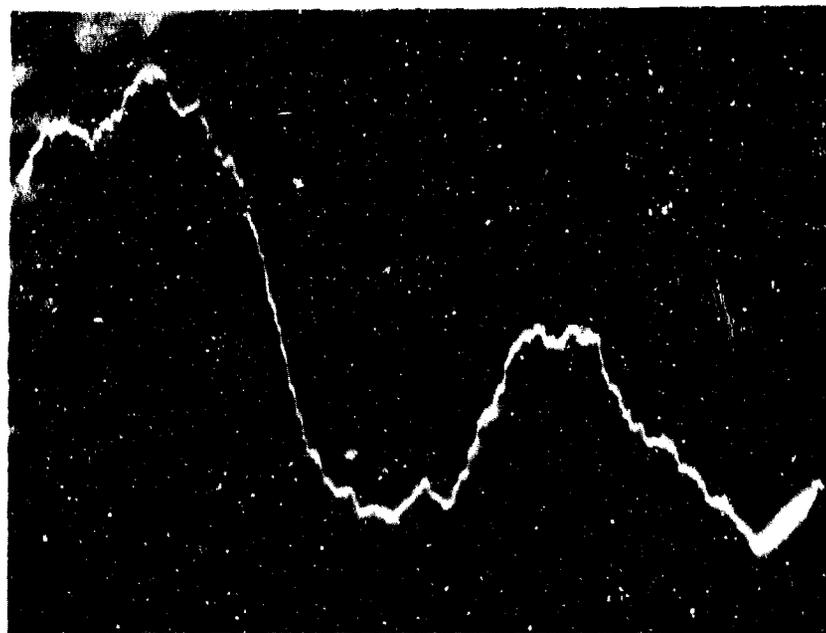
Figure 13. Surface of No. 20 (19/32) Kapton insulated unilay wire aged 500 hrs at 200°C with insulation removed prior to aging. (a) Typical surface of outer strands, X1600. (b) X5000 with superimposed CuK α X-ray emission trace.

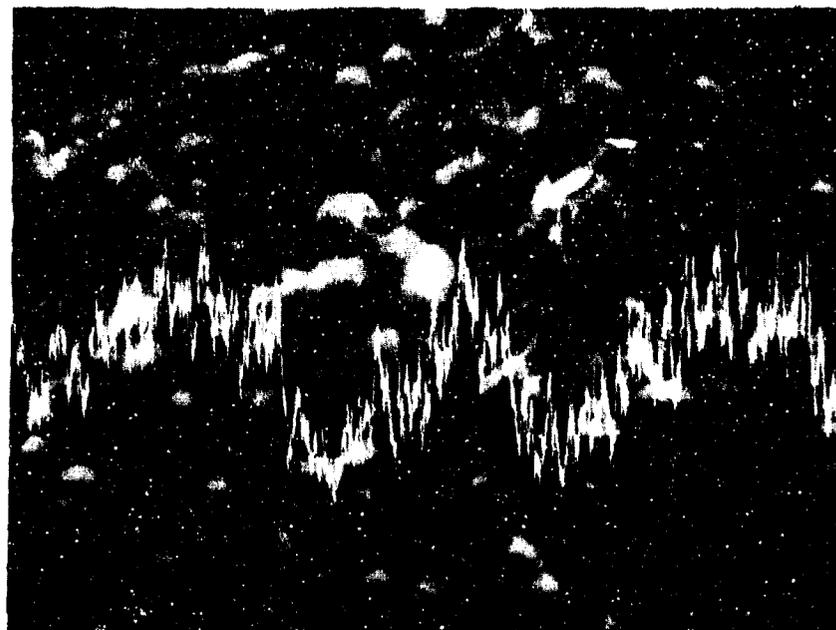
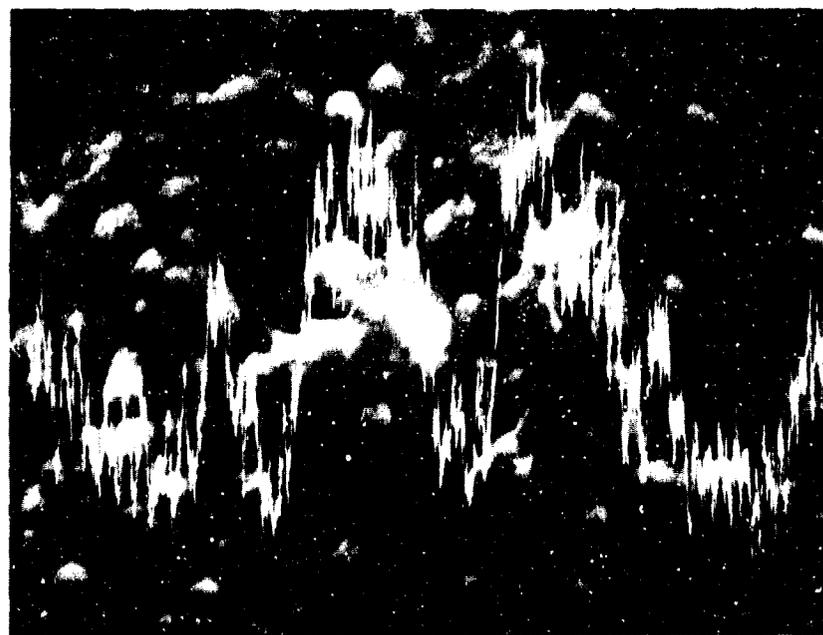
Figure 14. Surface of No. 20 (19/32) Kapton insulated unilay wire aged 500 hrs at 200°C with insulation removed prior to aging. X-ray emission scans superimposed on structure of outer strands in regions containing copper oxide spheres, X5000. (a) AgK_α . (b) CuK_α .
