FINAL REPORT ON  
PRODUCT IMPROVEMENT TEST  
OF  
TRUCK, UTILITY, 1/4-TON, 4X4, M151, MODIFIED  
WITH SOLID REAR AXLE  
BY  
C. M. BRYZEK, JR.  
MARCH 1967

USATECOM PROJECT NO. 1-6-4030-12

12 APRIL THROUGH 30 DECEMBER 1966

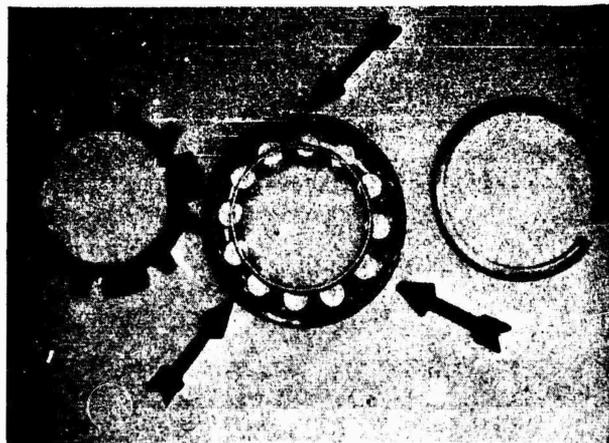
Figure 2.11-6: Snap-Ring Groove Broken Off Pinion-Shaft Pilot Bearing.

Examination of the rear axle assembly after completion of the durability test disclosed that the snap-ring groove in the pinion shaft pilot bearing was broken off around the circumference of the bearing (Figure 2.11-6).
