HEADQUARTERS
70TH ENGINEER BATTALION (COMBAT)(ARMY)
APO 96294

SUBJECT: Operational Report-Lessons Learned (RCS CSFOR-65), for Quarterly Period Ending 31 Oct 66.

SUBJECT: After Action Report - Golf Course Airstrip

SUBJECT: After Action Report - Golf Course Airstrip Repair

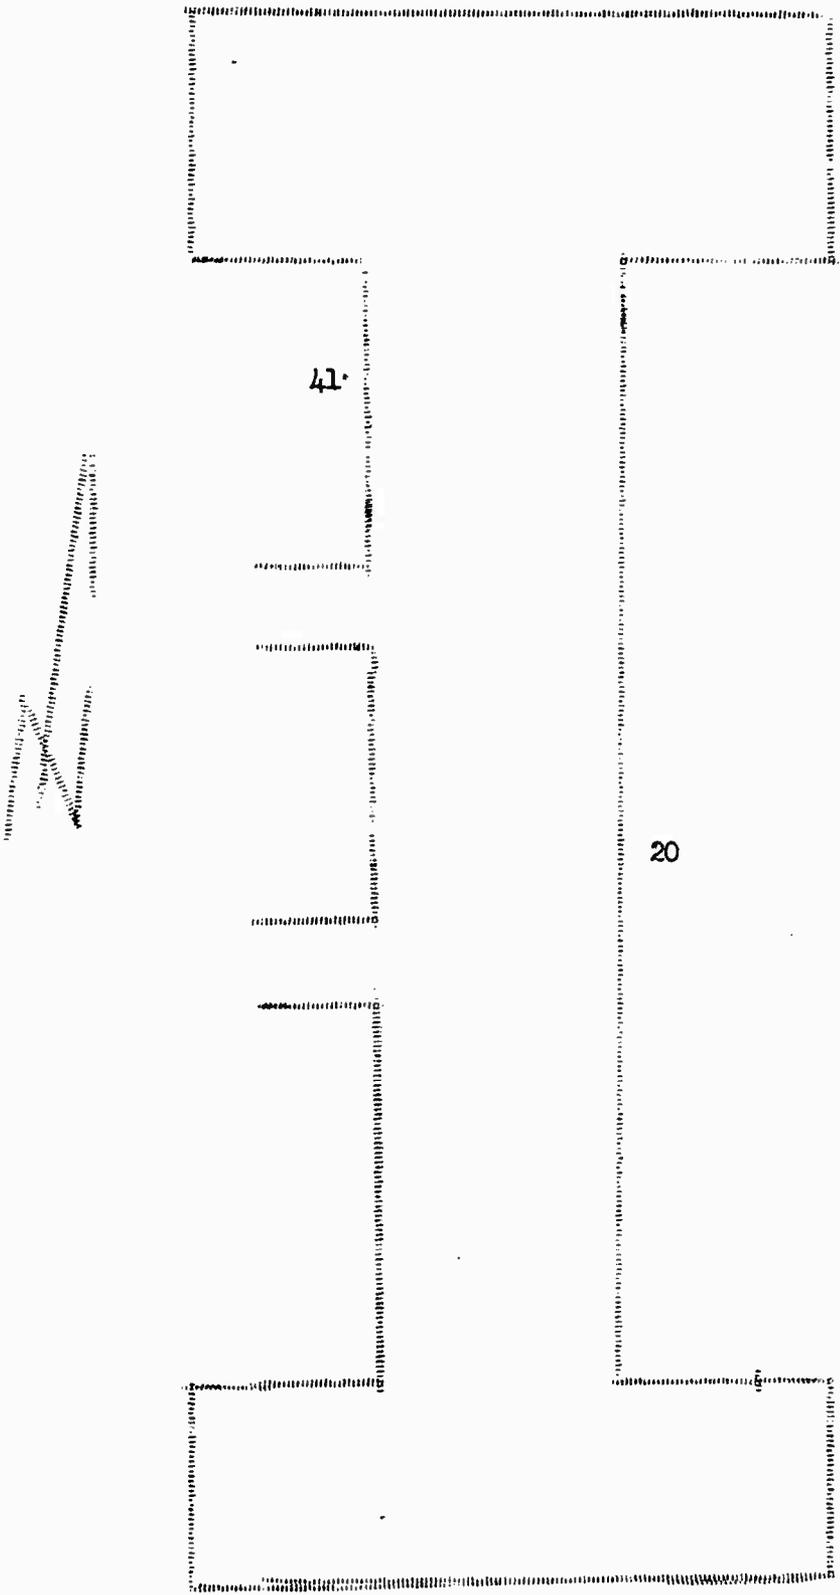
GOLF COURSE AIRSTRIP

a. Inspection of the existing runway disclosed that the southern 1000 feet was rutted badly. The average depth of these ruts was 10-12 inches. The existing CBR was 0-2 and in many areas the sub base was saturated. The north taxiway had a CBR of 0 and was completely untrafficable. The parking apron had many soft spots and was receiving runoff from the runway due to poor drainage in the area between the runway and parking apron.

Discussion: Since AM-2 matting accessory kits, which contain standard anchorage equipment, were not available no lateral anchorage was installed. To date the cyclic loading rate has been 91 sorties of C-130, C-123 and CV-2 aircraft landing from north to south. The maximum creep to date has been 33 $\frac{1}{2}$ inches south at station #20. Lateral shifting of 8" east was experienced at station #41 (see inclosure 1 for diagram). This expansion appears only in the impact area and the area between the two taxiways. The ends of the runway haven't moved.

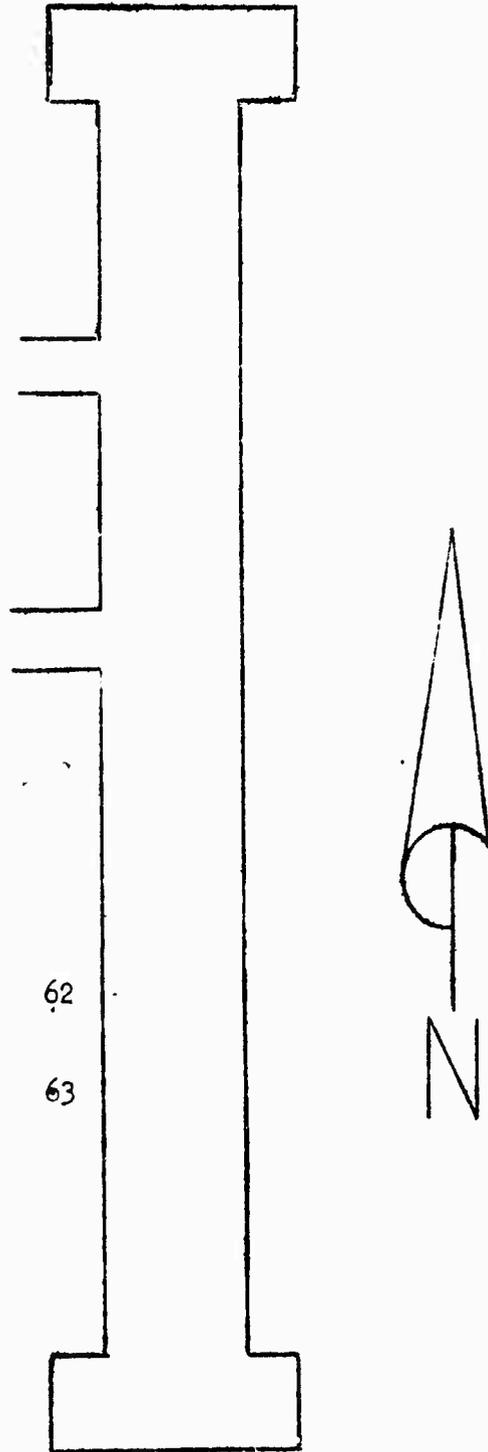
GOLF COURSE AIRSTRIP

1. General: On 19 Sep 66 a pumping action was observed at station #62, (see inclosed map) on the Golf Course Airstrip. This action at this particular time was confined to mud being forced up through the joints in the AM-2 matting. In as much as this was an isolated case and the AM-2 matting did not appear to be undergoing any damage it was decided to have this section monitored closely and keep the airfield open. On 30 Sep 66, personnel observing this area noted that the AM-2 matting was becoming deformed. The area undergoing a deformation process encompassed 1000 sq ft and had deflected approximately 2" vertically. The battalion continued to monitor the strip very closely since it could not be closed due to operation Thayer. At 1245 on 7 Oct 66, a hair line crack (sketch A) was observed in the joint of the end panel of the depression. Landing and taxiing of C-130 aircraft over the section where a depression had formed actually caused the AM-2 panels to become disengaged in two separate places. After removing the AM-2 matting and inspecting the sub-grade conditions the disengaging of the panels was attributed to the failure in the sub-grade, which when taxied upon by C-130 Aircraft effected a rippling action in the AM-2. The strip was officially closed as of 1800 hours 7 Oct 66.

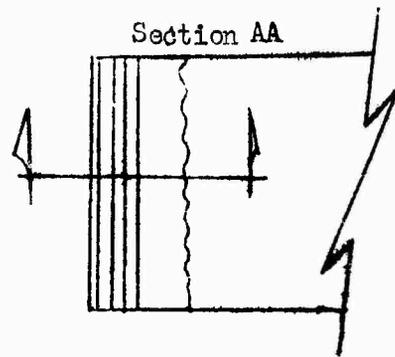
SKETCH A

Location of Hairline Crack

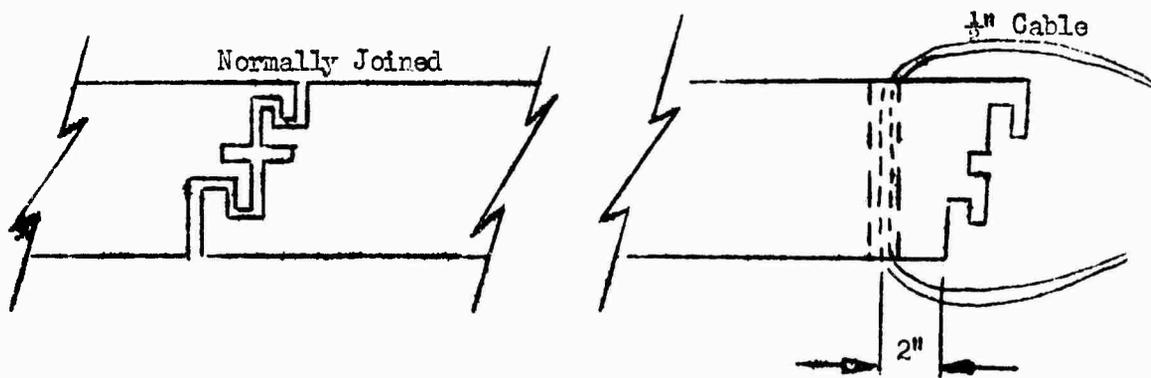
SKETCH B

(2) A modified short panel (sketch B) with an attached cable for towing was then connected to the one end of the panel and an HD-16 was used to pull the entire section out. This operation was repeated at 5 different locations in order to determine the extent of the area to be repaired and also to facilitate removal of the AM-2.

Modified Panel

c. Modified panels should be used in removing a row of AM-2 panels. These panels provide an expedient extraction system. Any removal of AM-2 using the modified panel or insertion of a closing strip using the modified panel should be accomplished by pulling the "run" with a HD-16 dozer. Pushing is undesirable because of possible buckling and destruction of the AM-2 panel.
