SUBJECT: Operational Report - Lessons Learned, Headquarters, 577th
Engineer Battalion (Const), Period Ending 31 January 1968 (U)

DEPARTMENT OF THE ARMY
HEADQUARTERS, 577TH ENGINEER BATTALION (CONSTRUCTION)
APO US Forces 96316

SUBJECT: Operational Report - Lessons Learned (RCS CSFOR-65), for
Quarterly Period Ending 31 January 1968

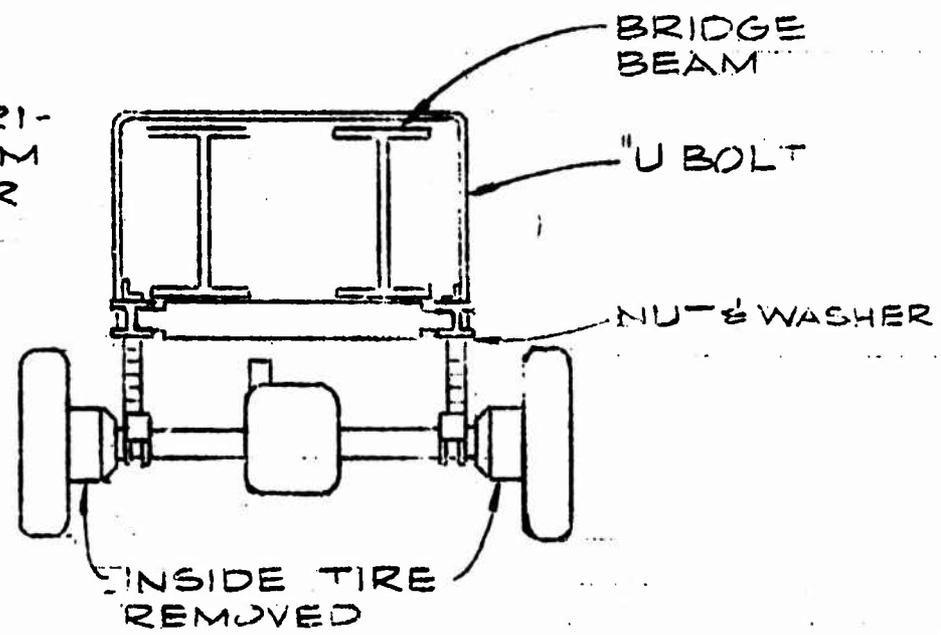
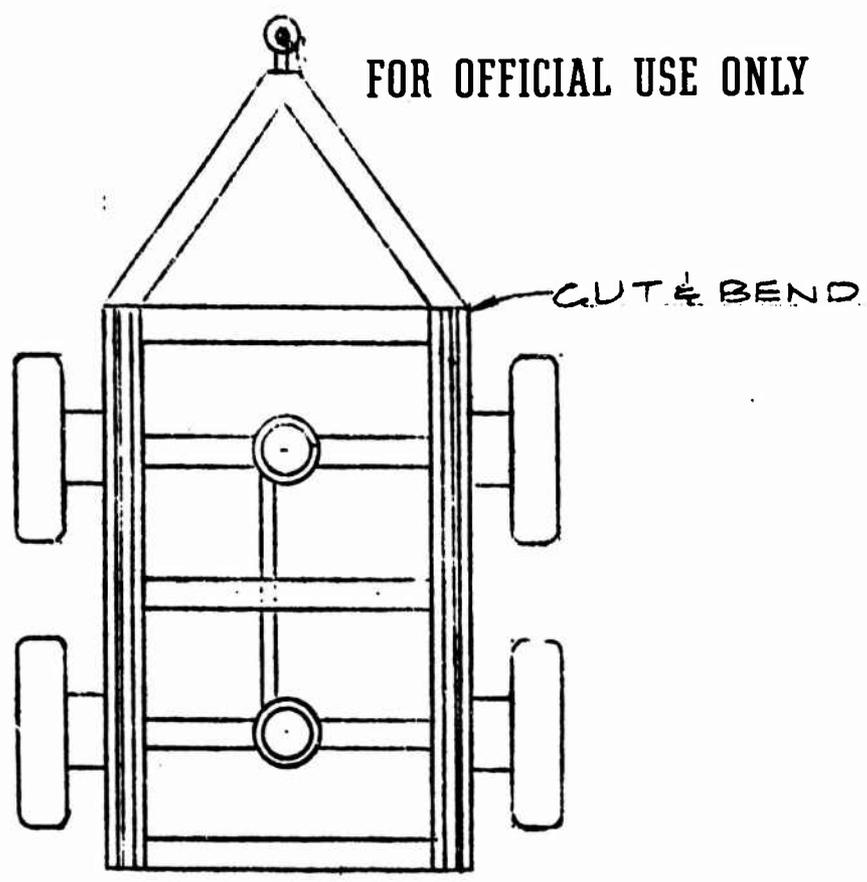
INCL. 3

Discussion: For bridge construction, long heavy beams and girders must often be transported over narrow winding roads where operation of 25 ton tractor-trailers is difficult and hazardous due to the overhang of the beams. A dolly-trailer was constructed from a salvaged M61 water distributor chassis and the goose-neck of a 25-T trailer (see sketch, Incl 3). The tractor chassis was cut off behind the cab, and the rear section was modified by eliminating the inside duals, providing a wider wheel base. Angle iron was used for bracing to prevent sliding of the beams. Four-foot long U-bolts were fabricated to secure the beams and a pintle hook was attached to pull the dolly when not hauling beams. The gooseneck of a 25-T trailer was modified by using angle iron as bracing to prevent sliding of the beams and again four-foot long U-bolts were used to secure the beams (see sketch, Incl 3).

Observation: Transportation of long length beams can be made easier through the use of a dolly-trailer.

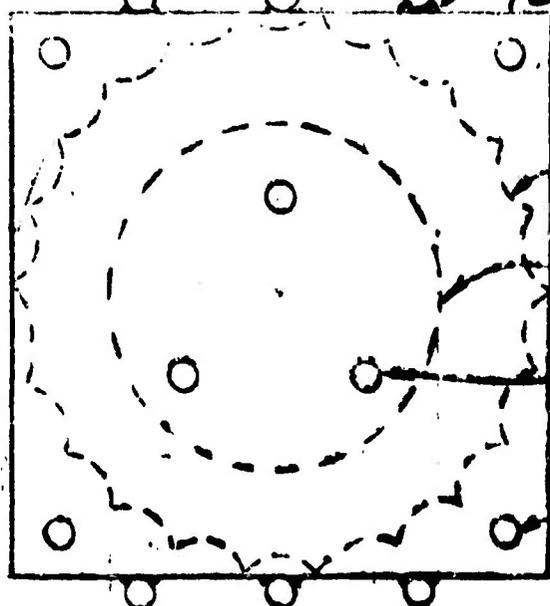
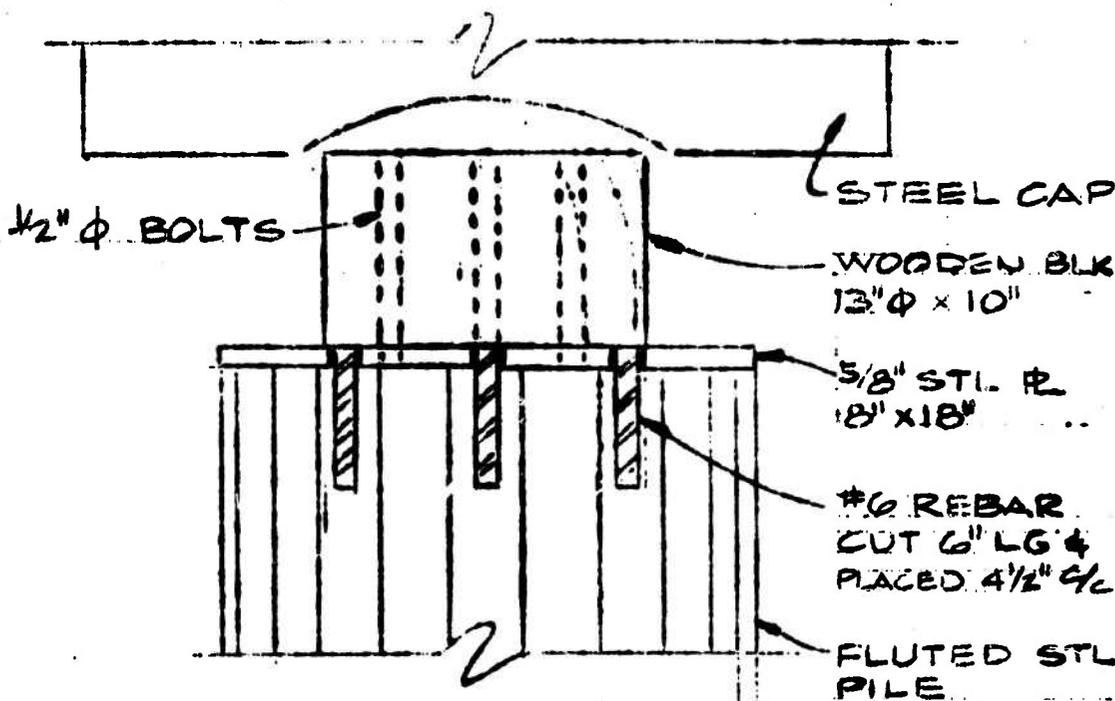
PLAN OF ADAPTOR

Discussion: To drive an 18-inch diameter fluted steel pile, a cap must be prefabricated since the pile cap normally found with the 3,000-pound hammer is too small. A 5/8 inch thick steel plate was cut 18 inches square, with three 6-inch pieces of #6 rebar welded at 4 1/2 inch intervals on both sides of the plate. (See Incl 4).

Observation: A pile cap adaptor can be fabricated from locally available materials which will provide adequate control for driving fluted steel piles.

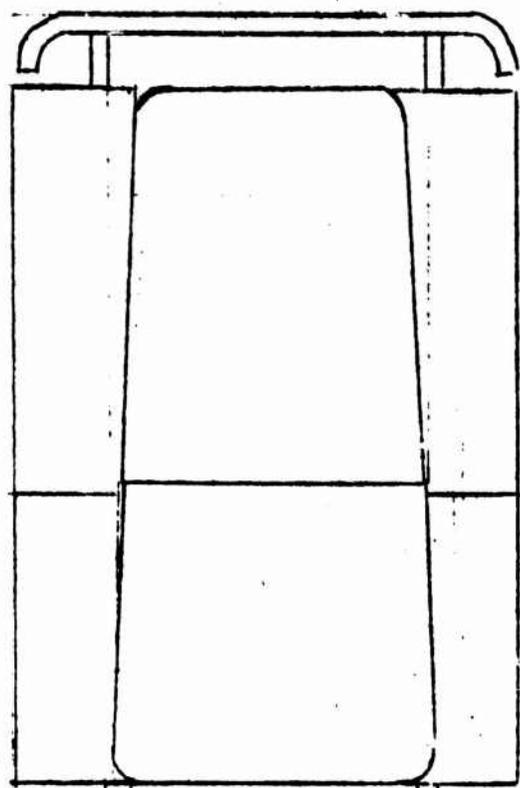
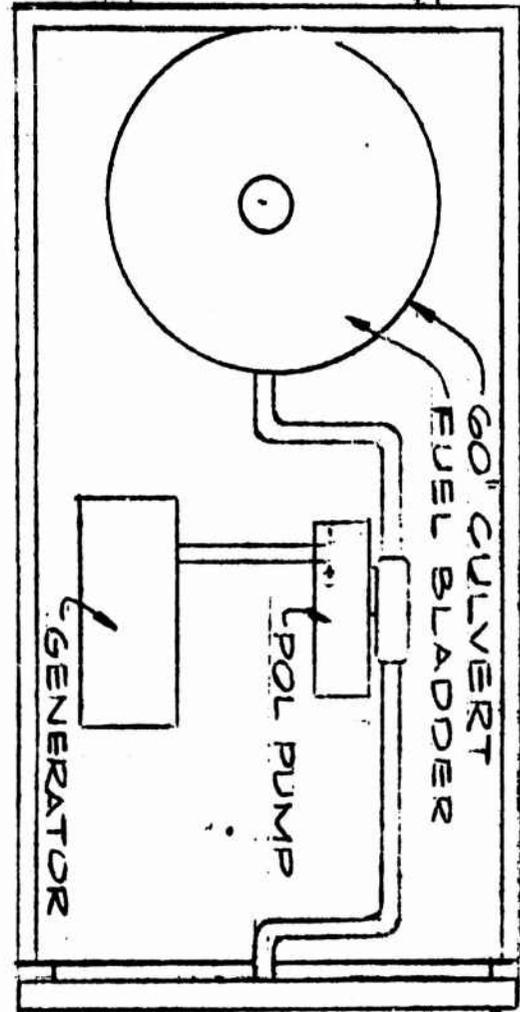
EXPEDIENT ASPHALT DISTRIBUTOR

Discussion: Asphalt distributors were in short supply and in great demand. The nonavailability of a distributor prompted the improvisation of an expedient distributor. The distributor was constructed using a 2 1/2 ton truck, a

section of 60" culvert, a generator, an electric pump, a POL bladder, and a pipe. When assembled, the unit has the capability to distribute cutback or emulsified asphalt for use as a dust palliative. (See Incl 5).

Observation: From materials and equipment normally available, an expedient asphalt distributor can be constructed and used for application of asphalt cutback.

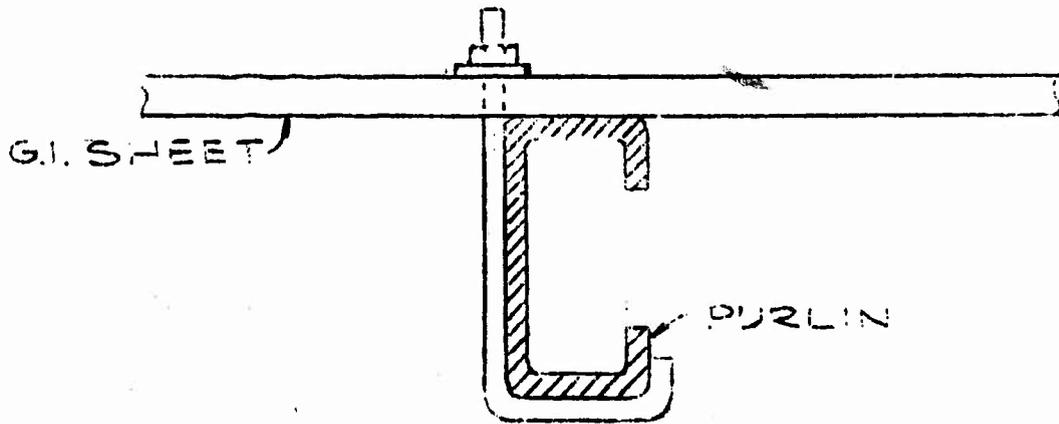
A. J-BOLT INSTALLED

Discussion: During Typhoon Freida the roof of the Nichimen 75' x 202' steel maintenance hangar at the Phu Hiep Army Airfield was subjected to a high dynamic wind loading and was blown off. The roof was constructed of heavy gage corrugated metal sheeting fastened to the roof purlins by use of 3/16-inch diameter J-bolts. It was observed that the bolts failed by bending (straightening out) and became disengaged from the purlins. No additional bolts were on hand to replace the damaged ones and experiments were conducted using a self-tapping screw driven thru the sheet metal into the purlin. This screw provided adequate holding power and had the advantage of easy and rapid installation. (See Incl 6).

Observation: The large J-bolts supplied with the Nichimen 75' x 202' maintenance hangar are inadequate. A self-tapping screw which is adequate and easier to install can be substituted.

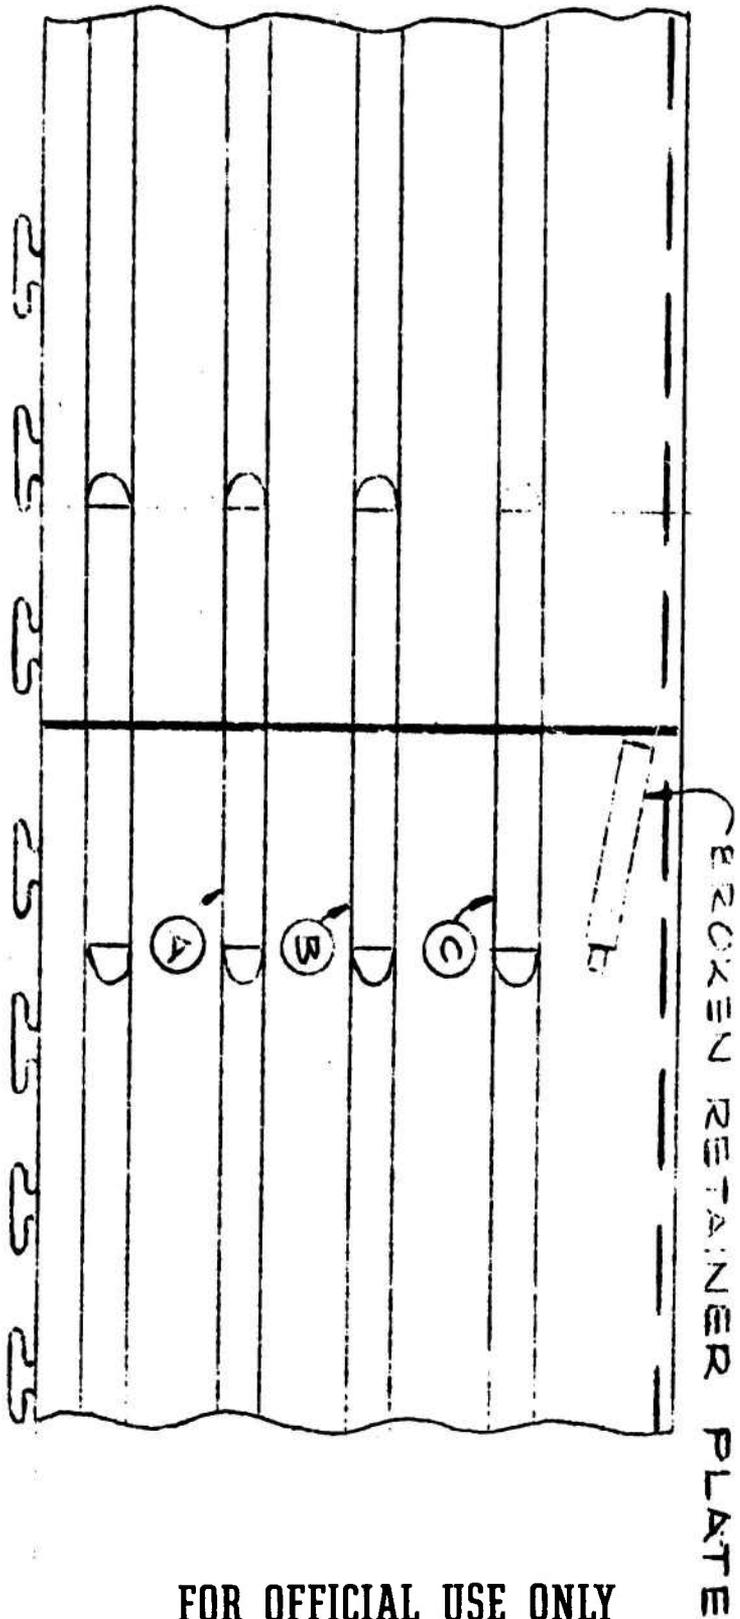
SURFACE FAILURE
OF
PHU HIEP ARMY AIRFIELD

Discussion: Phu Hiep Army Airfield is a 3,500-foot runway constructed of M8A1 mat over a one inch sand blanket over 10" of sand-cement base. A recent inspection of the mat on the airfield revealed a large number of weld failures. This weld is a factory weld in the mat which connects the retainer plate over the locking pins to the mat. When this plate is gone the mat can come apart, and loose pins and retainer plates on the runway create a safety hazard to aircraft. (See Incl 7). Investigation revealed the following:

(1) Over 800 sorties of C130 aircraft and 3,000 of OV-1 Mohawk aircraft have landed on the surface.

(2) The failures took place at the touchdown points on both ends of the field and in the propeller reversal zone at about midlength of the runway.

(3) The runway is adjacent to the South China Sea, thus exposing it to salt water.

Observation: The M8A1 mat at Phu Hiep Army Airfield has exceeded its design life of 200 C-130 sorties. The airfield will be in operation for an undetermined period of time and will require ever-increasing maintenance.

c. Section 2, Part I 2i: The M8A1 matting failure reported at Phu Hiep is strikingly similar to the M8A1 matting failure witnessed by the 14th Engr Bn at Bao Loc Airfield.

- 1 WELD CRACKED AT CONNECTOR (A)
- 2 CONNECTOR RETAINER PLATE (B)
- RAISED & FAILED, EXPOSING END CONNECTORS (C)

a. Reference Section II, Part 1, Item 2i; this Headquarters has initiated a study to determine the extent and nature of the failures of MSA matting. While the results of the study are not final, indications are that these failures are limited to points of maximum stress and that they can be readily detected and repaired through normal maintenance procedures.

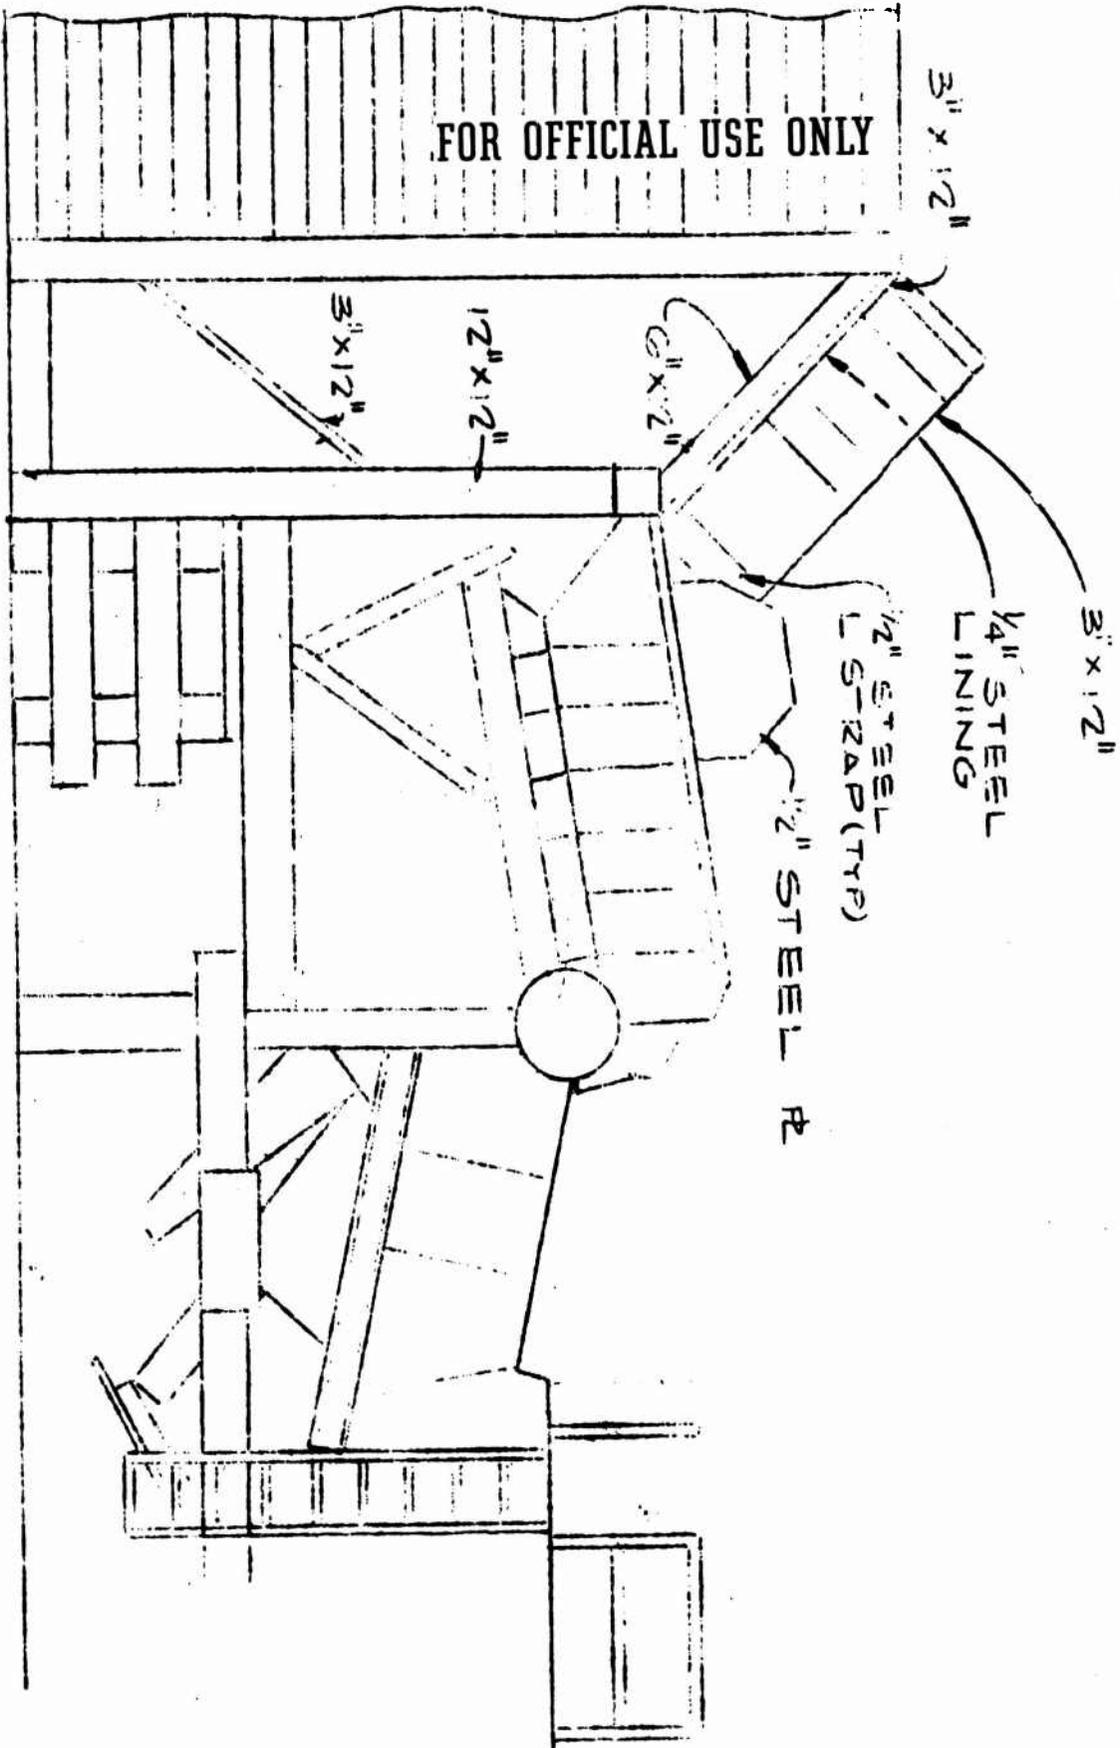
DUMPING CHUTE FOR 75TPH PRIMARY CRUSHER

Discussion: When loading a 75TPH Eagle primary crusher by a 5 ton dump truck, considerable wear resulted on the drive system for the hopper and
