Technical Note N-986

AIRFIELD PAVEMENT EVALUATION, ROYAL THAI NAVY STATION,
BAN U-TAPAO AIRFIELD, THAILAND

D. J. Lambiotte and R. B. Brownie

August 1968

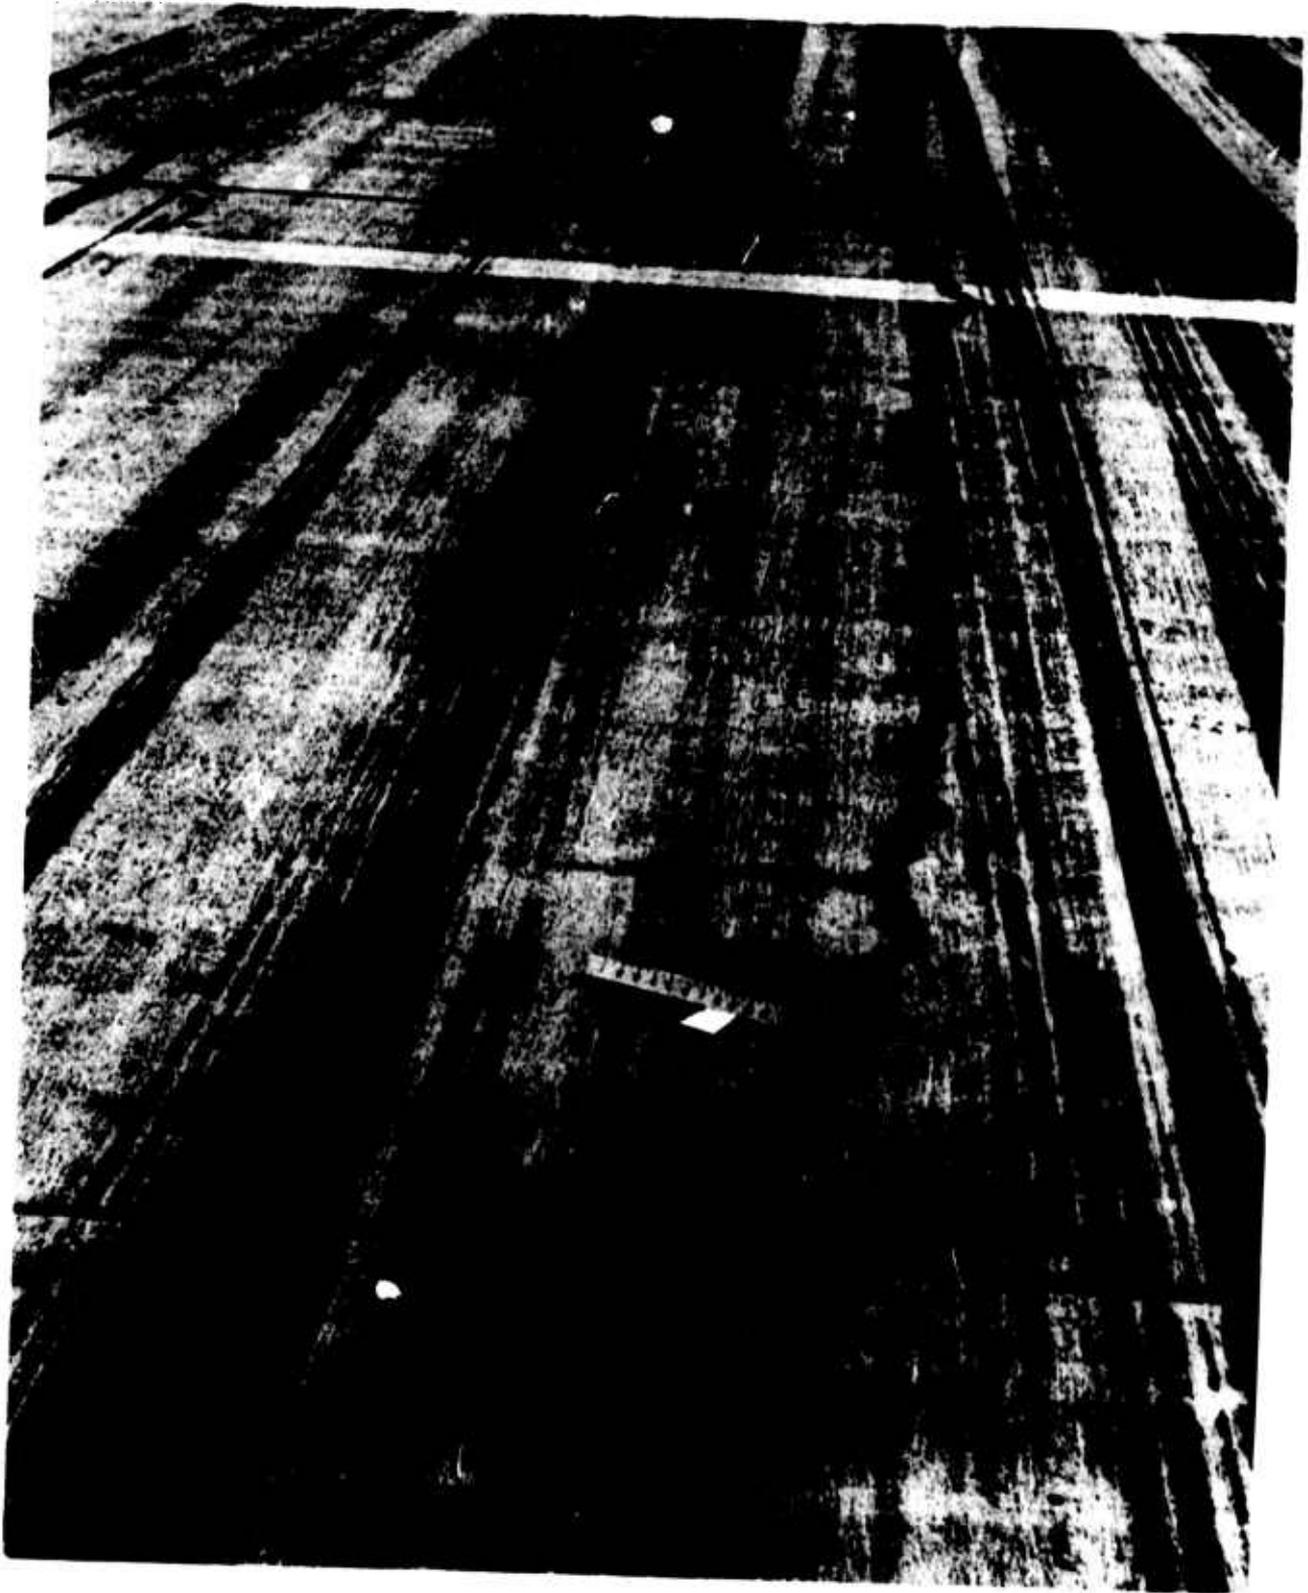
The cracked slabs appeared to follow a random pattern, except for two localized areas where more severe cracking (in terms of number of slabs) was evident. The most severe of these areas occurred at the intersection of the runway with Access Taxiway 2 and Cross Taxiway 2. At this spot, the three rows of runway slabs corresponding to the width of the taxiways on either side contained 11 cracked slabs out of a total of 24 (46 percent). (See Figures A-1, A-2 and A-3). Rated by itself, this small area could only be rated as poor. Designed as a runway interior, (Type C traffic), the area is being used as a taxiway (channelized traffic, type A) by heavy bombers entering and leaving the hardstand area by way of Access Taxiway 2.

Figure A-1. Longitudinal crack and corner break, Runway 18-36 at Cross Taxiway 2, Ban U-Tapao Airfield.

It was noted that most pavement defects on the runway had not received maintenance. It is thus recommended, in light of the accelerated traffic rate, that all cracks be routed and sealed, and all spalls and similar pavement breaks be patched to prevent further deterioration of these defects into FOD problems.

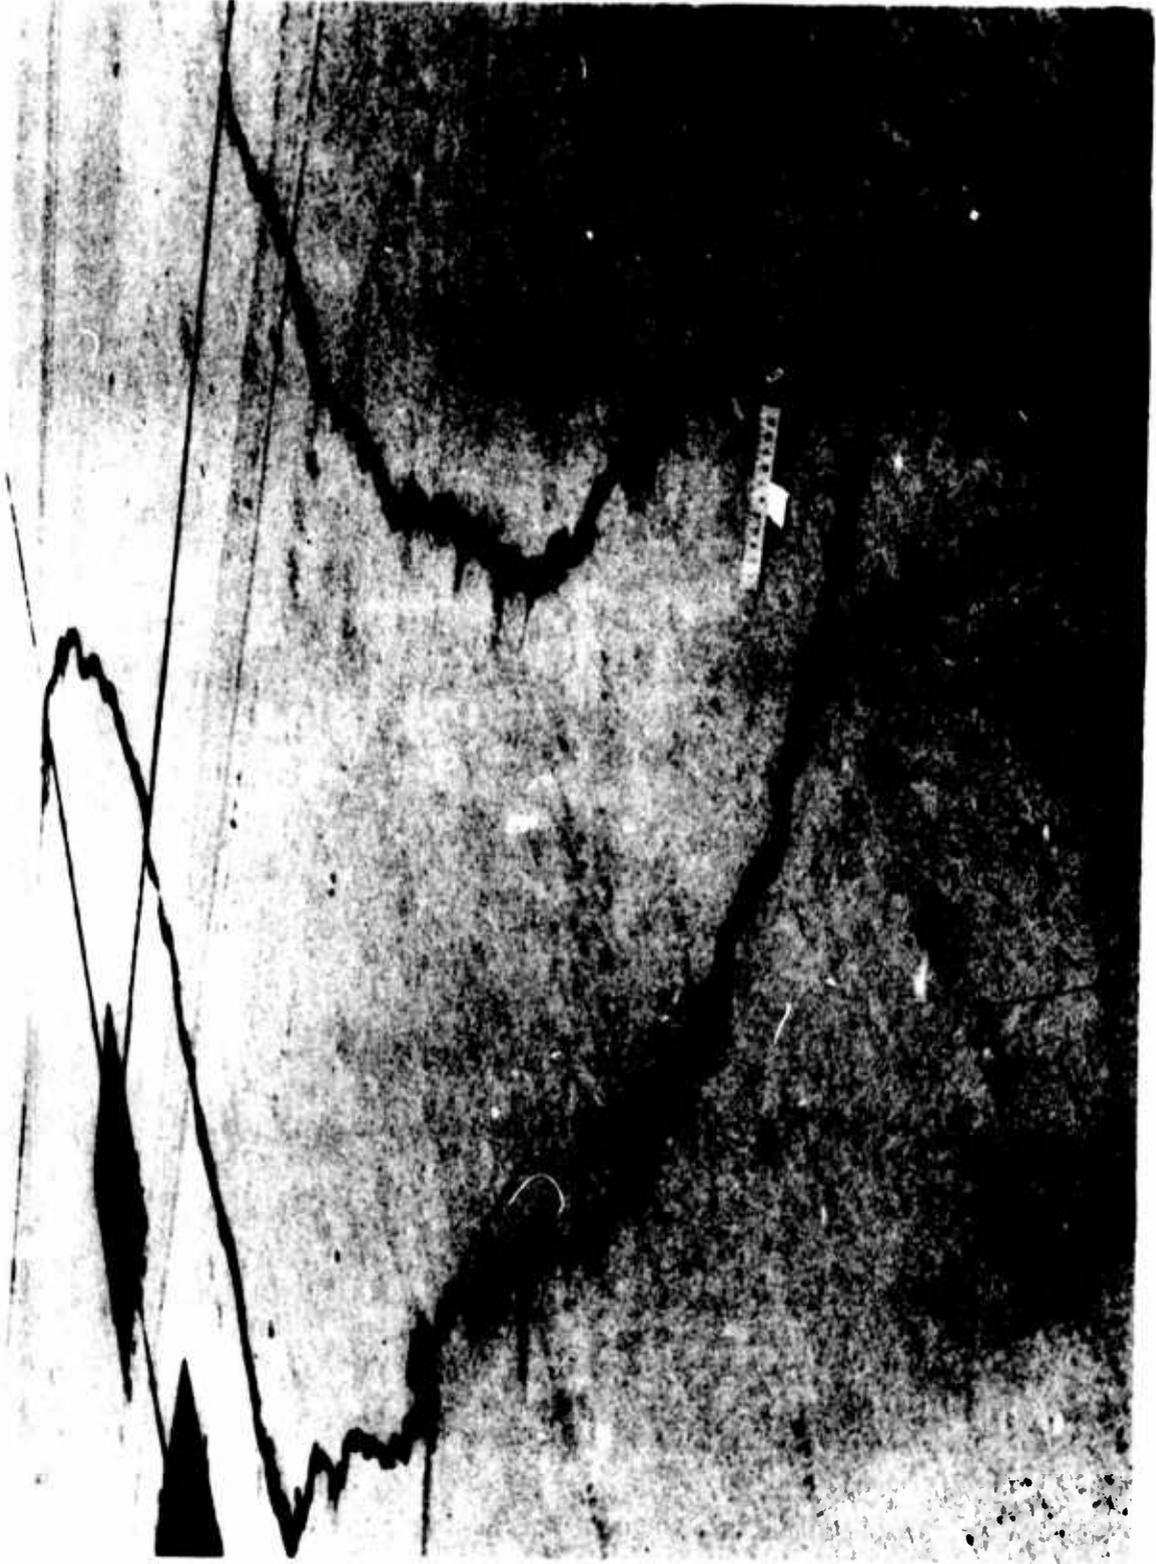
Figure A-2. Cracking in Runway 18-36 at Cross Taxiway 2,
Ban U-Tapao Airfield.

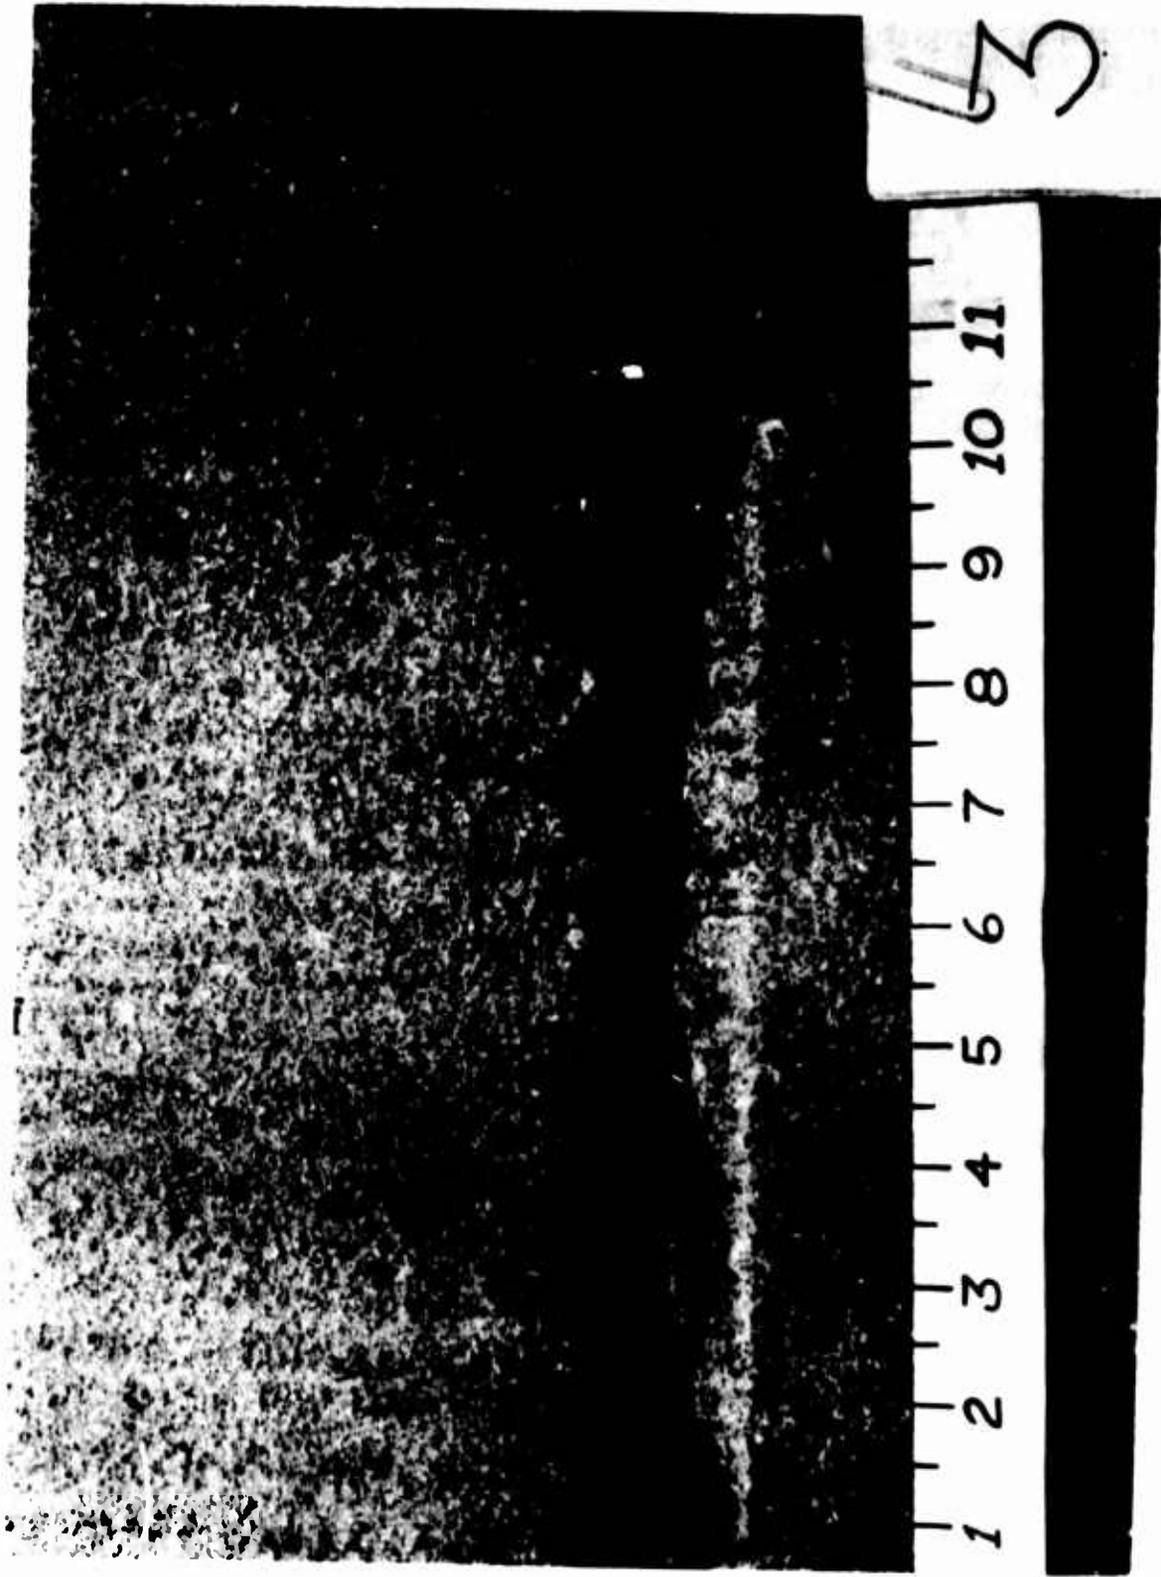
Minor slab defects were of varying types, but included small joint spalls, patches, popouts, embedded wood, and crazed slab surfaces. Approximately 15 percent of all slabs contained one or more of these minor defects. Joint spalls were usually very small, but some showed evidence of loosened particles and approximately 2 - 5 percent of these could be rated as severe. At least two corner spalls were observed from which loose material had disappeared, leaving sharp edges and potential tire problems. Except for a live 50-cal. cartridge and a small wrench, no loose material was observed on the runway.

Figure A-3. Typical minor transverse spalls, Runway 18-36, Ban U-Tapao Airfield.

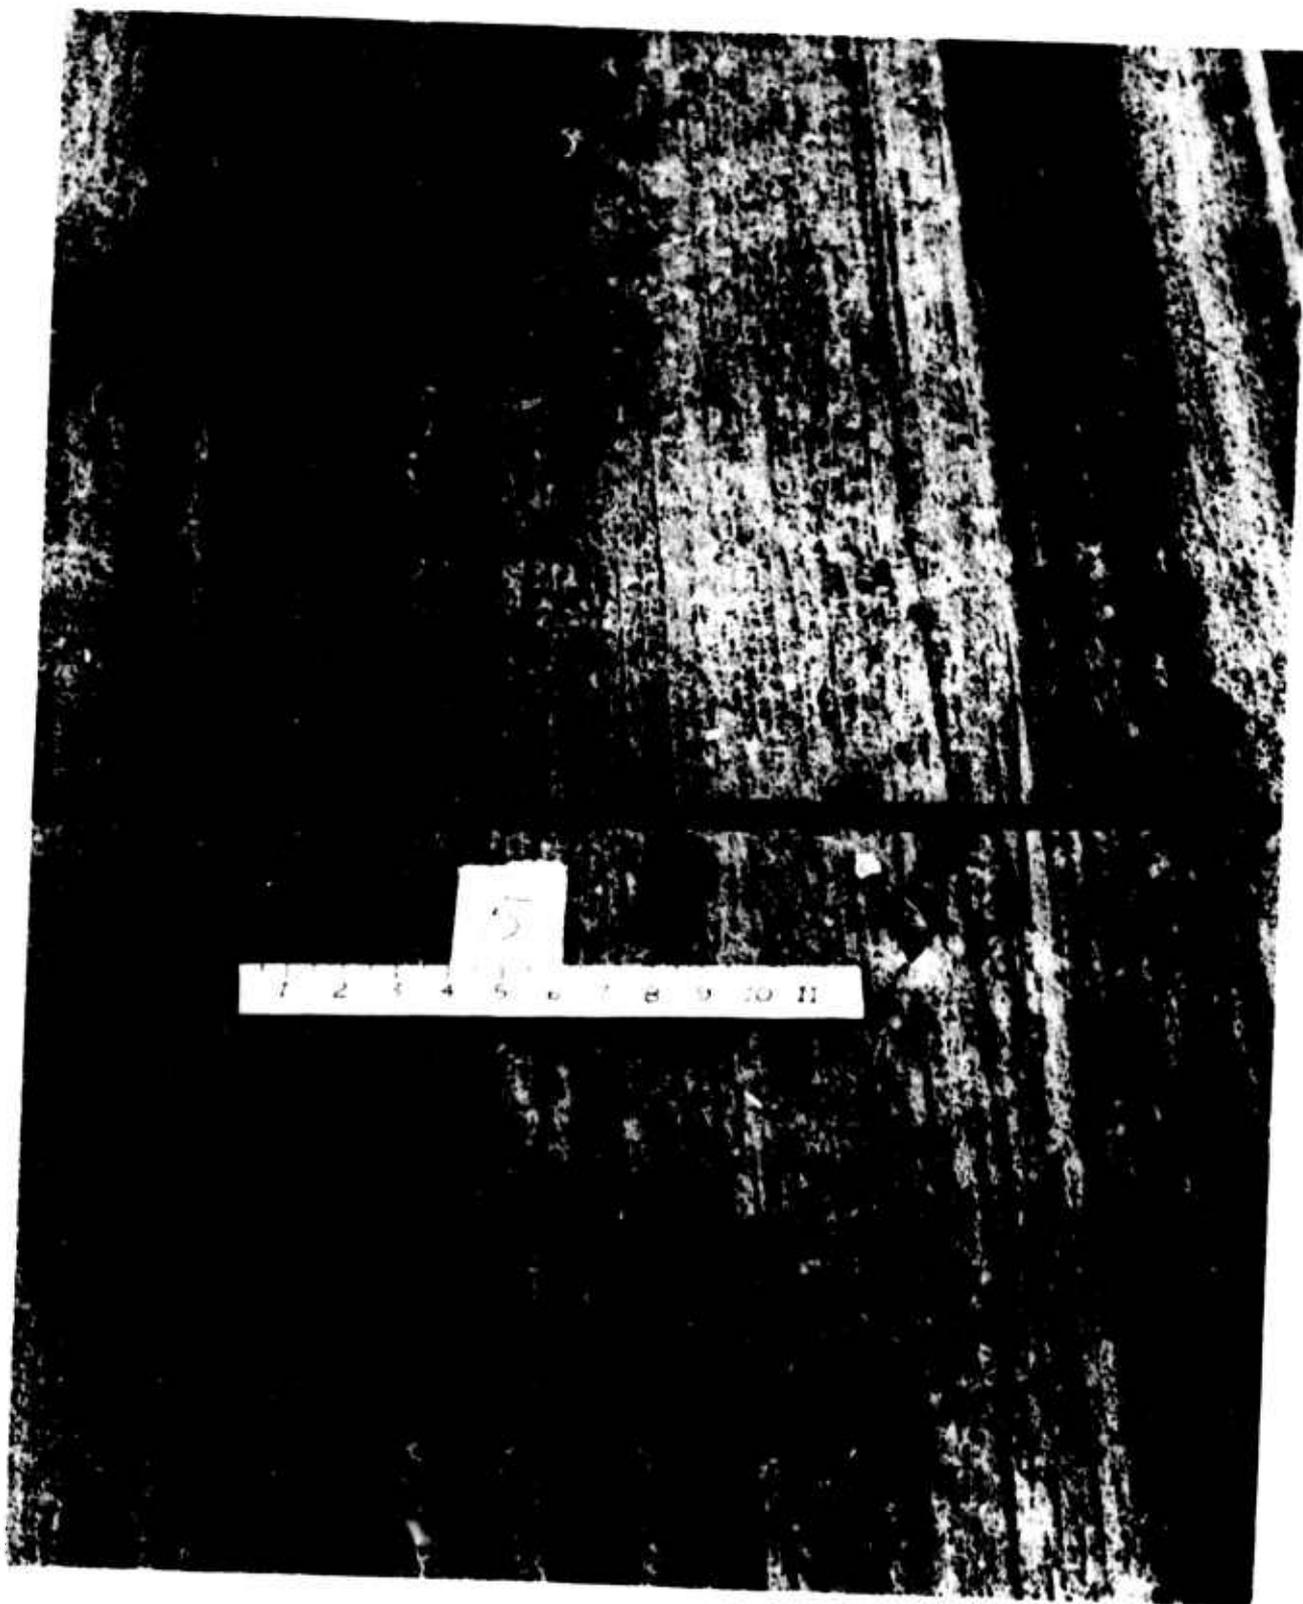
The second pavement area where localized distress has occurred is in the region of Station 55 + 250, about 900 feet from the south end of the runway. (See Figures A-4 and A-5). At this location, cracks have occurred in a group of 12 slabs, with some cracks occurring in lanes outside the center two. No evidence of lower-strength concrete could be found in this area. Contour maps, however, indicate that the site lies within a few feet of the course of an old klong (stream) over which 3 to 4 meters of fill was necessary during construction. It is thus possible that slight settlement and subsequent partial loss of subgrade support has occurred at this point. A majority of all cracks were unrepaired, unsealed, and showed evidence of incipient spalling.

Figure A-5. Longitudinal cracks with spalls in suspected klong area (Sta 55 + 250) of Runway 18-36, Ban U-Tapao Airfield.

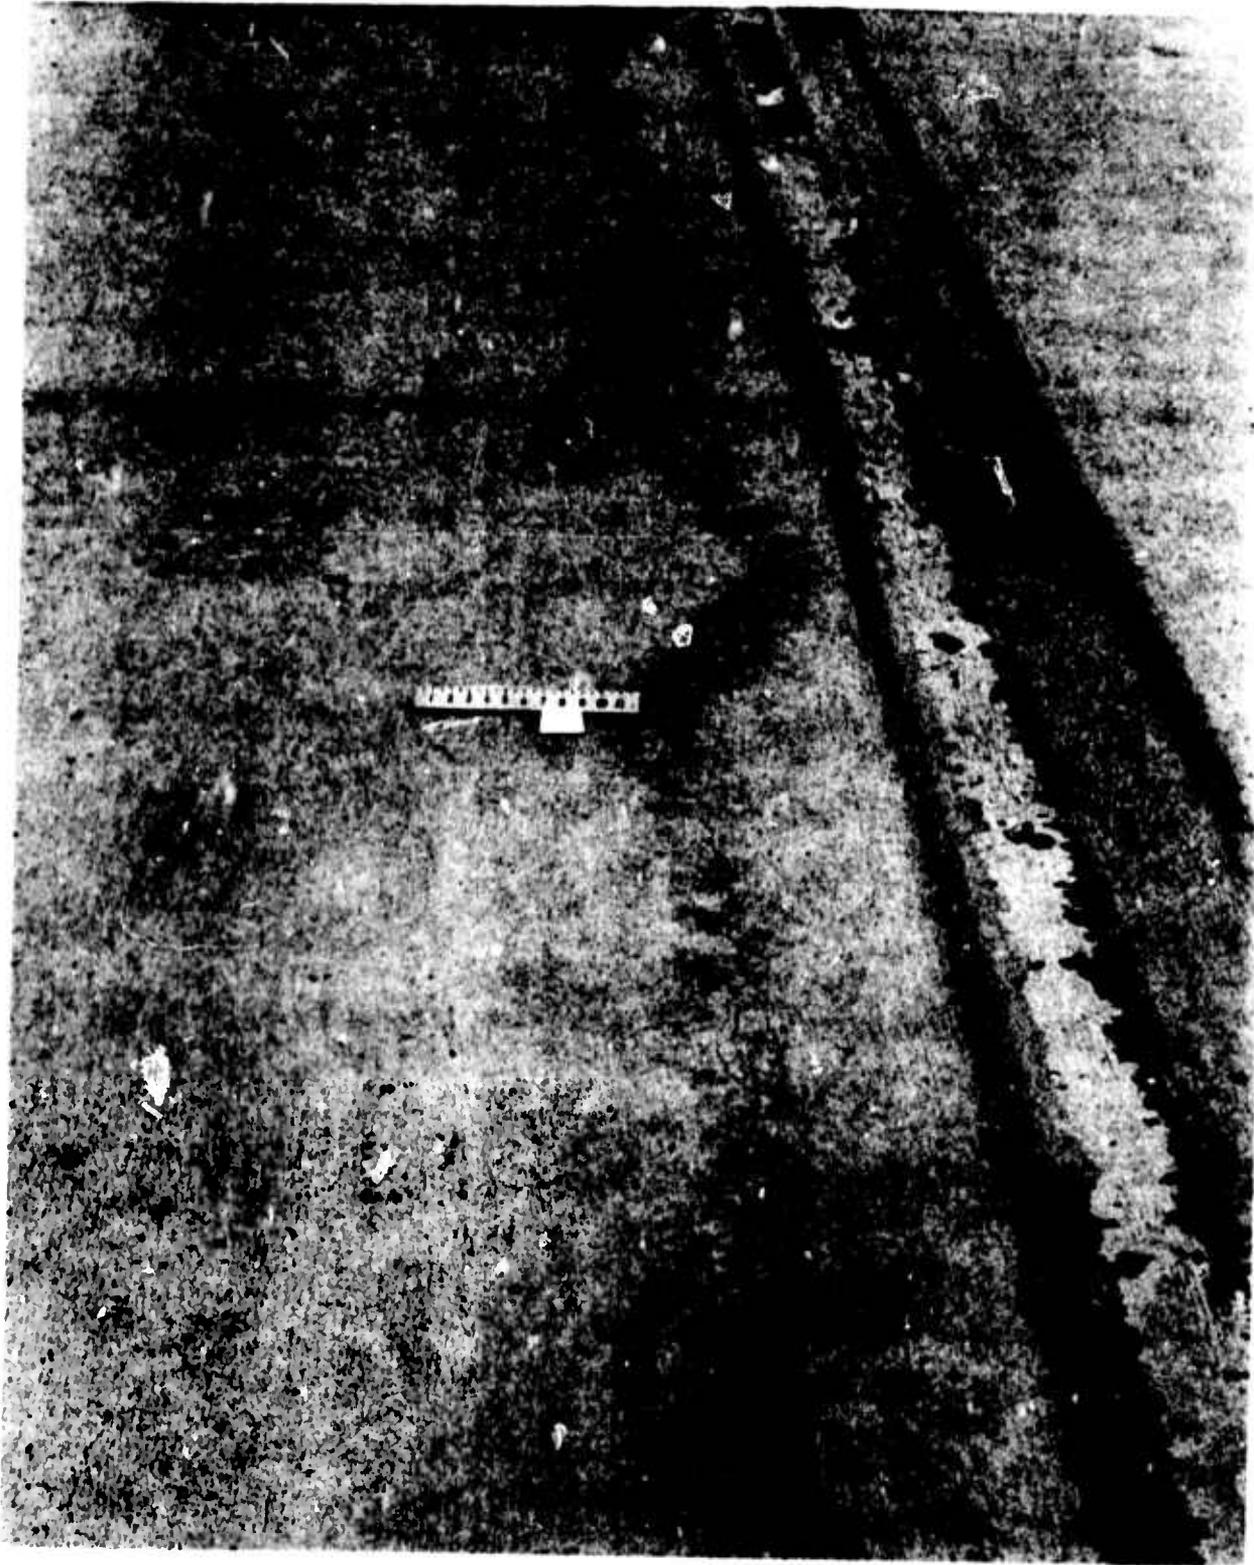
On the parallel taxiway allowable aircraft loads are also higher than actual aircraft loads, and the pavement is in excellent condition except for many longitudinal cracks occurring along the crown of the center lane. This type of distress has been observed on primary taxiways

One hundred eighteen of 1,274 total slabs (9.3 percent of all slabs) contained defects which must be classified as "major", according to the foregoing Corps of Engineers criteria. However, 100 of these defects were longitudinal cracks directly down the centerline of the center slabs. This is a common occurrence on channelized primary taxiways at heavy load airfields and occurred here soon after initial traffic began. When the cracking became apparent, a centerline joint was sawed in all remaining uncracked slabs (about 75 percent of all center slabs). This, in effect, stabilized further occurrences of uncontrolled cracking. These centerline longitudinal cracks act essentially as joints where none were placed and as such present no structural deficiency. (See Figure A-6).

Figure A-6. Typical centerline longitudinal crack in Primary Taxiway, Ban U-Tapao Airfield.

Maintenance on the taxiway had been performed to a greater extent than on the runway. No cracks had been repaired, however, and again it is recommended that these cracks be routed and sealed before further deterioration and subsequent FOD problems are encountered.

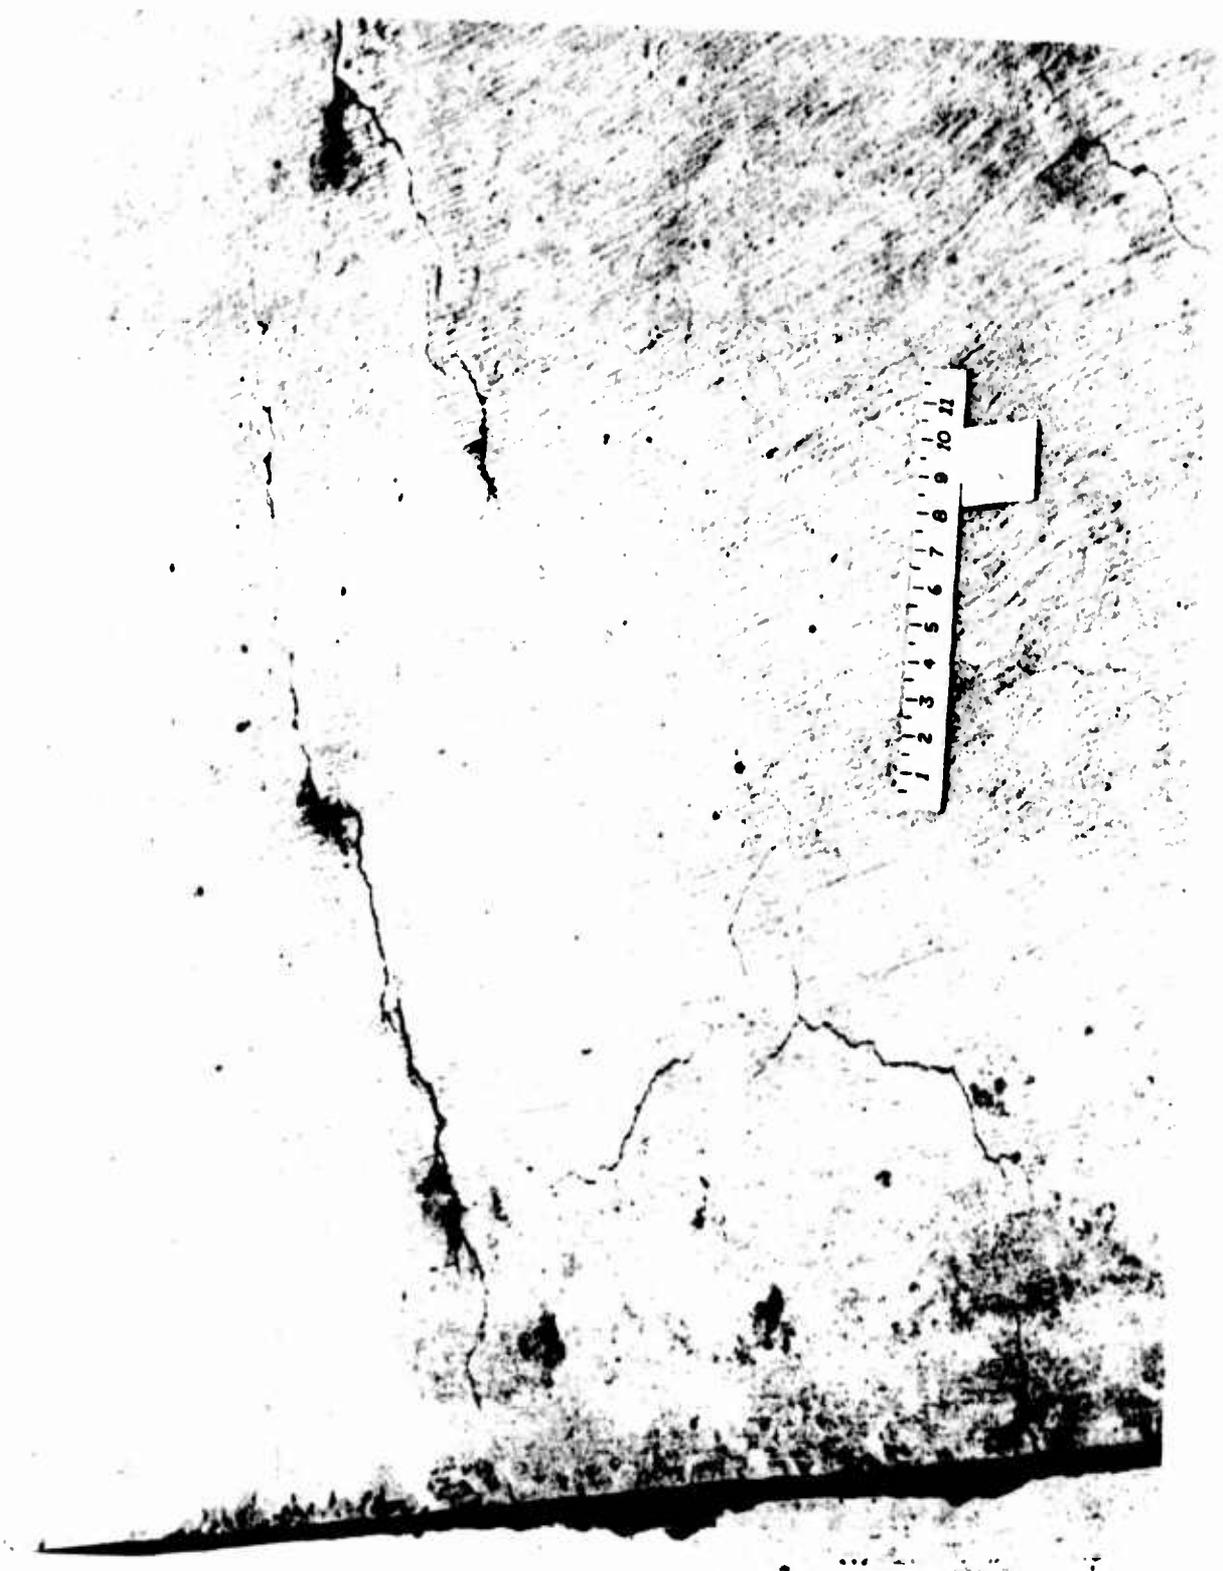
One group of seven adjoining slabs in the center lane were found to have severe surface map cracking indicative of poor concrete. (See Figure A-7).

Figure A-7. Typical map cracked slab in Primary Taxiway, Ban U-Tapac Airfield.

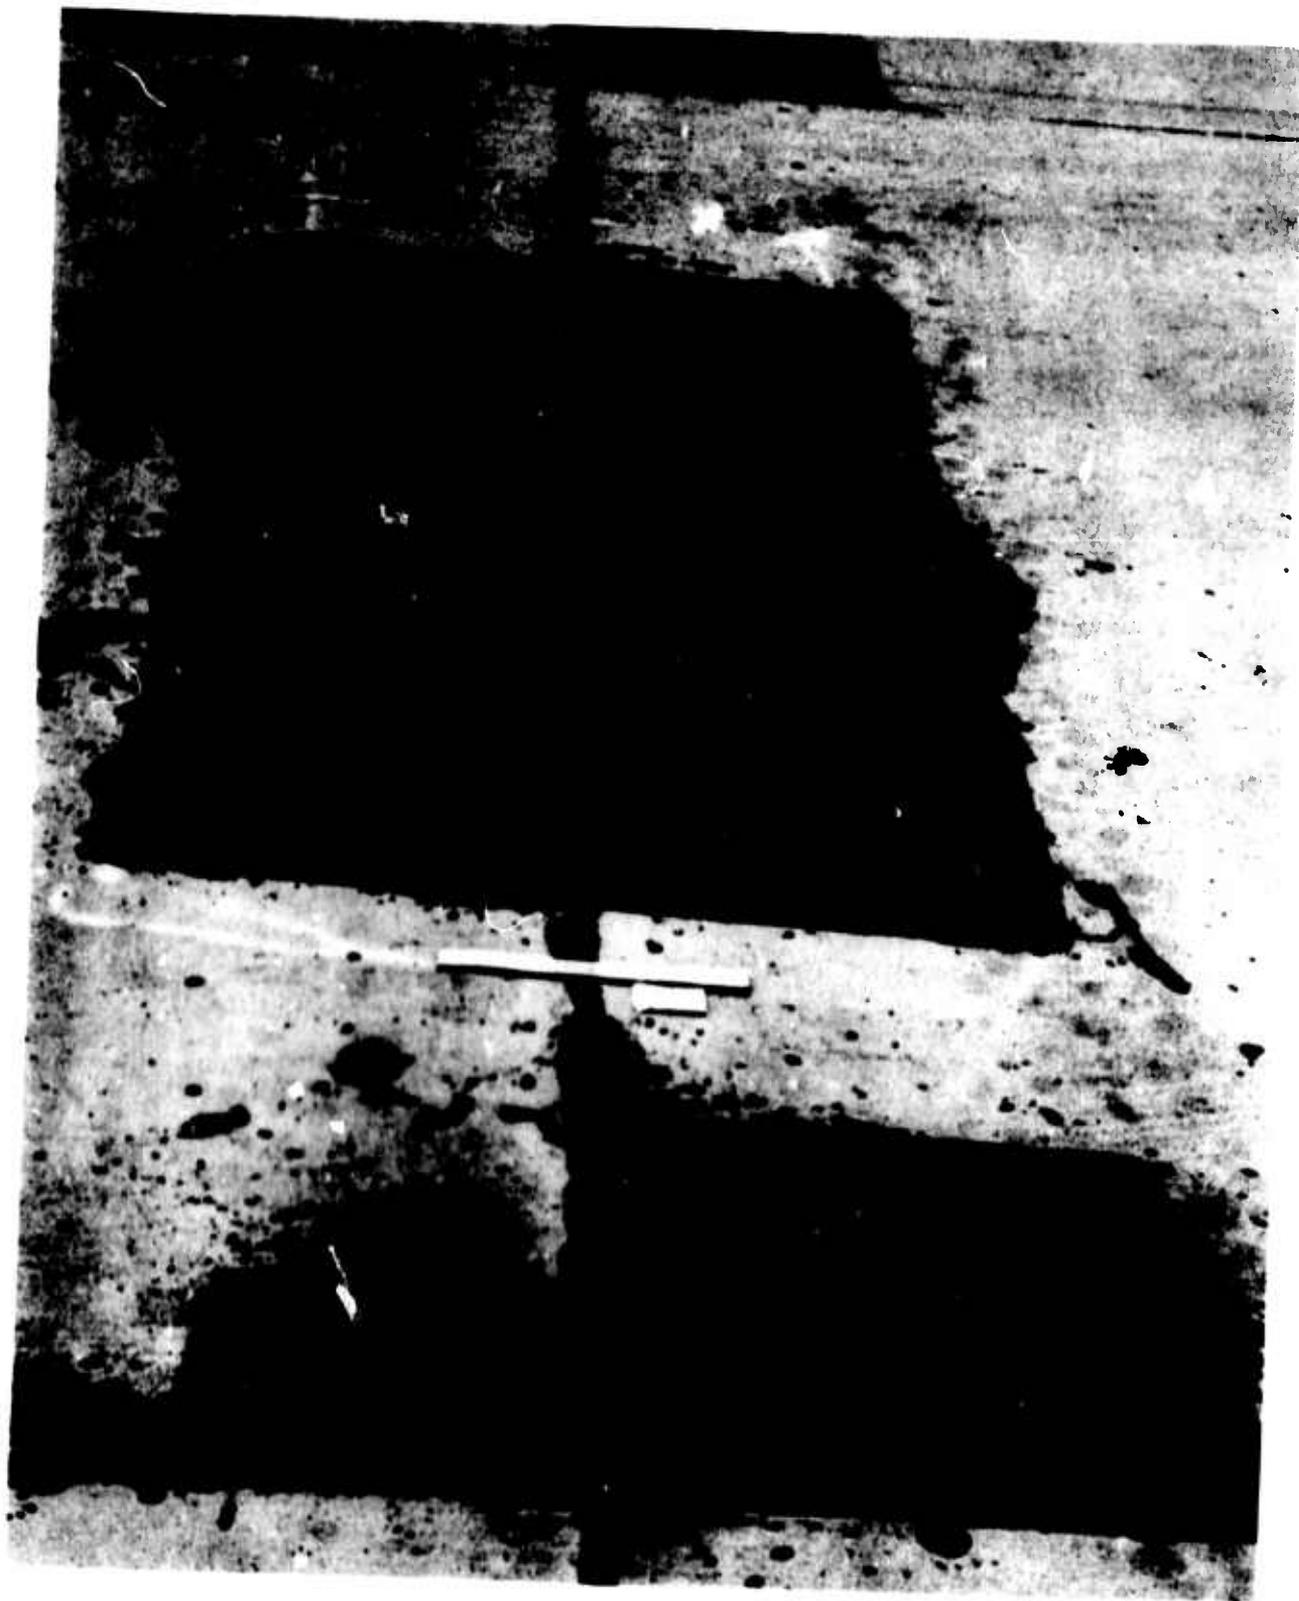
Figure A-9. Typical hot mix AC and epoxy concrete patches, Primary Taxiway, Ban U-Tapao Airfield.

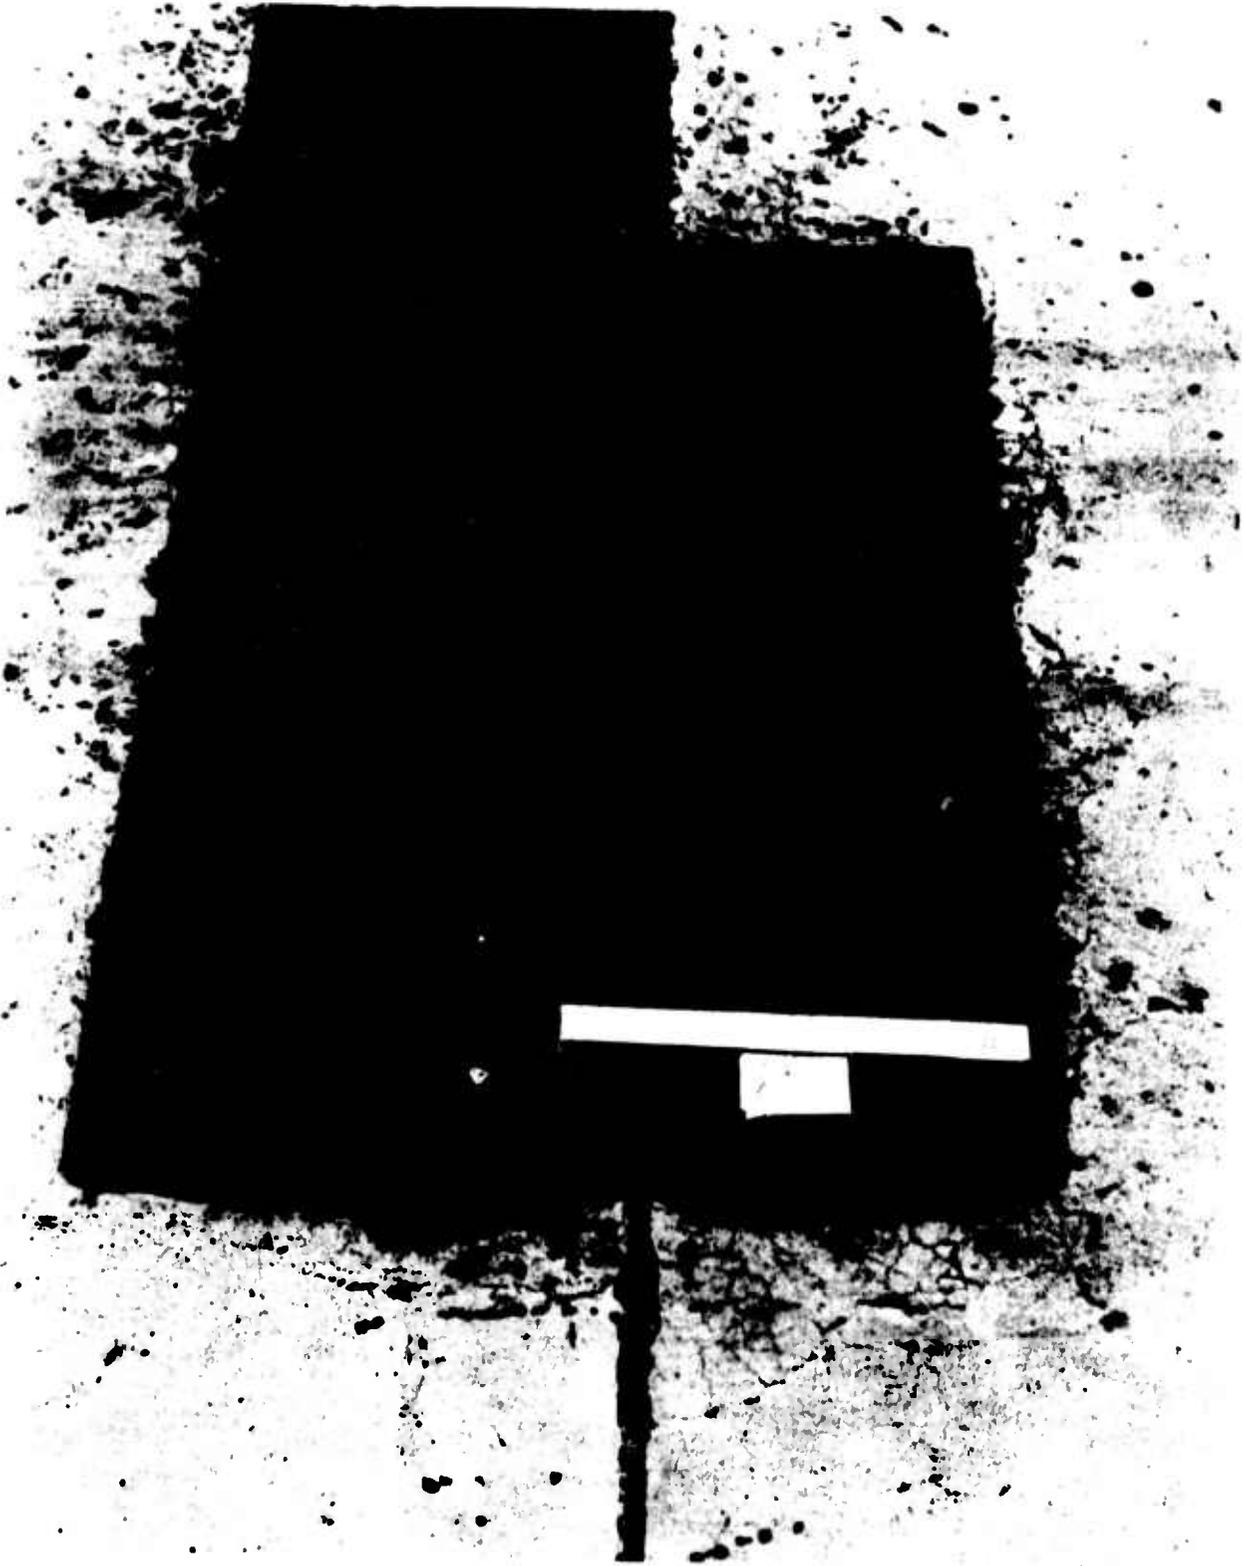
Figure A-10. Epoxy concrete patch with hairline cracking and incipient spalling at edge, Primary Taxiway, Ban U-Tapao Airfield.

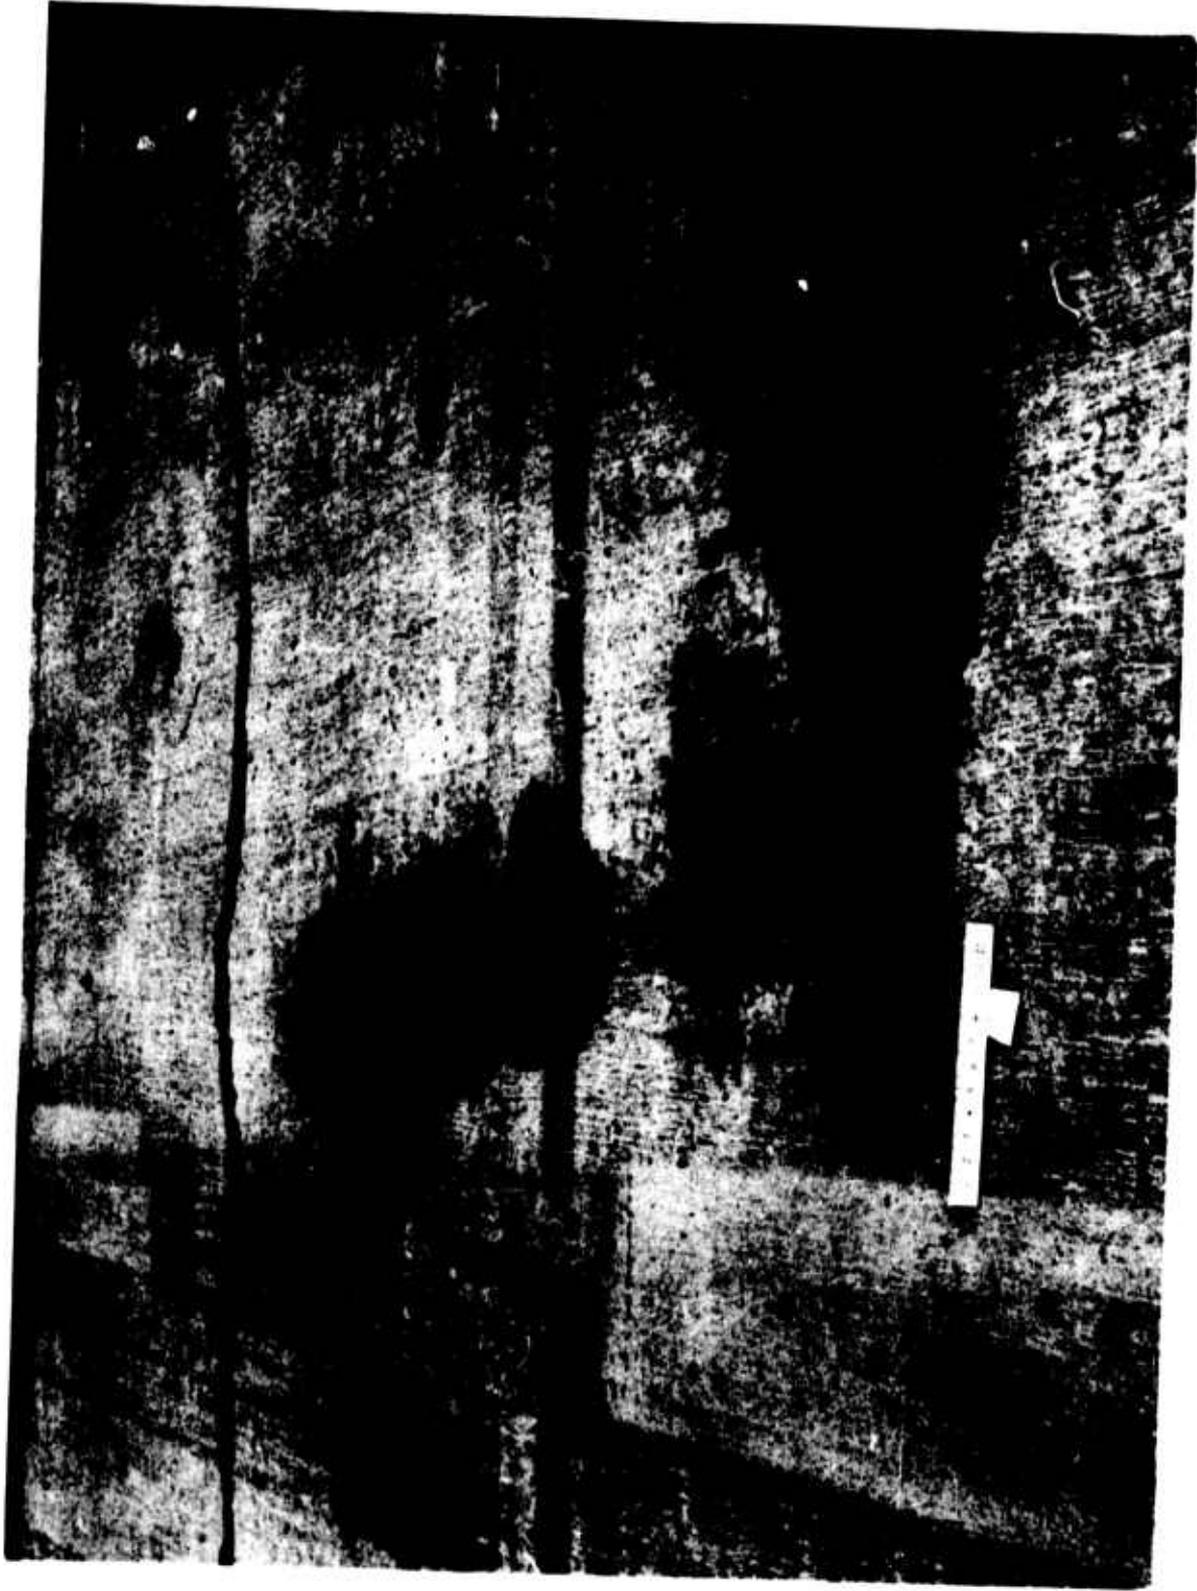
Twenty five of 60 center lane slabs (41.6 percent) contained major pavement defects. Most of these defects were transverse cracks with the appearance of having occurred under load. Seven other cracked slabs were observed in outer lanes. Some of these appeared to be shrinkage cracks. Slight dishing or settlement of at least two center lane slabs was noted, with standing water very evident on one of these. (See Figures A-11 through A-14). All cracks but one were sealed. Minor defects occurred in only 3.5 percent of all slabs. Joint seals were in excellent condition, as were the asphalt shoulders.

Figure A-11. Evidence of standing water and sealed transverse crack in Access Taxiway 2, Ban U-Tapao Airfield.

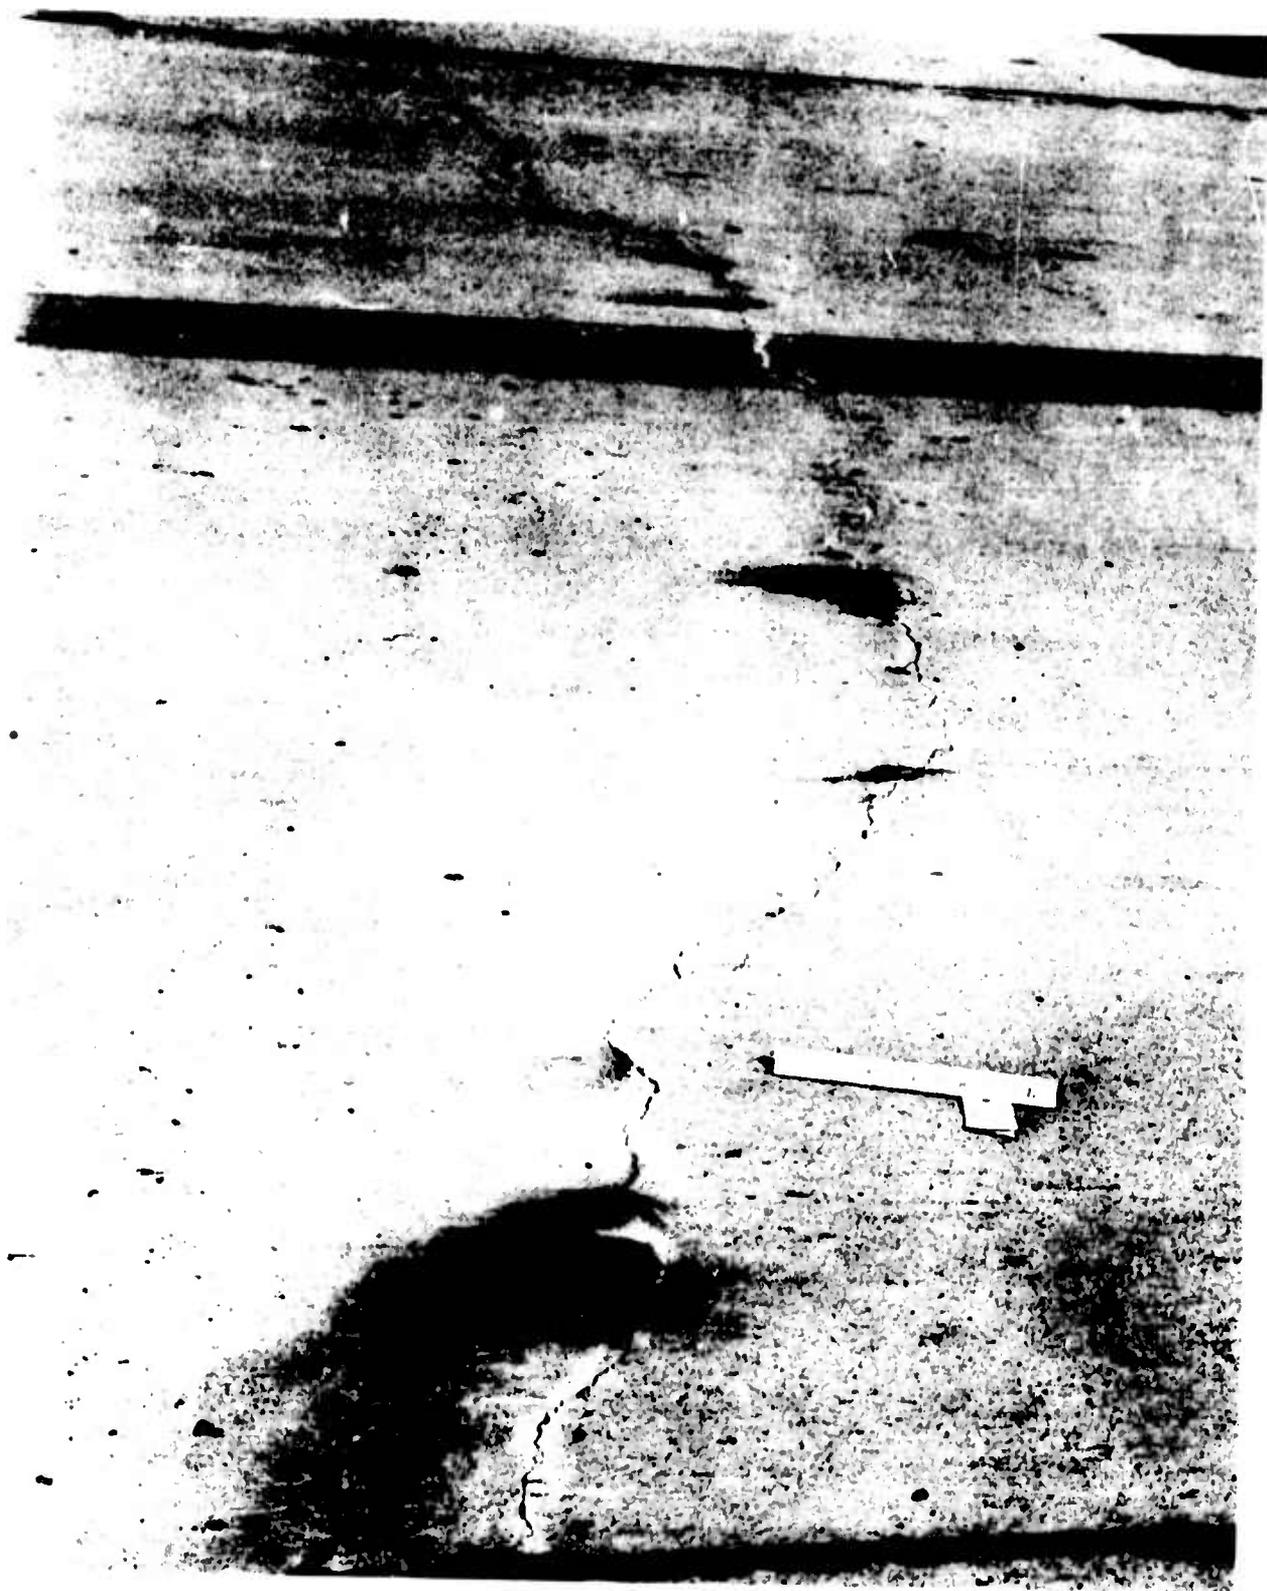
Figure A-15. Typical unsealed transverse crack in Hardstand Taxiway 1, Ban U-Tapao Airfield.

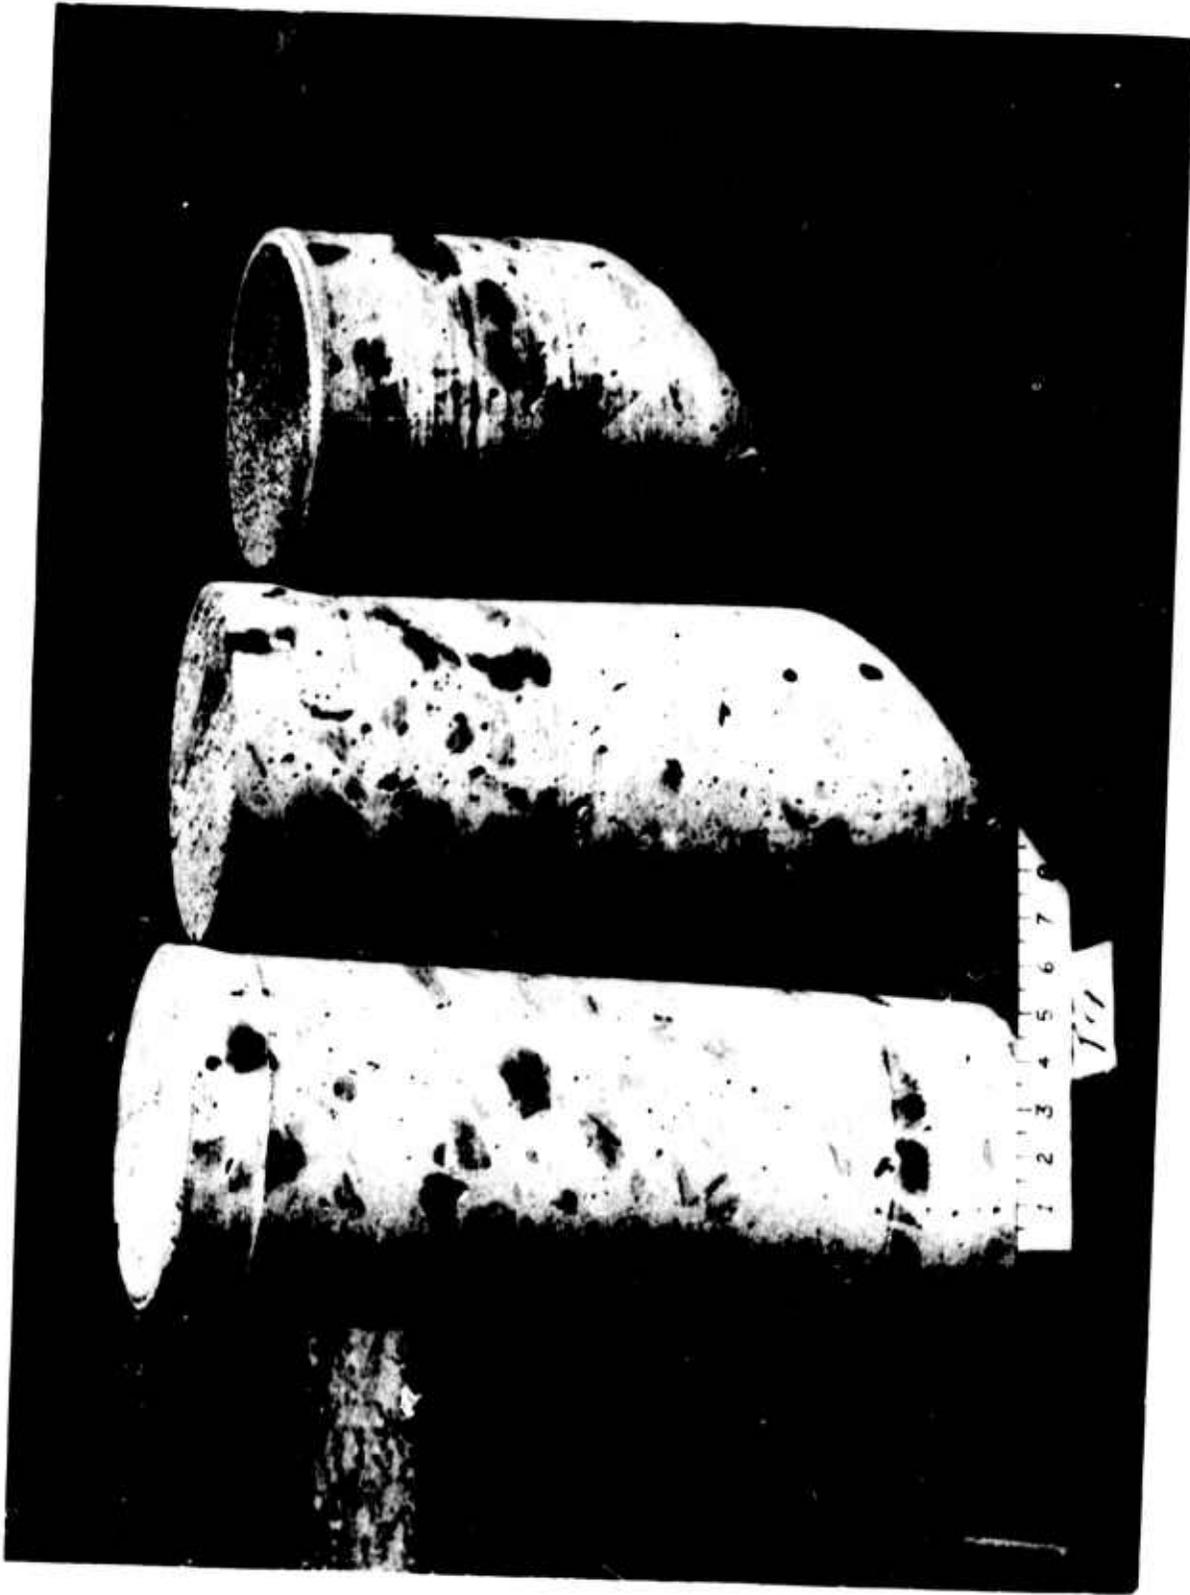
Figure A-17. Eight-inch diameter cores taken from Hardstand Taxiway 4, Ban U-Tapao Airfield.
