**FLIGHT TEST-WHIRLING ARM CORRELATION  
OF RAIN EROSION RESISTANCE  
OF MATERIALS**

GEORGE F. SCHMITT, JR.

TECHNICAL REPORT AFML-TR-67-420

SEPTEMBER 1968

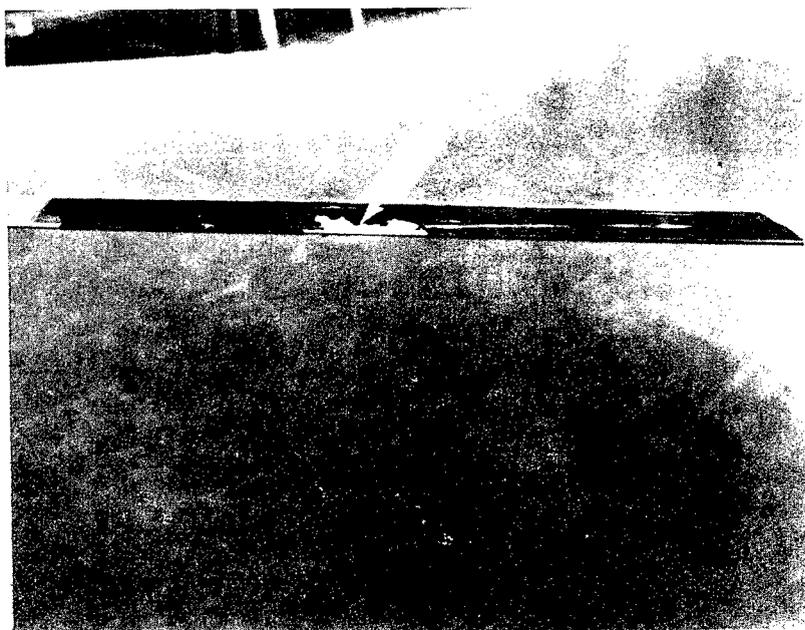
The first visible damage received by this coating was noted after Flight 7. Hail approximately the size of marbles was encountered on at least two penetrations. Figures 13 and 14 show that one-third of the leading edge of the sample was removed from the top and bottom of the right stabilizer. The neoprene on the left stabilizer received similar damage on this flight as can be seen in Figures 15 and 16. Only bare metal remained at the exposed sections. Both coatings had been torn from the stabilizer in small segments based on the jaggedness of the edge of the remaining samples. The sample on the left stabilizer was considered to have failed on Flight 7; however, the test continued with the sample on the right stabilizer. The postflight inspection for Flight 13 showed that three-fourths of the leading edge of the right stabilizer initially covered by neoprene was now exposed (Figures 17 and 18). The neoprene adhered to the bottom of the stabilizer but gradually peeled from the top of the stabilizer during Flights 12 through 16. Testing was terminated on this sample after Flight 16 because the entire leading edge and most of the top surface had eroded away (Figures 19 and 20).

Figure 13. Results of Hail Impact on the Specification Neoprene Sample on Upper Surface of Right Horizontal Stabilizer

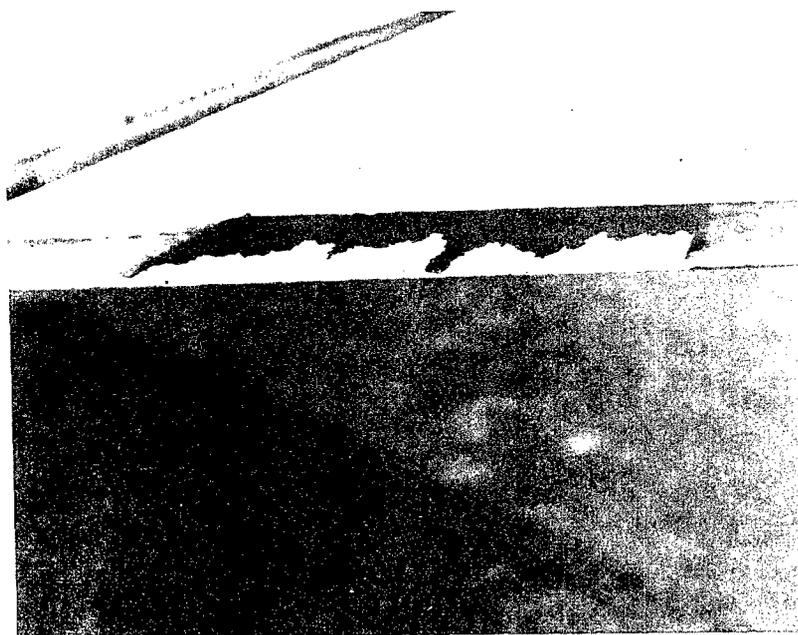
Figure 15. Specification Neoprene on Inboard Section of Left Stabilizer After Flight 7

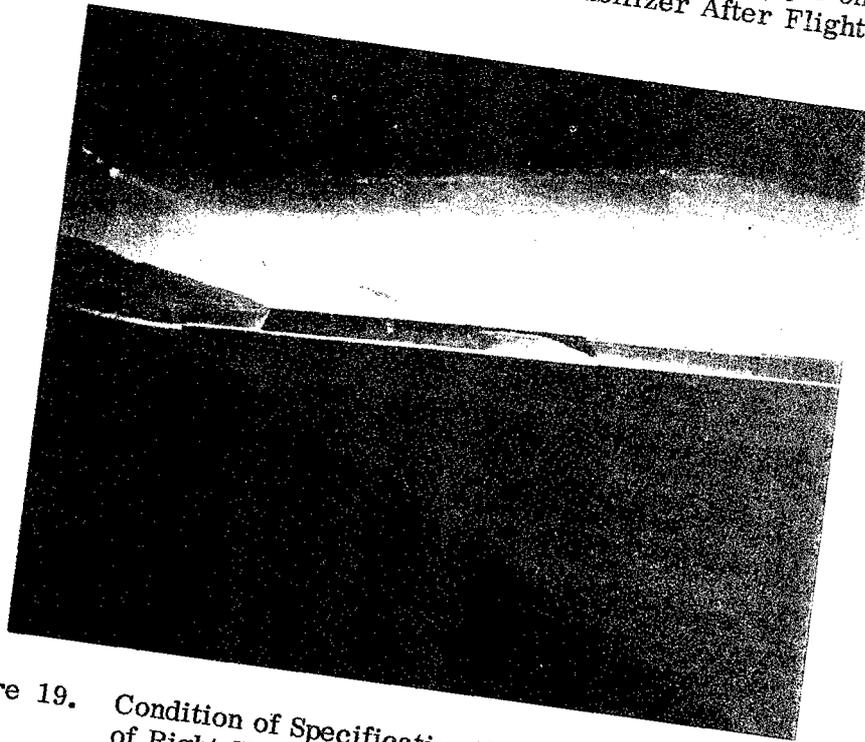
Figure 19. Condition of Specification Neoprene on Upper Surface of Right Stabilizer After Flight 16

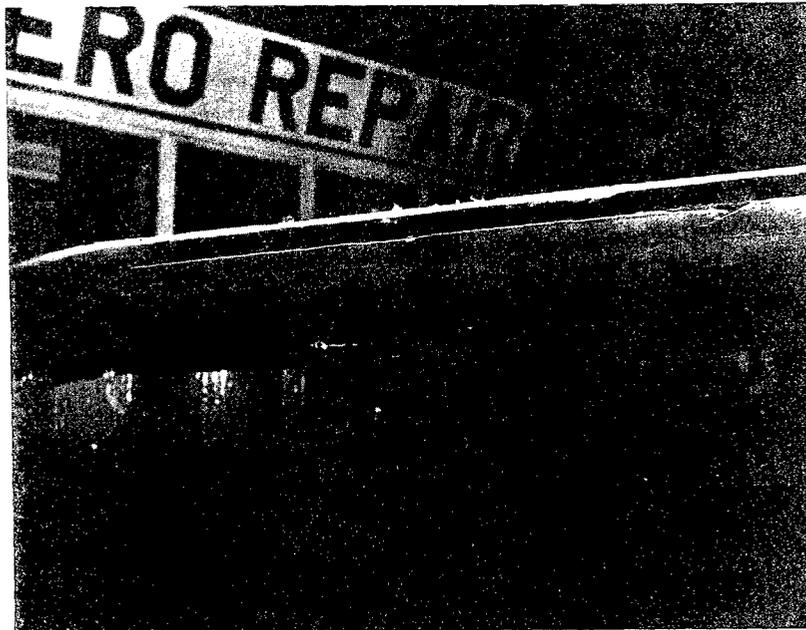
Figure 20. Condition of Specification Neoprene on Lower Surface of Right Stabilizer After Flight 16

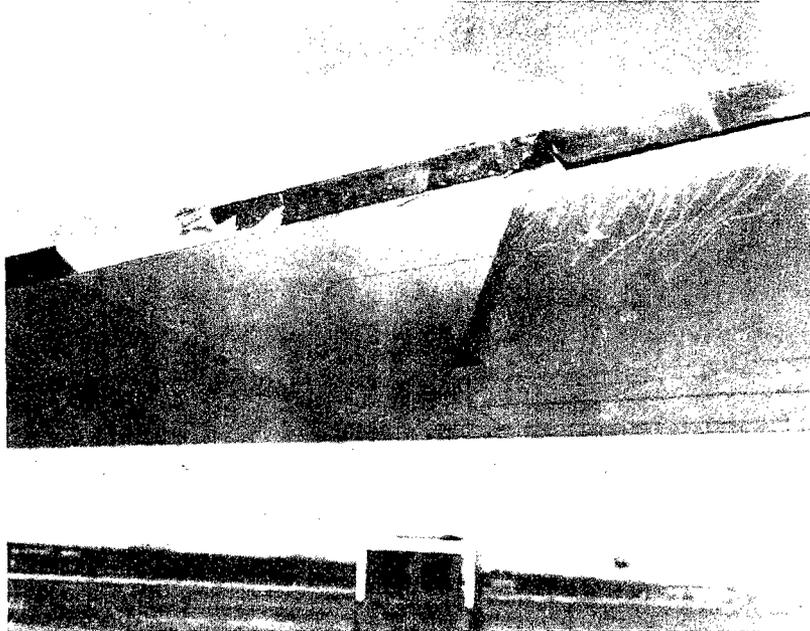
The pigmented urethane on the right stabilizer withstood the adverse conditions until its bond to the metal was broken when the inboard, adjacent urethane sample was blown from the aircraft during Flight 20. The sample peeled 4 inches during the next two flights. Figures 23 and 24 show the condition of this sample

Figure 24. Final Condition of Pigmented Urethane Sample on Lower Surface of Right Stabilizer

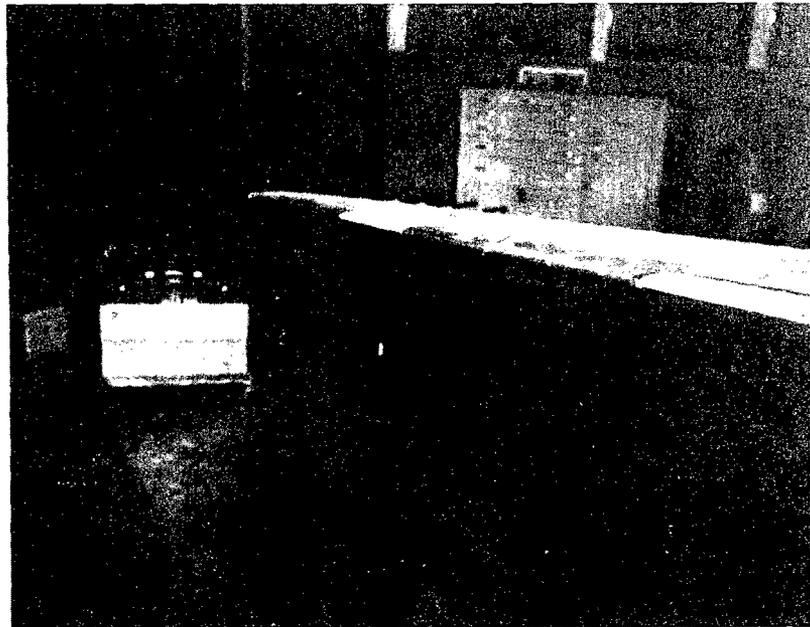
Figure 25. Peeling of Clear Urethane on Right Stabilizer Indicated by Arrow Was Attributed to Overlapping of the Nickel Sample

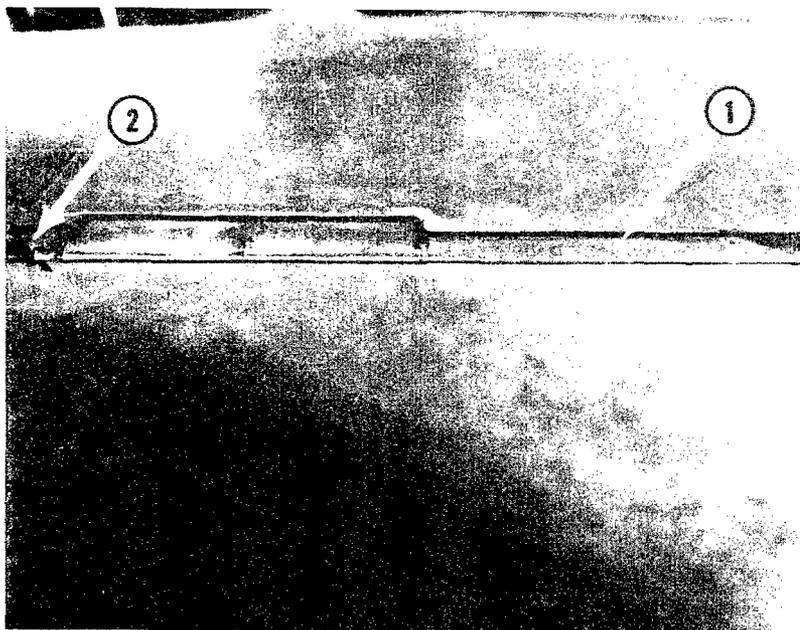
Figure 26. Sections of Clear Urethane Tape (1) Were Torn From Sample on Right Stabilizer During Hail Encounter on Flight 7 and Clear Urethane (2) Was Peeled an Additional Amount on the Inboard Edge

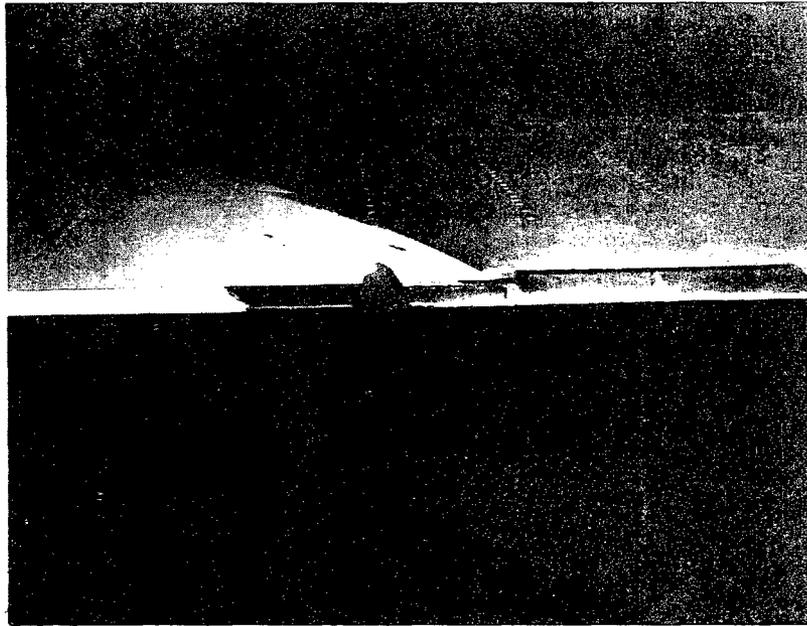
Figure 28. After Flight 16 the Clear Urethane on Right Stabilizer was Being Peeled Intact With No Visible Erosion of the Surface

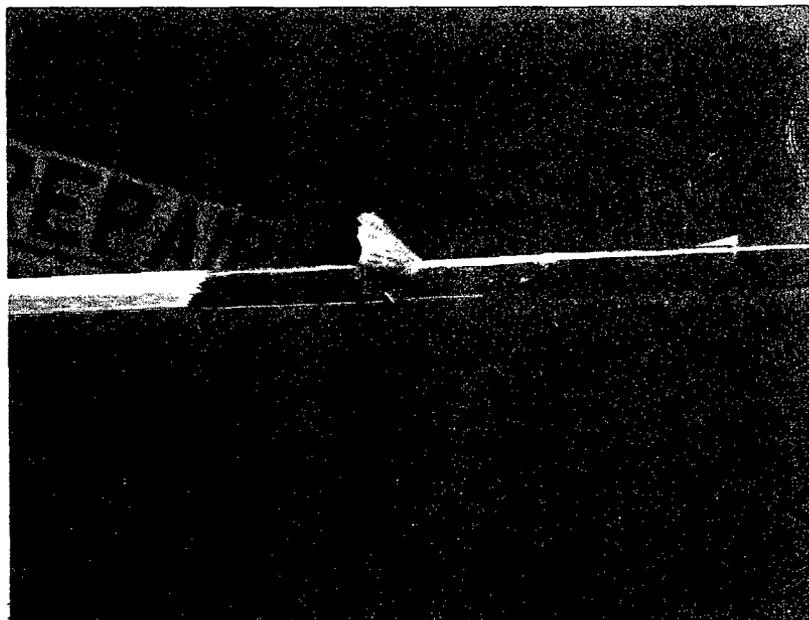
Figure 29. Clear Urethane on Lower Surface of Right Stabilizer Was Also Peeling Intact With No Wear on the Surface of the Material

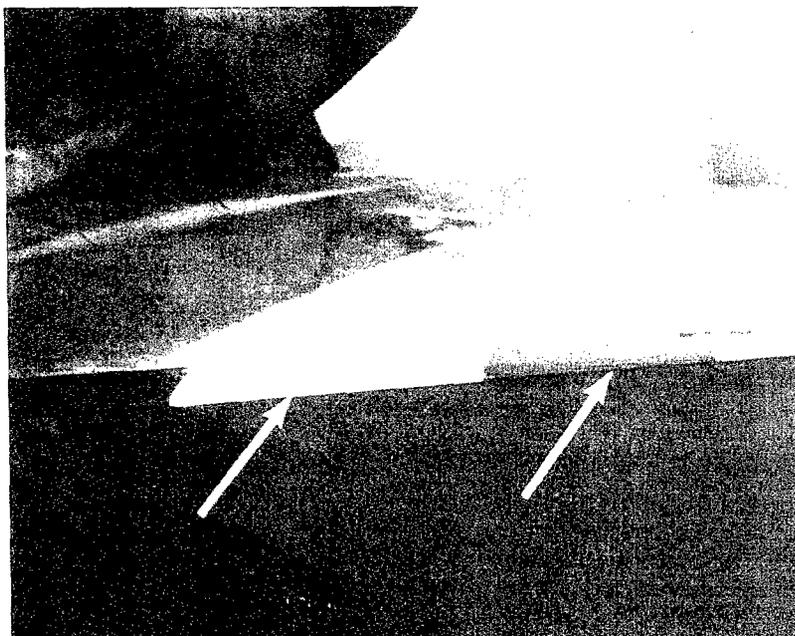
Figure 30. Pigmented Urethane and Clear Urethane on Left Stabilizer Completed the Tests With No Adverse Effects

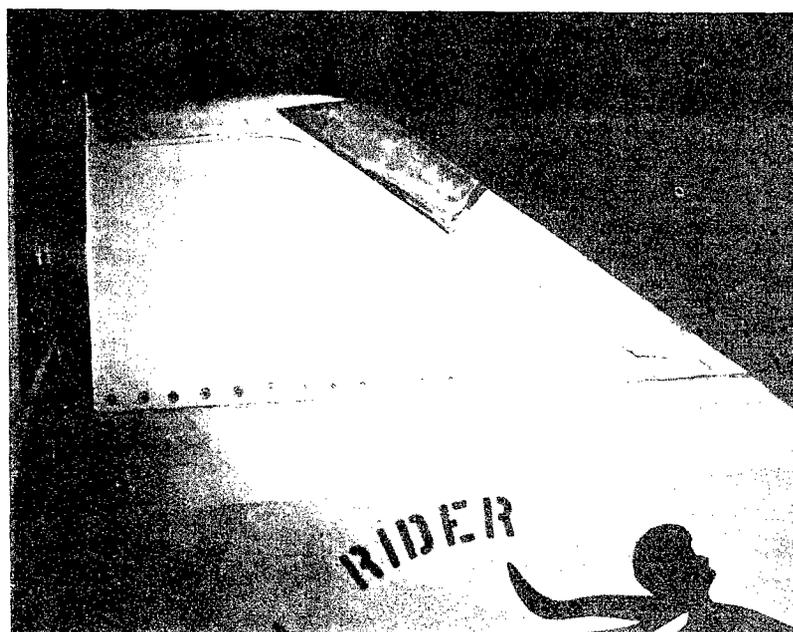
Figure 31. First Sign of Breakdown of Nickel Sample on Leading Edge of Vertical Stabilizer After Flight 7

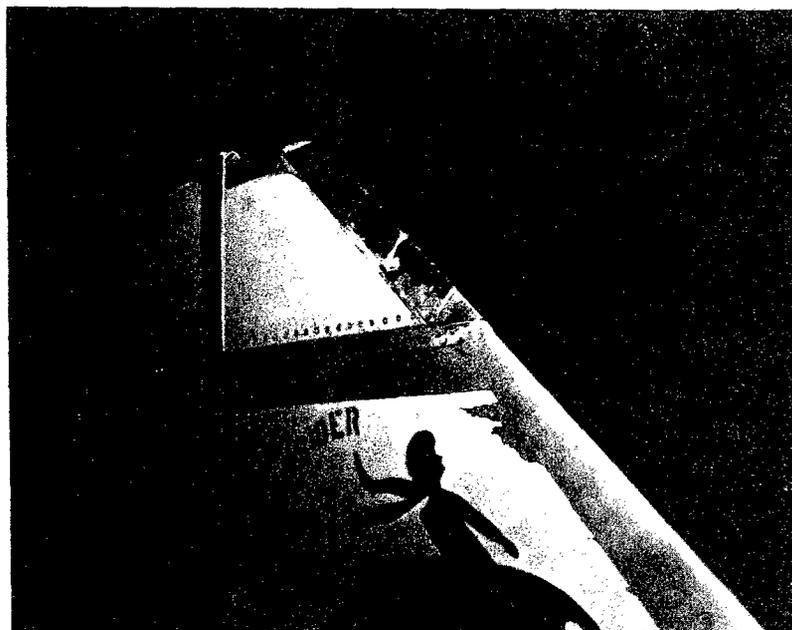
Figure 32. Increased Damage to Nickel Sample on Vertical Stabilizer as of Flight 16

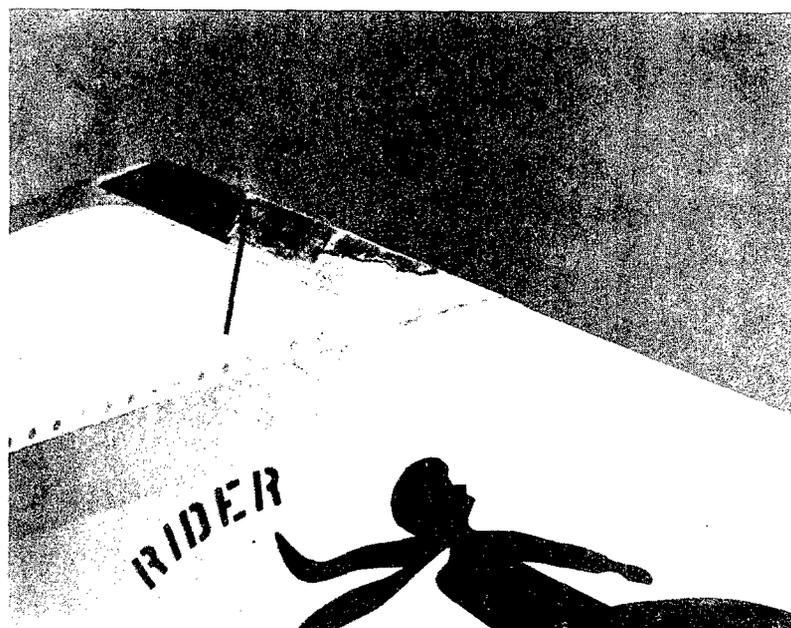
Figure 33. Approximately Two-thirds of the Nickel Sample on the Right Side of the Vertical Stabilizer Was Lost by the End of Program; the Urethane Sample Above the Nickel Had Little Damage

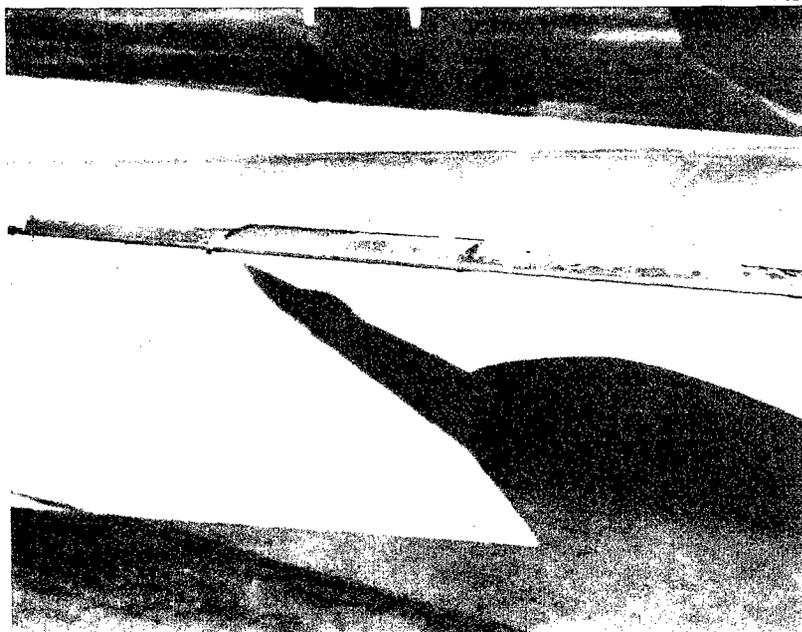
Figure 34. Damage to Nickel Sample on Right Stabilizer Upon Completing Tests

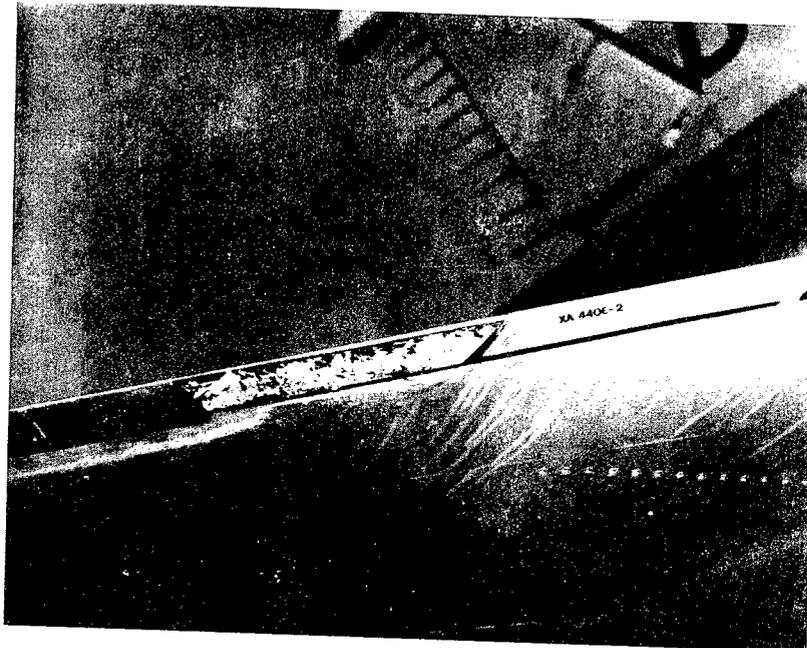
The first visible sign of damage was peeling of the inboard edge of the sample on the left stabilizer which occurred during Flight 7 (Figures 38 and 39). This partial breakdown continued through Flight 13 at which time approximately one-third of the shoe had been sheared away (Figures 40 and 41). This loose segment was not brittle nor did it have any surface roughness. (The shoe retained these characteristics until complete removal occurred.) The failure of this sample appears due to the inability of the adhesive to hold the shoe to the metal. This was particularly noticeable during the Flight 16 postflight (Figures 42 and 43). The adhesive along the leading edge was adhering to the loosened section of Estane, but no adhesive remained on the exposed metal surface. This shoe was lost during flight 17. The Estane boot on the right stabilizer showed slight peeling of the inboard edge as a result of Flight 16; however, the peel was too insignificant to photograph. This sample remained glossy with no surface roughness or breaks throughout the test phase except for the peeling of the inboard edge which had increased about an inch on the top and bottom stabilizer surfaces (Figures 44 and 45).

Figure 45. Corner of Estane Pulled Slightly From Lower Surface of Right Stabilizer

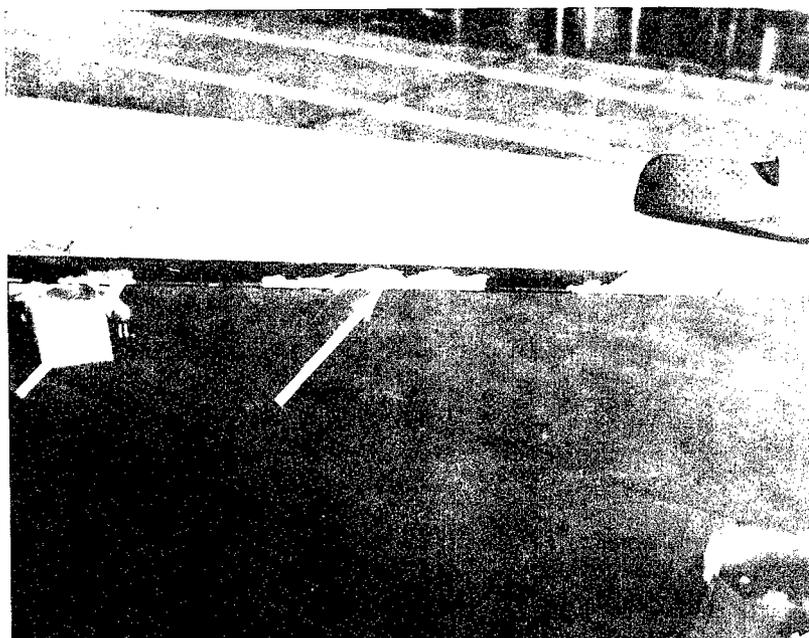
small cuts received were enlarged during the following flights as can be seen in the Flight 13 postflight photograph of the sample (Figures 50 and 51). The final damage was received and photographed after Flight 16 (Figures 42 and 43). The test was considered to be over for this sample since the entire leading edge had been destroyed.

Figure 50. Increased Deterioration of Neoprene and Hycar Boots on Left Stabilizer Observed By Flight 13

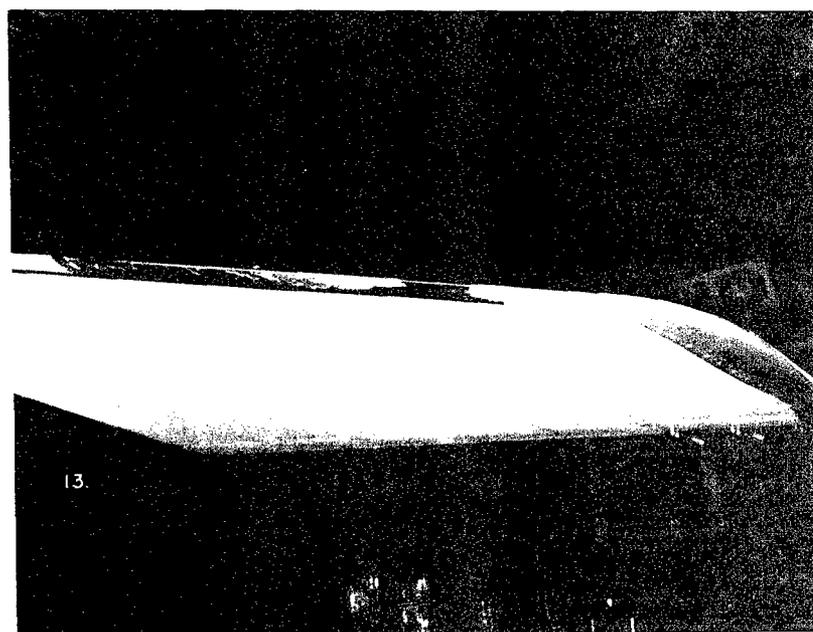
Figure 51. Damage to Neoprene and Hycar Boots on Lower Surface of Left Stabilizer After Flight 13

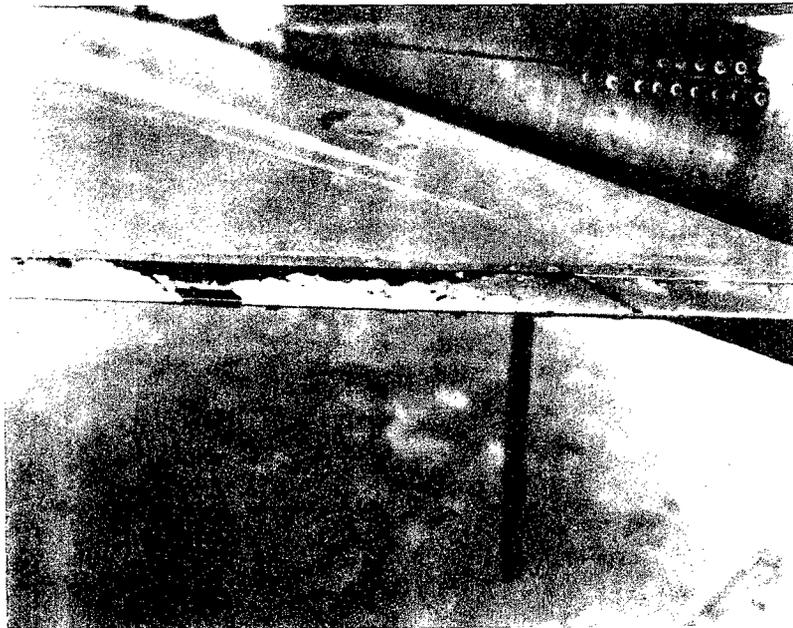
Figure 53. Hail Encounter on Flight 7 Removed Almost All the Hycar Boot From Upper Surface of Right Stabilizer

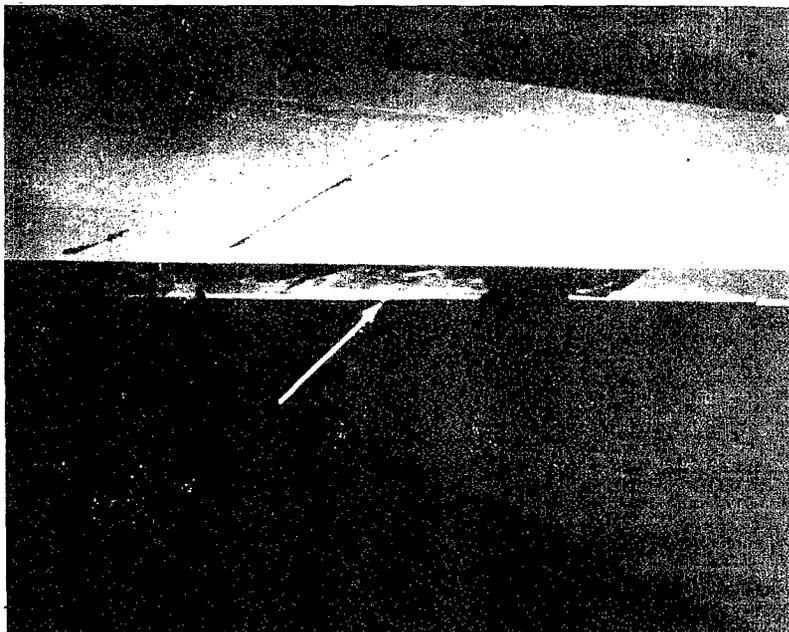
Figure 55. Three-fourths of Hycar Boot Removed From Upper Surface of Left Stabilizer During Flight 16

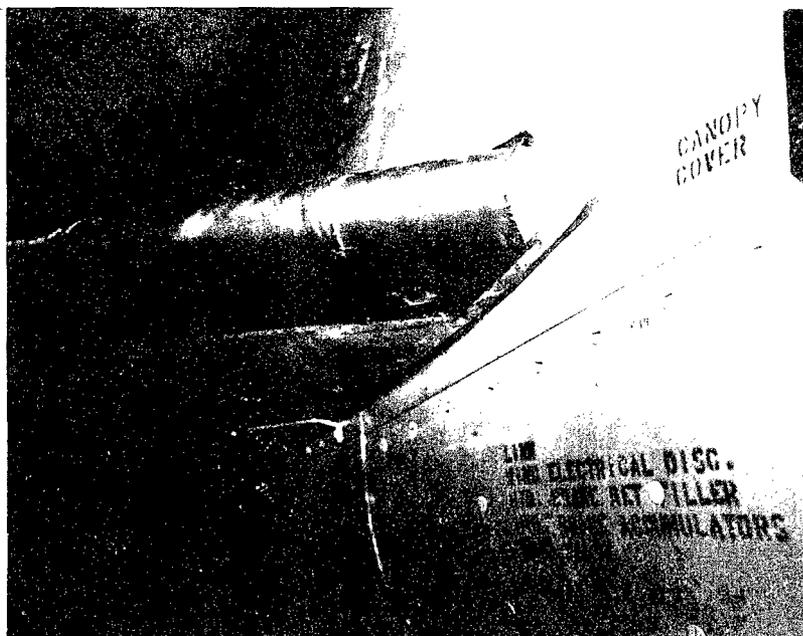
Figure 56. Edge of Slit in Deicing Boot Frayed After Flight 2

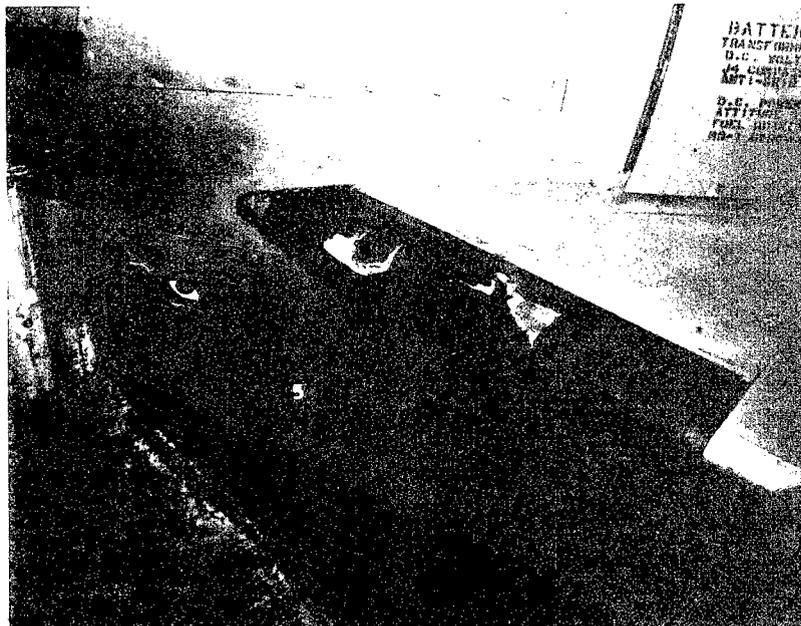
Figure 59. Increased Failure of Deicing Boot on Left Wing After Flight 3

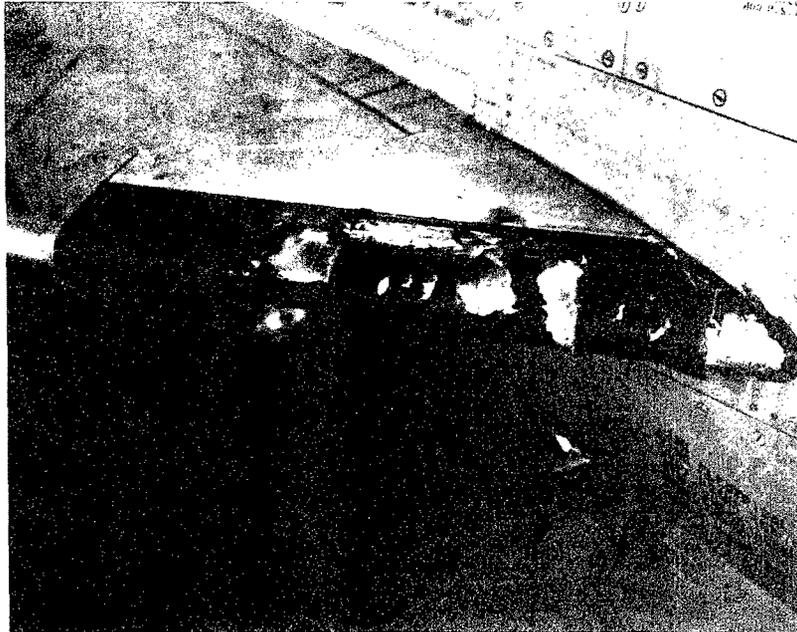
Figure 60. Severe Damage to Deicing Boot Caused by Hail and Ice Crystal Impingement During Flight 7

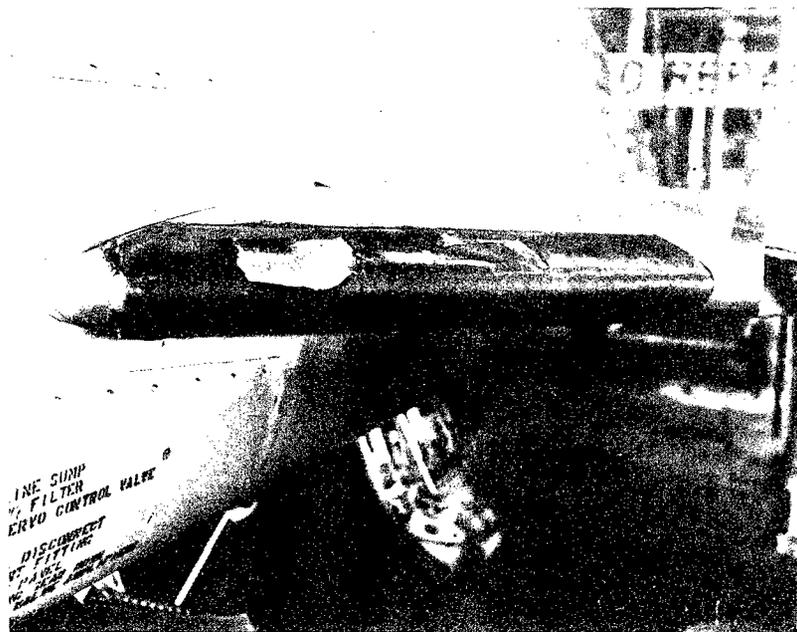
Figure 61. Significant Damage to Deicing Boot on Left Wing Caused by Hail and Ice Crystal Encounter on Flight 7

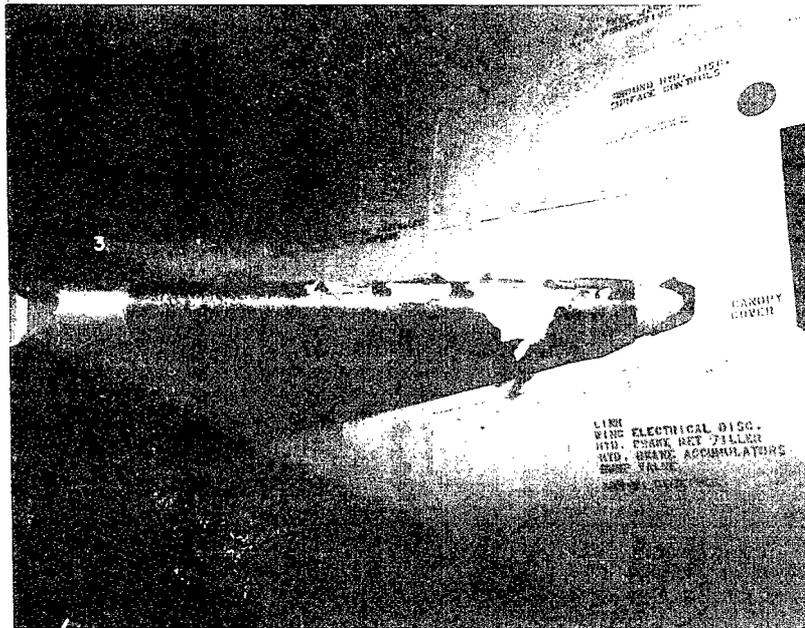
Figure 62. Severe Breakdown on Deicing Boot on Right Wing Observed After Flight 13

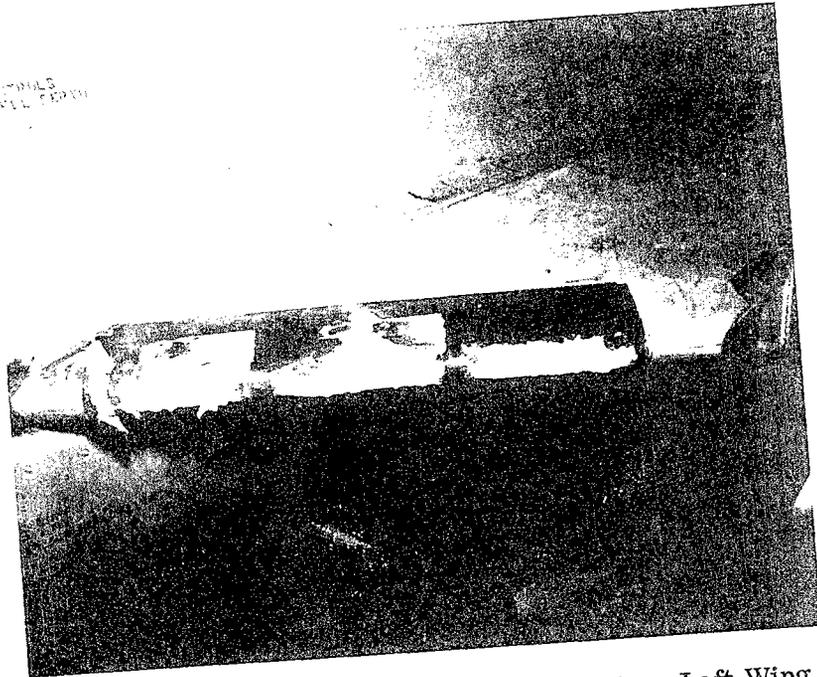
Figure 64. Complete Breakdown of Deicing Boot on Left Wing After Flight 16

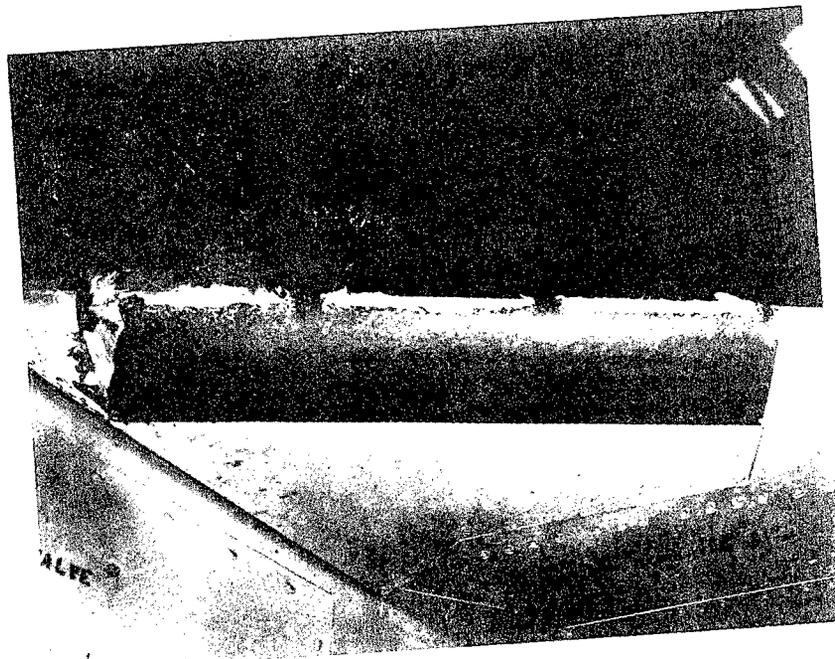
Figure 65. Section of Deicing Boot on Lower Surface of Left Wing Received Little Damage on Flight 16

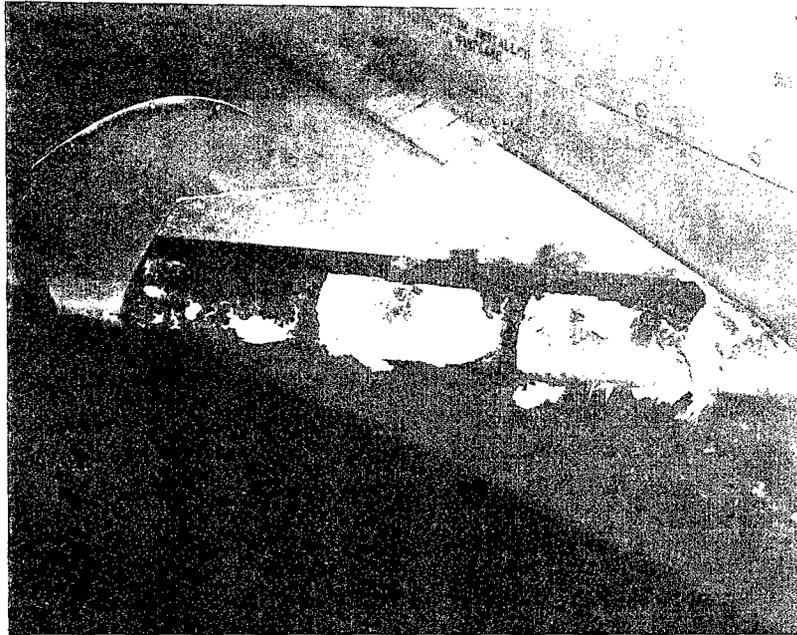
Figure 66. Surface of Deicing Boot on Upper Leading Edge of Wing Severely Damaged During Flight 16

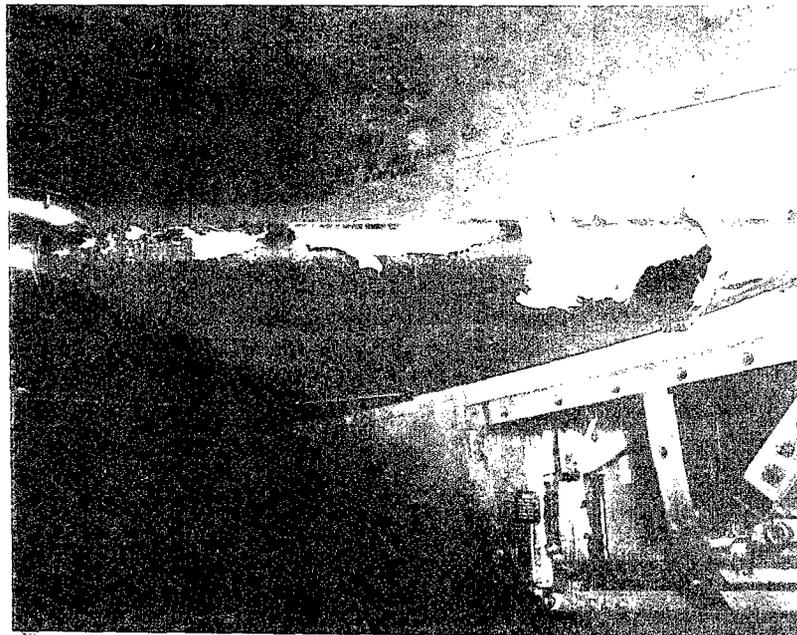
Figure 67. Surface of Deicing Boot on Lower Surface of Right Wing Leading Edge Not Damaged as Much as the Section on Top of Wing

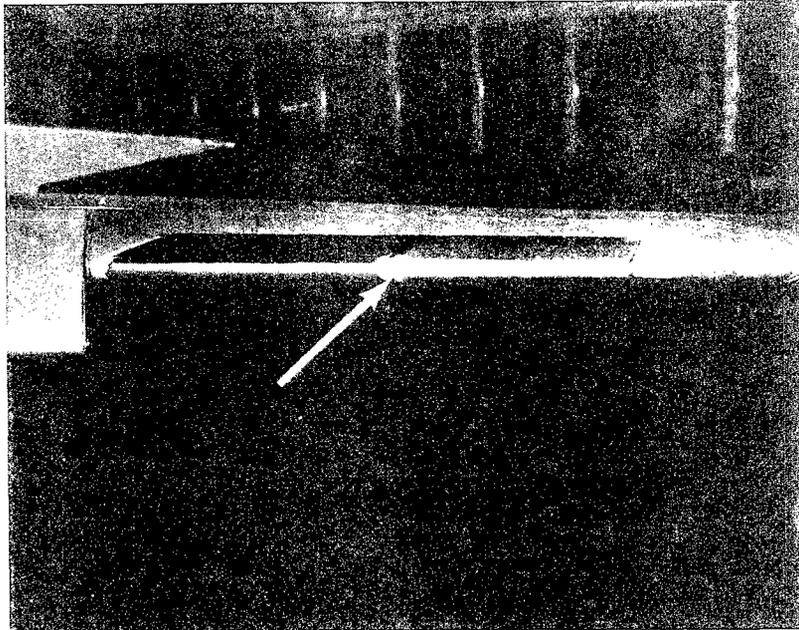
Figure 68. Goodrich Samples 1 and 2 on Left Wing Tip Show Little Adverse Effect After Flight 16; the Arrow Indicates Slight Damage to Inboard Edge of Sample 1

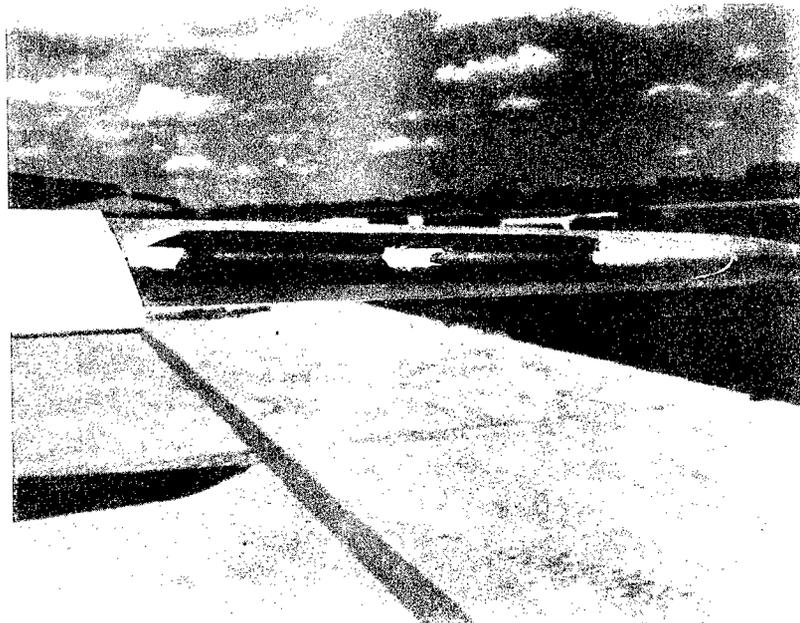
Figure 69. Final Damage Received by Goodrich Samples on Left Wing Tip

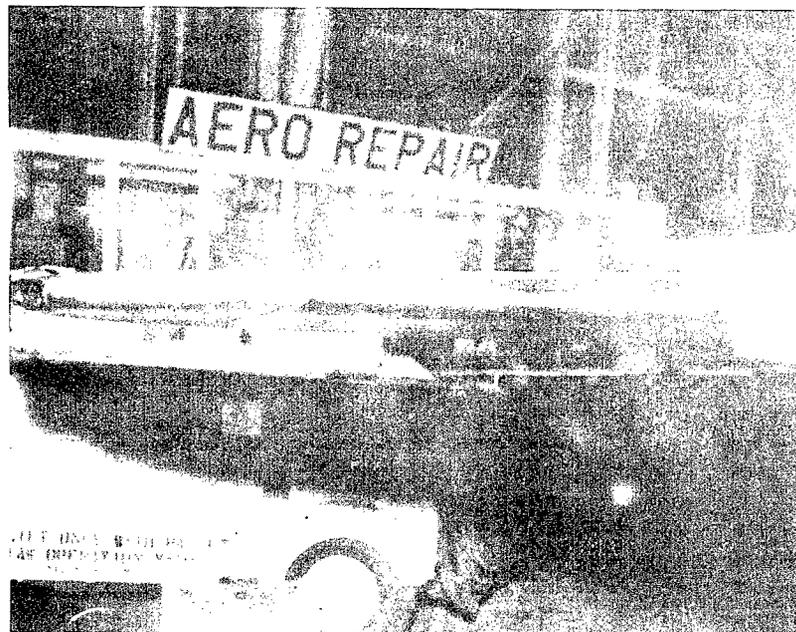
Figure 71. Inboard Sample on Right Wing Tip With Torn Leading Edge After Flight 13

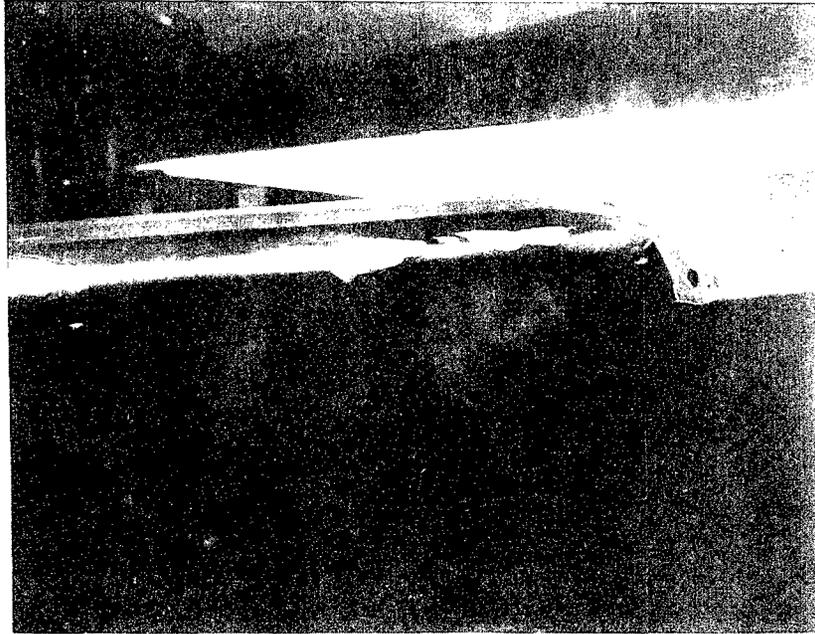
Figure 72. Samples 3 and 4 on Right Wing Tip After Flight 16

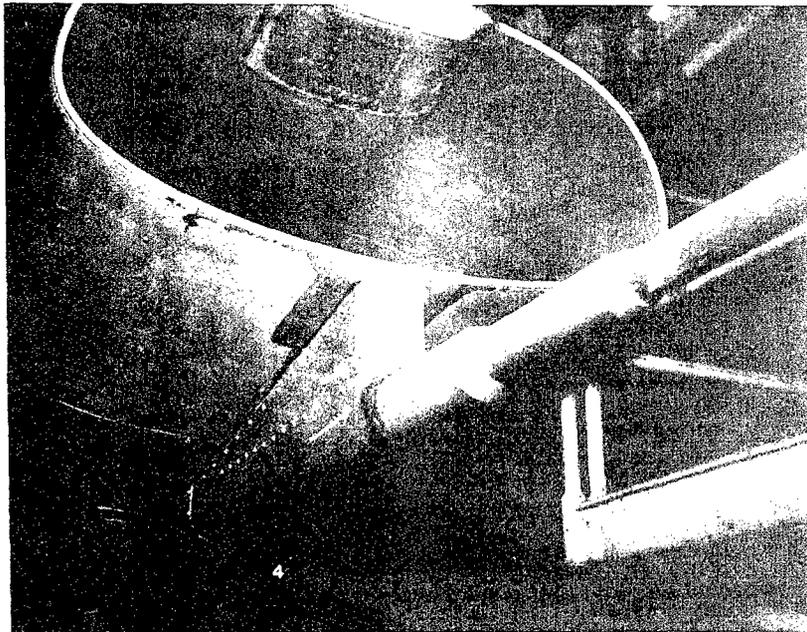
Figure 74. Damage to Goodrich Sample on Noseboom Mount During Three Flights
