Technical Note N-1044

PROTECTION OF FLOATING PONTOONS FROM CORROSION -- PART III.
CONDITION OF TEST FLOATS AFTER THREE YEARS

August 1969

NAVAL CIVIL ENGINEERING LABORATORY
Port Hueneme, California 93041

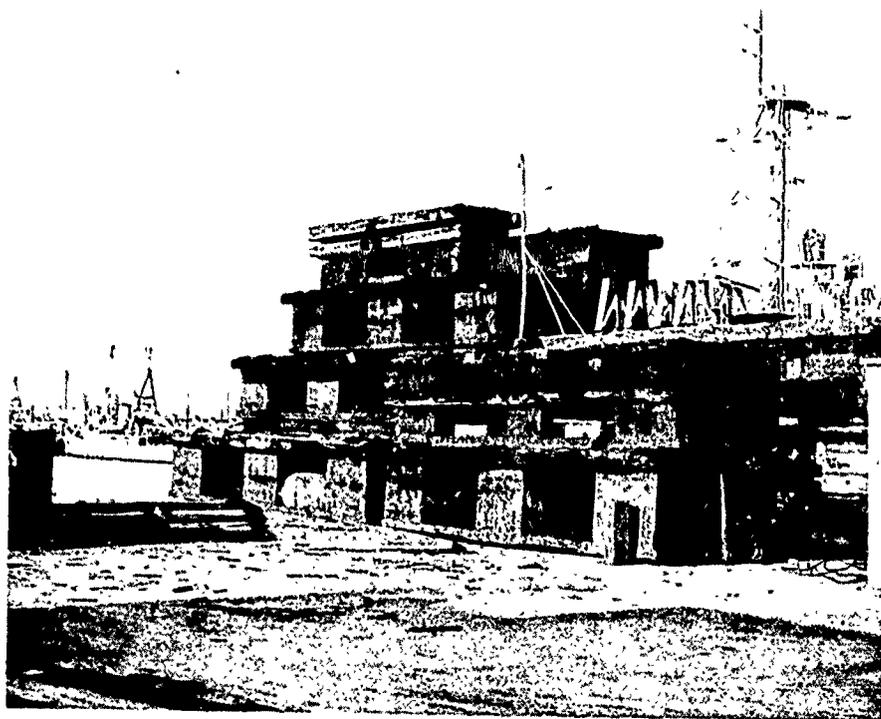
Much of the damage to camel floats occurs below the water line (Figure 2), causing them to sink. Thus, cathodic protection was also investigated in this study as a means of extending the service time of the floats before required overhaul and further reducing maintenance costs.

Figure 2. Deteriorated pontoon camel floats removed from service.

The greatest cause for removal of pontoon floats for repair or scrapping is the flooding of pontoons through holes caused by corrosion or impact. Filling of pontoons with polyurethane foam would render the floats unsinkable and would greatly extend their service lives. A study of the costs of such foams and the increased service lives of floats filled with them would be necessary for justification of their use.

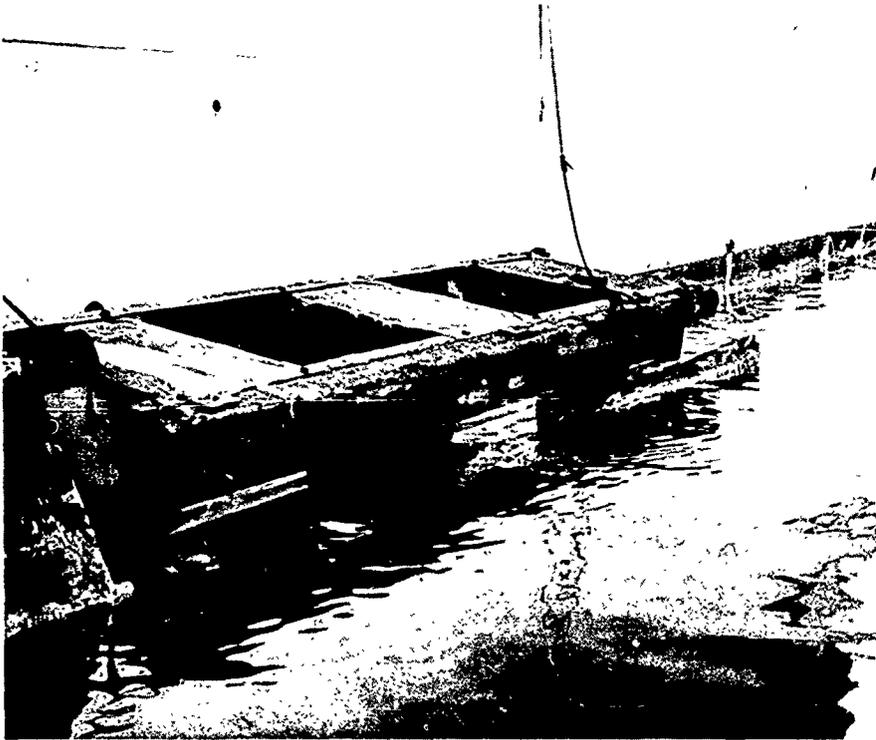
The upper wooden fenders of Float No. 01 were still in good condition, but those located below water had suffered severe marine borer attack at their bolt holes and had been torn partially from the float (Figure 5).

Figure 5. Pontoon No. 01 secured to hull of ship.

3. On floating steel structures rubber fenders should be used underwater in place of wooden fenders subject to marine borer attack.

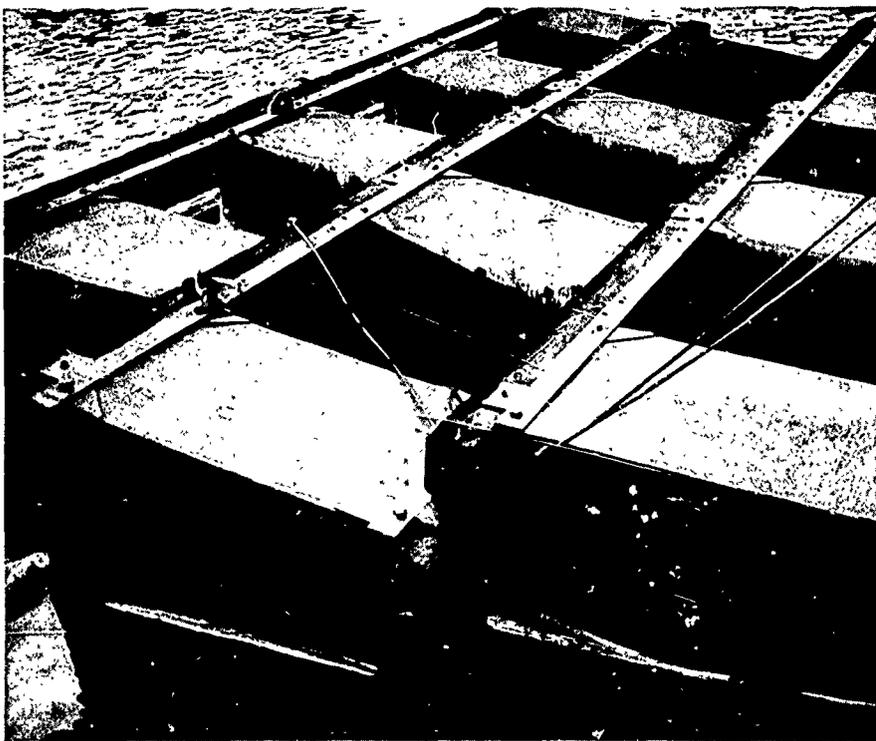
The relatively rapid loss of fenders below water is caused by marine borer attack where untreated wood is exposed at cut ends (Figure 6) and at bolt holes. This can be avoided by making the necessary cuts before treating the wood (e.g. pressure creosoting). Probably a much better system is to use hard rubber fenders rather than wooden ones. Such fenders are available in a variety of sizes and shapes and have performed well on mooring buoys both above and below water.²⁵ They are resistant to marine biological attack and absorb impact and abrasion better than do wooden fenders.

Figure 6. Untreated wood exposed at cut ends of camel fenders.
