DEPARTMENT OF THE ARMY  
ARMY CONCEPT TEAM IN VIETNAM  
APO San Francisco 96384

2 FEB 1970

SUBJECT: Final Letter Report - Night Flying Control System for UH-1

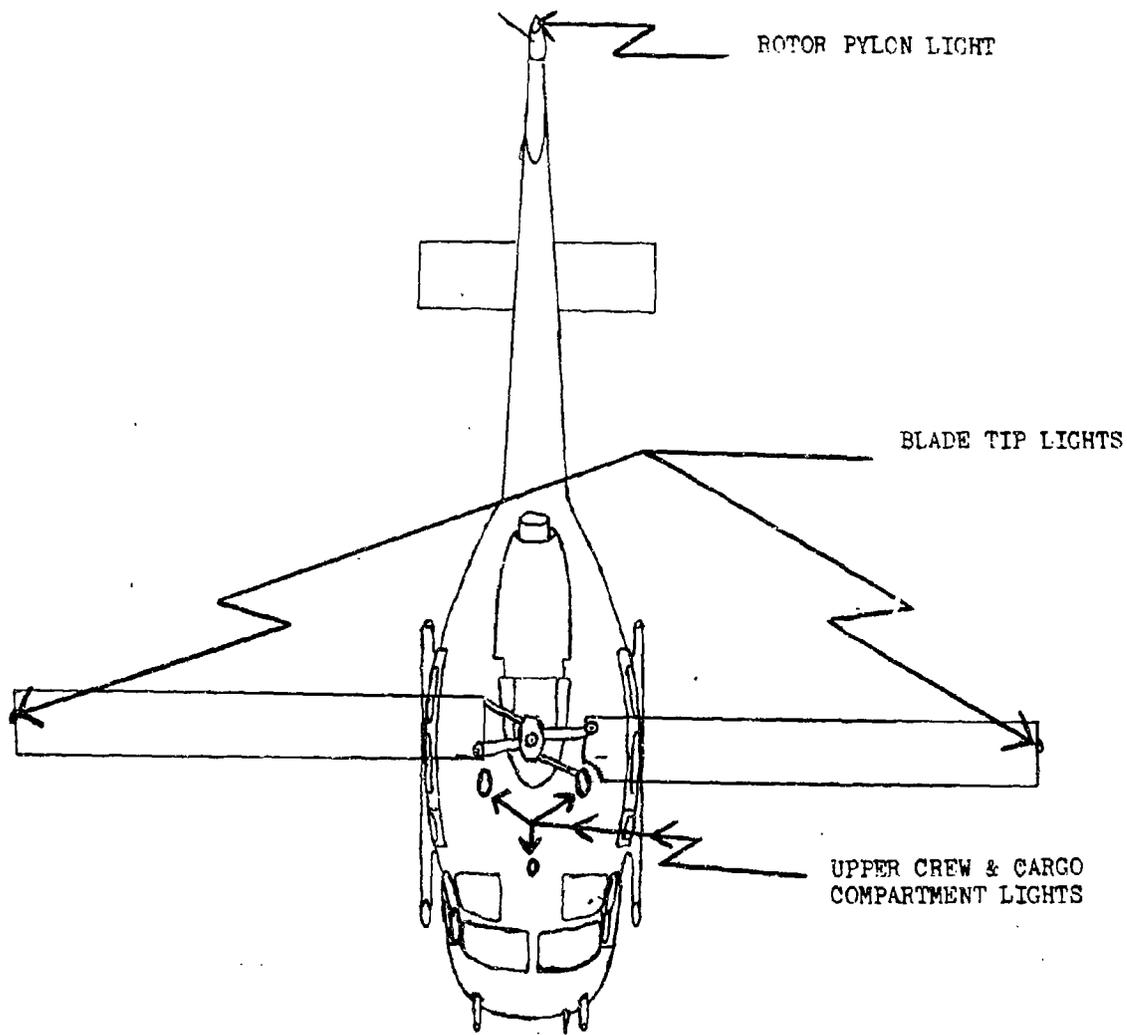
FIGURE 1.

Installation of Lights on Blades and Fuselage.

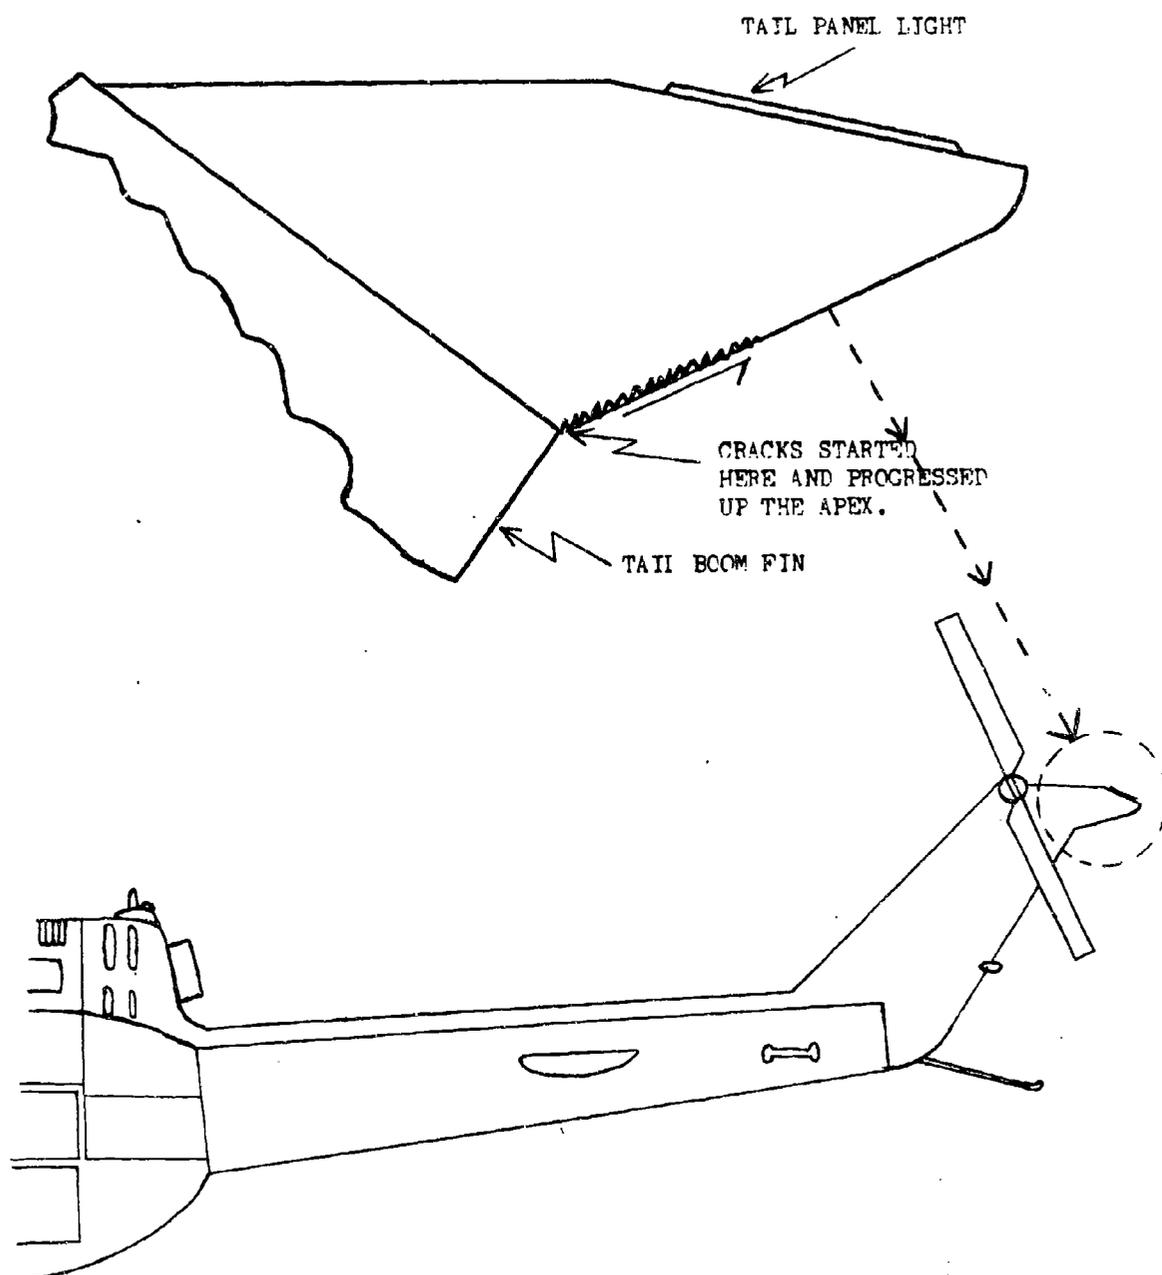
FIGURE 6. Diagram of Crack on Tail Boom Pylon.

(2) All fuselage light systems worked with no failures. One panel light was cracked, presumably when someone stepped on it. Three out of six tail pylon panel light mounts cracked along the rear edge. A simple repair job using a strip of fiberglass to reinforce the weakened area corrected this problem. (See Figure 6)

(4) The FM antenna support mount on which the rear panel light is mounted developed cracks and should be made of stronger material.
